BAT SURVEY

**AT
53 KNOWSLEY ROAD
WILPSHIRE**

**DATE AND TIME OF VISIT
7th MAY 2015 8.30 - 10.00 pm**

REFERENCE NO. 4186 EVENING SURVEY

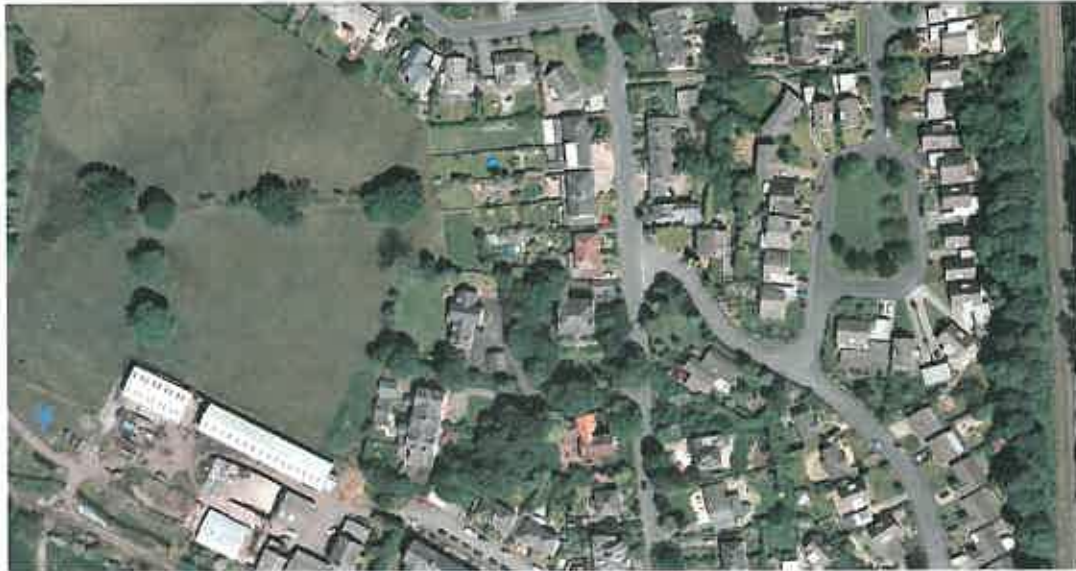
COMMENTS: The house is located in large mature garden extending to the west, south and east, an adjacent house being located close to the north boundary. This aerial photograph does not accurately represent the current planting in the garden, some of the trees have been removed from the site. Mature trees are located in the adjacent gardens. There is medium level foraging potential in this location.

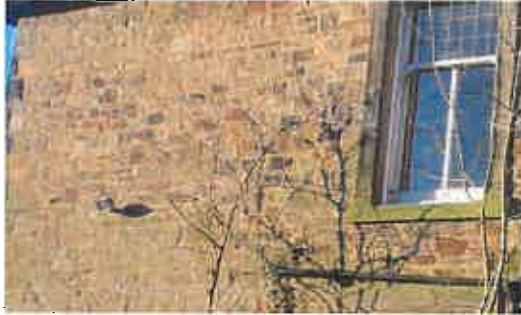
COMMENTS: The walls are stone to the South and East elevation with brick to the West and North.

COMMENTS: The house pointing is in good condition with no cracks or crevices for bat access. The garage has access via a door opening and a gap above the garage door opening.

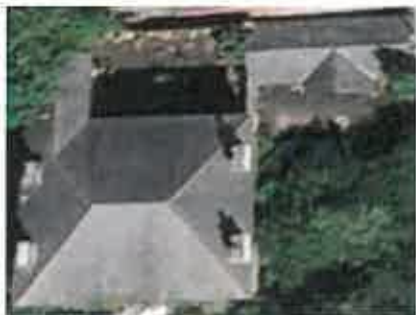
COMMENTS: The roof construction is slate with overhangs, fascias and boarded soffits. The main roof is a hipped construction with a pitched roof outrigger. The outbuilding has a pitched roof with a gable over the central garage section.

COMMENTS: The house roof slate is in reasonable condition with no significant access points for bats. However on the North and West outrigger elevation the timber soffits are in poor condition with possible access points. The outbuilding roof slates although not in perfect condition does not have any significant access points.

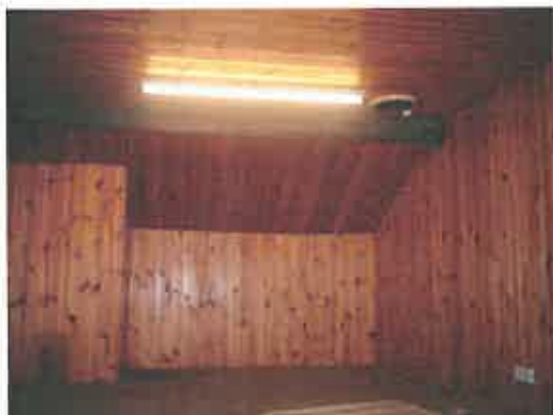
Boarded roof space

COMMENTS: The house roof was accessible via two hatches, the main hatch opens into a boarded out roof space located in the centre of the main roof. The second hatch allowed access to the roof space towards the eaves behind the boarded area. The outrigger roof space was not accessible.

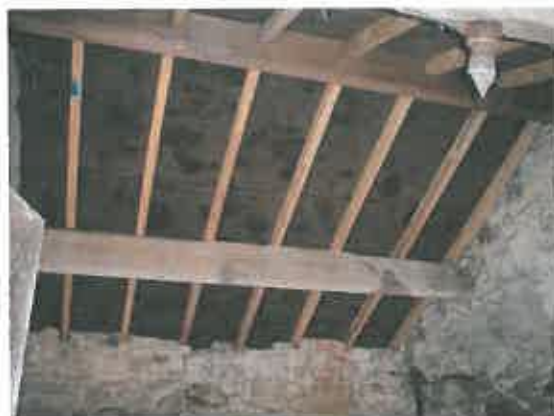
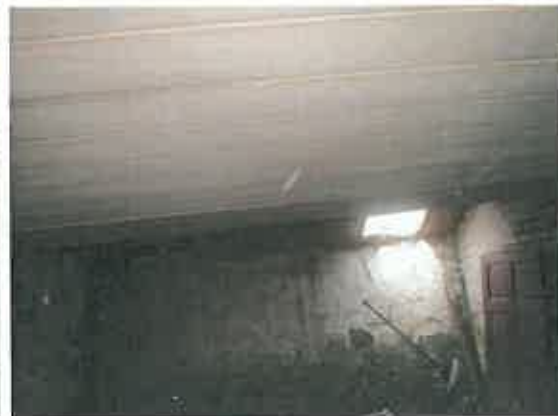
The outbuilding roof has felt and purlins and is open to the underside, the garage section has a boarded ceiling

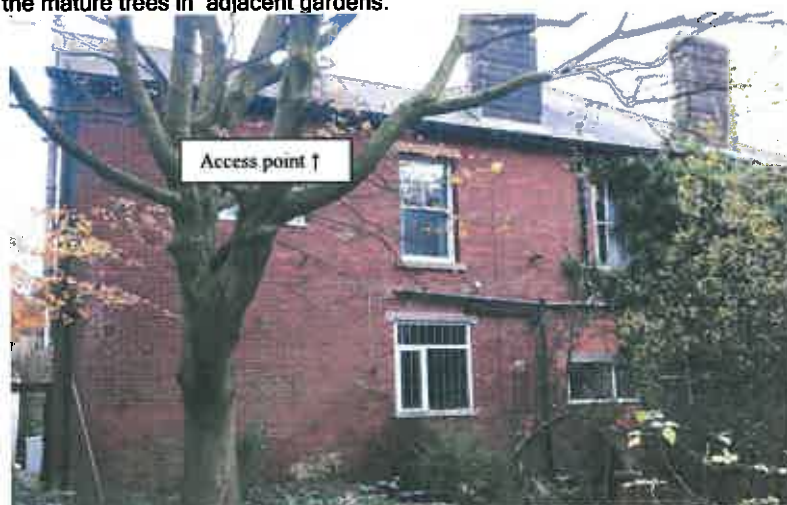
The evening survey recorded low level bat activity emerging from the brick outrigger eaves soffit, commencing at 9.40pm this emergence activity continued until 10.20 pm approx 6no bats (pipistrelle) emerged to circle over the garden adjacent to the west elevation and commute forage from the house in a south westerly direction towards the mature trees in adjacent gardens.

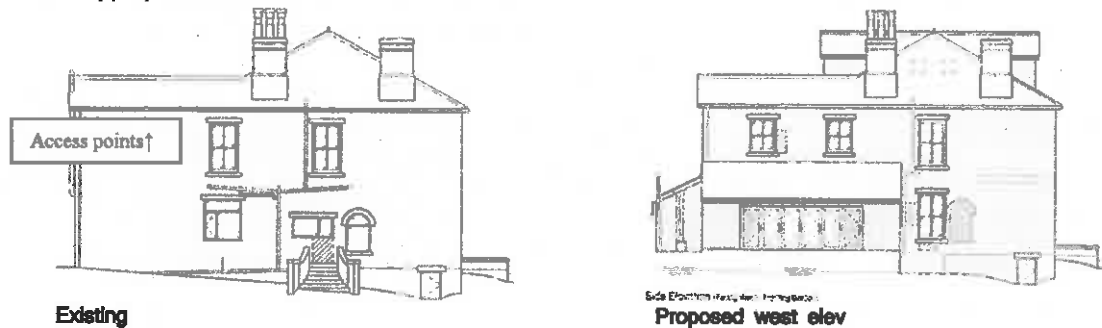
Elevations to illustrate the location of access points

The number of bats recorded emerging from the building indicates that this is a very small roost located behind the fascia boards (roof not accessible to determine if bats have accessed the roof void). This section of roof is not being affected by the extensions or adaption to existing loft roof, the fascias on this elevation will not be disturbed. However it is recommended that the mitigation listed below be followed and carried out.

- Summary of mitigation strategy: - The proposed work will not result in the loss of the existing roost. The existing access points behind the fascia as indicated on the elevations **MUST NOT** be affected by the extension of the existing roof room.

- Timing constraint: In order to limit any disruption to the local bat population **work on in the roof room should be carried out during the September - April period when no bats are present.**

- If any slate removal is required a Licensed ecologist/bat worker should inspect the affected roof space prior to commencement of slate removal. If in the event any hibernating bats are found, work must not commence until a mitigation License has been issued from **Natural England**.
