Desk Study Report

**Mearley Brook
Clitheroe
Lancashire**

Beck Developments Limited

J11218

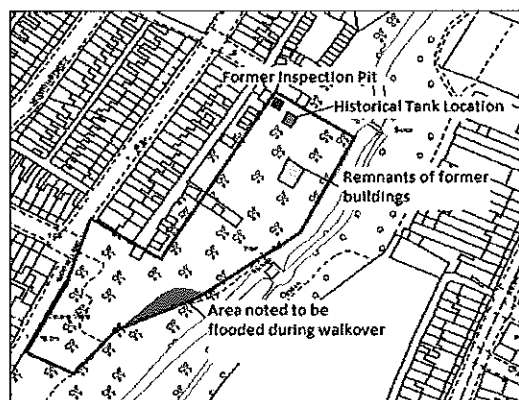
The fly tipped material noted at the site was generally observed to be demolition rubble; this rubble contained some fragments of corrugated cementitious panels which may

contain asbestos.

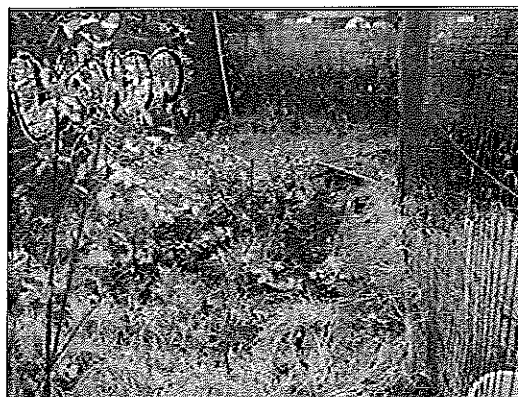
The photograph opposite shows what appears to have been a vehicle inspection pit, which is filled with demolition rubble and water.
