**ARBORICULTURAL REPORT
AND
ARBORICULTURAL IMPACT ASSESSMENT
to BS 5837:2012
at
Malt Kiln Brow
Chipping
Near Clitheroe
Lancashire**

Client:
SCPi Bowland Ltd.

JCA Ref:
12407/AJB

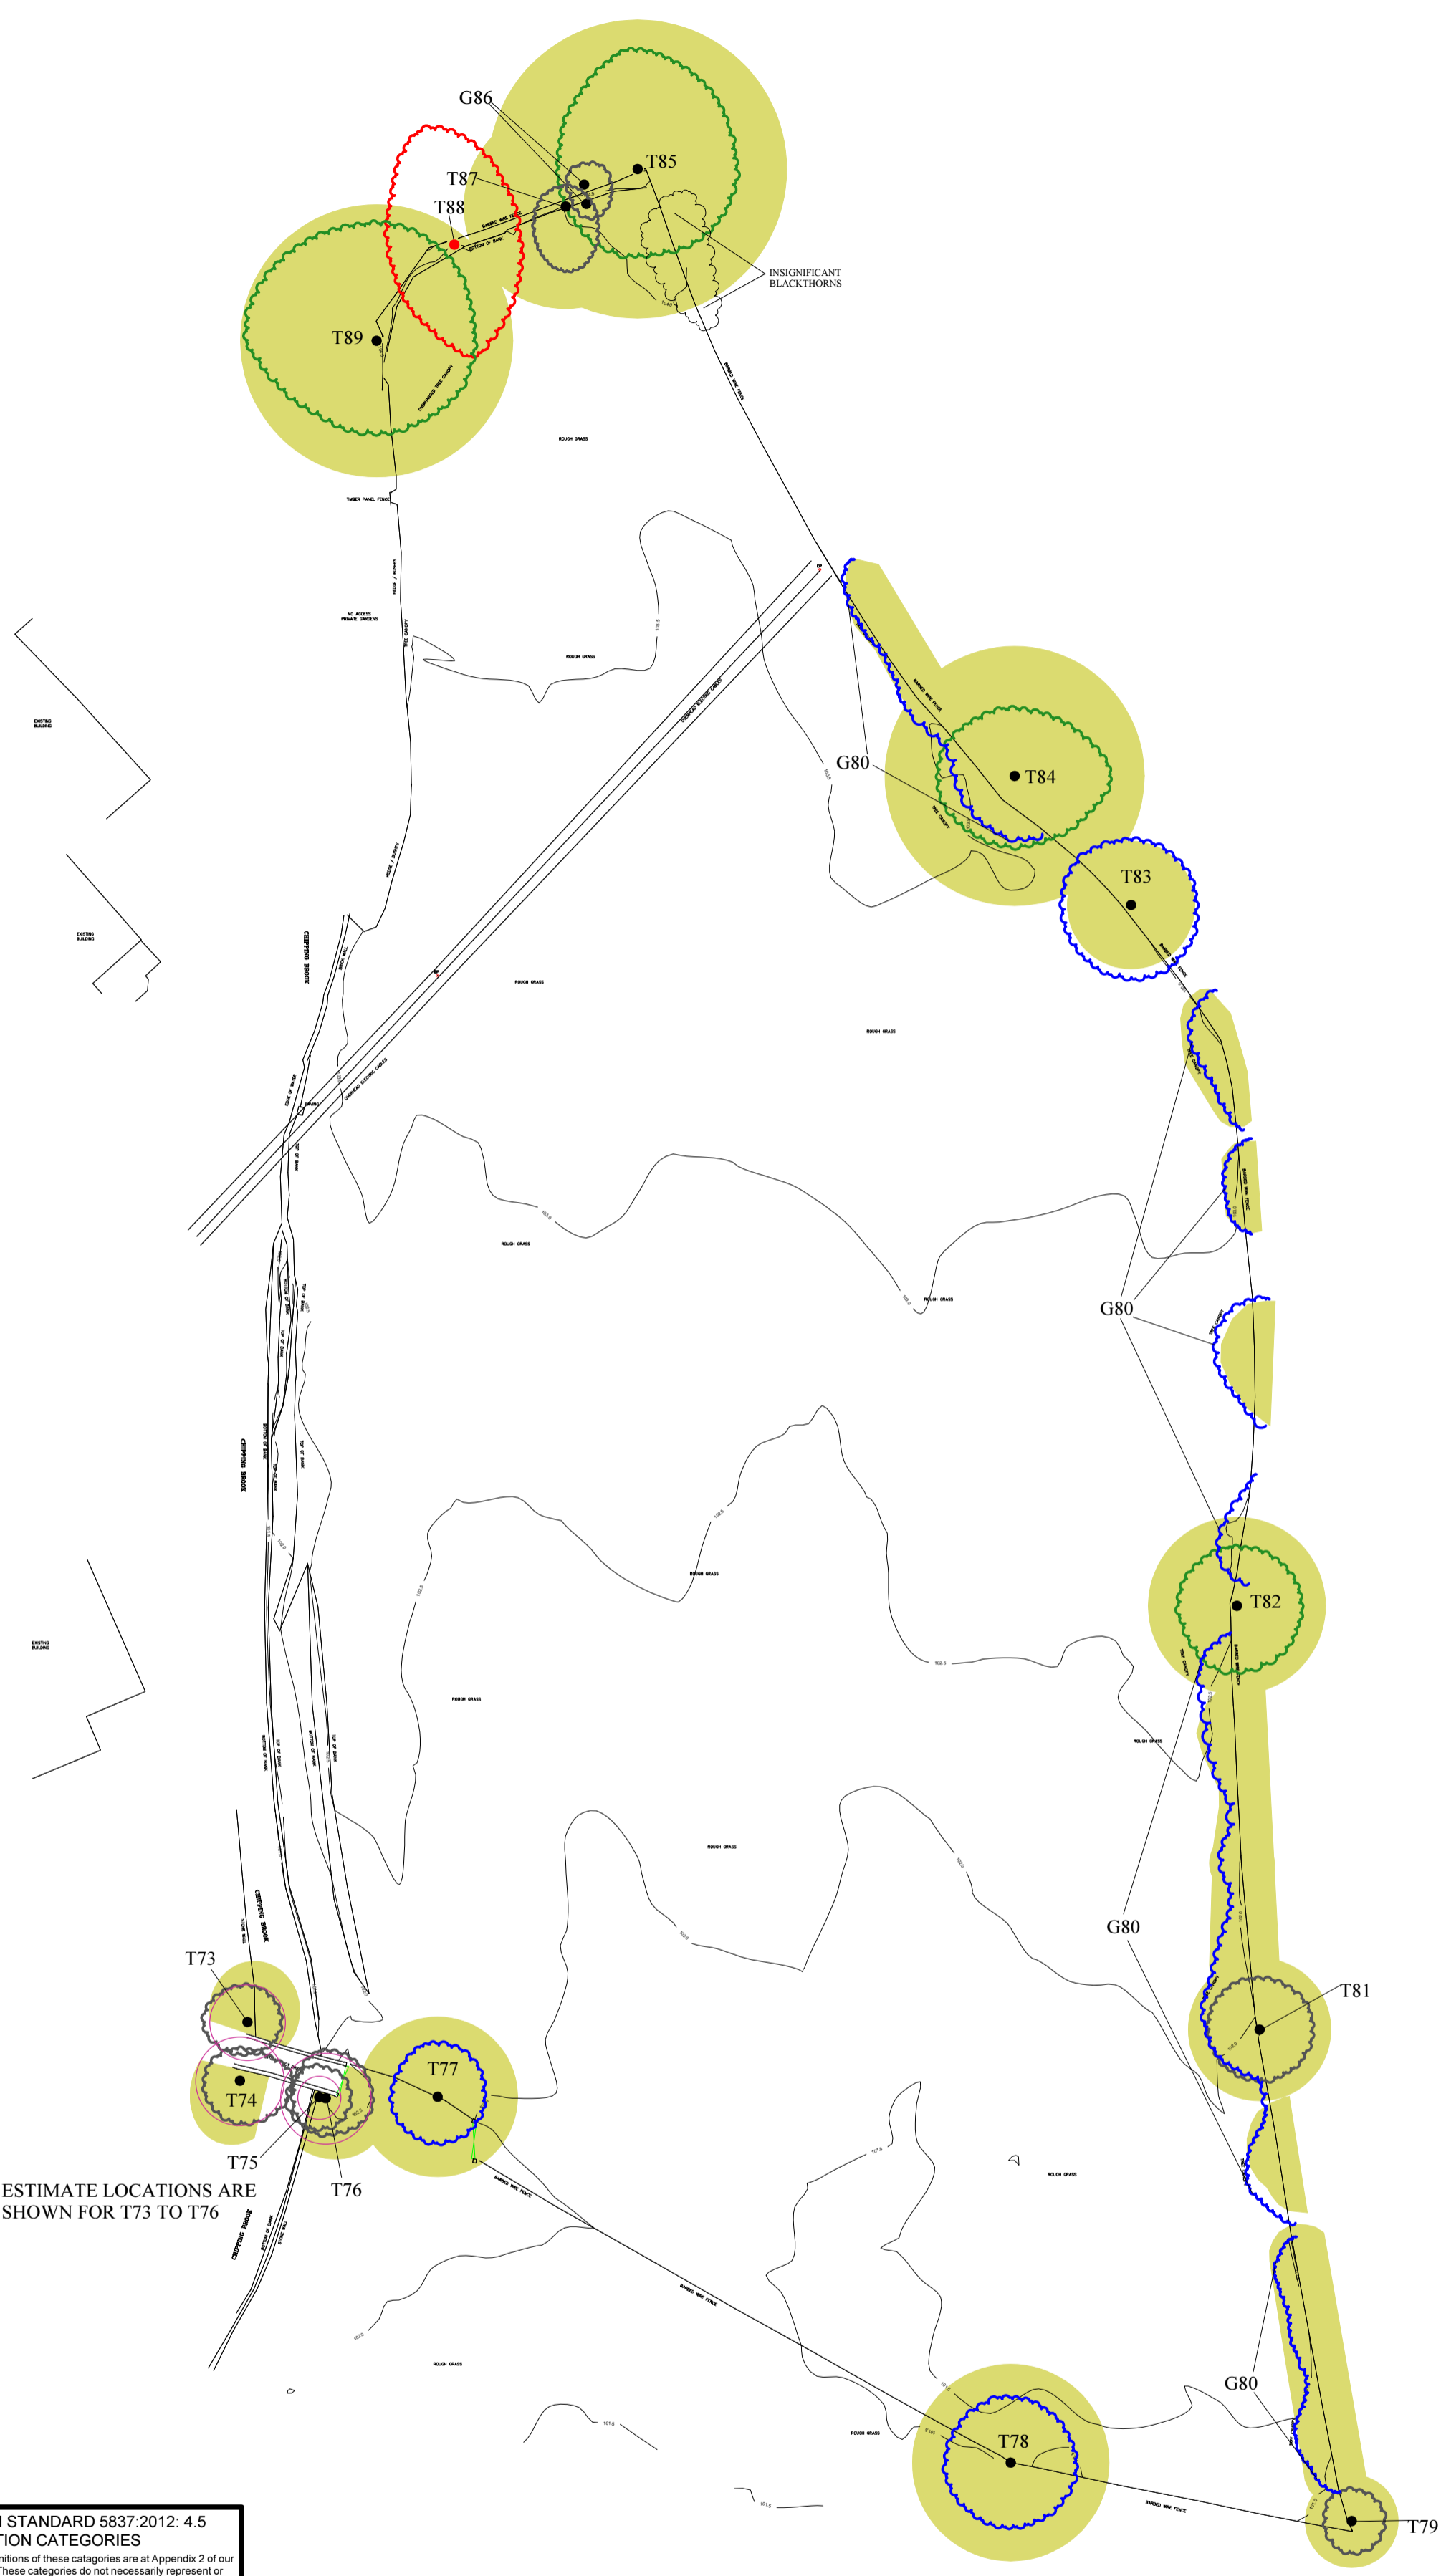
**Appendix 6: Site-B
Tree Constraints Plan**

ESTIMATE LOCATIONS ARE SHOWN FOR T73 TO T76

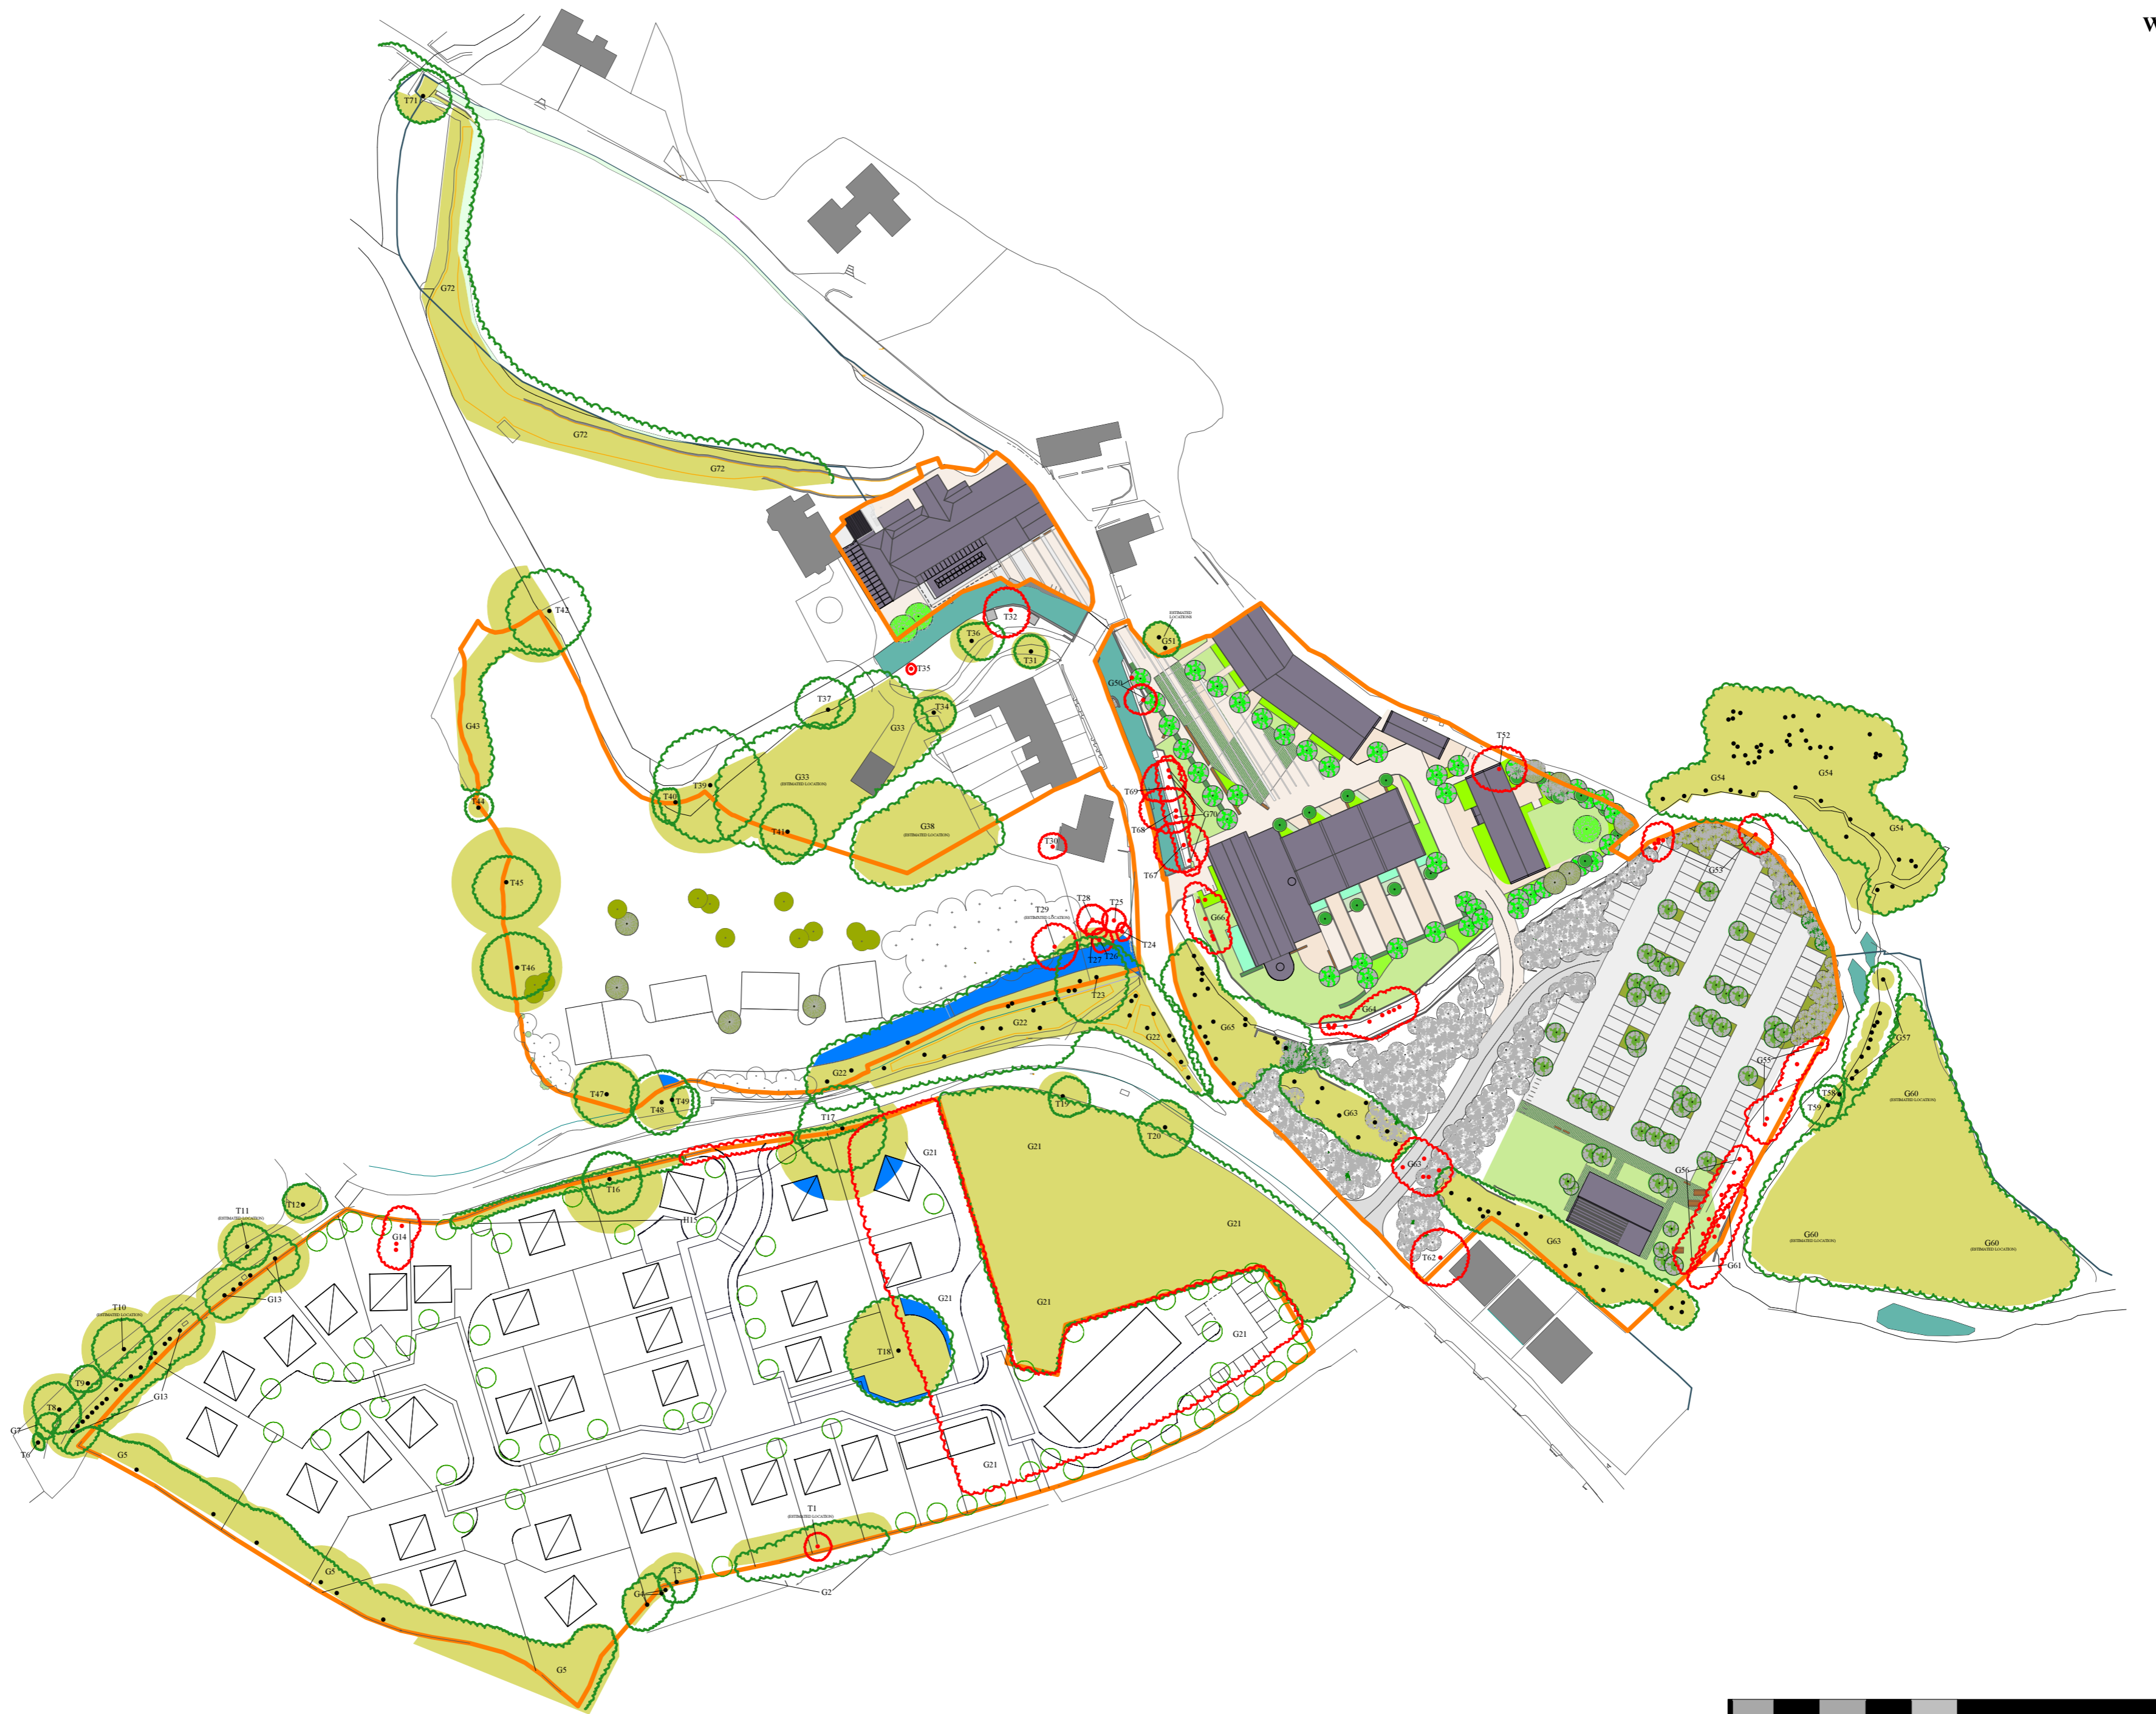
**Appendix 7: Site Plan-A
Development Proposals**

- 6.3.7 Areas where work is required within the RPA of a retained tree are highlighted in **blue** on the Development Proposals Plan at **Appendix 7**.
- 6.3.8 Where utilities need to be brought onto the site, these should ideally be routed away from the RPAs of the trees. Where this is not possible, methodologies on the installation of underground services without damage to tree roots should be considered. All service providers should be consulted prior to commencement of works with the aim of minimising the number of service runs on the site.
- 6.3.9 The site compound, which typically includes the site office, mess facilities, toilets, storage of materials and parking, must be located away from the trees and outside the RPAs. Care should also be taken to prevent soil contamination with chemical spillages, including petrol, diesel and oils.

- 6.3.6 New buildings are proposed adjacent to **T17**. Where the new buildings encroach into the RPA of this tree, in order to minimise root damage, special engineering techniques, such as pile foundations, must be adopted in favour of the more traditional strip foundations.
