11 February 2016

Land at Higgins
Brook, East of
Chipping Lane,
Longridge – Phase 1

Bat Inspection Report
for Discharge of
Condition 19

Report Number: 2001_R16_PM_LP

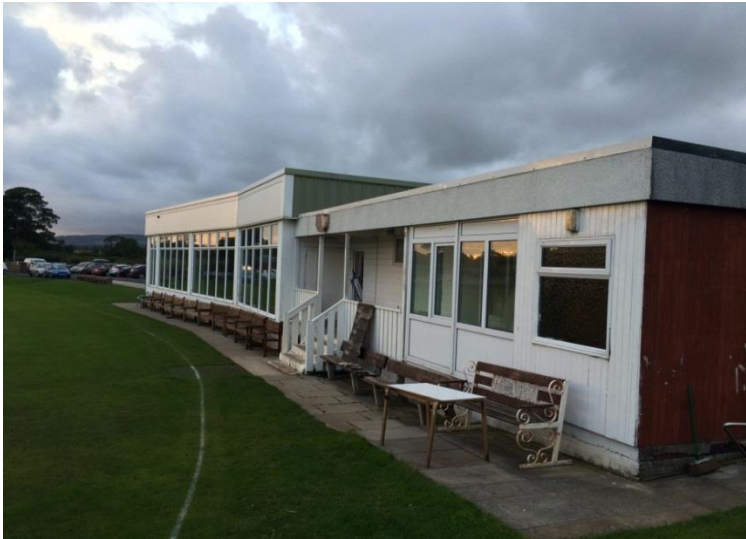
Plate 3.1 showing the exterior construction of the cricket pavilion

Building	Description	Assessment
Cricket Club	Single- storey stone building with flat steel/ iron roof. Occasional gaps behind steel fascia boards and wooden soffits which may offer some potential access point for bats.	Low Potential – Category 3

- 3.4 The cricket pavilion was found to have low potential to support roosting bats due to the limited presence of suitable features. No evidence of use by bats was recorded during the building inspection.
