ARBORICULTURAL DEVELOPMENT REPORT

**ON TREES LOCATED ON AND ADJACENT TO
TRACK OF PROPOSED NEW DRIVE TO PROPOSED RETREAT CENTRE
AT STONYHURST COLLEGE.**

November 2016

**TREE CHECK LTD
252 LEYLAND LANE
LEYLAND
LANCS
PR5 3HL**

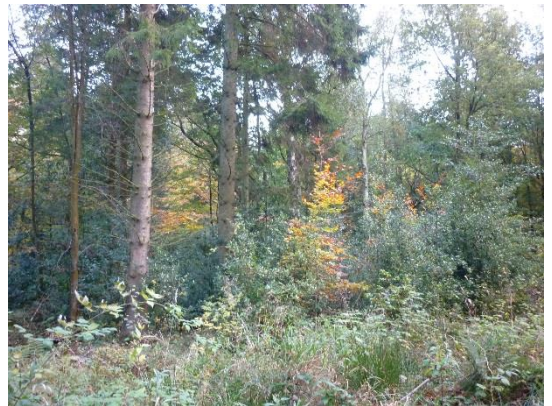
6. The dominant species within the woodland is alder followed by young ash and birch. The alder has readily developed coppice and basal growth and has responded to the wet conditions. The area is scattered with windthrows of spruce, alder and birch with shallow root plates uplifted and with the exposed water table showing below.

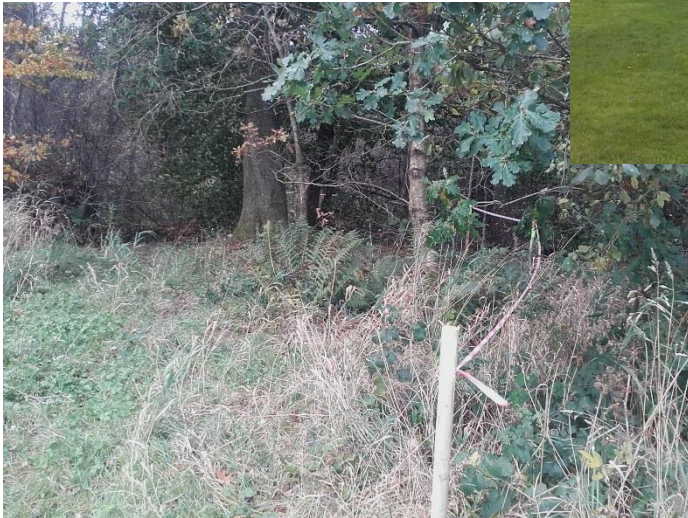
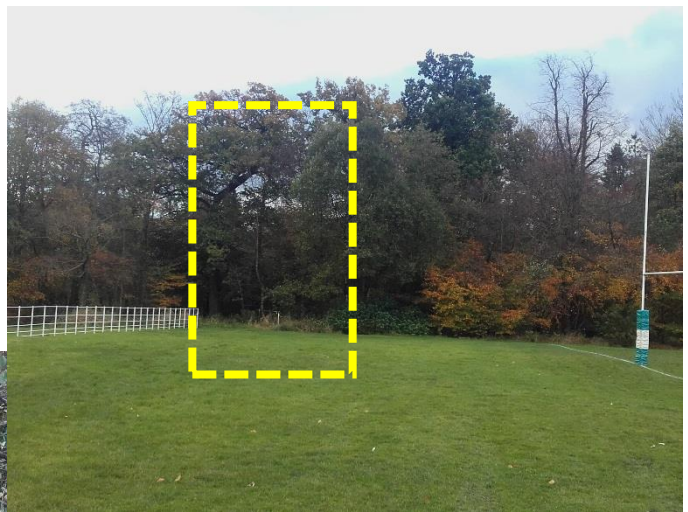
P1 Entrance of road into woodland and as viewed from existing drive:

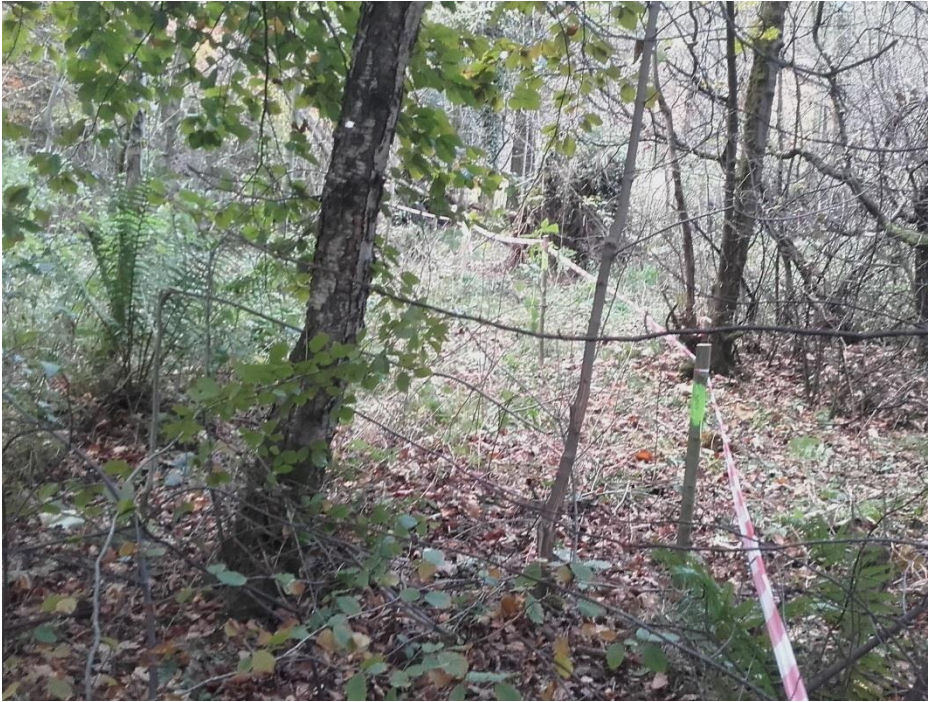
P2/3/4 Showing young regrowth and old windthrow to left

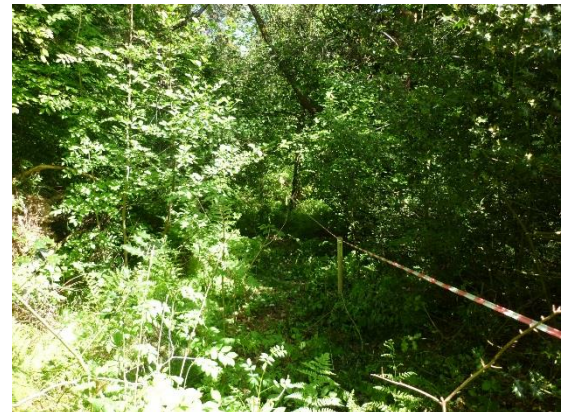
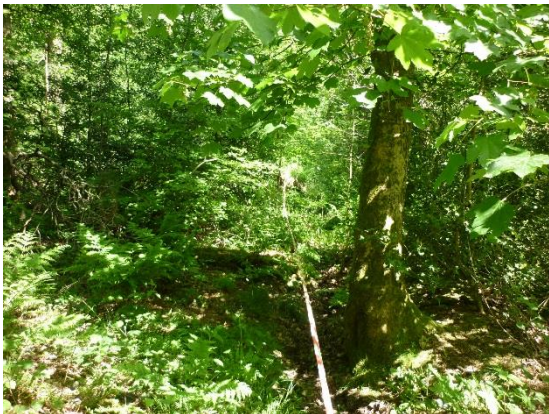
P8/9 showing young regrowth close to past windthrows

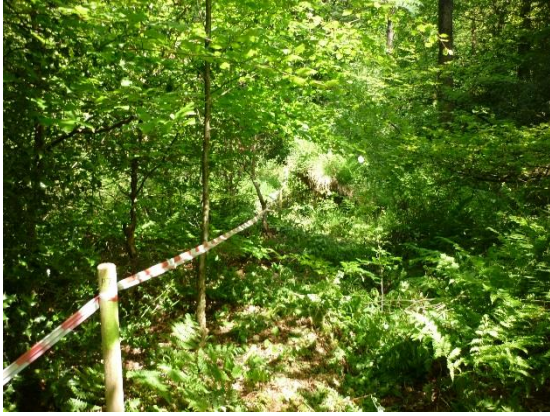
P10 Showing ground dropping away towards stream

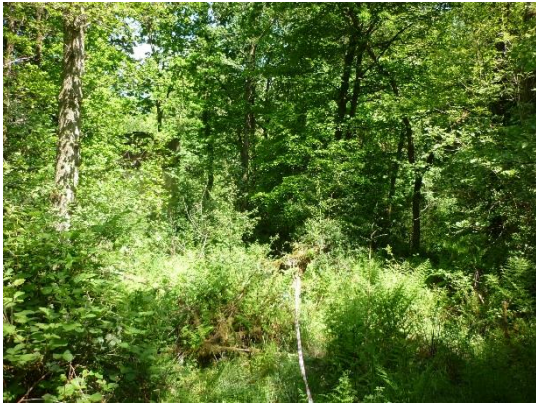
P11/12/13 showing young ash and beech regrowth

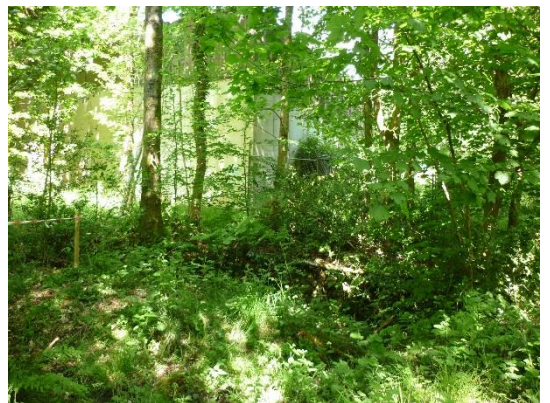
P14 Showing last post with stream side trees and existing building beyond
