# HERITAGE STATEMENT

Crabtree Cottage  
Back Lane  
Wiswell, Clitheroe  
BB7 9BU

NOVEMBER 2017

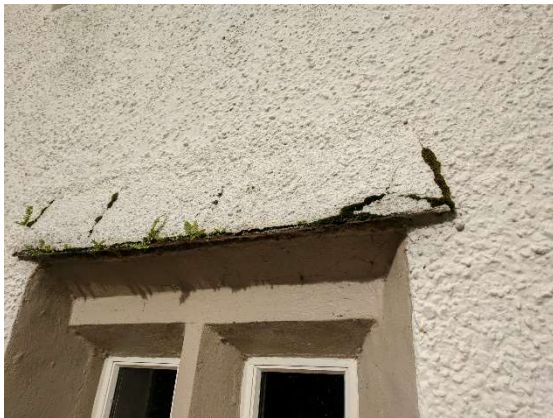
Figure 2 - Moss growing in cracks of render, allow water to sit in the cracks and penetrate further in to the fabric of the building

The existing sand and cement render is to be removed using hand tools only and the waste is to be disposed of appropriately offsite. From inspection there are large areas of delamination of render from the face of the building. This will mean that there will be minimal additional damage caused by the contractors when removing the render. The structure of the existing building will then be checked and any areas of disrepair are to be repaired using appropriate conservation methods. Original fabric will be retained in-situ and be conserved and repaired with replacement only done as a last resort. The building will then be re-rendered using a sand and cement render as per the removed render. The render will have a smooth sponge finish to it. Then the new render will be finished with Dulux Weathershield Smooth Masonry Paint. The colours are to be as per the existing removed render.

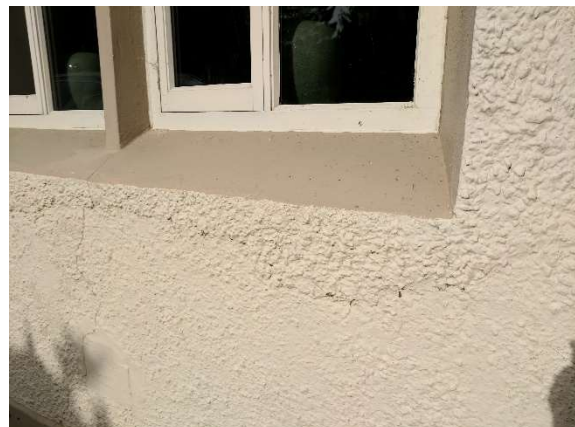
Figure 1 - Patched render, highlighting previous repairs

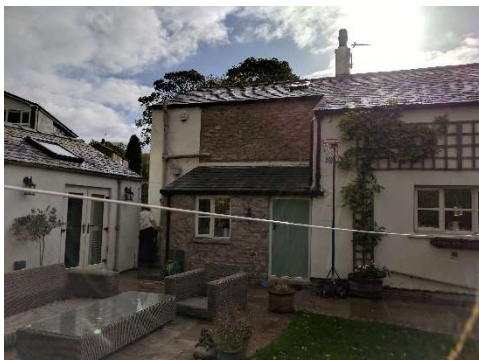
Figure 3 - Areas where render has fallen off previously, then cleansed off by applicant until Planning Application has been submitted

The current owners of the property have been living in the property for over a decade and have been gradually carrying out improvements to the property both internal and external. After the issues with the render to the rear of the property (shown in Figure 3 previously) they have realised that the render requires renewing as a whole to prevent further damage to the fabric of the building.
