320171110P

*ecological*

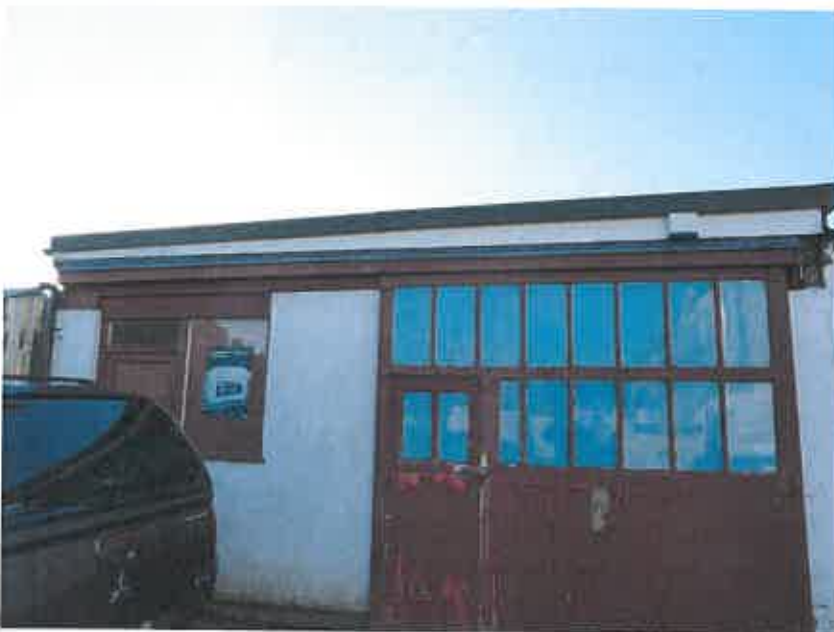
**Photograph 1: Typical view of the front (north elevation) of the building.**
