**DESIGN & HERITAGE STATEMENT
IN CONNECTION WITH
29 AND 33 WINDY ST
CHIPPING
LANCASHIRE**

**ON BEHALF OF
THE BRABINS TRUST**

(LM/LM/1608/02)

John Brabin's Almshouses

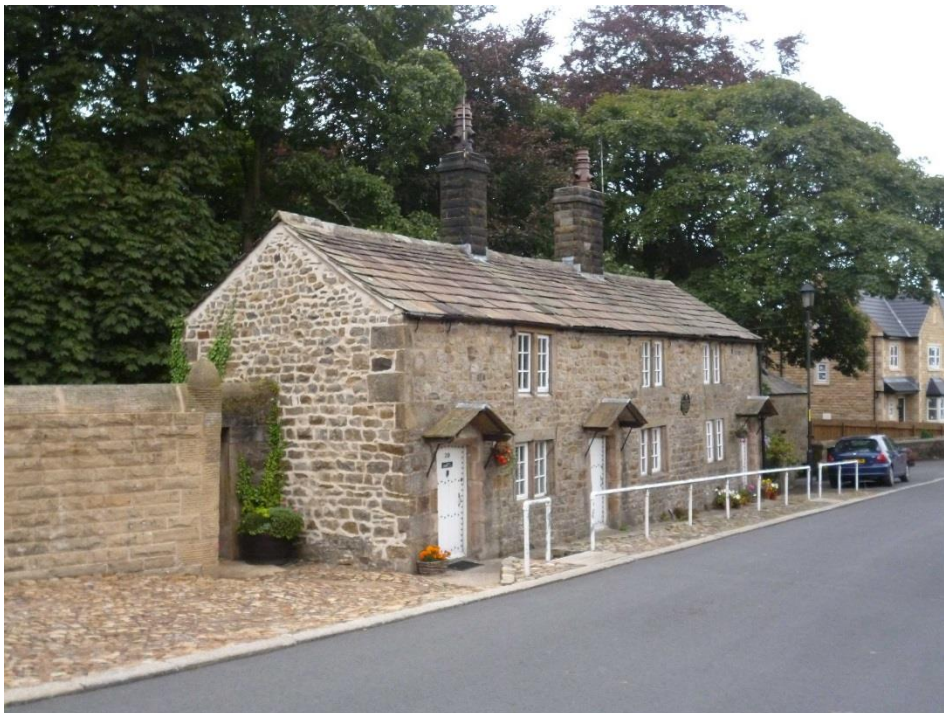
Photo 01 - View from Longridge road, showing 29 and 33 Windy Street.

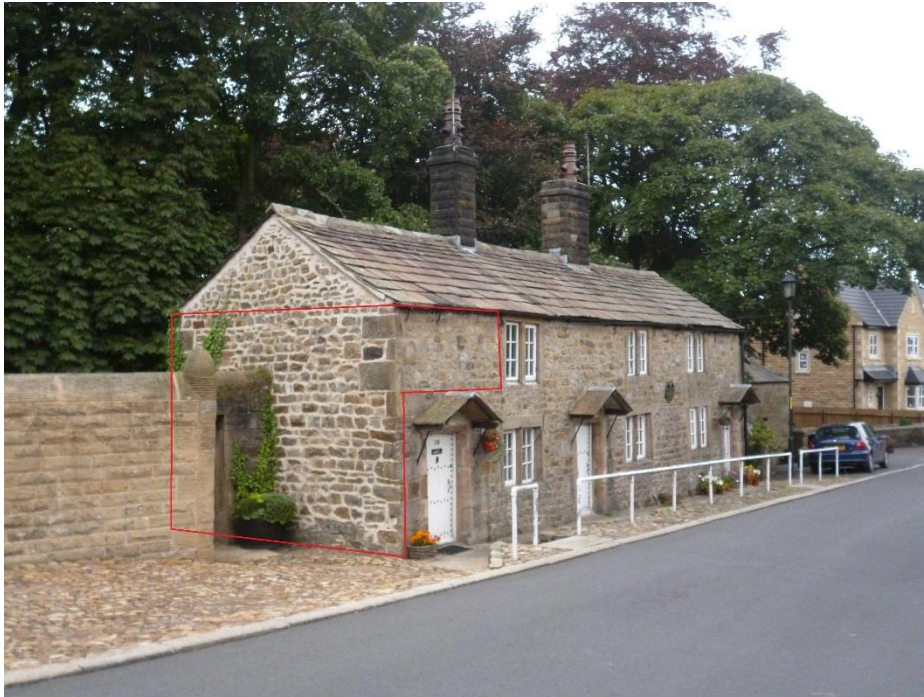
Damp penetration has occurred within the property at 29 Windy Street, at low ground floor level to first floor. It is understood that external repointing and internal re plastering works have been undertaken previously and it is believed a cement based plaster and mortar have been used, although this has been unsuccessful due to its unsuitability with the stonework and has failed in preventing further damp from occurring due to the cement mortar being impermeable therefore not allowing the building to breathe.

Damp is visible across the cottage along the interior walls, increasingly towards the northern facing gable, specifically around the staircase. This can also be seen across the first floor northern facing elevation and the areas surrounding the internal chimney flue. Damp penetration is visible throughout these areas in the form of damp staining and efflorescence. A moisture meter was also used on the internal walls visibly effected by damp staining and high readings were recorded even in summer with minimal recent rainfall.

Photo 02 - Showing the front and side elevation to be repointed inside the red highlighted area.

To avoid a loss of character and retain the appearance of the conservation area, it is proposed that a lime mortar is used for the external repointing as this is most compatible with the original stonework and would have been used originally on the Almshouse itself. Lime mortar is also porous and should allow for the building to breathe and allow water to permeate out of the building, reducing the damp on the internal walls.

The process of raking out the cement mortar will be done using hand tools and low impact tools only. Heavy machinery and angle grinders will not be used due to the risk of damaging the original stonework. Although only using hand tools and low impact tools does not completely eliminate the risk, it is thought the chances of damage are very low and any damage would be minor.

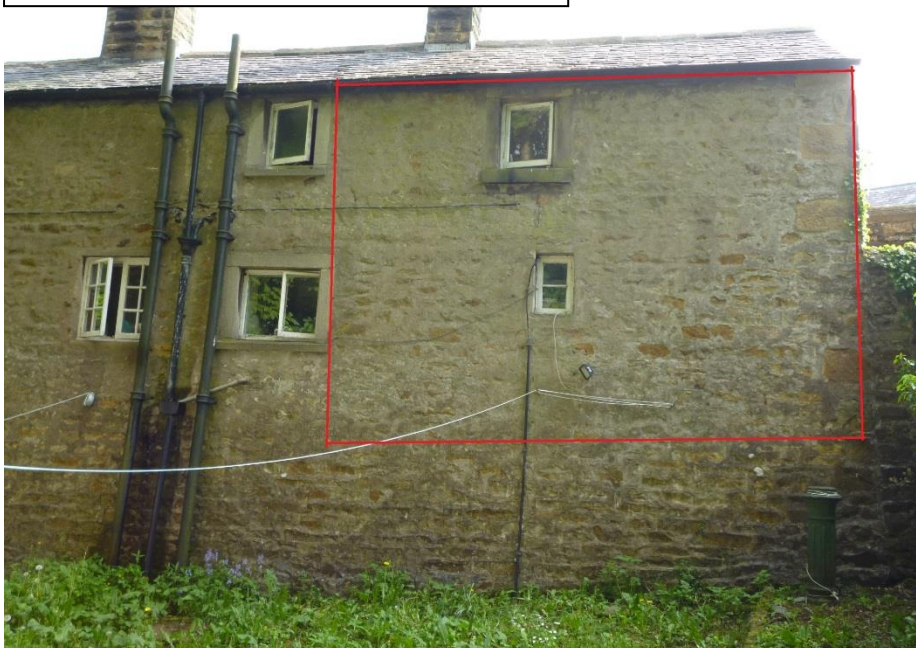
The slobbered lime render to the rear of the Almshouses is thought to be a vernacular feature of buildings in the Ribble Valley (see area of slobbered render in Photo 03). With pockets forming behind the slobbered render itself, this is becoming a perfect place for water to ingress into the stonework. Centuries of water saturation to the stone behind the slobbered render will have caused damage to the stonework itself and this will continue to deteriorate unless some of the slobbered render is raked off so the building can breathe. As this is seen as a vernacular feature, extra care will be taken to mitigate any further damage and only necessary areas of the slobbered render will be removed. If not removed, the stonework behind will continue to deteriorate and cause significant damage in the long term requiring further invasive works that would result in a significant loss of the original material.

Photo 03 - Showing the slobbered render to the rear elevation inside the red highlighted area.
