YEW TREE AND GARDENS

CLIENT: MR & MRS TAYLOR MANOR HOUSE, HOWGILL LANE RIMMINGTON, CLITHEROE

TREE REPORT

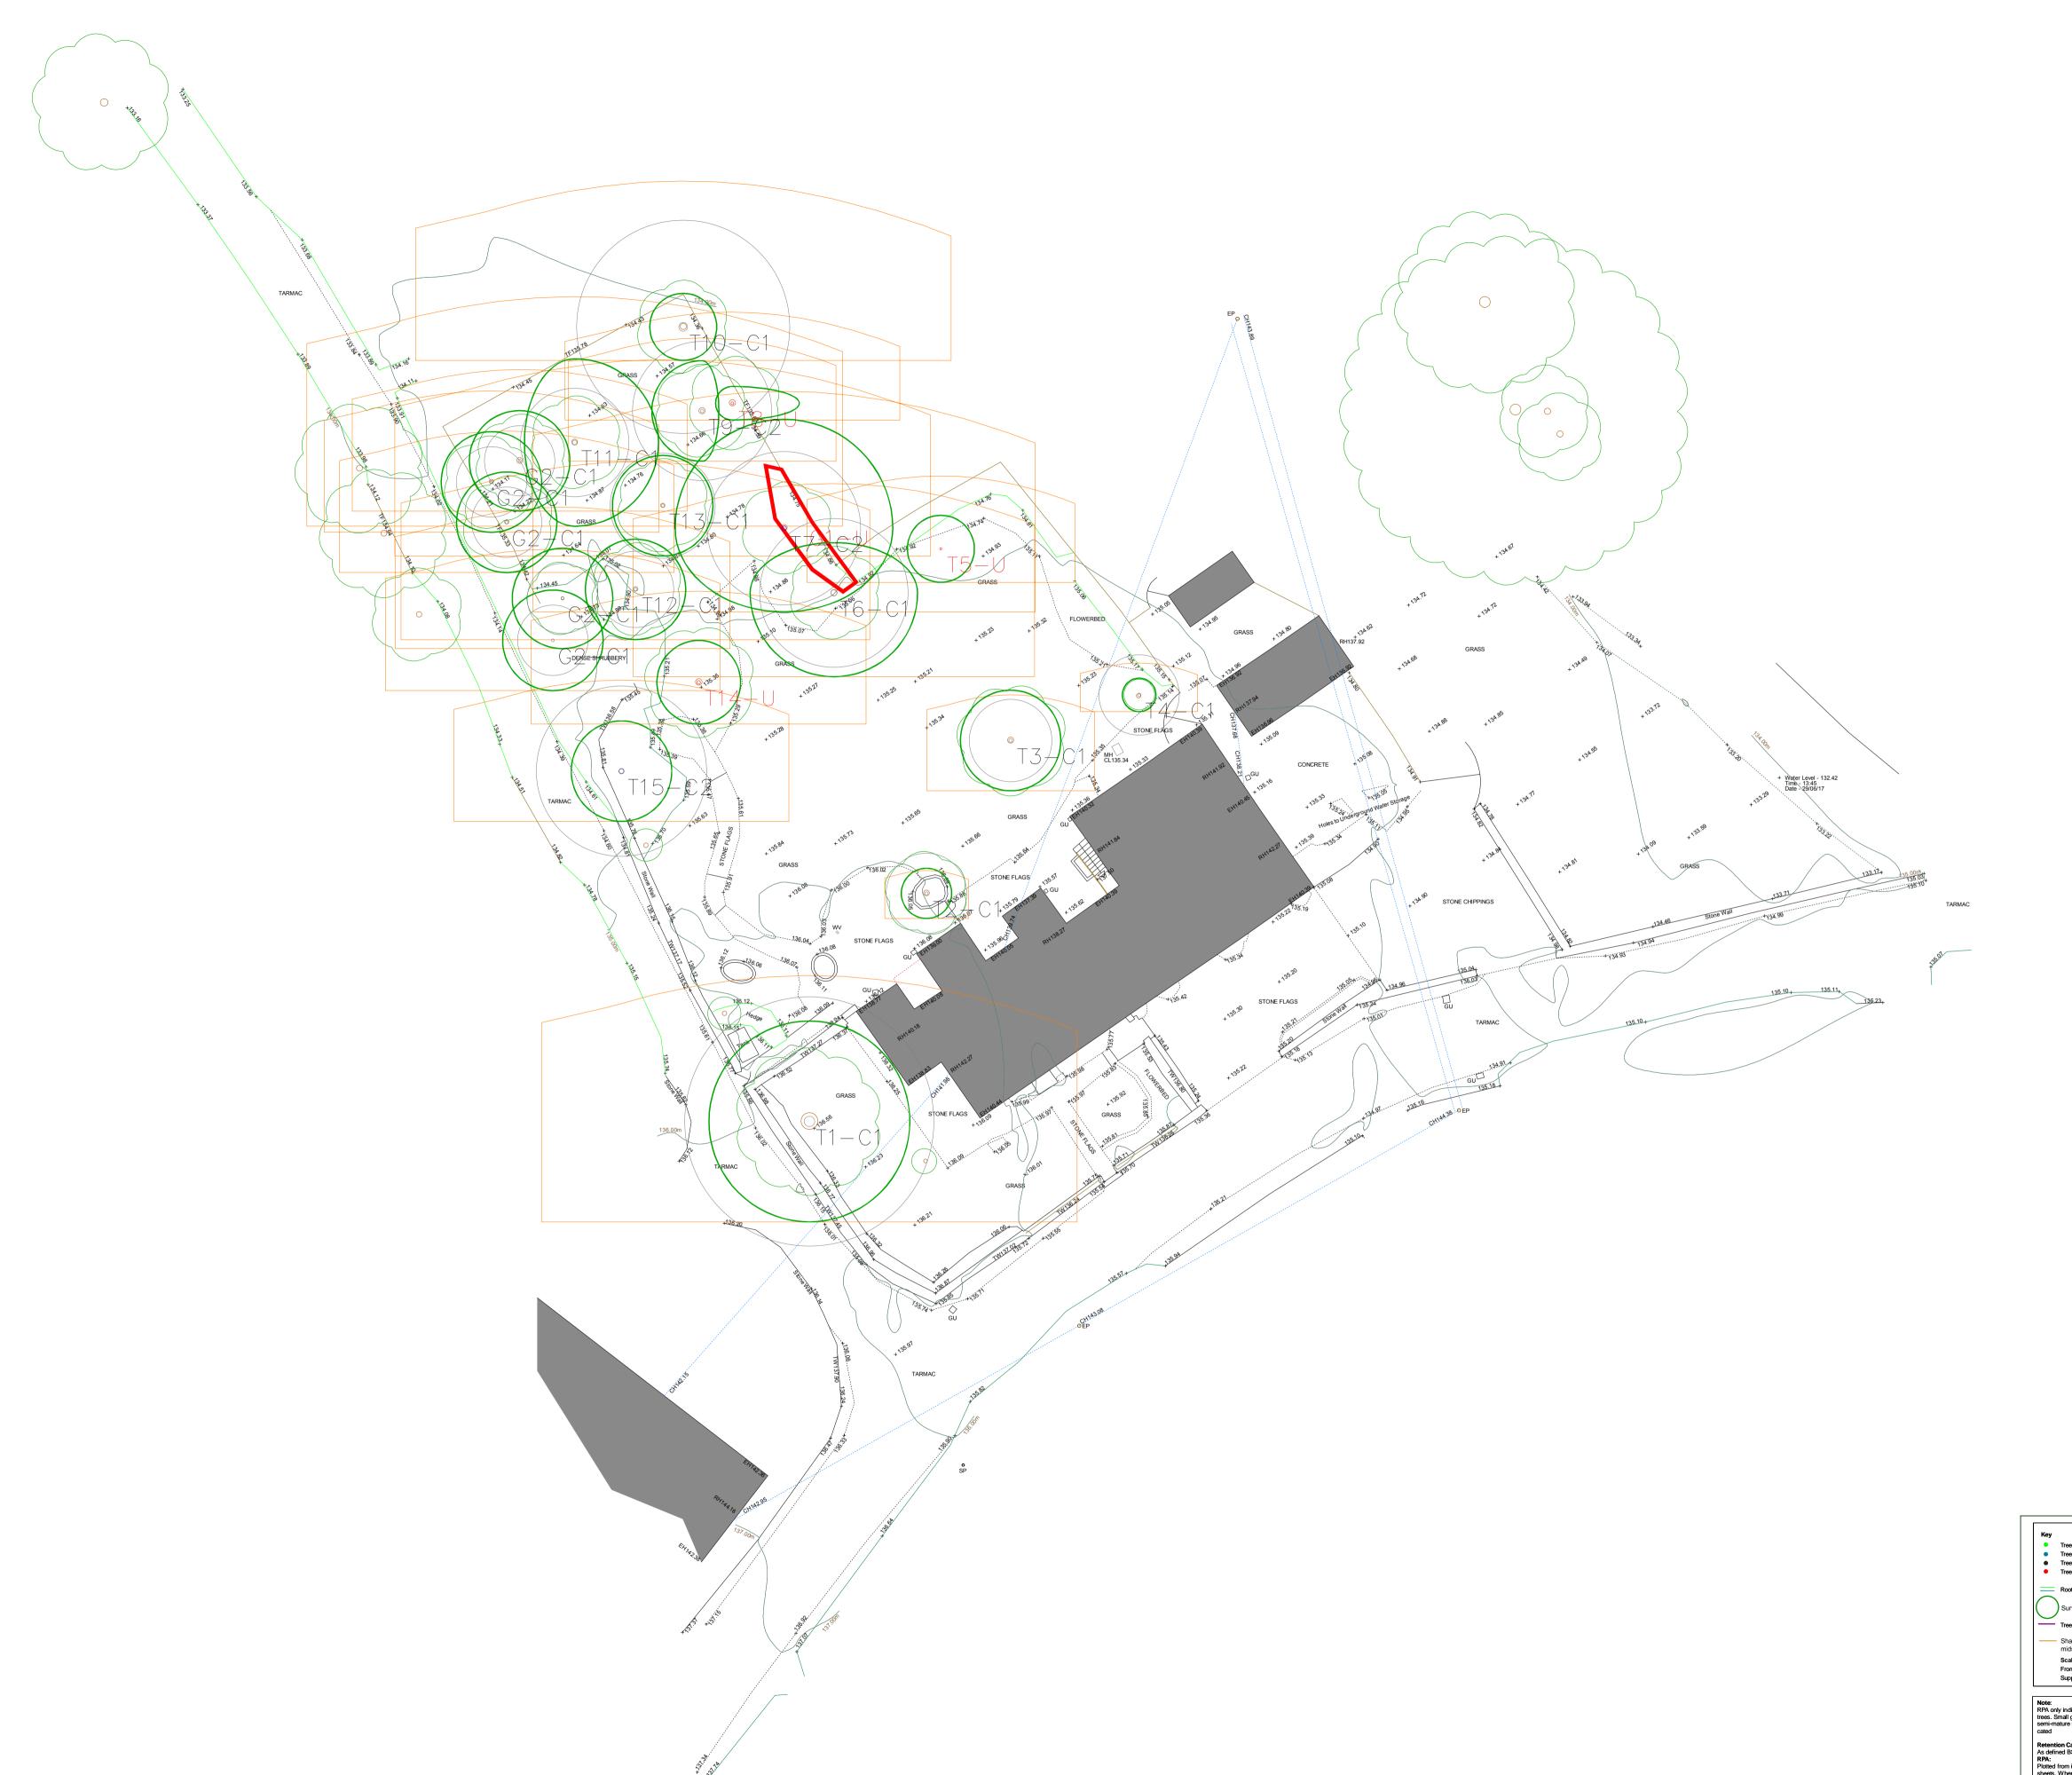
Tree Location Plan

- 4. Shadow extents are indicated within Appendix 2 of this document see estimated Midsummer shadow plots (orange line Appendix 2: Tree Location Plan). Due to the nature of the proposed development it is unlikely that shadow extents will have an impact upon it
