THE
ENVIRONMENT
PARTNERSHIP

**WADDOW VIEW
CLITHEROE
ARBORICULTURAL IMPACT ASSESSMENT
MARCH 2018**

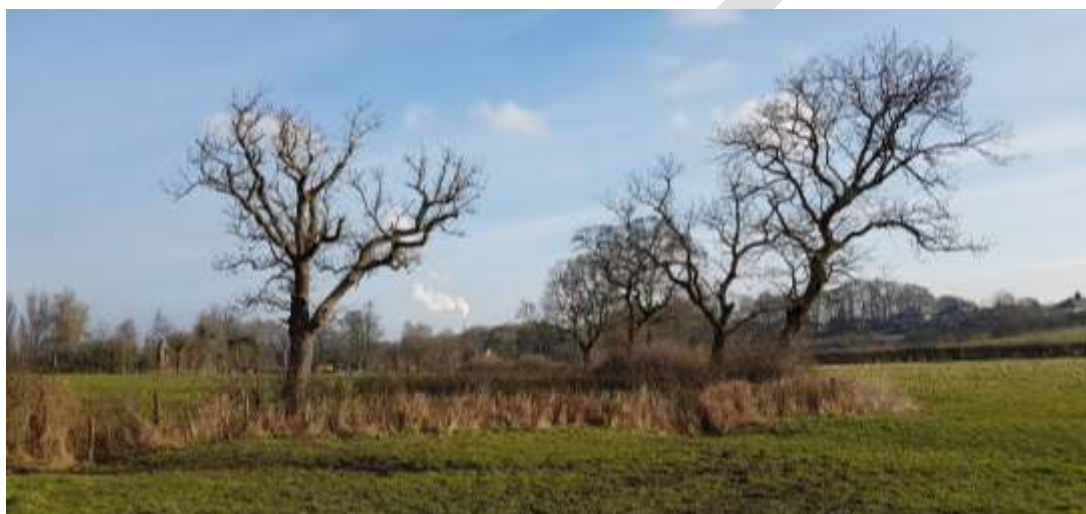
Figure 2 View north at T14, T15 and T16

- 5.6 Along the western boundary 7 trees within the field boundary hedgerow would require removal due to the incursion of new roads or hard surfacing and proximity to new buildings due to their poor condition. 4 of these (T15, T16, T17 and T18) are thought to be located on third party land and the applicant would need to demonstrate control over these trees before tree removal occurs.

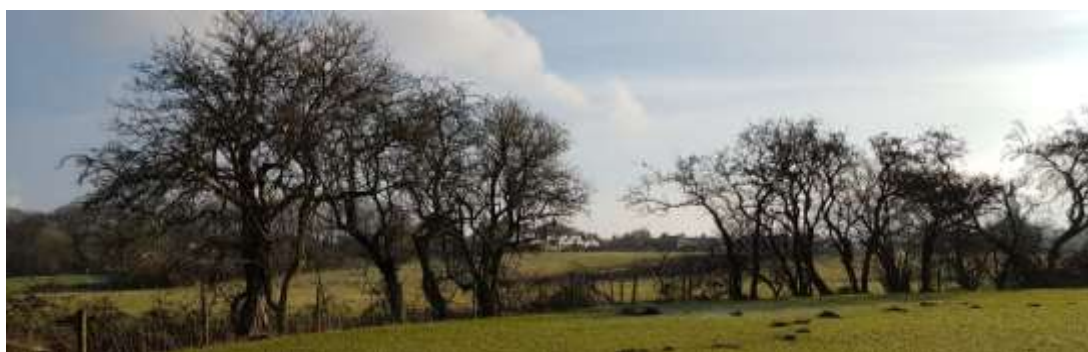
- 4.3 Across the southern half of the site and forming the boundary of one of the fields is a lapsed hedgerow that now forms a linear group of very old hawthorn trees in varying condition. They are all mature trees, some with very large stem diameters for this species. A high proportion of trees in the group are multi-stemmed with a gnarly form and snapped out limbs, have evidence of brown rot decay and dead wood, features typical of veteran trees. However, some of the trees are in decline and some have failed stems with the crowns lying in the adjacent fields. This arboricultural feature no longer functions as hedgerow as it is not stock proof and it would be difficult to bring back into hedgerow management without extensive new planting but it does provide valuable niche habitat and connectivity across the wider site.

Figure 3 Lapsed hawthorn hedgerow group G1

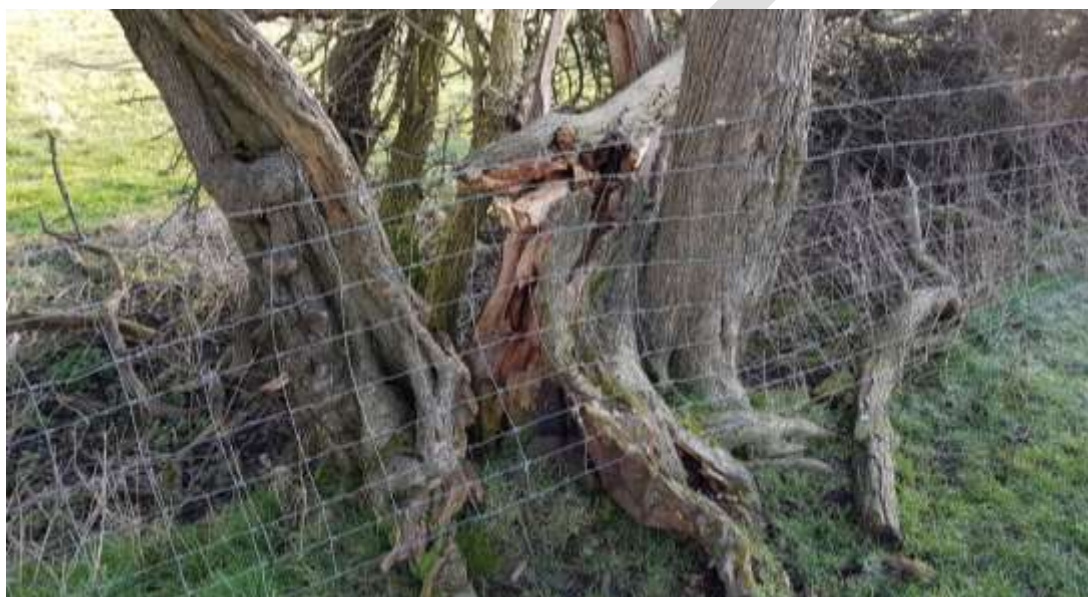
- 3.3 On this site there are no ancient woodland or veteran trees. Hawthorn trees forming group G1 are very old and contain features commonly associated with veteran trees. Based on their overall condition however, they fail to meet the full criteria required to designate them as true veterans, although they do pose increased ecological value due to the niche deadwood habitats they provide.

Figure 4 Deadwood habitat on failed hawthorn in group G1

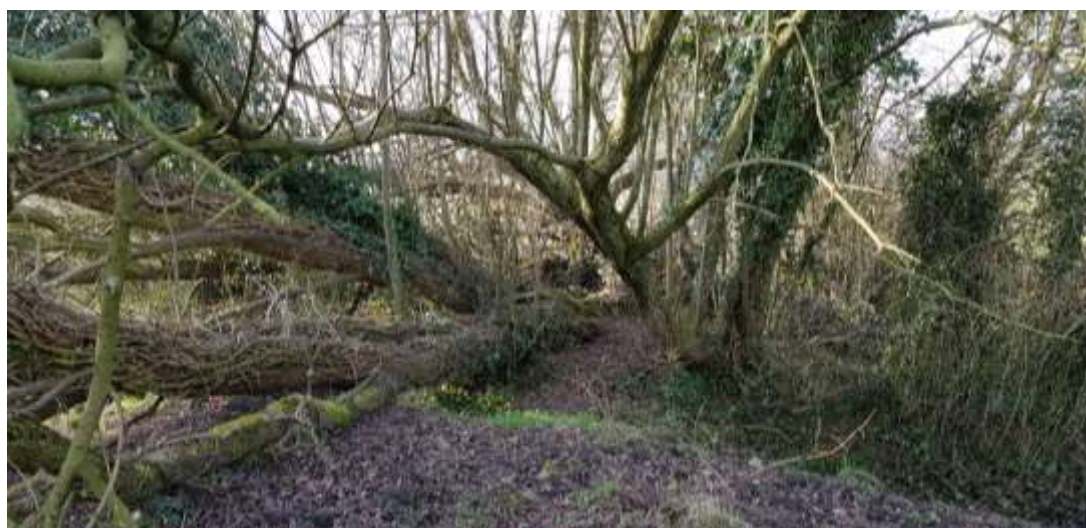
Figure 5 View south at layered stems of T26
