ARBORICULTURAL REPORT AND **ARBORICULTURAL IMPACT ASSESSMENT** to BS 5837:2012

at Victoria Mill Watt Street Sabden Lancashire BB7 9ED

JCA Ref: 13611-A/AJB

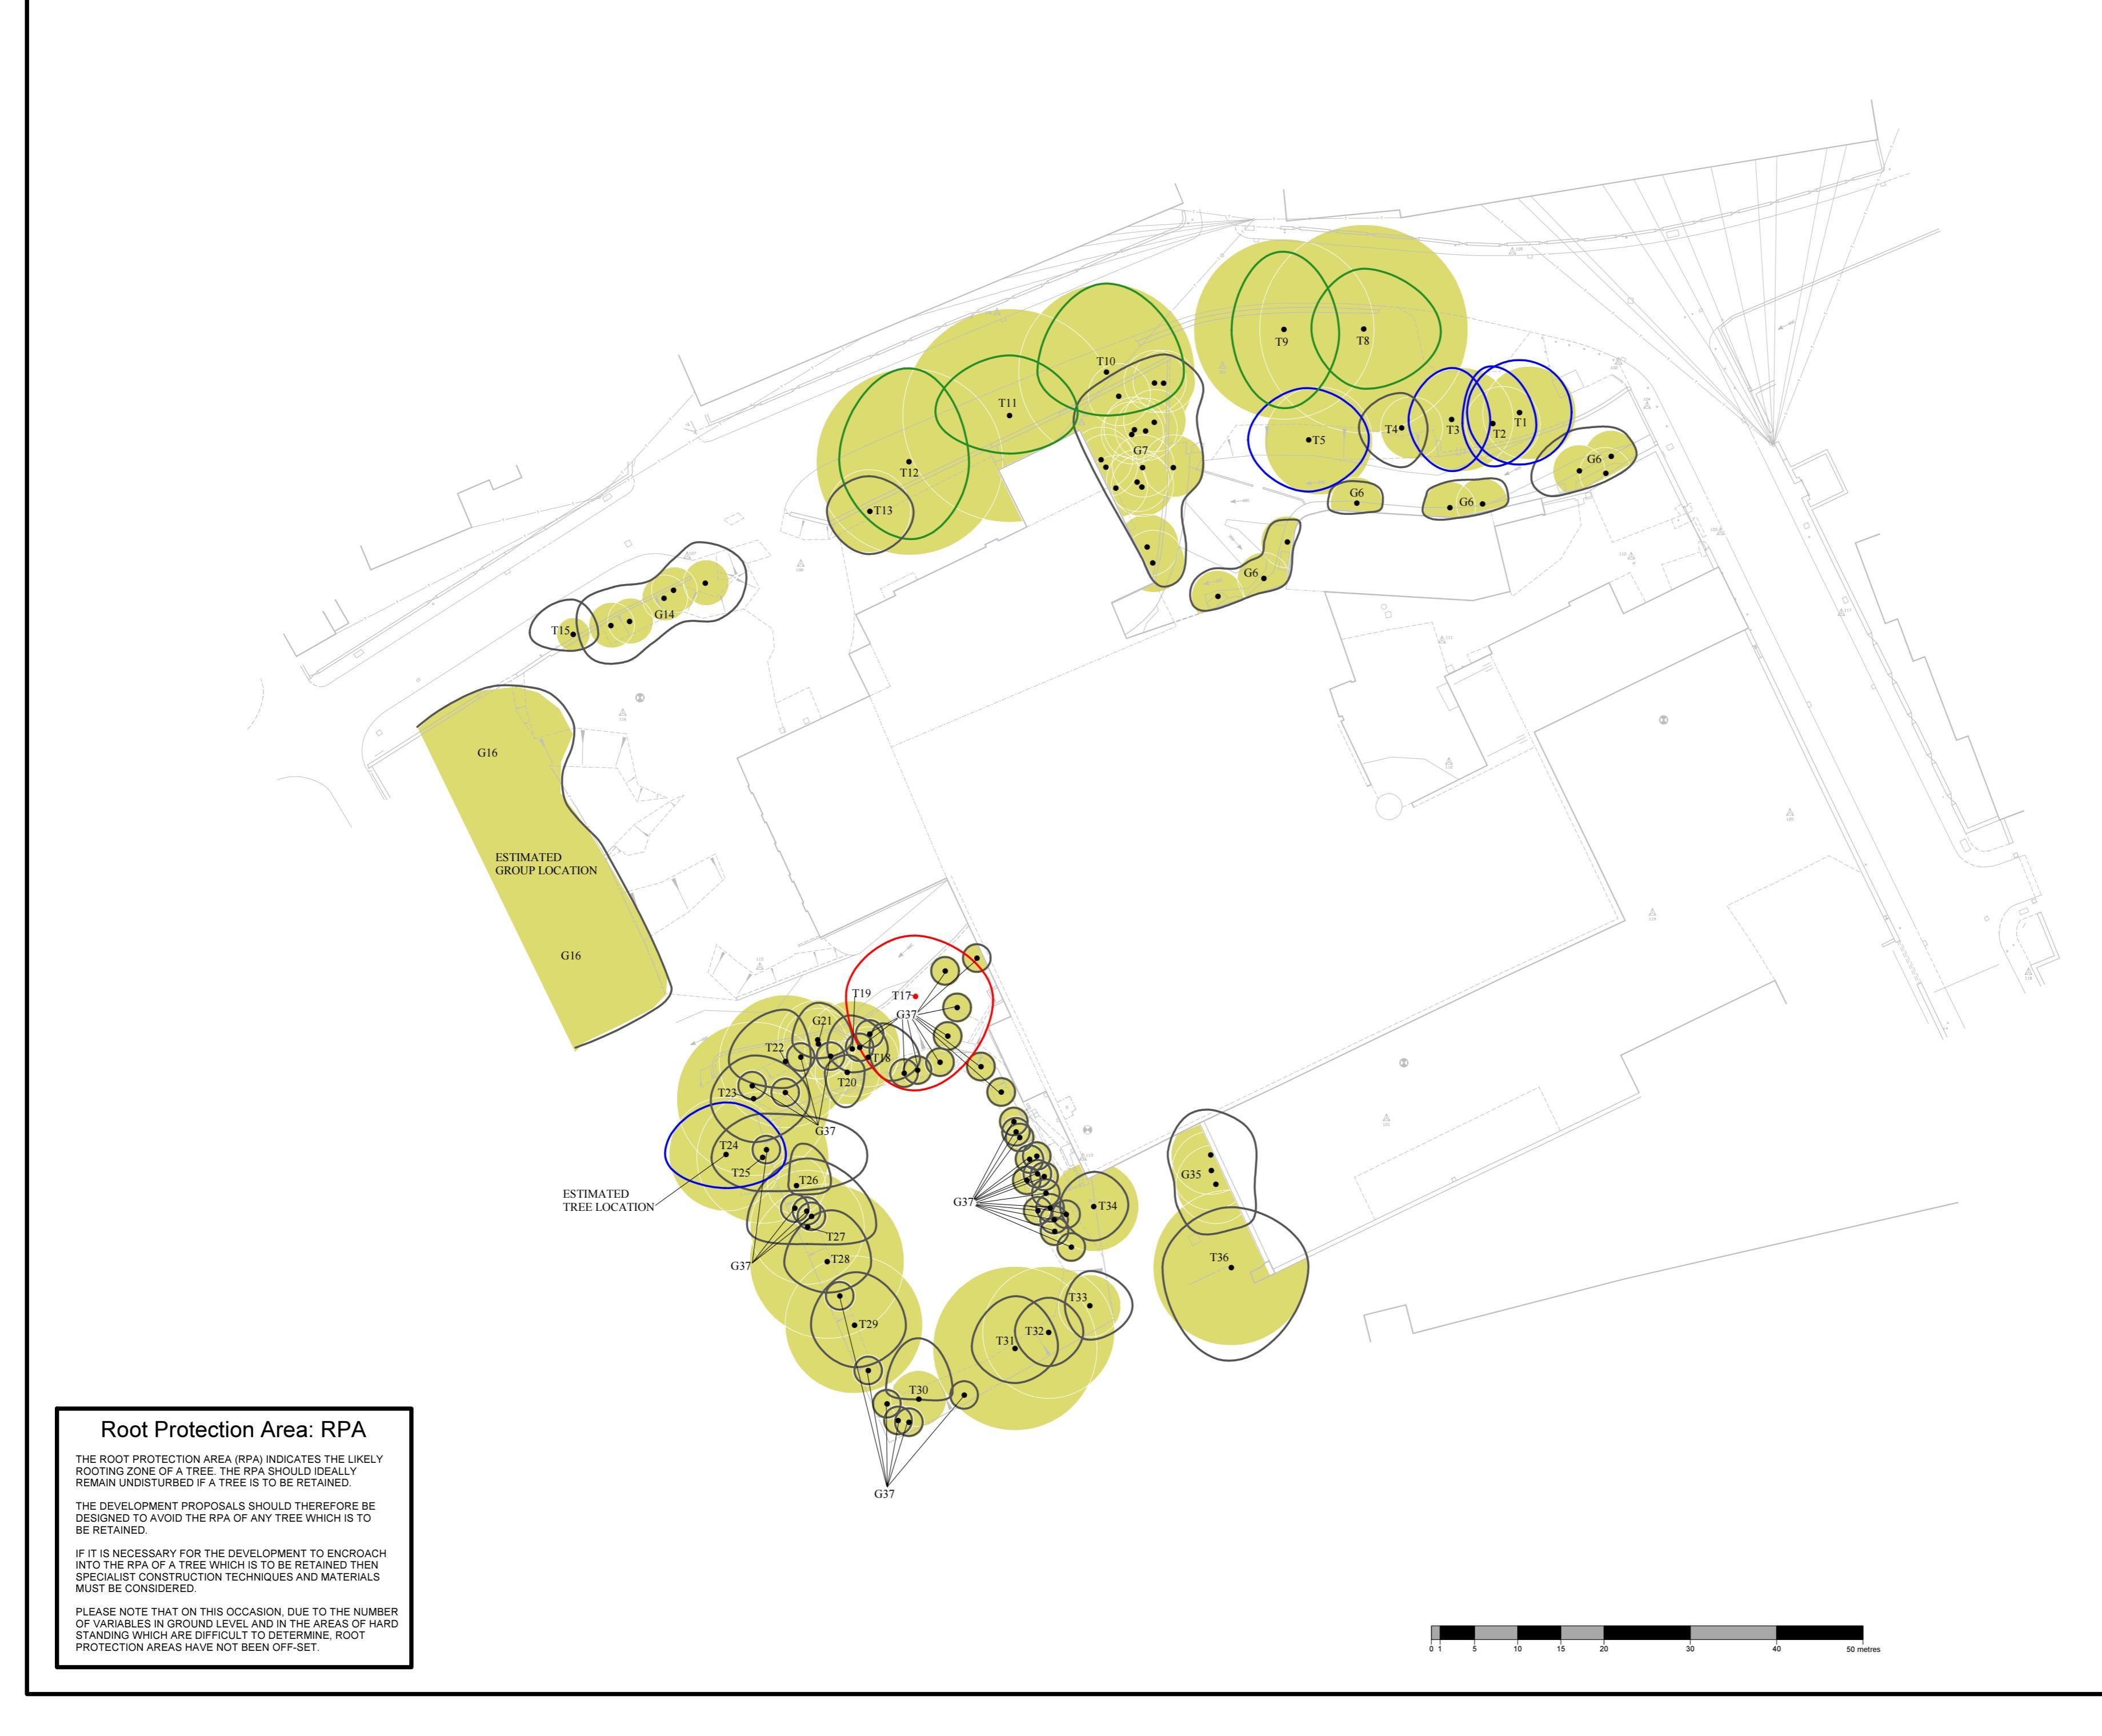
5.1.1 The tree survey revealed a total of 37 items of vegetation (30 individual trees and 7 groups of trees). Of these, 5 trees were identified as retention category 'A', 5 trees were identified as retention category 'B', 19 trees and 7 groups as retention category 'C' and 1 tree as category 'U'. Please refer to Appendix 2 for retention category and definition criteria.

5.2.1 **T17** was identified as retention category 'U' and requires removal as a matter of **moderate priority** because it poses a health and safety risk and has the potential to cause structural damage to adjacent features should it collapse.

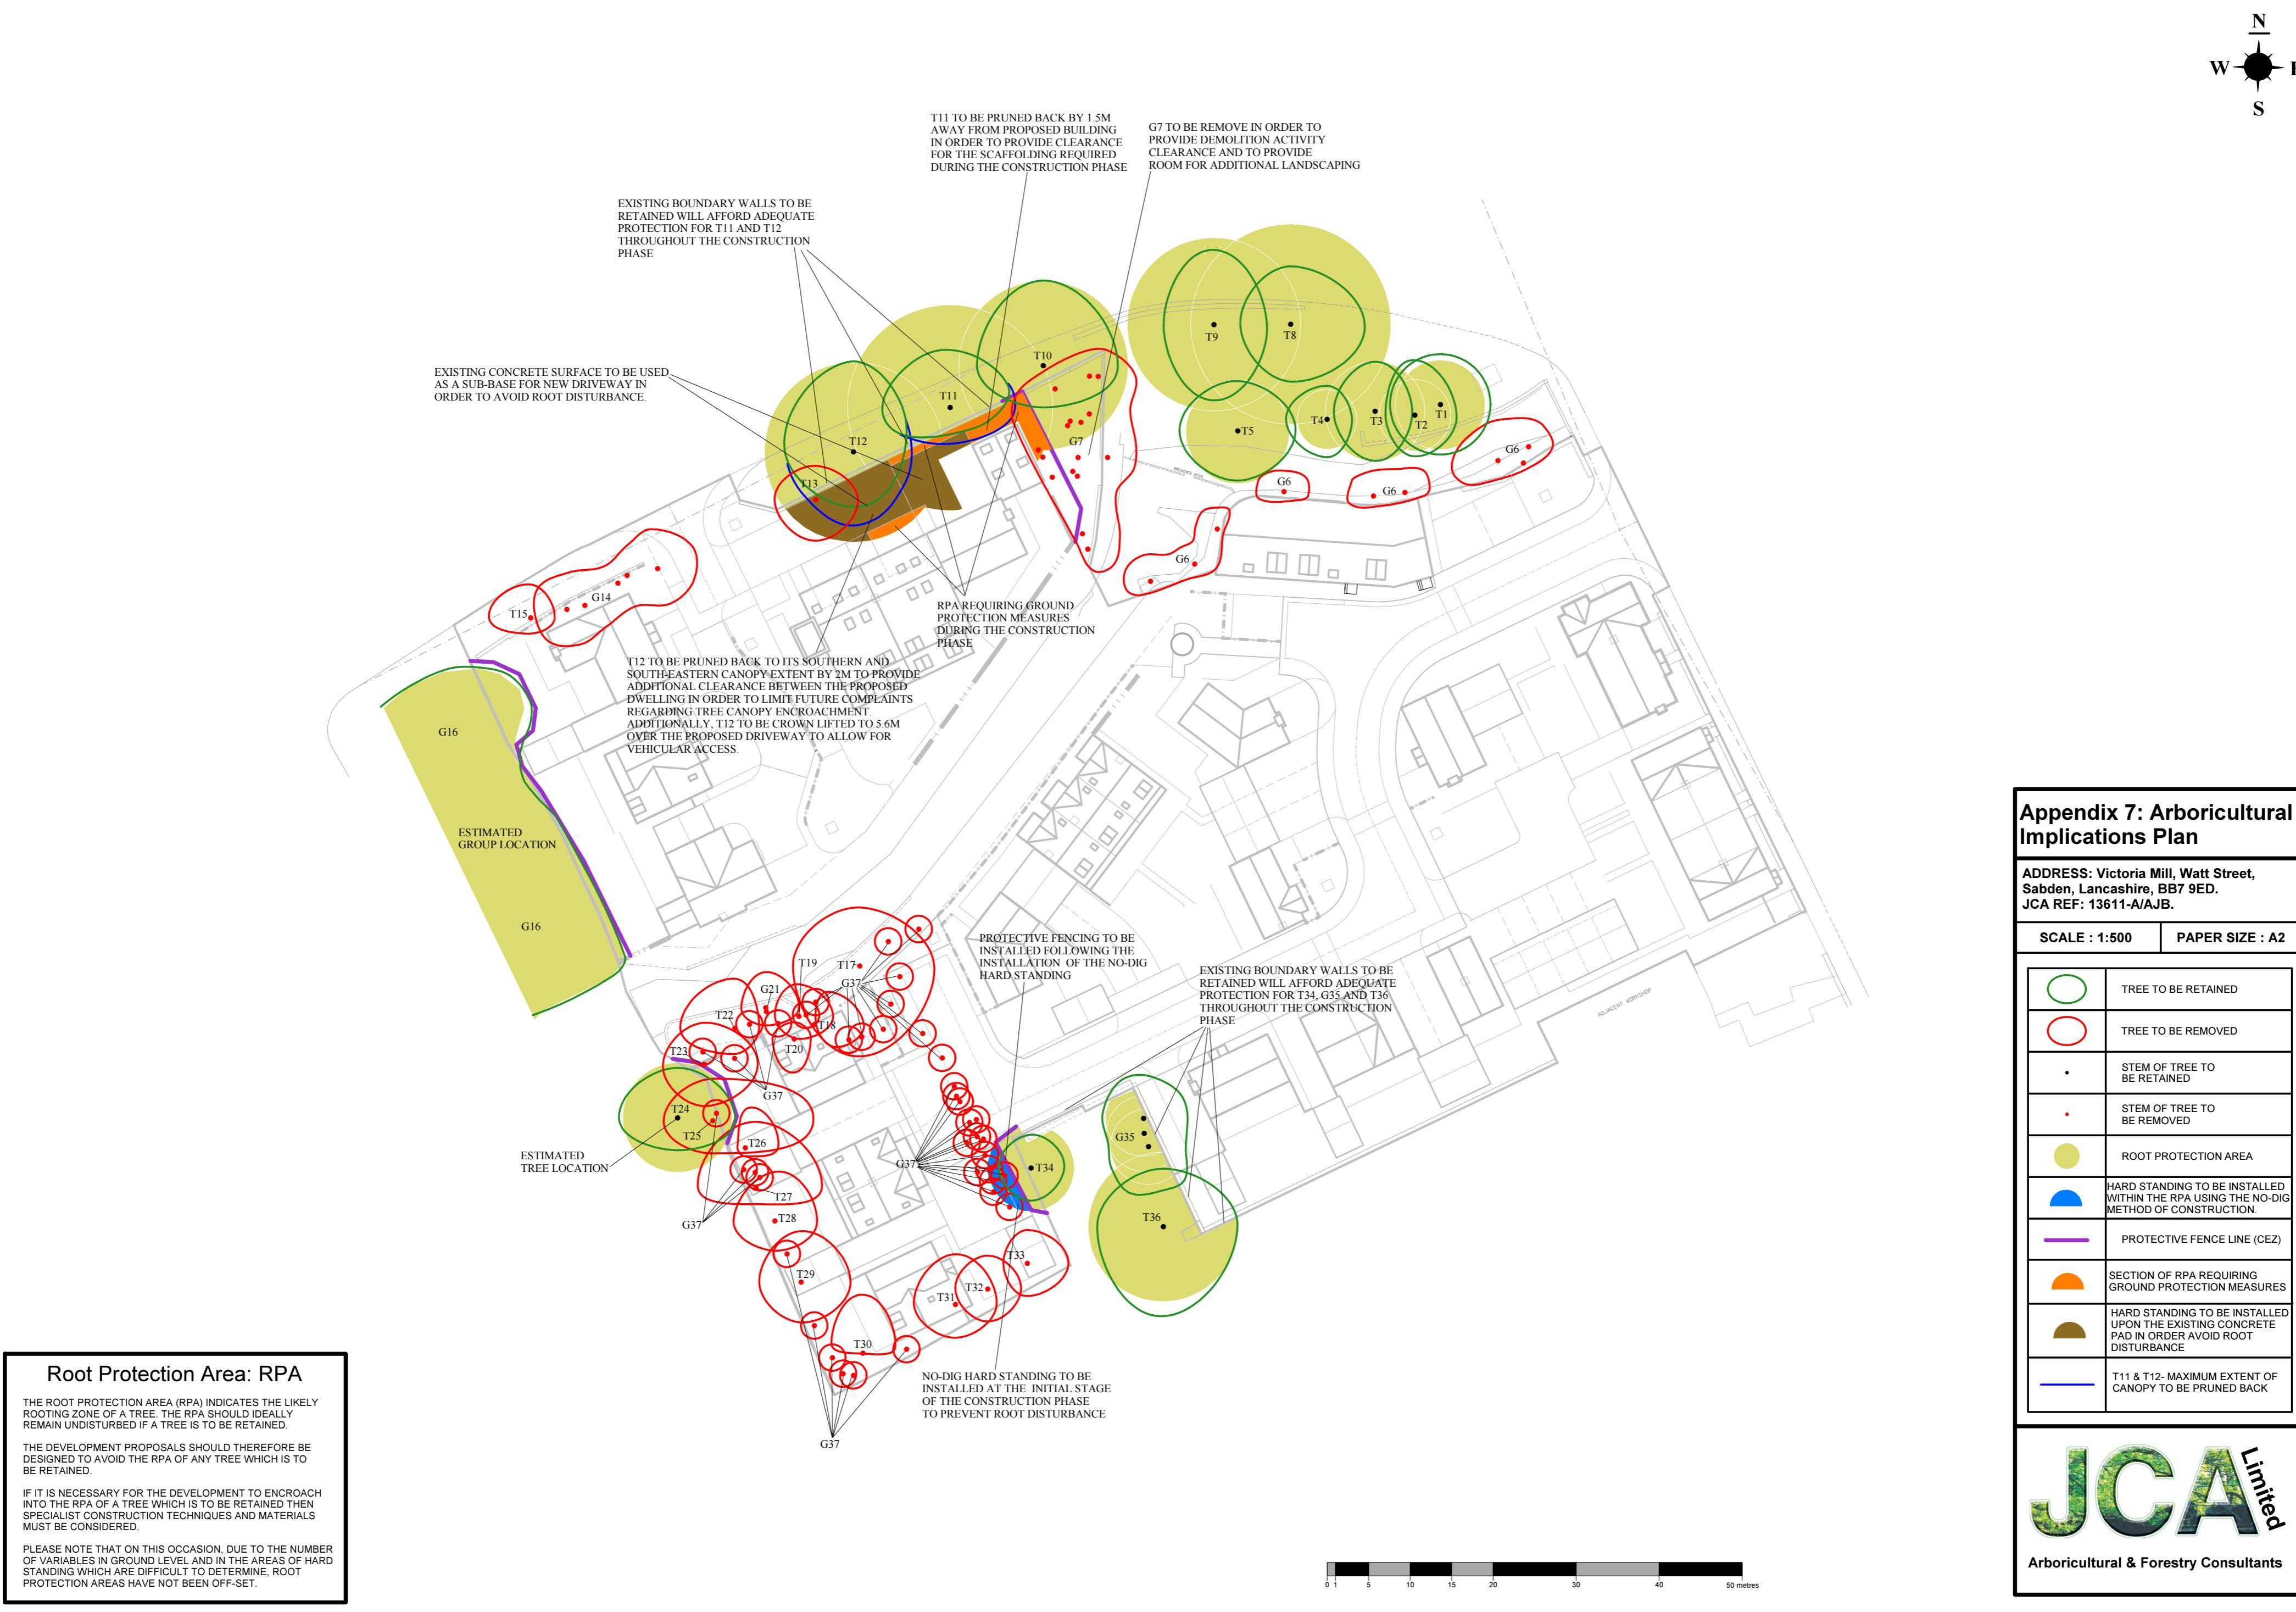
- 6.4.1.3 Where ground protection or work is required within the RPA of a retained tree, specialist measures must be adopted during the construction phase to avoid ground compaction and minimise root damage. Such areas are highlighted in orange on the Arboricultural Implications Plan at **Appendix 7**.

- 6.4.2.1 The proposed development entails the construction of hard surfacing in the form of a driveway within the RPA of **T34** (an off-site tree). In order to prevent foreseeable damage to tree roots, a 'no-dig' method of construction will be utilised within the area shown in blue shade on the plan at **Appendix 7**.

- 6.4.2.4 Proposed hard surfaces are present within the RPA of **T11** and **T12**, as shown in brown shade on the plan at **Appendix 7**. In this case, the proposed surface is situated within the footprint of existing hard surfacing in the form of a concrete pad. As such; the existing surface will be retained in situ to prevent disturbance to tree roots.

- 6.2.1 In order to facilitate the required demolitions or the development proposals, it will be necessary to remove G6, G7, T13, G14, T15, T18, T19, T20, G21, T22, T23, T25, T26, T27, T28, T29, T30, T31, T32, T33 and G37, each of which fall into retention category 'C'.
- 6.2.2 Whilst the development will require the removal of multiple lower value trees within the site, it should be noted that a substantive tree planting scheme is included within the soft landscaping proposals. This will act to mitigate tree losses, improve the visual benefits of the site and the surrounding area, and will improve the localised tree stock.

6.3.1 In order to allow for the erection of scaffold, clearance for new buildings and access heights for new driveways, it will be necessary to sympathetically prune off-site trees T11 and T12. The specifics of this facilitation pruning works are discussed in Appendix 1 and demonstrated as a blue line on the plan at Appendix 7.
