13 June 2018

Land East of Chipping Lane, Longridge – Phase 1

# **Bat Inspection Report**

Report Number: 11319\_R03\_LT\_LP

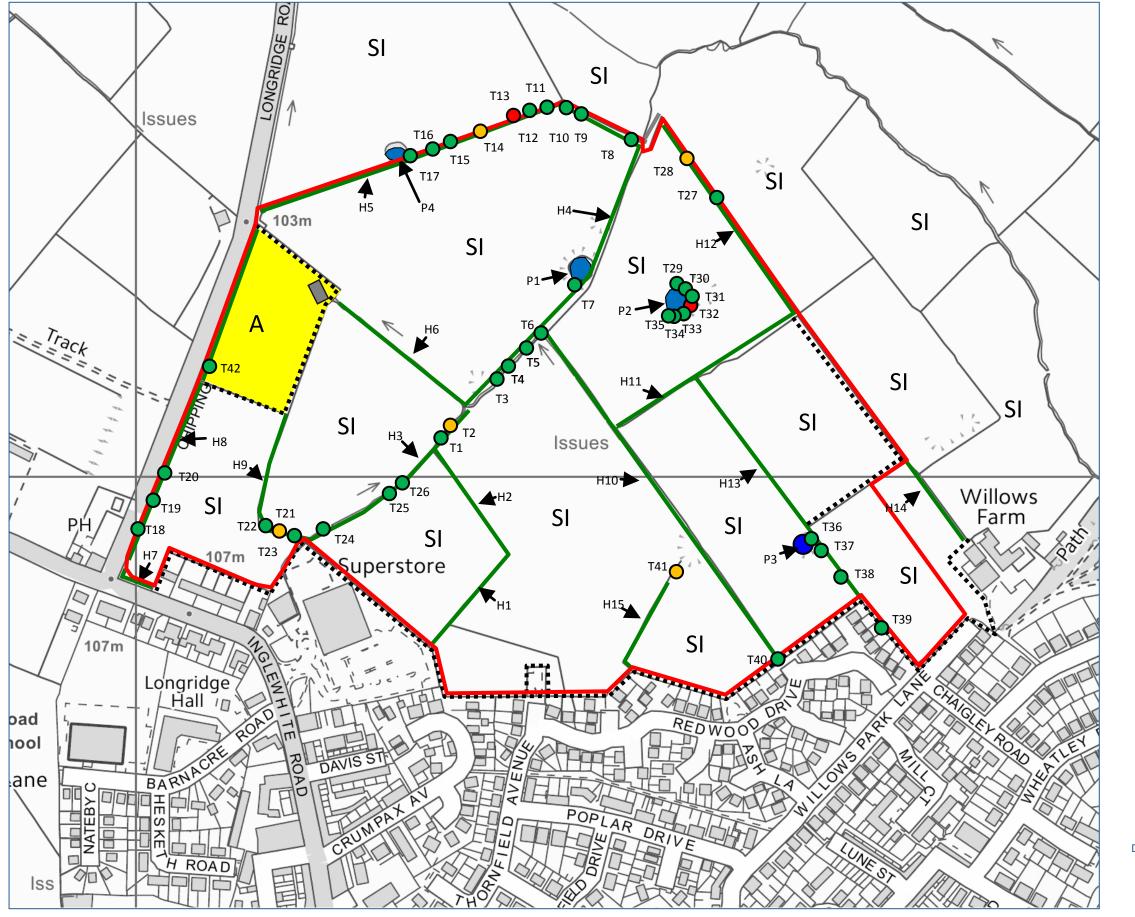
2001/P47a

3.1 Four trees which were likely to be affected by the development and had been identified as having bat roost potential were inspected. These were Trees 2, 18, 19 and 23 (locations are shown on plan **2001/P47a**), no other mature trees were identified that required further assessment. The results of the tree assessment are provided in **Table 3.1**.

Tree Reference (see Plan 2001/P47a)	Species	Description	Roost Suitability (Hundt, 2012)
T2	Alder	Mature alder with a damaged stem and possible bat access hole (tree climbed 12 <sup>th</sup> January 2016).  Suitability of potential roost feature found in cavity extending up the stem for approximately 40cm. No evidence of use by bats found.	2
T18	Sycamore	Mature sycamore, some old ivy cover (ivy has been cut) one knot hole is present to the west but is blind (30th January 2014).  Ivy was dead and falling off and contained no suitable roost features. Rot hole was inspected found not lead to a cavity capable of supporting bat roosts. Ivy was falling off and contained no suitable roost features.	3
T19	Ash	Mature ash with old dead ivy cover and a damaged limb, however this appears to be exposed and not lead to a cavity (climbed 12th January 2016).  Damaged limb was inspected; cracks were full of rotting tree matter and did not lead to cavities capable of supporting roosting bats. A rot hole was found at 4m on the western side. This was inspected with an endoscope. No bats were present and no signs of previous occupation were found.  Ivy was falling off and contained no suitable roost features.	2

T23	Alder	Alder with single woodpecker hole which extends upwards into the stem. (Inspected from ladder 12th January 2016)  Suitability of potential roost feature confirmed but no evidence of use by bats found.	2

- 4.1. Although no evidence of roosting bats was recorded within any trees to be lost or otherwise affected by the development, potential roosting features were present within Trees 2, 19 and 23. T18 and T19 have been felled since this time, in accordance with the existing reserved matters consent.
- 4.2. According to current plans (see **Plan 11319/P02**), T2 and T23 are to be retained, and no further tree loss is proposed. Therefore, no mitigation is required in respect of roosting bats.
- 4.3. However, should plans be revised resulting in loss of additional trees, an update PRA should be completed prior to felling.

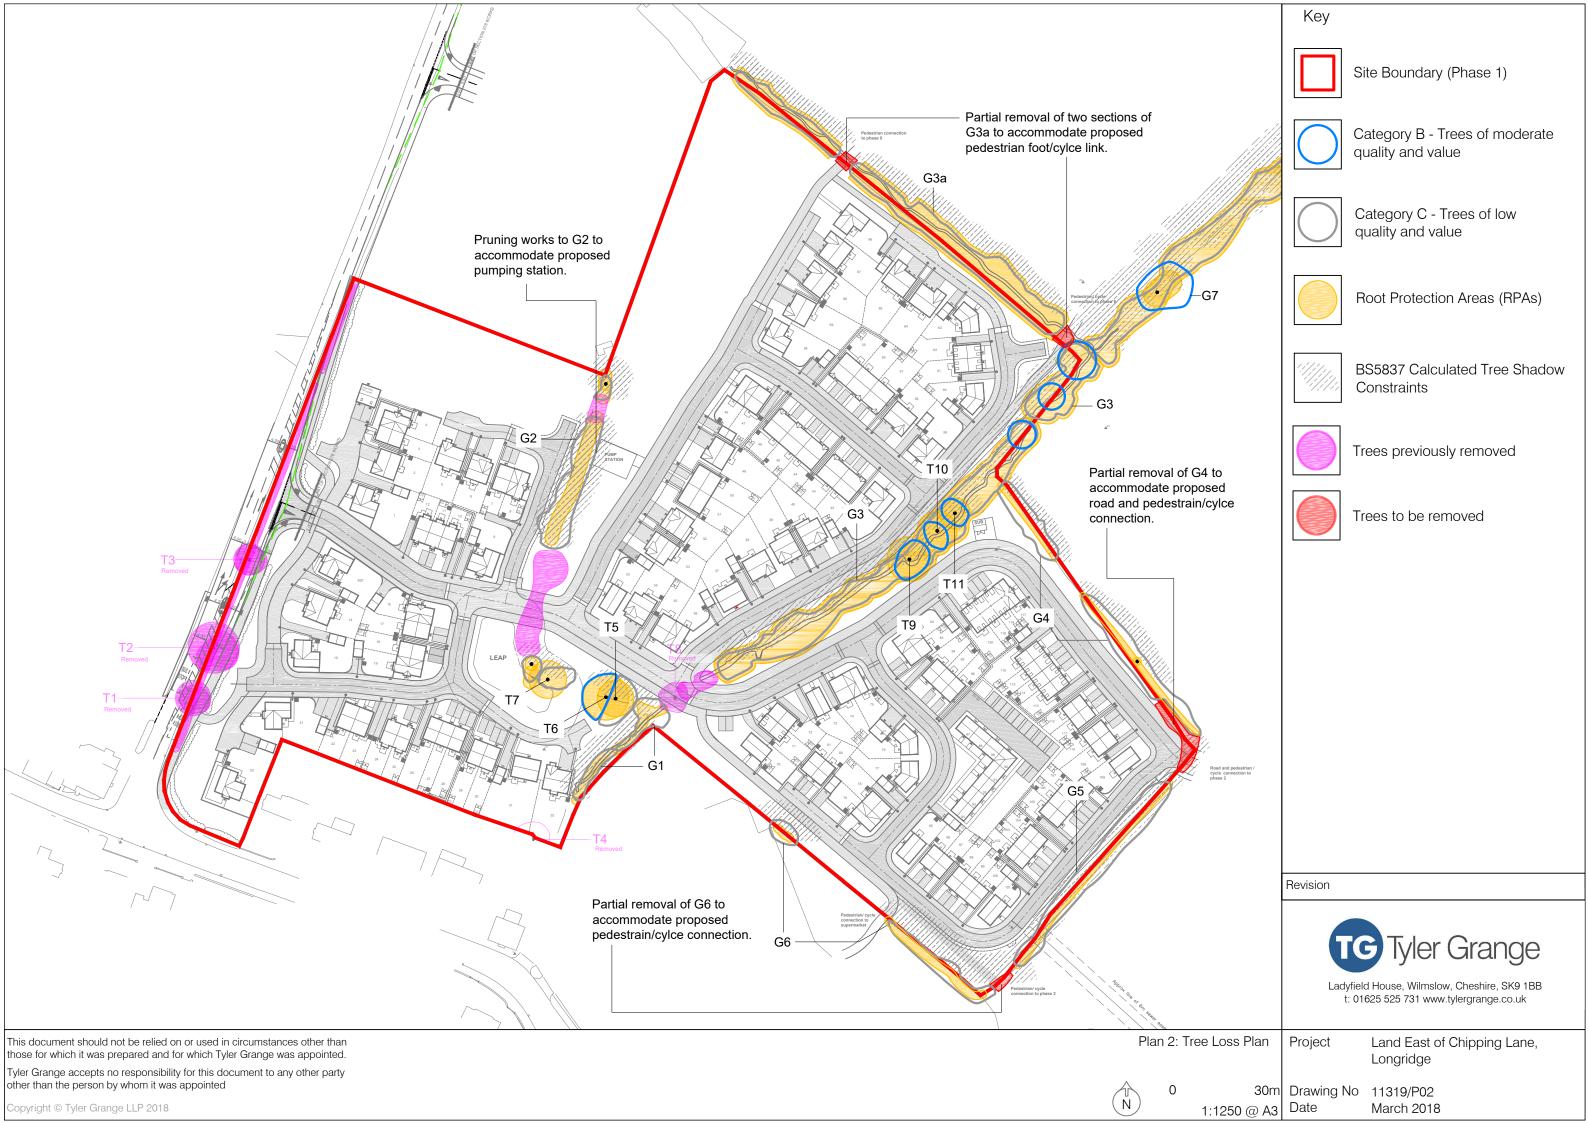
11319/P02 - Tree Loss Plan

- 3.2 Construction is already underway on the south-west portion of the site, which is not subject to the S73 amendment. As a result, a number of trees have already been felled in accordance with the existing reserved matters consent (see Tree Loss Plan 11319/P02). This includes T18 and T19; T2 and T23 have been retained (see Plan 2001/P47a).
- 3.3 No further tree loss is proposed as a result of the S73 amendment (see **Plan 11319/P02**), losses are limited to small sections of hedgerow which have no potential to support roosting bats.
