Land at Higgins
Brook, East of
Chipping Lane,
Longridge – Phase 1

Bat Inspection Report
for Discharge of
Condition 19

Report Number: 2001_R16_PM_LP

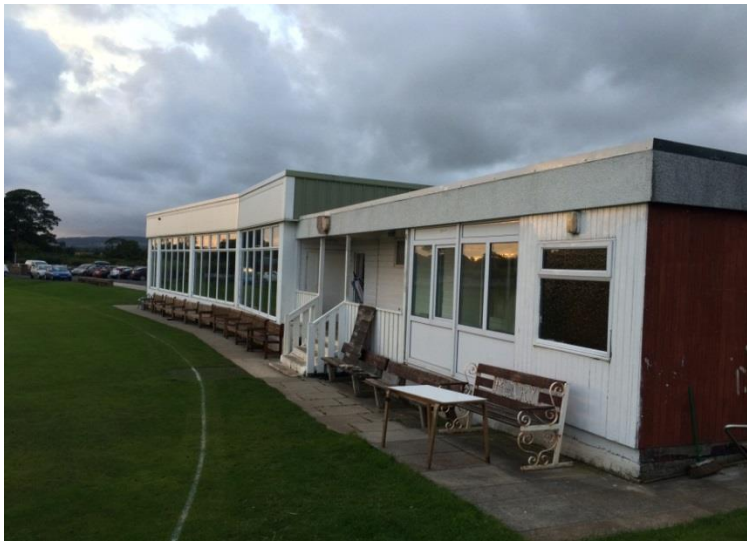
Plate 3.1 showing the exterior construction of the cricket pavilion

| Building | Description | Assessment |
|---|--|---|
| Cricket Club | Single- storey stone building with flat steel/ iron roof. Occasional gaps behind steel fascia boards and wooden soffits which may offer some potential access point for bats. | Low Potential – Category 3 |

- 3.4 The cricket pavilion was found to have low potential to support roosting bats due to the limited presence of suitable features. No evidence of use by bats was recorded during the building inspection.

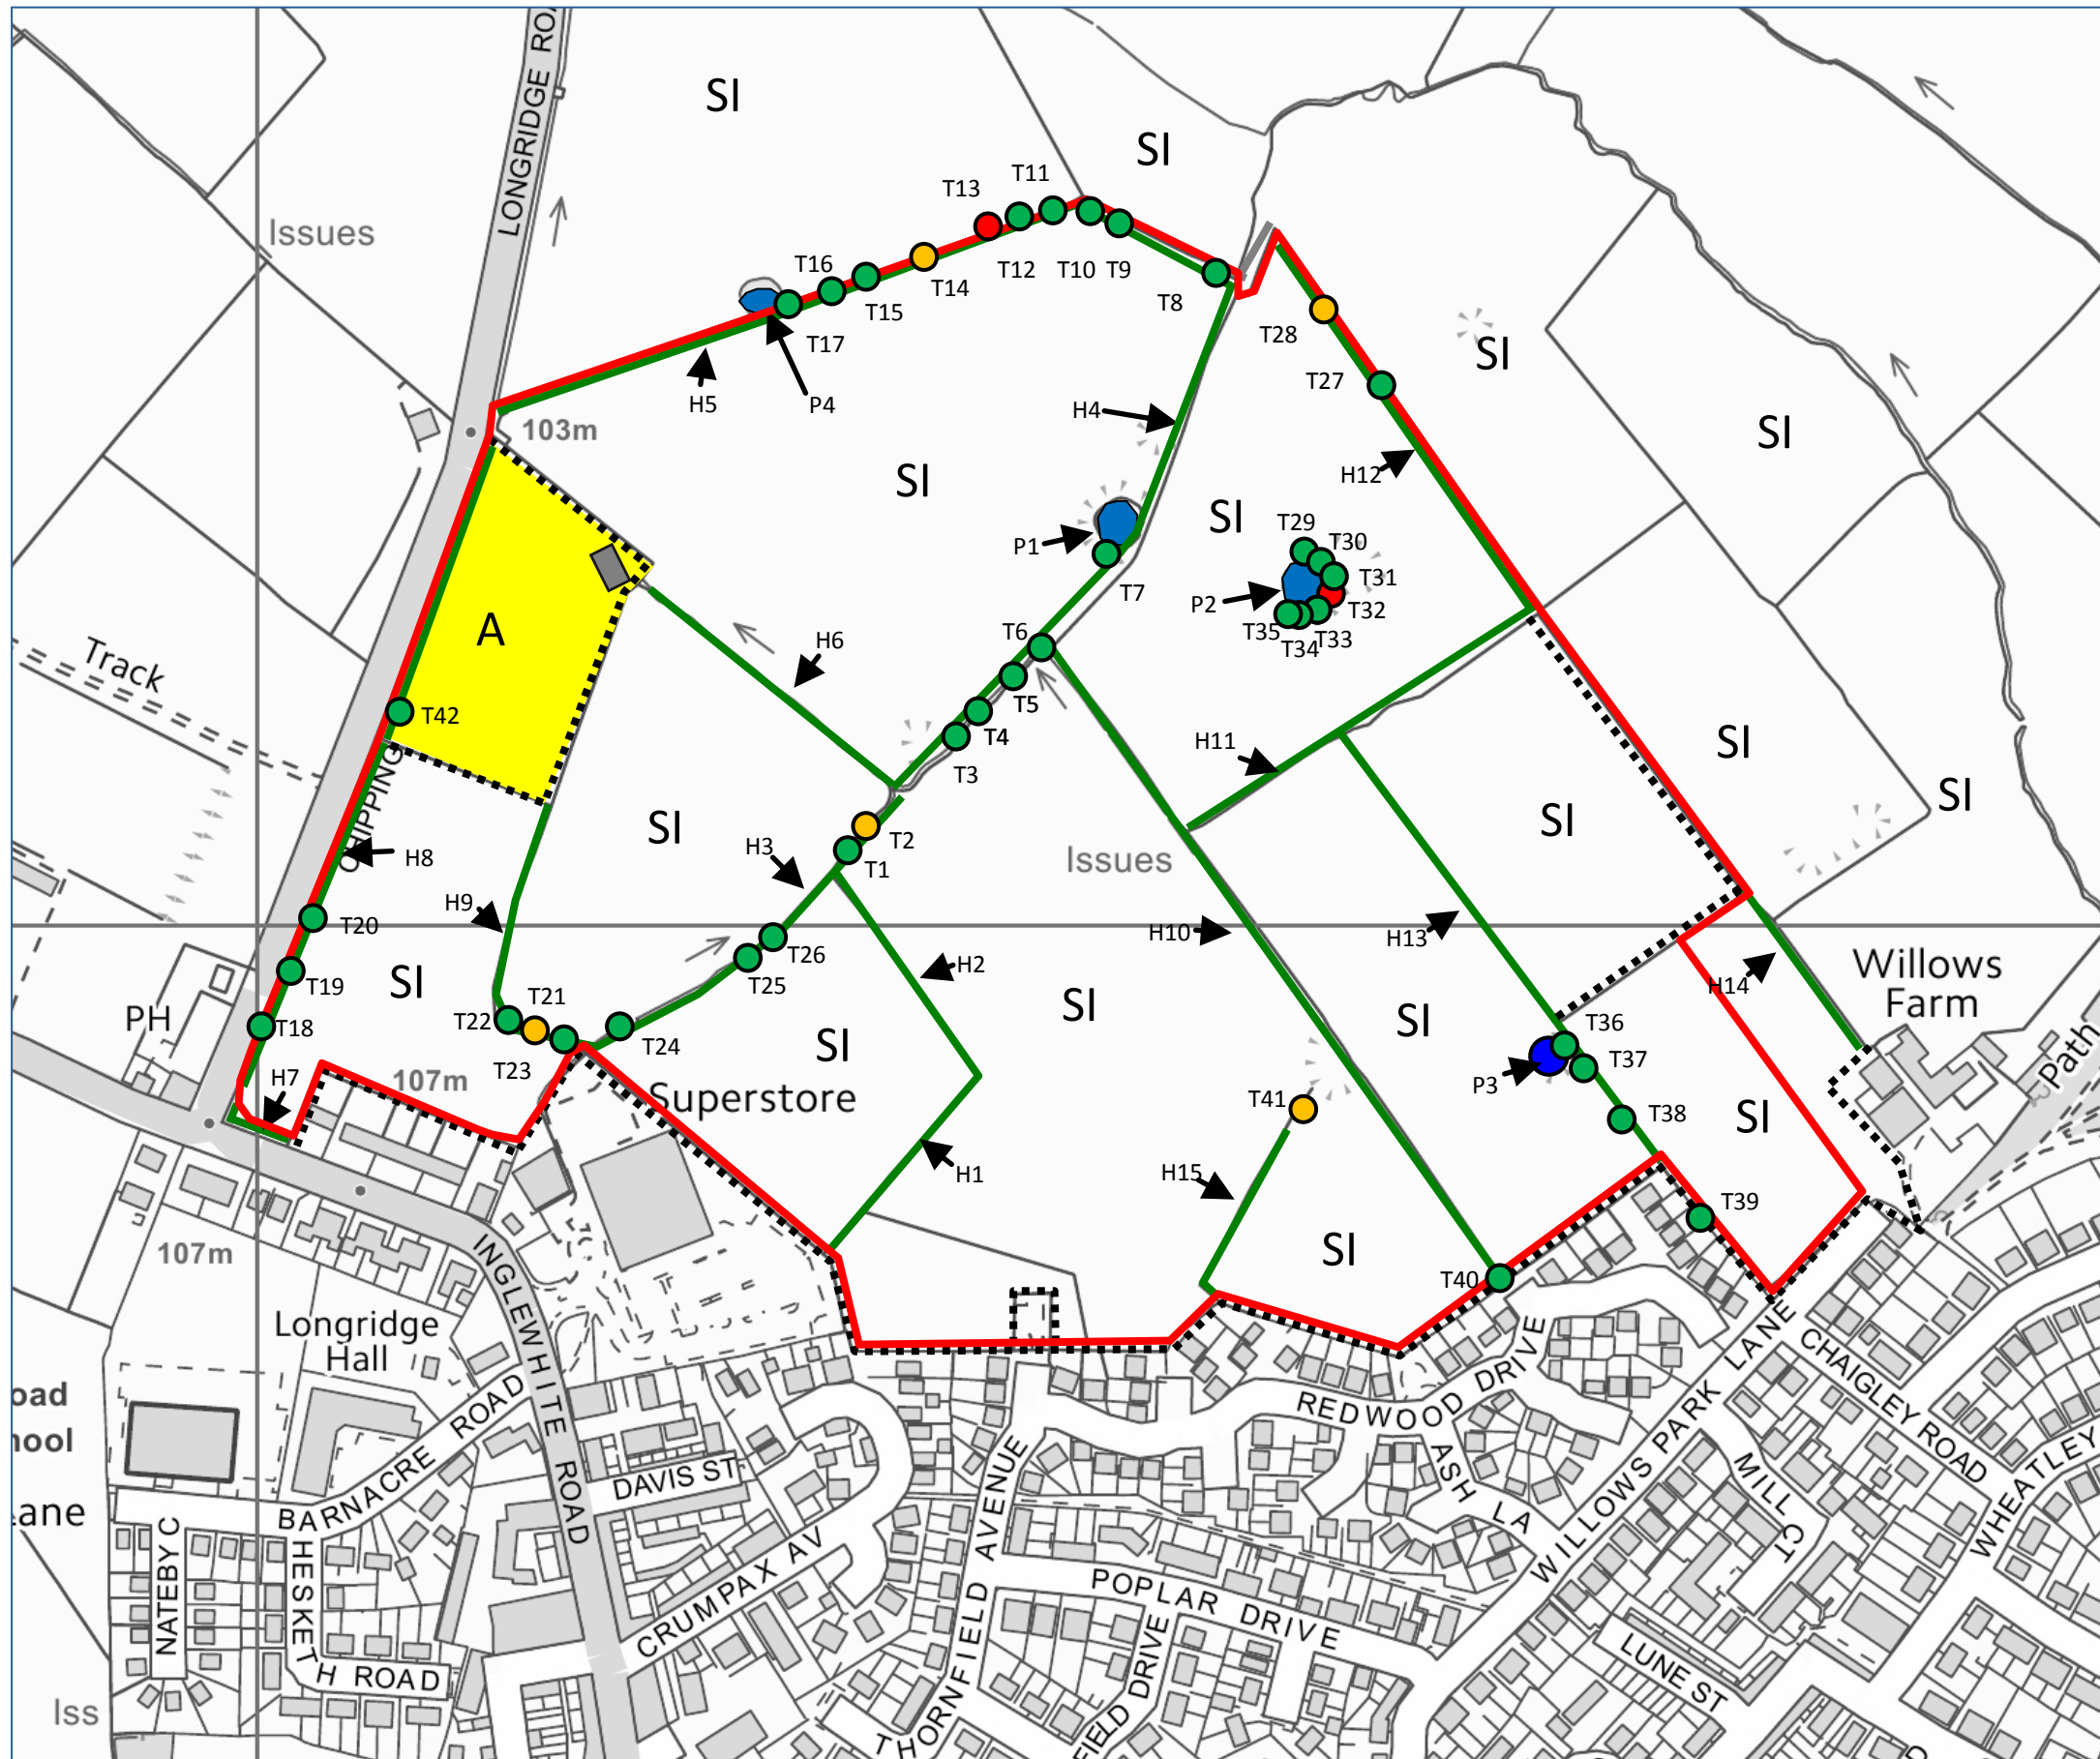
Drawing No. | 2001/P47a

- 3.1 Four trees which were likely to be affected by the development and had been identified as having bat roost potential were inspected. These were Trees 2, 18, 19 and 23 locations are shown on plan **2001/P47a**, no other mature trees were identified that required further assessment. The results of the tree assessment are provided in **Table 3.1** below.

| Tree Reference | Species | Description | Bat Roost Assessment Category |
|---|---|--|---|
| T2 | Alder | Mature alder with a damaged stem and possible bat access hole (tree climbed 12 th January 2016). Suitability of potential roost feature found in cavity extending up the stem for approximately 40cm. No evidence of use by bats found. | 2 |
| T19 | Ash | Mature ash with old dead ivy cover and a damaged limb, however this appears to be exposed and not lead to a cavity (climbed 12th January 2016). Damaged limb was inspected; cracks were full of rotting tree matter and did not lead to cavities capable of supporting roosting bats. A rot hole was found at 4m on the western side. This was inspected with an endoscope. No bats were present and no signs of previous occupation were found. Ivy was falling off and contained no suitable roost features. | 2 |
| T23 | Alder | Alder with single woodpecker hole which extends upwards into the stem. (Inspected from ladder 12th January 2016) Suitability of potential roost feature confirmed but no evidence of use by bats found. | 2 |

- 4.1. Although no evidence of roosting bats was recorded within any trees to be lost or otherwise affected by the development; however potential roosting features were present within Trees 2, 19 and 23.

- 4.2. These trees should be inspected immediately prior to felling and should be soft felled under supervision from a suitably experienced and qualified ecologist.

- 4.5. As the loss of these trees will lead to a loss of roosting opportunities for bats, replacement roosting features should be provided through the provision of bat boxes, either on retained trees or on new buildings within the development. Details of the placement of these features can be found in document 2001/R14.
