## **GOOD HEYS FARM, THORNLEY WITH WHEATLEY**

**WYVERN ARCHITECTS**

## **DAYTIME BAT SURVEY**

**MAY 2018**

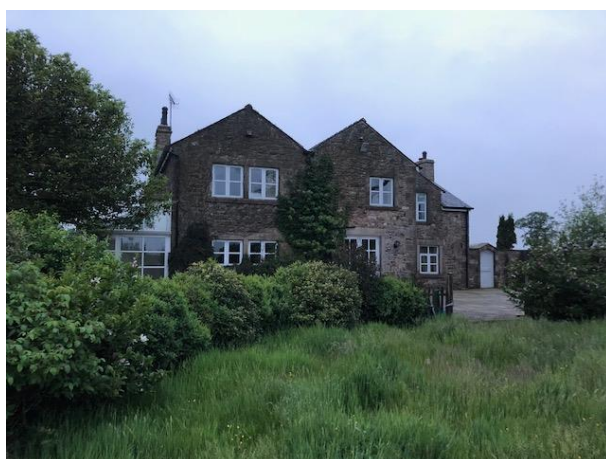
- 3.3 The main residential building comprised a two-storey stone-built building with a multi-pitched slate tiled roof, with gable features (Photo 1).

Photo 1: Main residential house, north-eastern elevation

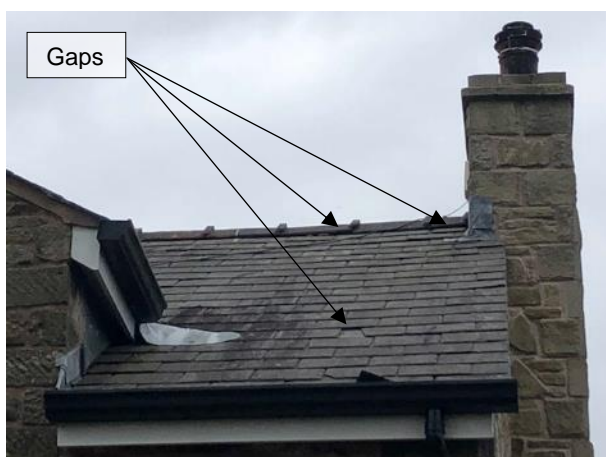
- 3.4 The roof tiles of the building were recorded to be in good condition, however gaps were noted beneath the ridge tiles where mortar was recorded as missing (Photo 2), and beneath occasional broken and lifted tiles across the roof pitch (Photo 2). These gaps may provide potential roosting features for crevice dwelling bats, and/or ingress opportunities for bats into the building loft spaces.

Photo 2: Example locations of gaps beneath roof tiles

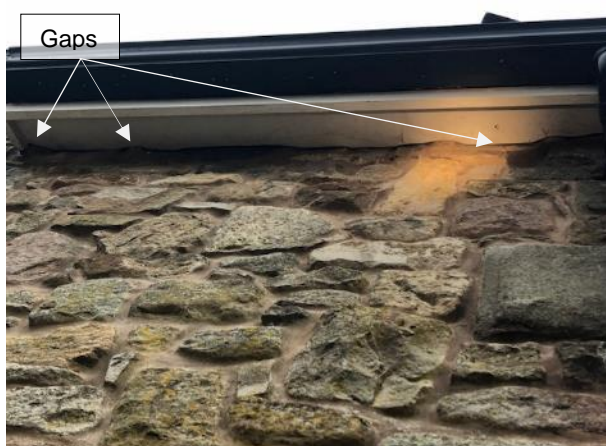
- 3.7 Narrow wooden soffit boxes were present at the eaves, the undersides of which were slanted to run parallel to the angle of the roof pitch. Narrow gaps were present between the soffit boxes and stone walls (Photo 3), which may provide ingress opportunities into roosting locations for bats within the soffits, loft spaces or any potential wall cavities. Five bat droppings were identified on the stone wall immediately beneath a soffit box, on the north-eastern elevation (Photo 4). These droppings were considered likely to be from the current bat activity season, and resembled droppings of a pipistrelle *Pipistrellus* sp. bat.

Photo 3: Typical gaps along soffit boxes at eaves

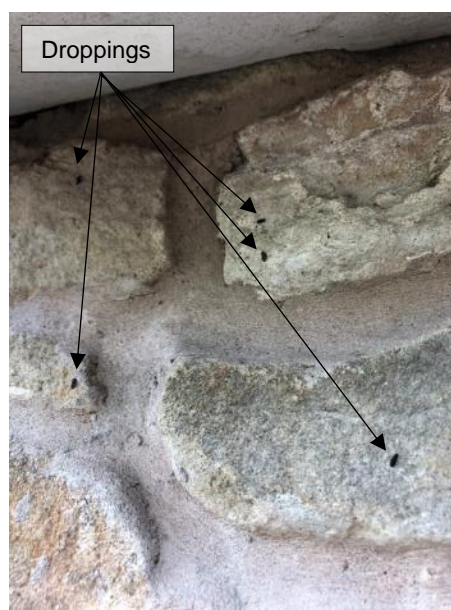
Photo 4: Bat droppings beneath soffit box

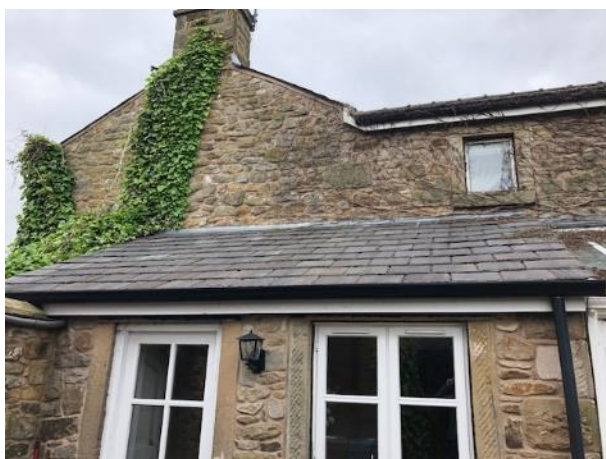
- 3.10 A stone built single-storey extension was present on the south-eastern elevation, with a half-pitched slate tiled roof (Photo 5). The slate tiles across this roof pitch were in recorded to be in good condition with no gaps suitable for roosting bats recorded. The eaves of the extension were similar to those around the remainder of the building, with occasional gaps present between stone work and wooden soffit boxes. A glass conservatory also adjoined the south-eastern gable end (Photo 6), with no potential roosting features recorded.

Photo 5: Single storey extension on south-eastern elevation

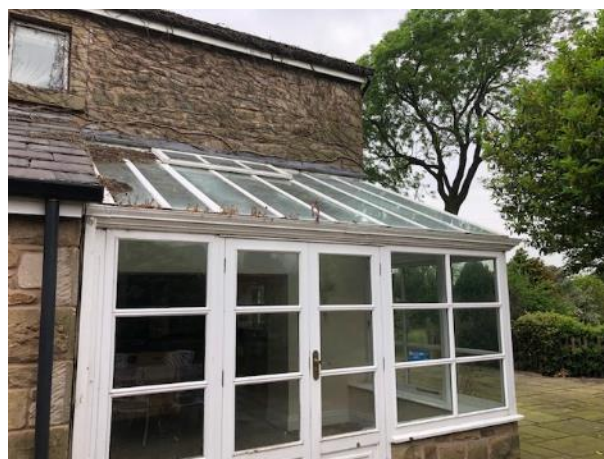
Photo 6: Conservatory on south-eastern elevation

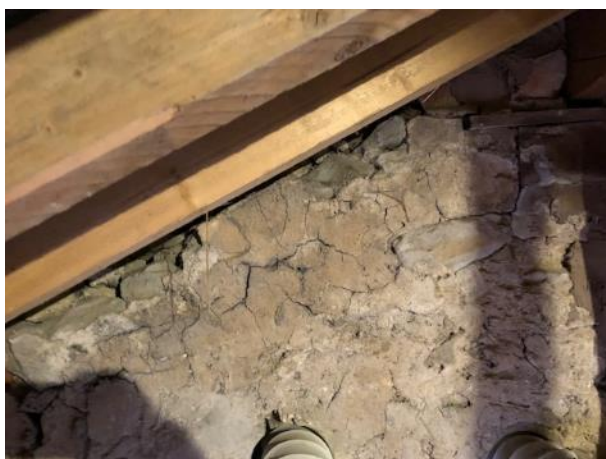
- 3.13 For ease of interpretation, the five loft spaces are labelled Loft Spaces A – E on Drawing 2019-E2-01 (Appendix 2). The loft spaces within the south-western half of the house comprised stone gable walls

Photo 7: Stone wall – south-eastern gable end of Loft Space C

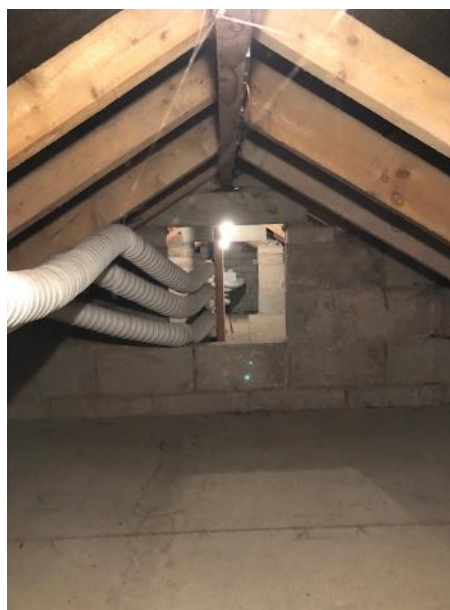
(Photo 7), whilst the roof spaces of the north-eastern half of the building possessed breezeblock dividing, supporting and gable walls suggesting a more recent construction (Photo 8).

Photo 8: Breezeblock supporting walls of Loft Space C – looking north-east

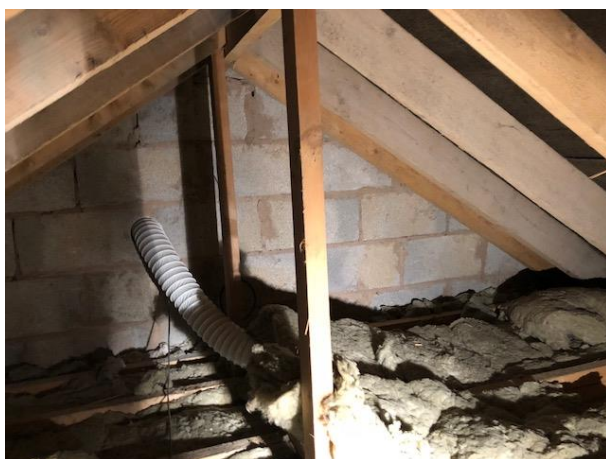
- 3.14 Each loft space comprised a supporting structure of narrow wooden beams, including purlins, a single ridge beam and central supporting beams (Photos 9 and 10). The beams were in good condition, with no rot holes or splits recorded of potential value to roosting bats.

Photo 9: Loft Space C

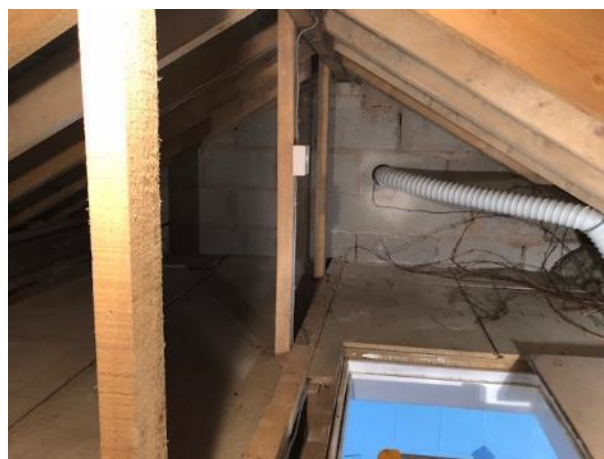
Photo 10: Loft Space B

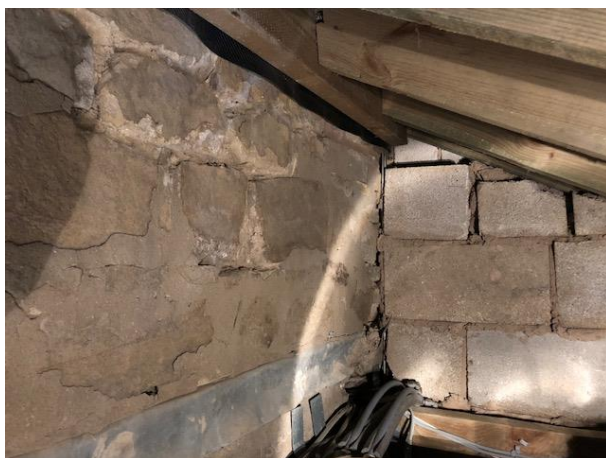
- 3.17 Within half-pitched space of Loft Space E, gaps were present between the stone wall and adjacent wooden ridge beam, and between the breezeblock gable walls of the extension (Photo 11). These features were fully inspected, and no evidence of bat usage was recorded.

Photo 11: Loft space E

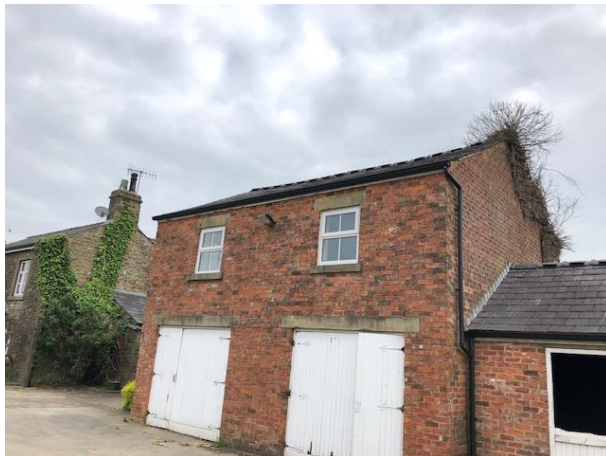
- 3.25 The granary building comprised a two-storey red brick building with a single pitched, slate-tiled roof (Photo 12). The roof ridge possessed vented tiles, which may provide potential access points for bats into the roof void. No evidence of bats was recorded around or beneath these potential access points when inspected through binoculars, however due to their height and location, the features could not be fully inspected. The remainder of the tiles were generally in good condition with no broken or lifted tiles recorded.

Photo 12: The Granary – southern elevation

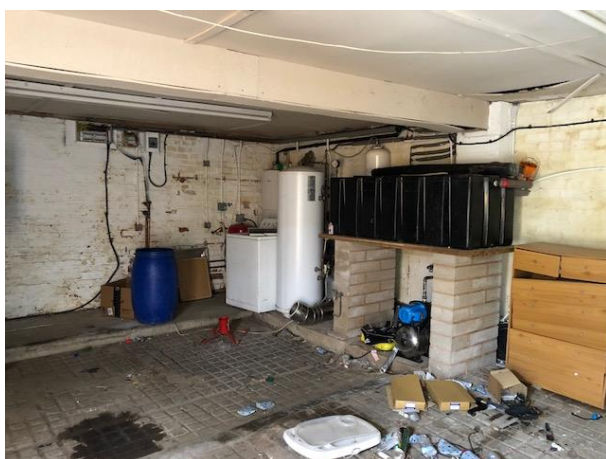
- 3.31 The ground floor comprised an open garage / boiler room / storage area with a boarded ceiling and painted brick walls (Photo 13). No potential roosting opportunities were identified, and no evidence of bat usage (i.e. bat droppings, feeding remains, staining or individual bats) was recorded.
- 3.32 The upper floor comprised a self-contained flat with plastered walls and ceiling (Photo 14). No potential roosting features, or access points from roof voids or the outdoors were identified, and no evidence of bat usage was recorded. The roof void of the building could not be accessed due to the absence of a loft hatch.

Photo 13: Ground floor of The Granary

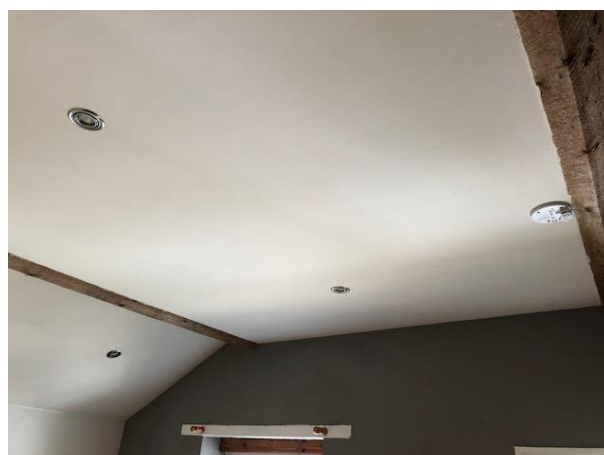
Photo 14: Ceiling of upper floor of The Granary

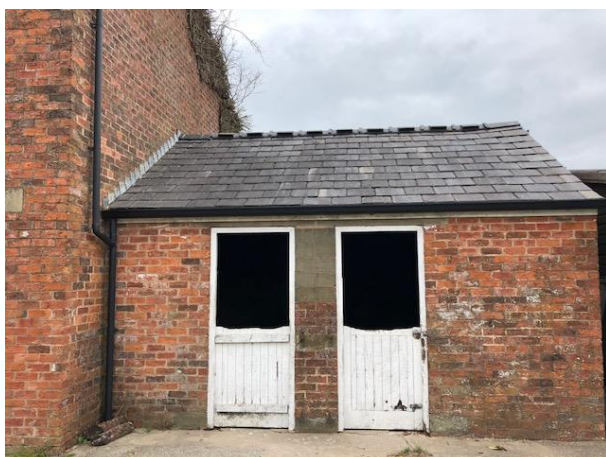
- 3.34 A small brick building, comprising two stables, adjoined the eastern elevation of The Granary (Photo 15). The northern elevation was crowded with dense ivy. The stables were accessed through two half-height stable doors, providing open access for fauna into the internal spaces.

Photo 15: Brick stables

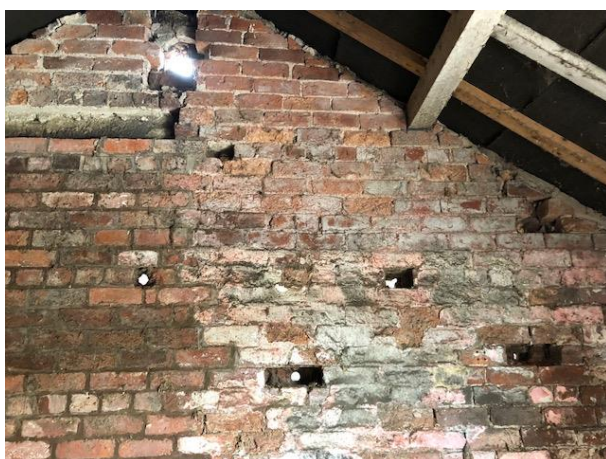
- 3.38 Several holes were present across the south-eastern brick gable end, which lead directly into the open internal space (Photo 16) with no sheltered cavities suitable for roosting bats. No evidence of roosting bats was recorded at or beneath these features.

Photo 16: Gaps within south-eastern gable wall

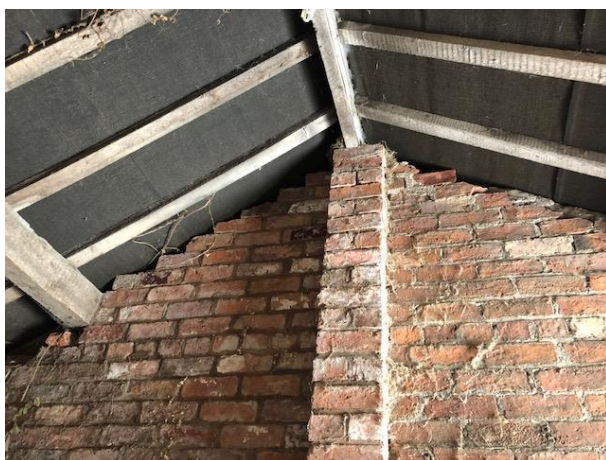
Photo 17: Brick dividing wall between stables

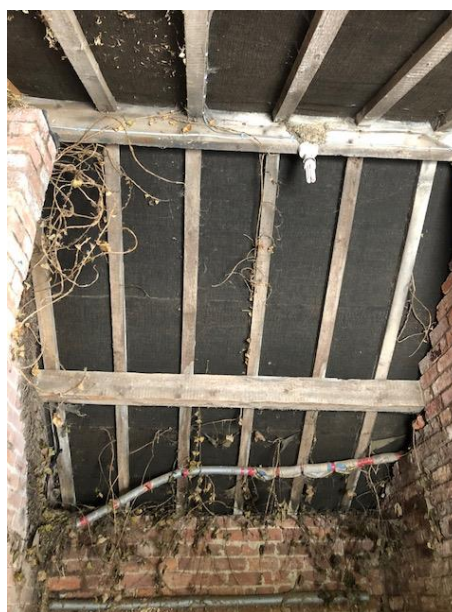
Photo 18: Felt sarking and ivy growth

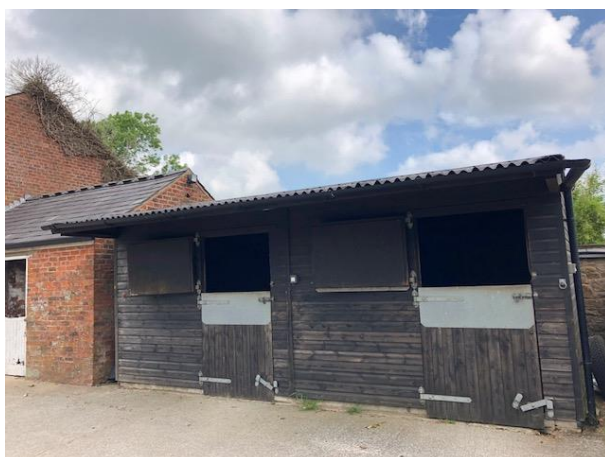
- 3.44 Five wooden stable blocks were present within the survey area, with a combination of pitched corrugated and felt covered roofs (Photos 19 and 20).

Photo 19: Wooden stables with corrugated roof

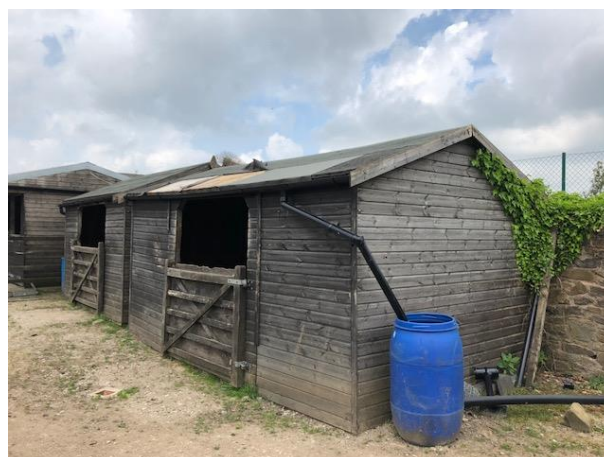
Photo 20: Wooden stables with felt-covered roof

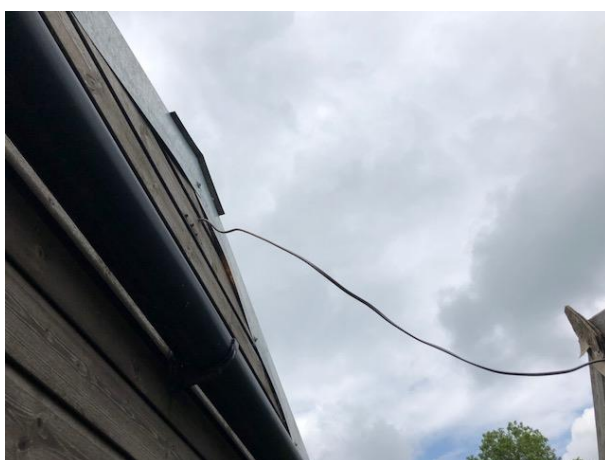
- 3.48 Lead flashing was present along the verges of the gable ends of the two longest stable blocks, which was occasionally lifted (Photo 21). These gaps were fully inspected and found to be blocked with dense cobwebs suggesting no recent usage by roosting bats.

- 3.49 The wooden slatted walls were in good condition, with no gaps between panels recorded (Photo 21).

Photo 21: Gable end with lifted flashing

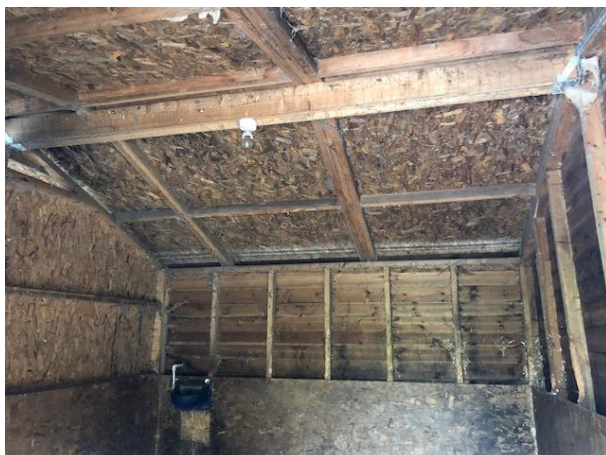
- 3.50 The internal spaces of the stables were open and draughty, due to the half open stable doors. Each stable comprised wooden or chipboard walls and a concrete floor (Photo 22). Each stable was open to the

underside of the boarded roof. The walls and roof beams of the stables were recorded to be in good condition and no features of potential value for roosting bats were recorded.

Photo 22: Typical internal space of wooden stables

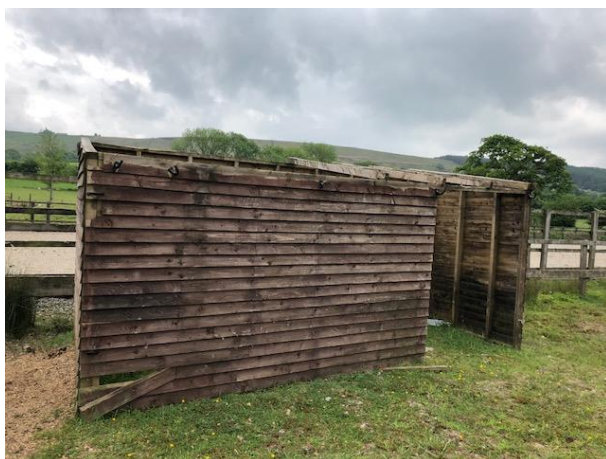
- 3.53 Wooden slatted walls of an old shed structure were present to the north-east of the stable blocks (Photo 23). This structure had no roof. The wooden slats of the walls were tightly fit to one another (Photo 24), and no features of potential value for roosting bats were recorded.

Photo 23: Old shed structure

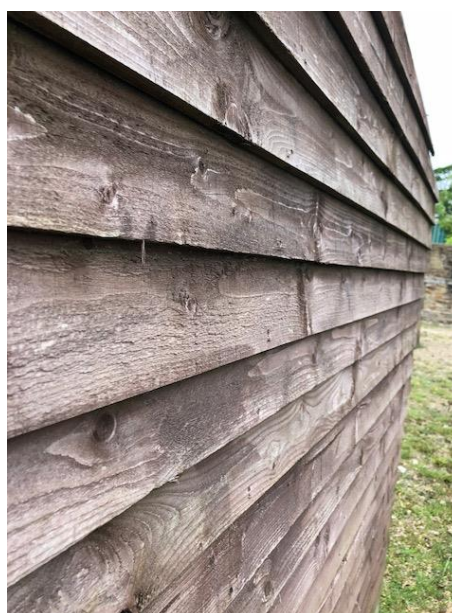
Photo 24: Wooden slats of old shed structure

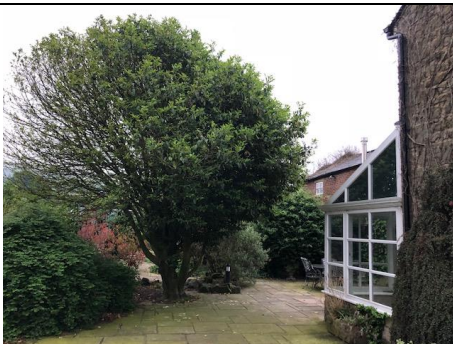
Tree Ref. S1	
Species	<i>Prunus</i> sp.
Life stage	Mature
Approx. Height	6-7 metres
Approx. Diameter at Breast Height	0.65 metres
General description Any potential roost features, height and elevation Any evidence of bats	Large shrub. Historical pruning and shaping to contain canopy with enclosed courtyard area. No features recorded of potential value to roosting bats.
Category of Bat Roost Potential	Negligible
To be removed as part of proposals	Likely to be removed.
Photo

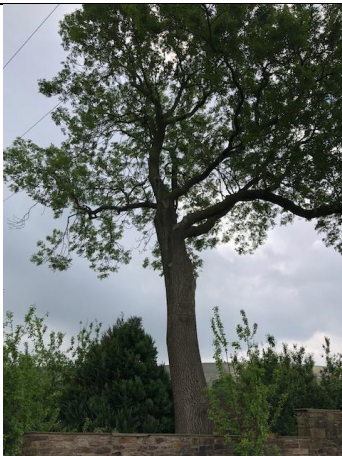
Tree Ref. T2	
Species	Ash <i>Fraxinus excelsior</i>
Age	Mature
Approx. Height	12+ metres
Approx. Diameter at Breast Height	0.9 metres
General description Any potential roost features, height and elevation Any evidence of bats	Large tree with high spreading canopy. Large limb lost close to trunk with wound decaying back and partial occlusion, at 5 m in height on southern aspect. Four rot holes, between 7 m and 12 m in height. Split in bark at 6 m in height, southern aspect. Deadwood in canopy. No evidence of bat usage through binoculars, however features could not be fully inspected due to height.

Category of Bat Roost Potential	Moderate
To be removed as part of proposals	No
Photo
