Brabins Almshouses, 29Windy Street, Chipping, Lancashire

Brabins Charitable Trust

Roof Works

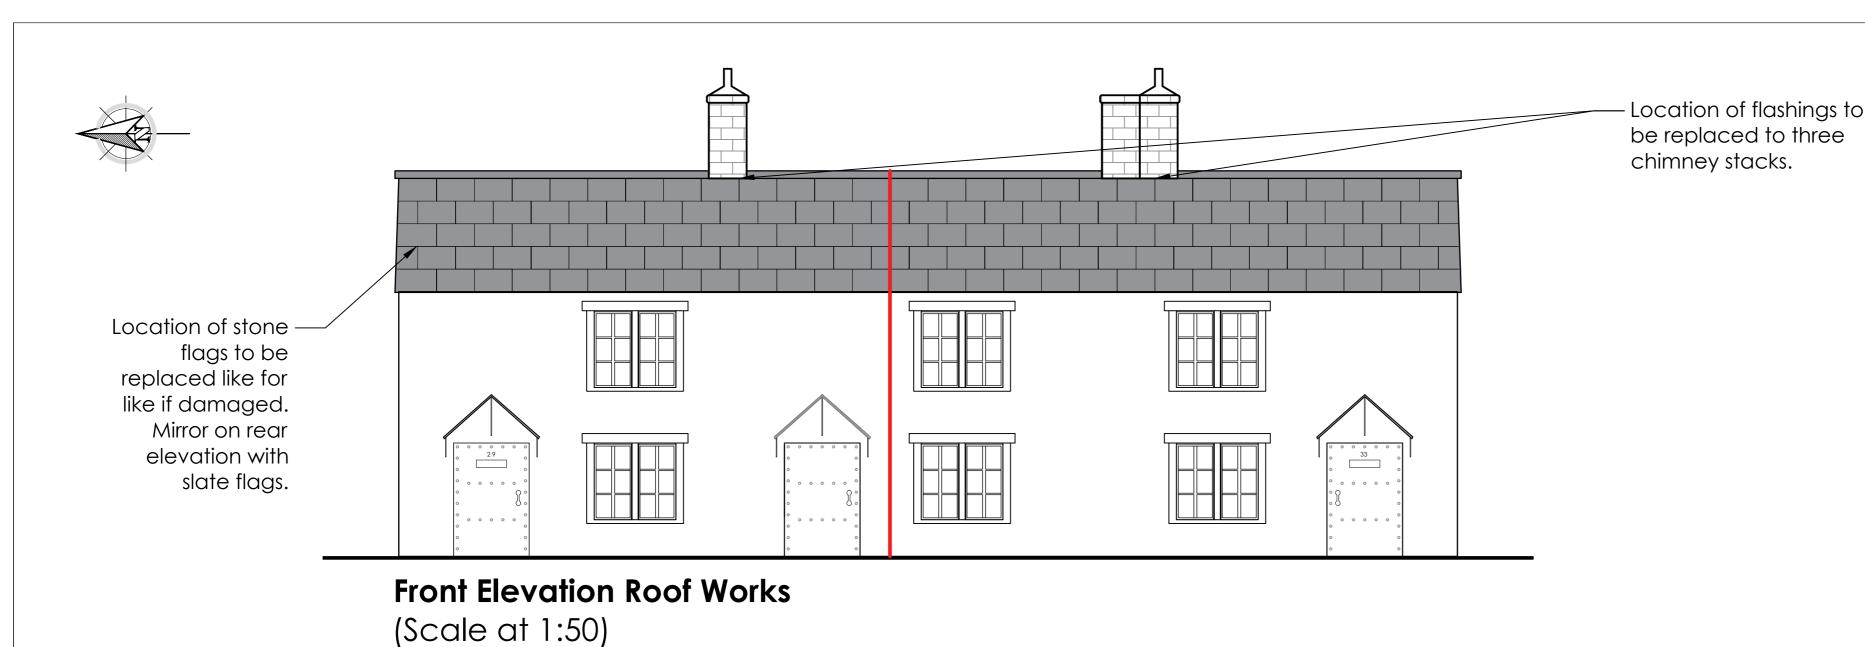
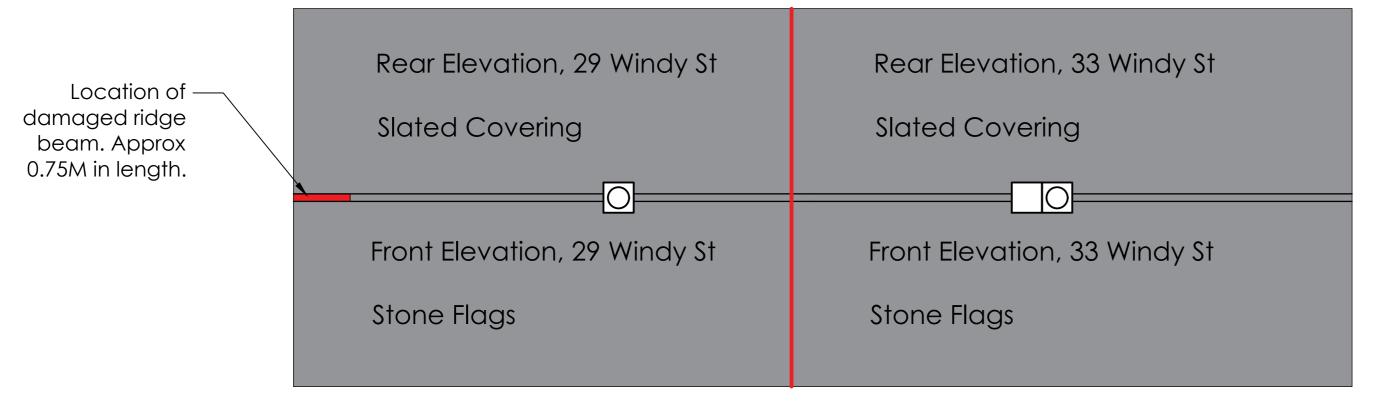
Roof Elevation

Whenever possible, the stone and welsh slate flags will be preserved and re used. When this is not possible, the stone flags should be replaced like for like from a local quarry. It is strongly presumed that the stone flags used are of Pendle gritstone. The ridge beam above 29 Windy St has also been damaged by wet rot towards the north facing gable. It is proposed to remove only the damaged part of the ridge beam and replace it with a timber as existing.

Roof works are proposed in the form of replacing the lead flashings to the chimney stacks at 29 & 33 Windy St. At 29 Windy St only it is proposed to replace damaged stone flags on the front roof pitch and replace damaged slates on the rear roof pitch, both of these will be over a breathable sarking membrane.
