BS 5837:2012 Tree and Hedgerow Survey Report Clitheroe Road, Whalley, BB7 9RG Presented to Trafford Housing Trust

Issued: August 2018

Delta-Simons Project No. 18-0886.02

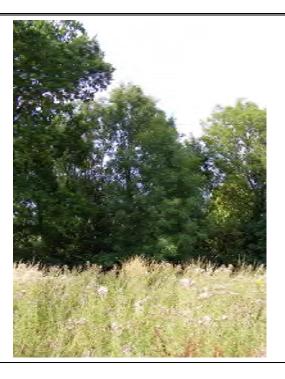
Photograph 2 – TG2

- ▲ TG2, is a semi-mature group in fair condition and includes the species sycamore, goat willow, ash and cherry, with a mutually shared canopy. A number of trees along the stream bank have exposed roots, while a number of trees support ivy.

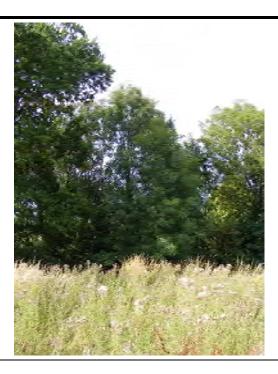
Photograph 3 – Tree (T)3

- ▲ T3, a young ash, has a rounded canopy and is in fair condition.
- ▲ T4, a mature oak, with a rounded canopy is in fair condition. Bifurcated at 4 m.

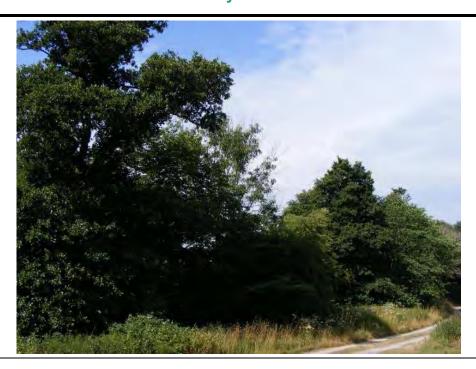
Photograph 13 - TG14

- ▲ TG14, a group containing semi-mature ash, cheery and alder in fair condition, is sited along the stream with spreading crowns. This group contains specimens with bifurcation at ground level, included unions and ivycovered stems.

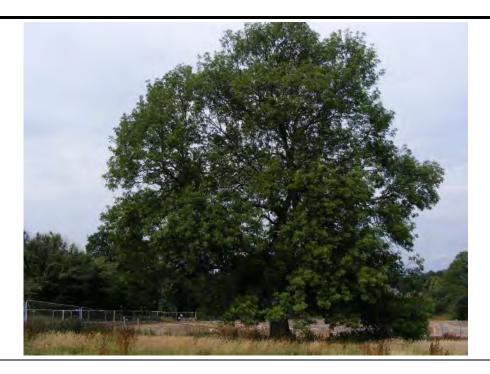
Photograph 15 – T16

- ▲ T16, a mature ash has a slightly unbalanced crown in good condition.
- ▲ T17 is a mature oak with a rounded canopy in good condition.
- ▲ T21 is a semi-mature oak on the bank of the stream that has collapsed to the north. Main stem has lifted bark, though is generally in a fair condition.
