FEB  
2019

# Preliminary Roost Assessment (Bats)

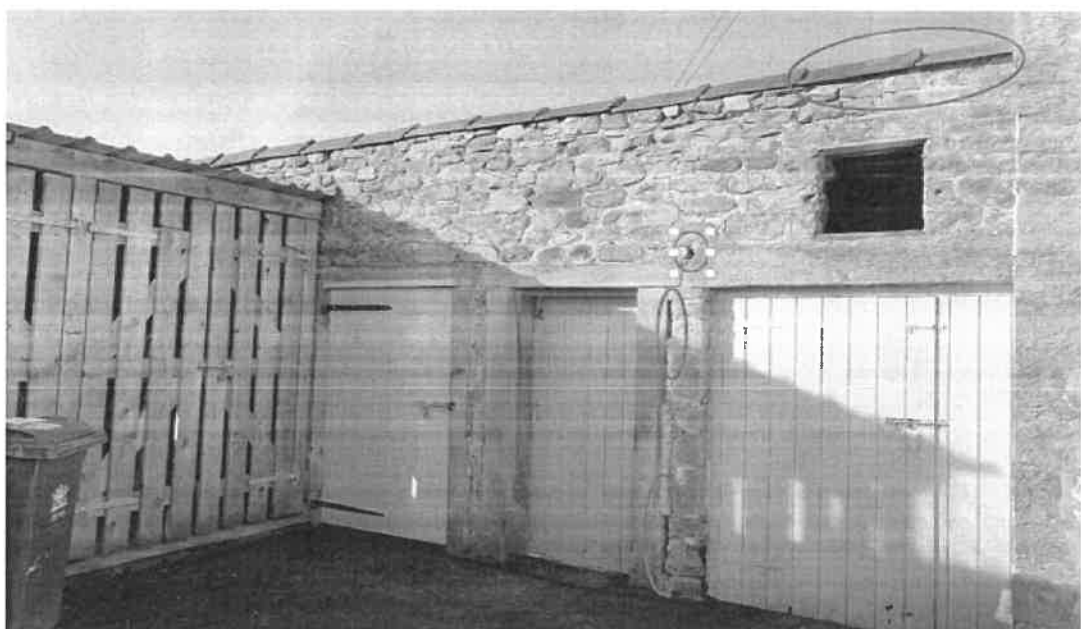
**Photograph 2: Example of missing mortar in stone work and raised ridge tiles on southern facade**

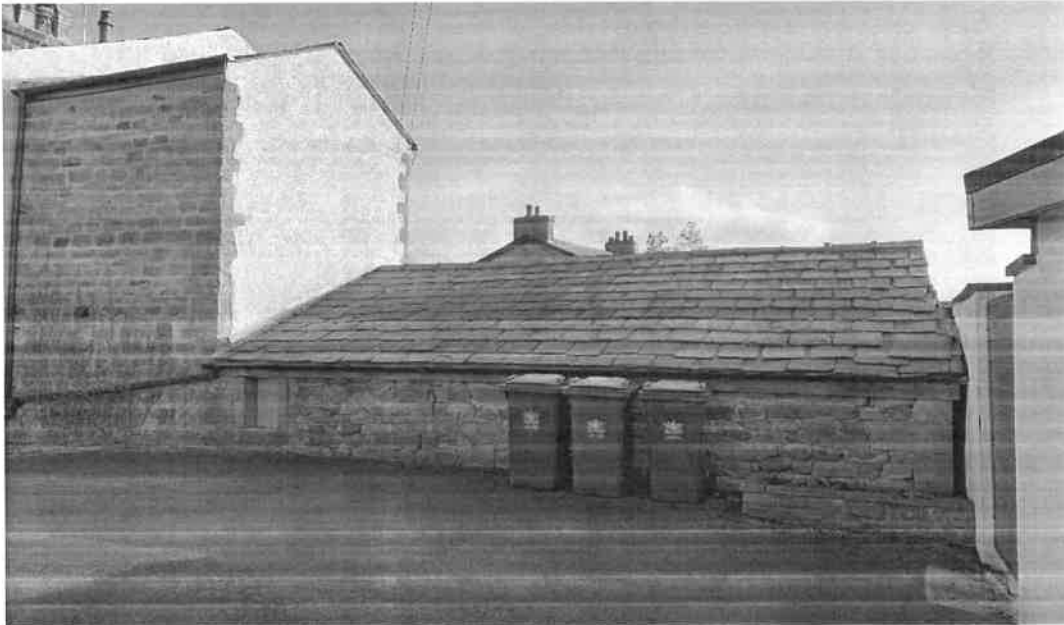
**Photograph 3: Northern façade showing the attachment to the western gable of the main dwelling and the 8-10cm gap between the western façade of the survey structure and neighbouring property (to the right of image).**

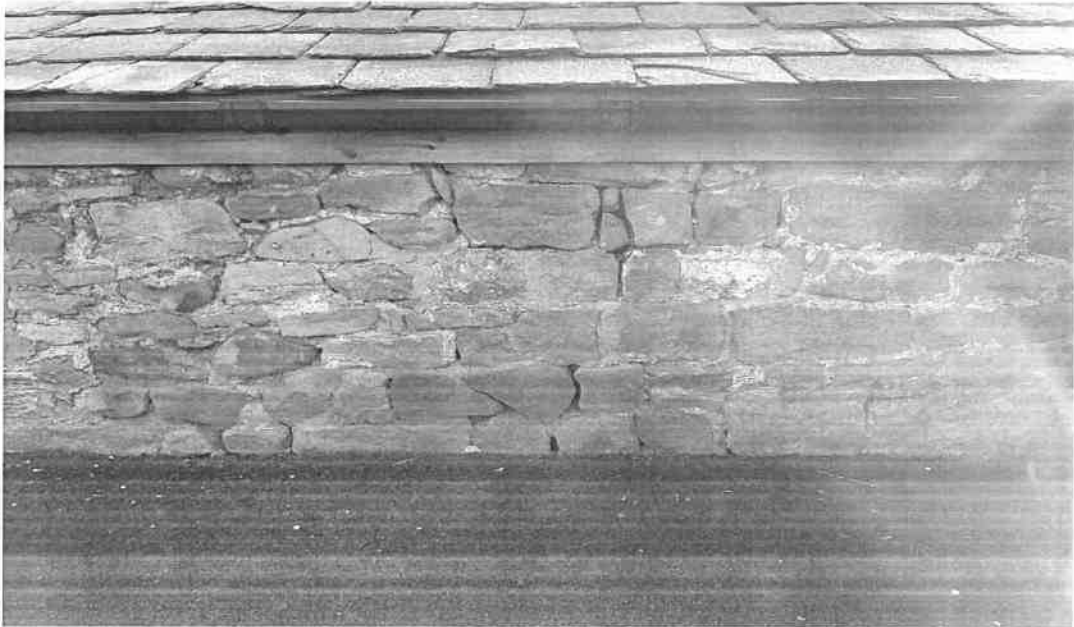
**Photograph 4: Example of the gaps and cracks in the stone work on the northern façade**

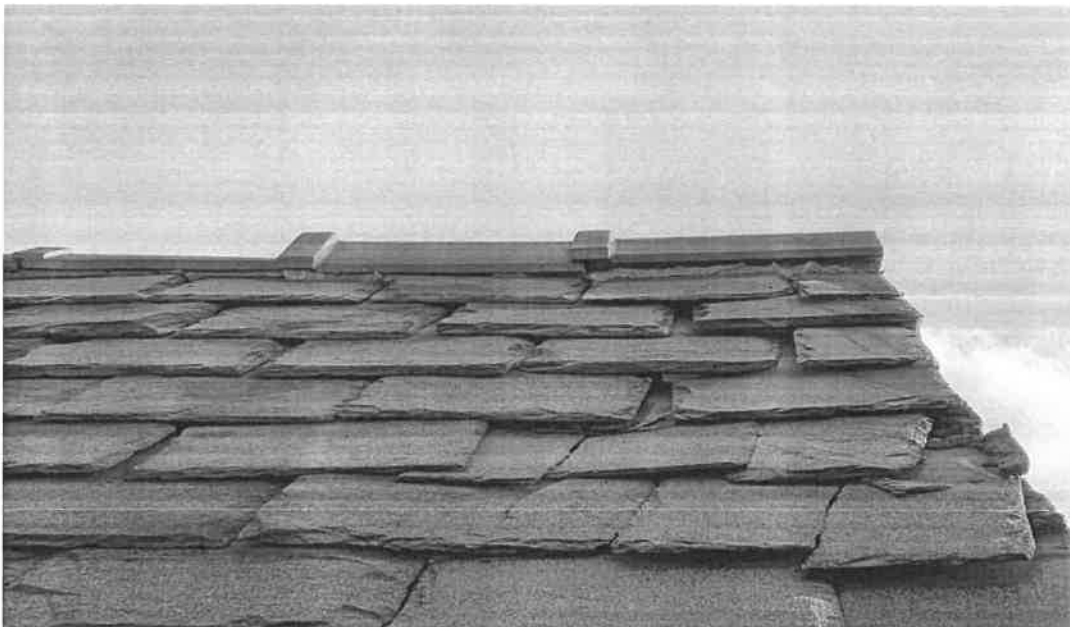
**Photograph 5: Raised ridge tiles at western end of northern façade – showing gaps with expandable foam.**

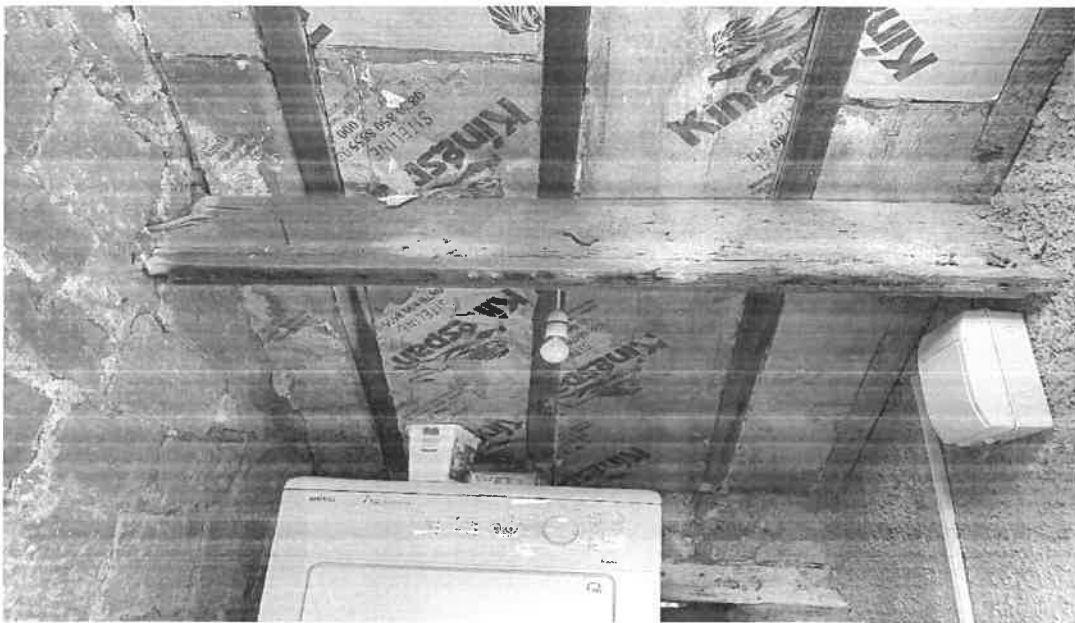
**Photograph 8: Kingspan insulation blocks in room A.**

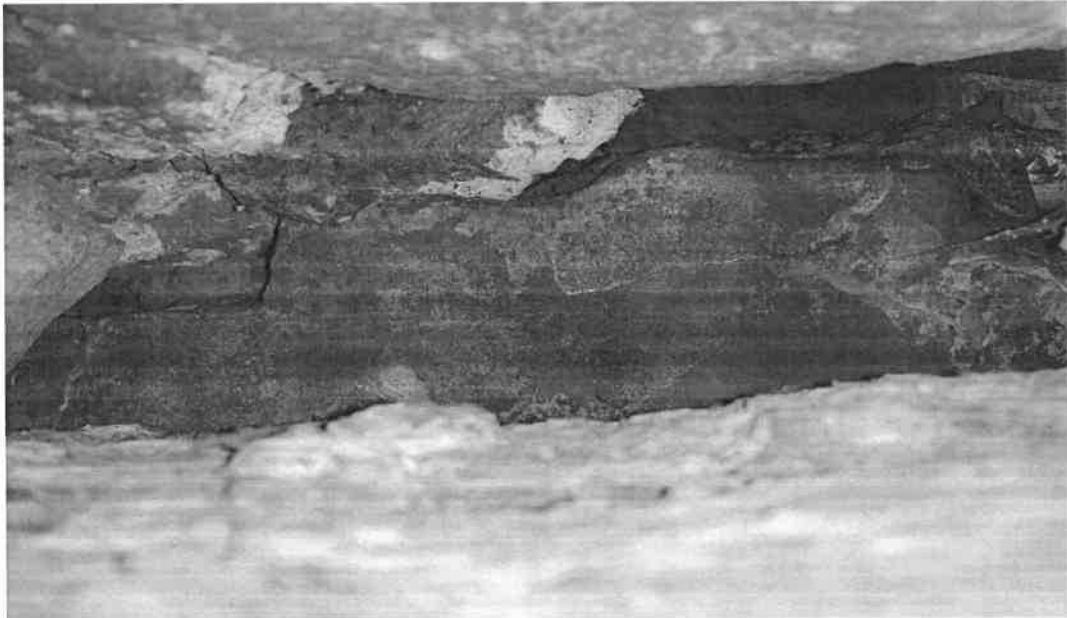
**Photograph 9: Example of gaps around lintels, stonework and joists from room A.**

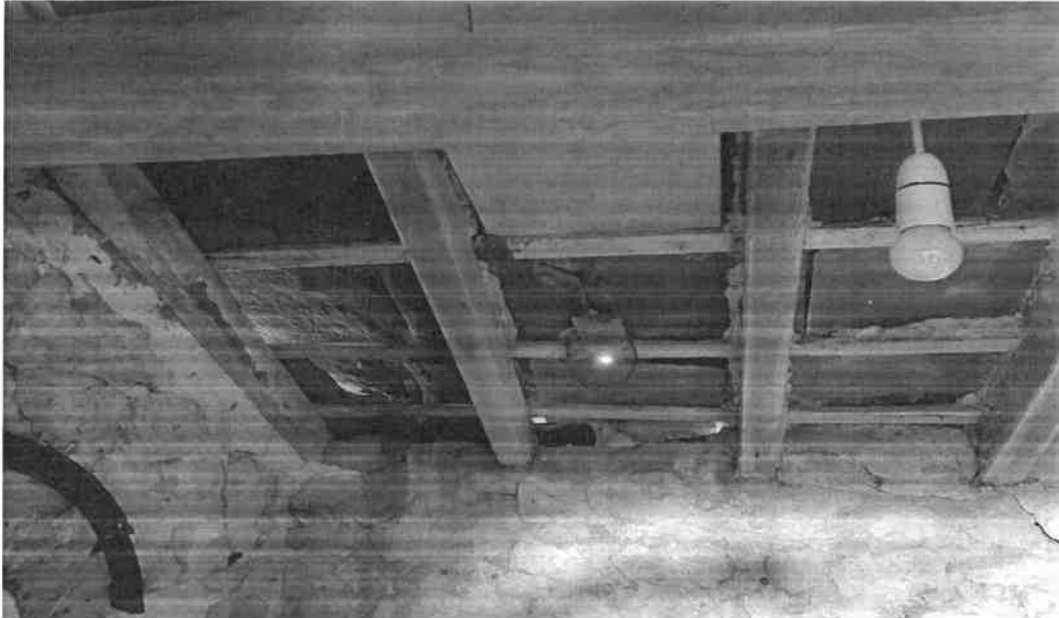
**Photograph 11: Unlined roof slates within remaining compartments, showing daylight through missing slates.**

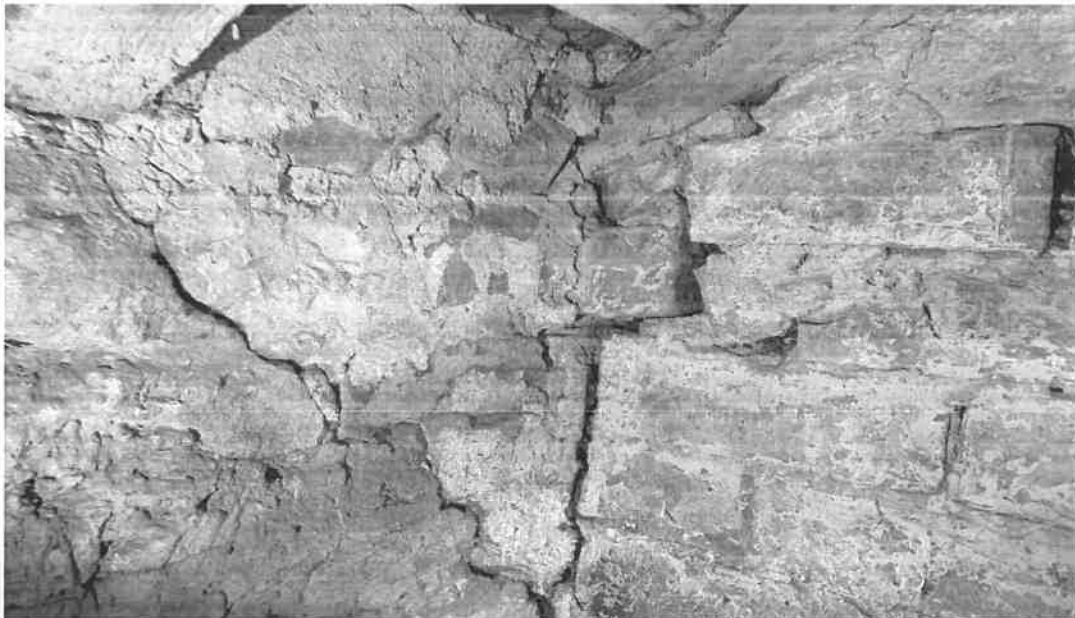
**Photograph 12: Example of cracks and gaps in the stonework of rooms B, C, and D.**

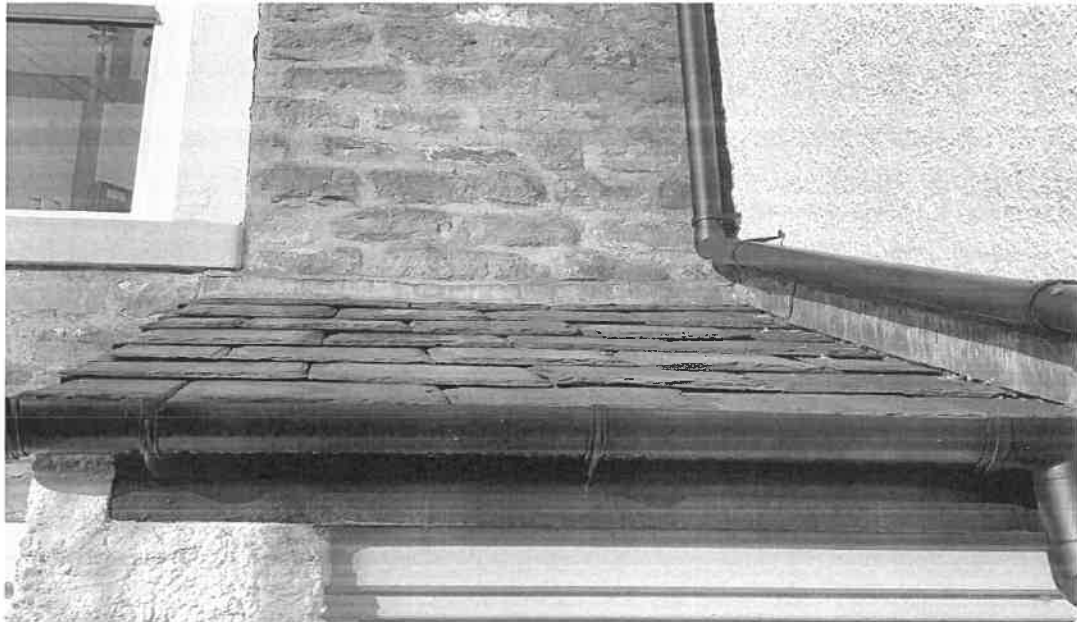
**Photograph 14: Example of natural lifting of the roof slates above the entrance porch.**
