**DESIGN & ACCESS WITH
HERITAGE STATEMENT
IN CONNECTION WITH
29 AND 33 WINDY ST
CHIPPING
LANCASHIRE**

**ON BEHALF OF
THE BRABINS TRUST**

(LM/LM/1608/03)

John Brabin's Almshouses

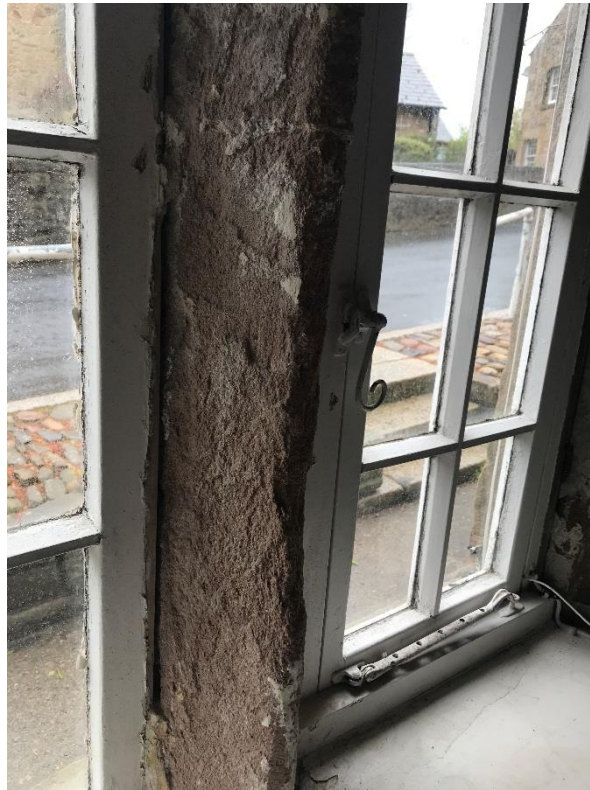
Figure 2,

The first issue is in the form of severe spalling to the central section of the stone mullion on the ground floor to the front elevation. If not replaced, this would continue to deteriorate and cause the mullion to become unstable which could result in eventual collapse and loss of historic fabric.

Following the removal of the asbestos textured coatings internally, it became visible that the internal section of the central section of the sandstone mullion on the ground floor at 29 Windy Street was severely spalling. This is presumably due to the non-breathable textured coating that was applied which sped up the natural decay of the sandstone, as shown in Figure 1 below.

Visible decay of the central section of the sandstone mullion following removal of asbestos textured coatings.

The proposed external works would be to the rear elevation and would include removal of small sections of stone to install the ventilation louvres which would be 200x200 in size. The replacement of the guttering to the front elevation would also be part of the external works. The replacement of the central section of the stone mullion would consist of supporting the lintel, removing the damaged central section and replacement with a like for like sandstone mullion.

The replacement of the central section of the stone mullion would be classed as a like for like repair, therefore the replacement section would be of a local sandstone of the same aesthetic as the existing. This would not have any impact on the aesthetic value of the heritage asset. The method is minimally invasive and the removal would require propping the lintel whilst the central section is removed and the new section is fixed. Once the new section is fixed into place the support can be removed.
