# Preliminary Roost Assessment

31 Waterloo Road

# Gritstone ecology

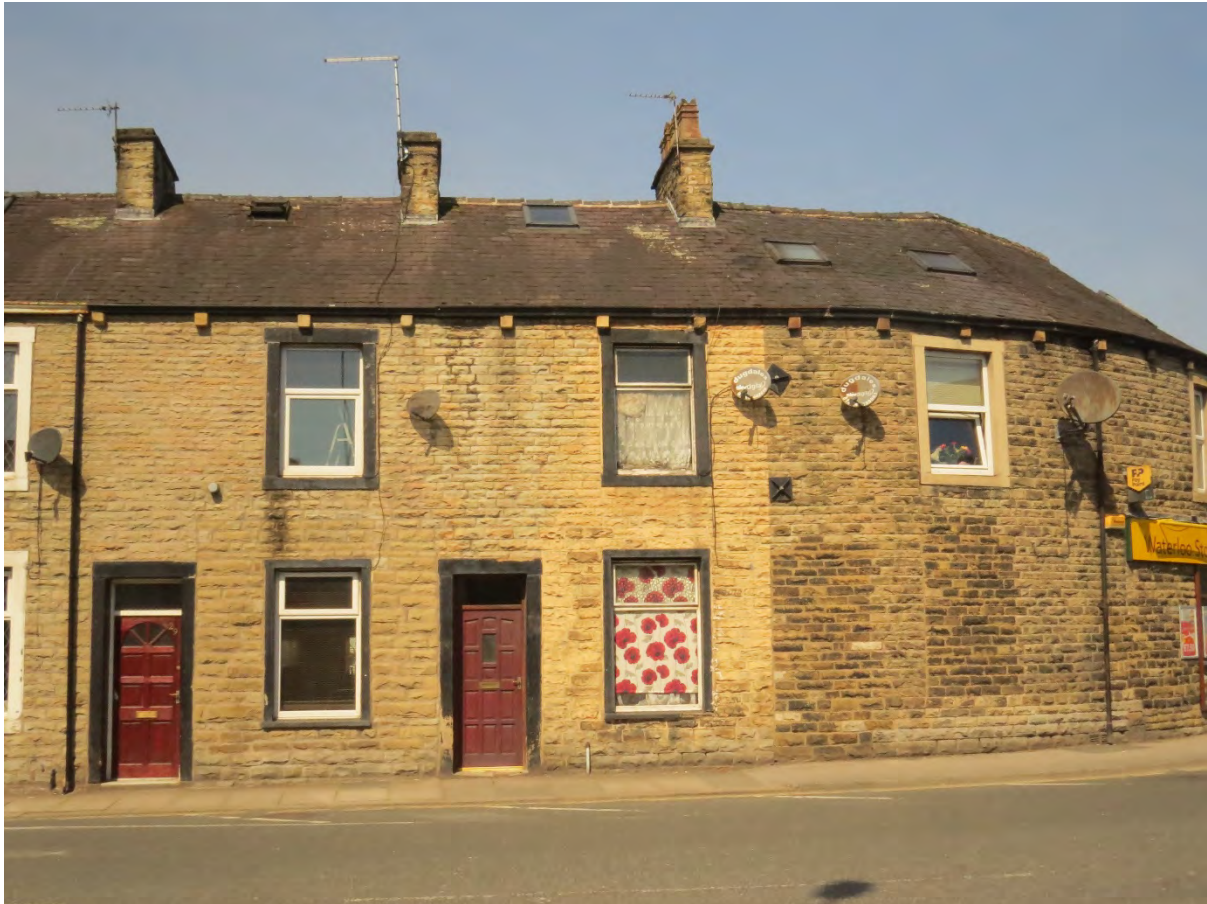
3.1a – The front of the house from Waterloo Road.

There are no features externally which are likely be used by roosting bats, and no evidence of use by bats was present during the inspection.

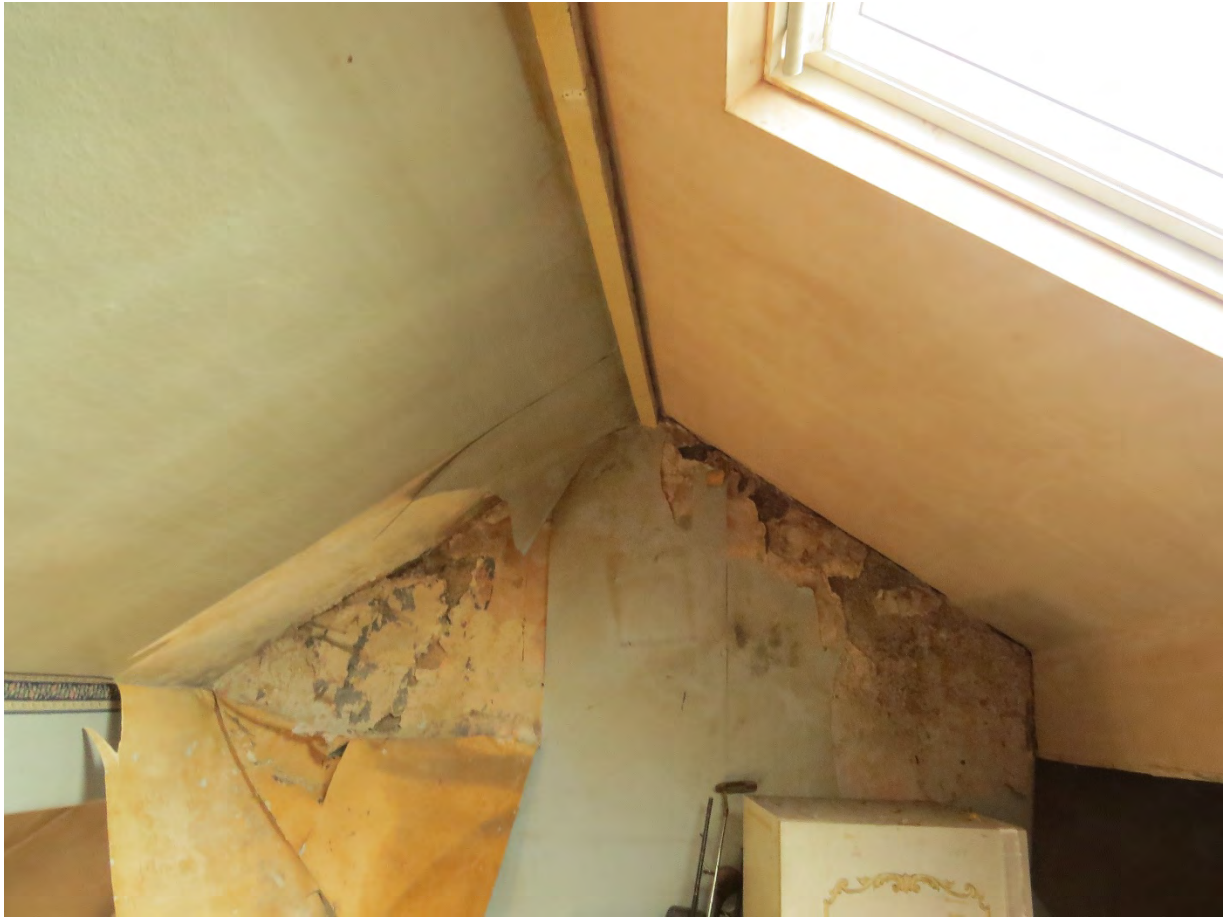
3.2a – The roof void.

The house has a single roof void, which has been boarded out, and is used for storage. The room is well-lit by natural light through a Velux window. The gap between internal boarding and roof tiles has been insulated with mineral wool.

The small gaps between brickwork, roof timbers, and tiles, in the roof voids were inspected in detail using an endoscope. These areas were dusty and cobwebbed. No droppings were found, and no suitable gaps were present which could give access, or shelter to roosting bats.

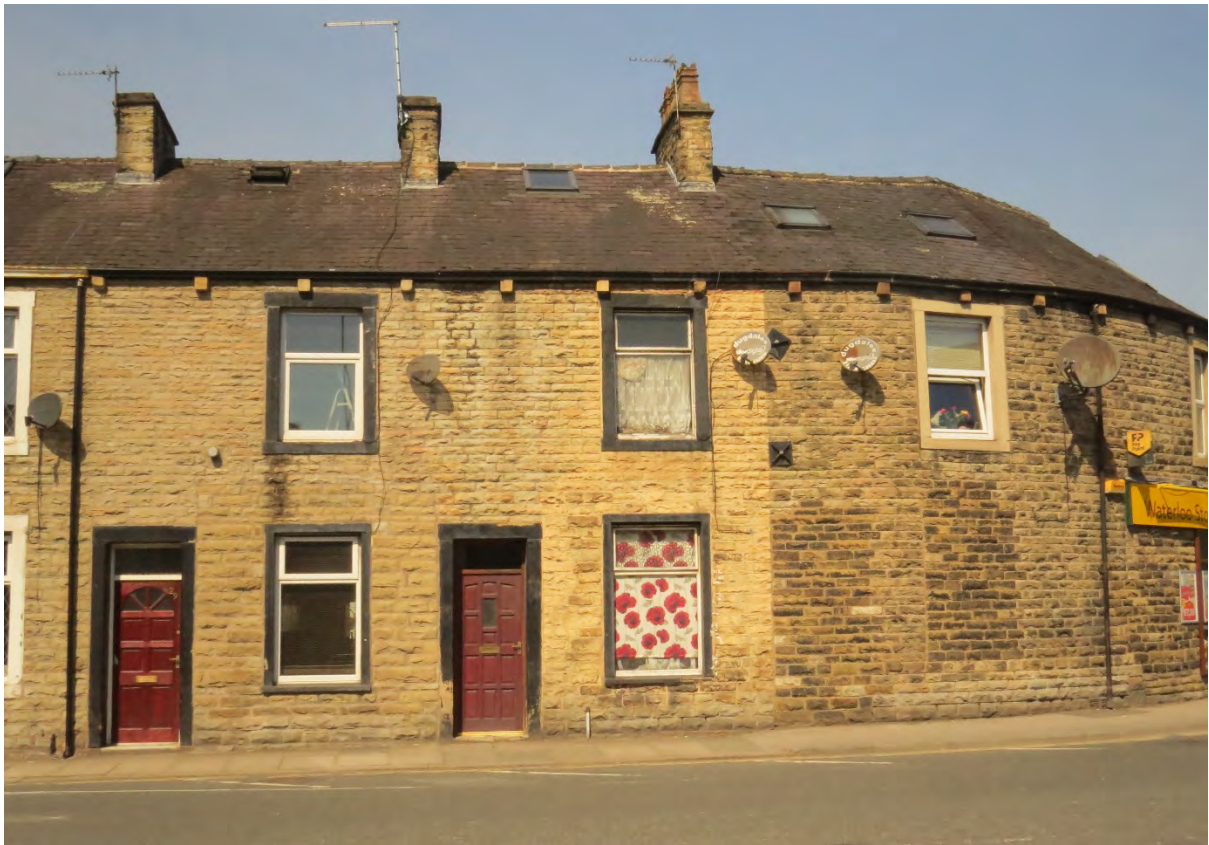
1 – The front of the house from Waterloo Road.

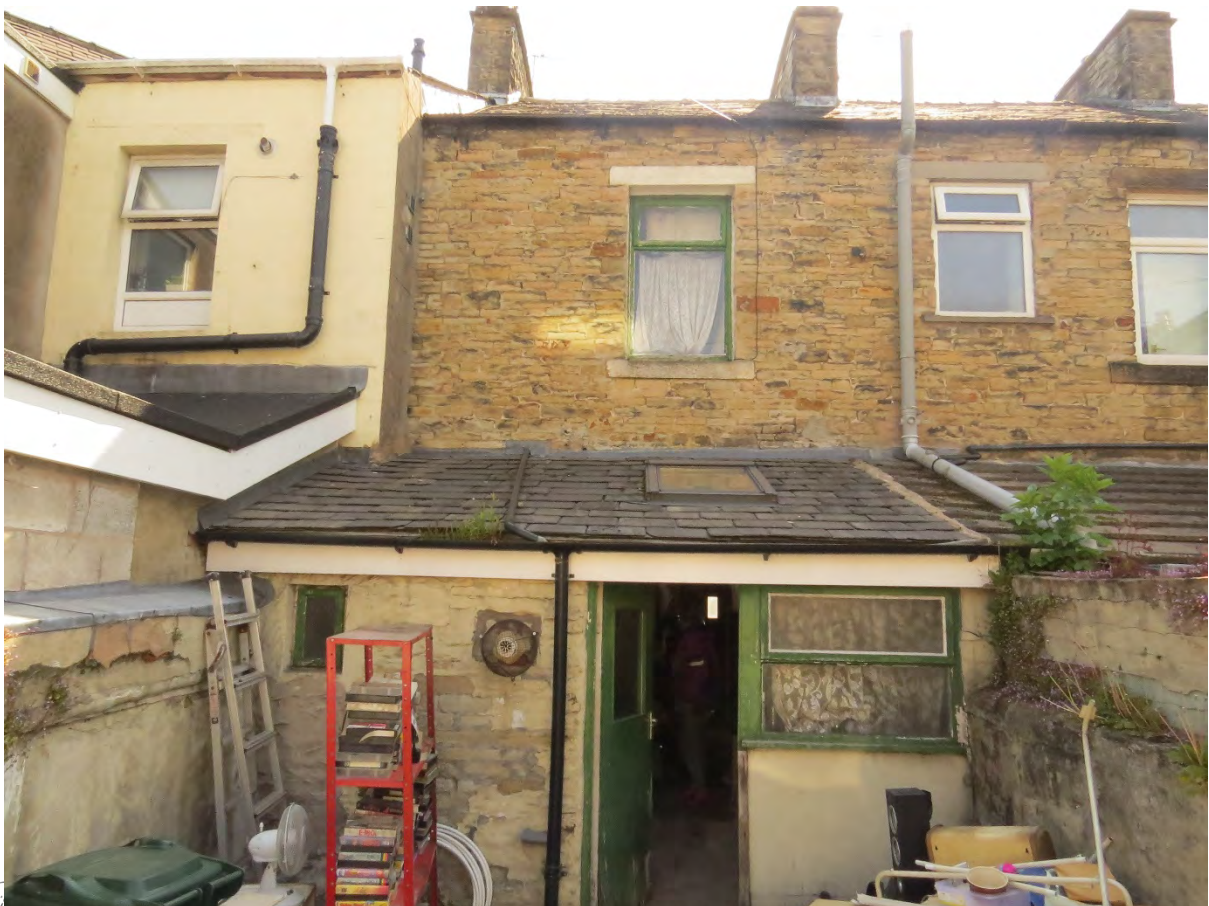
2 – The rear of the house, and ground floor extension.

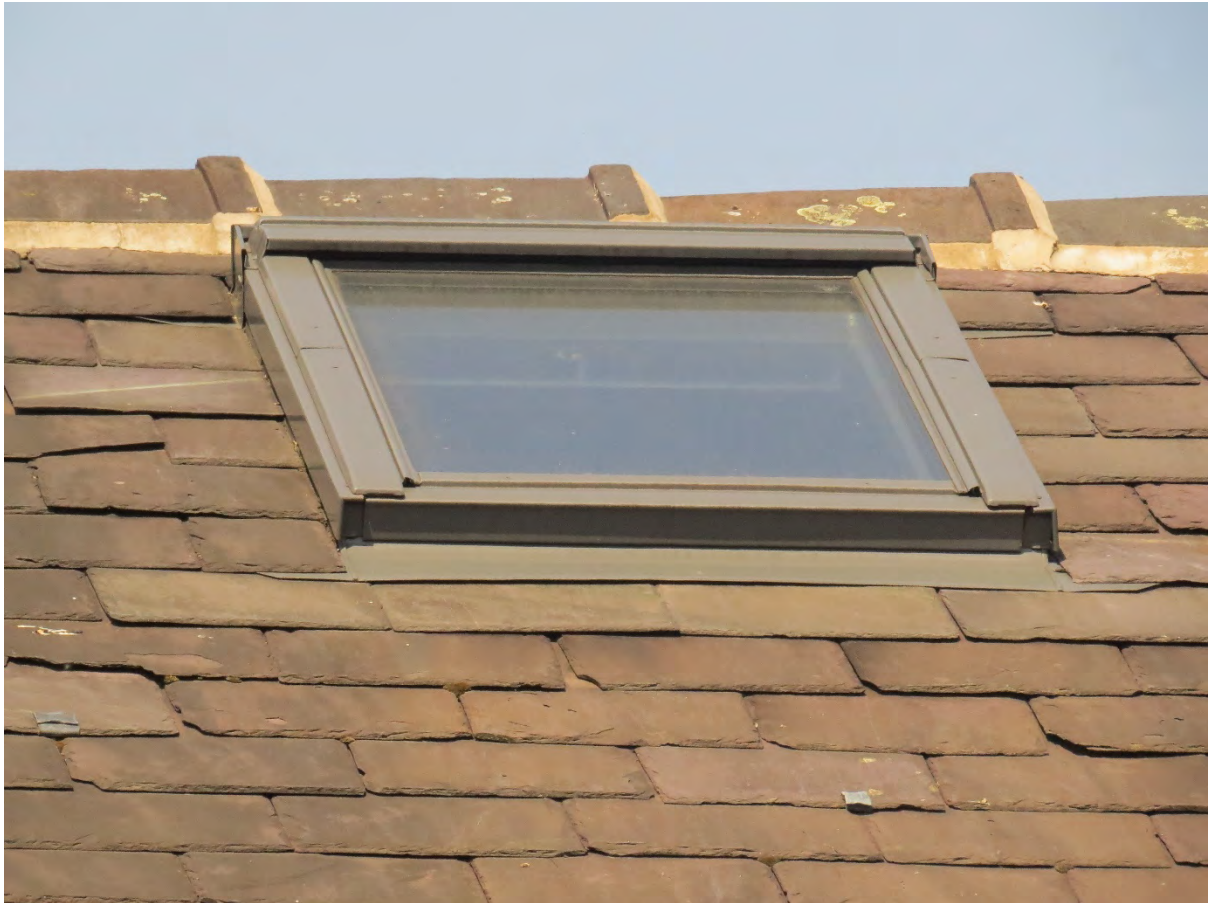
3 – The roof has a Velux roof light fitted.

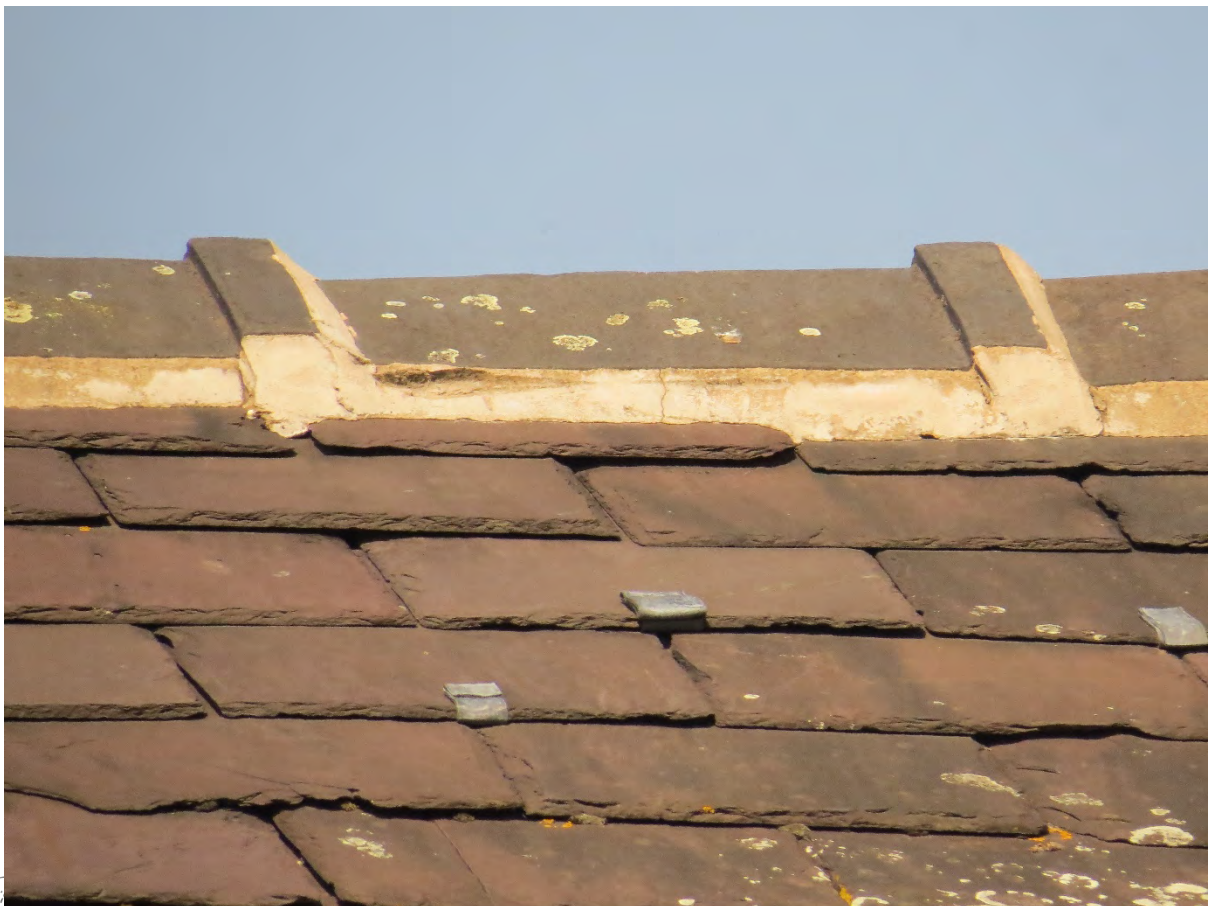
4 – Ridge tiles are tightly cemented in place with no suitable gaps.

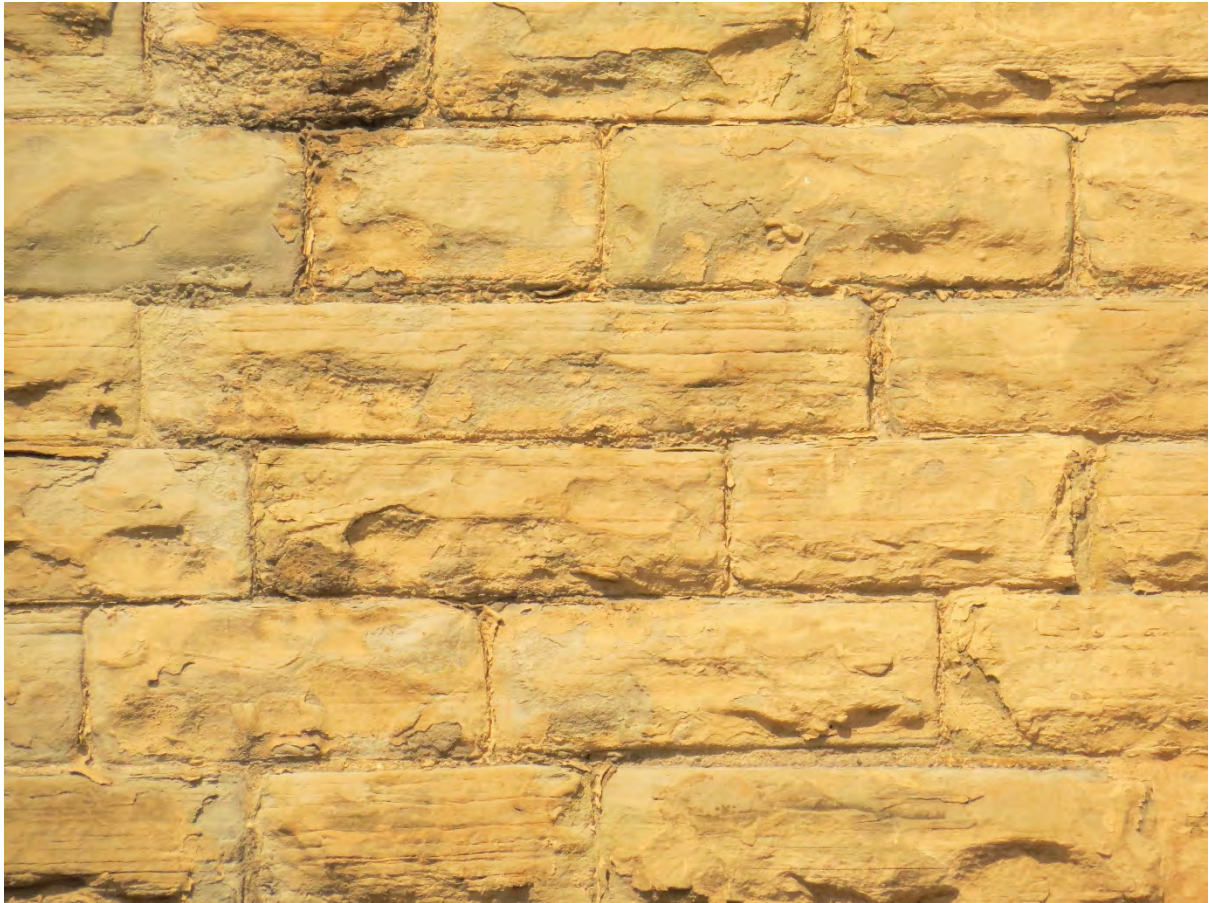
The walls are stone and brick with no insulating cavity. The walls are in good condition, with no cracks, or missing mortar which could be used by crevice dwelling bats.

5 – Stonework is in good condition with no cracks or missing mortar.

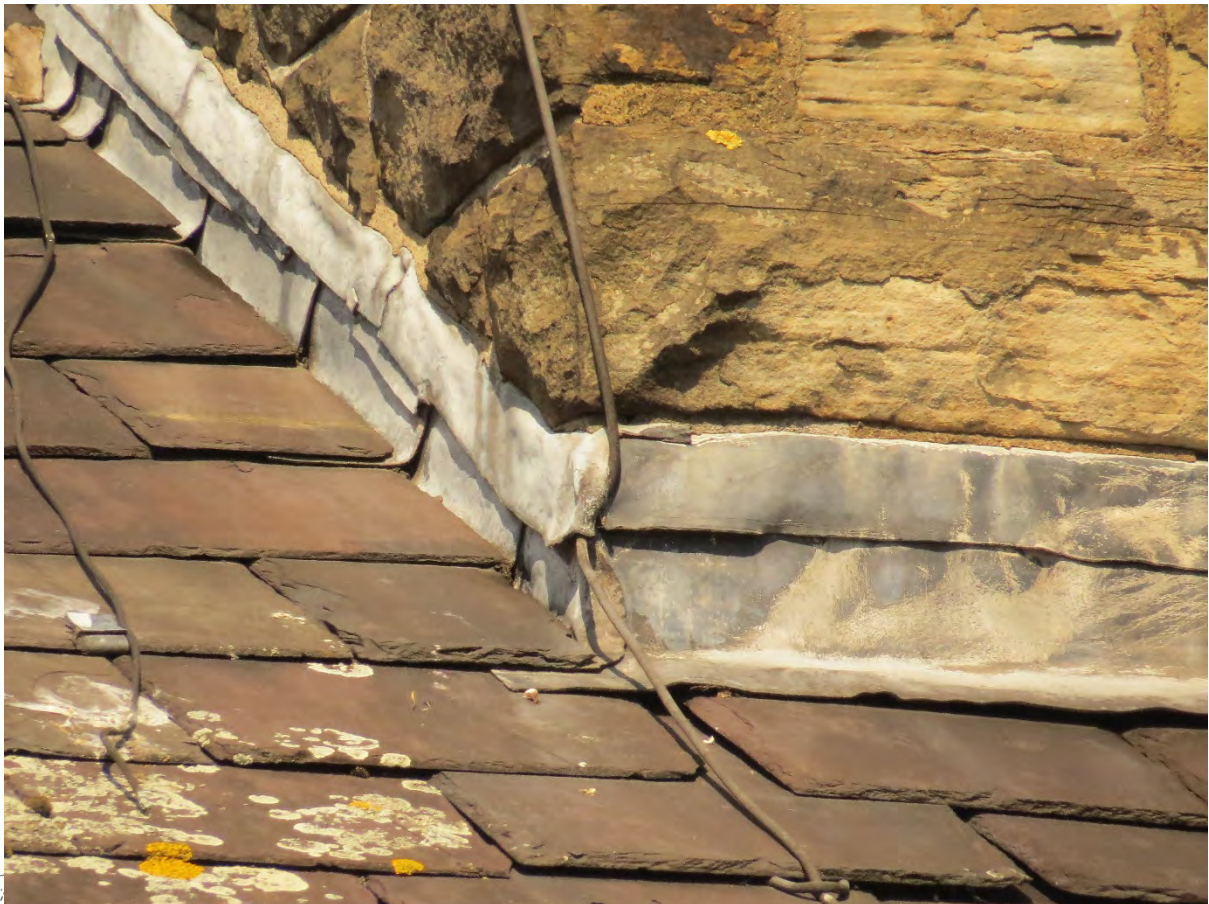
6 – Leadwork is tight with no suitable gaps.

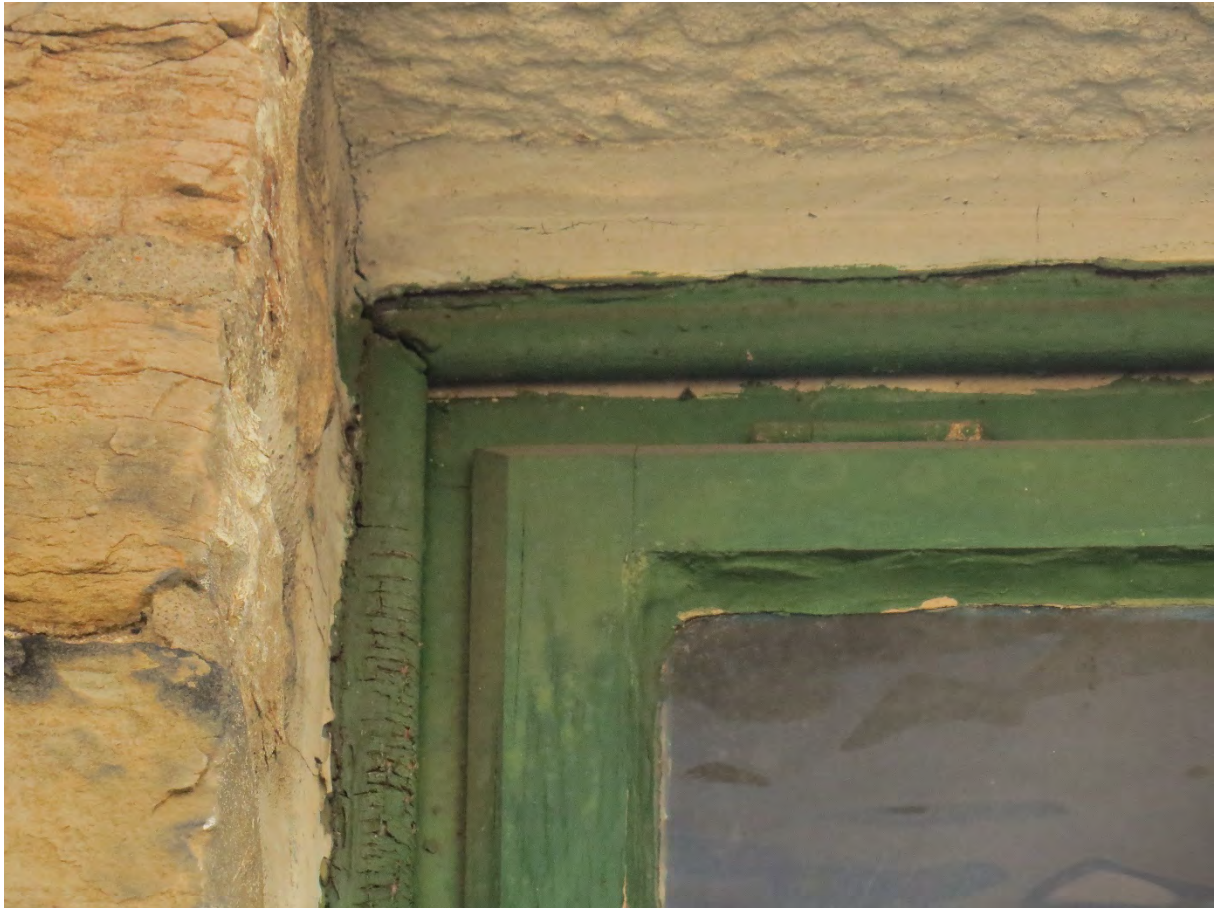
7 – Window and door frames are tightly sealed into stonework with no suitable gaps.

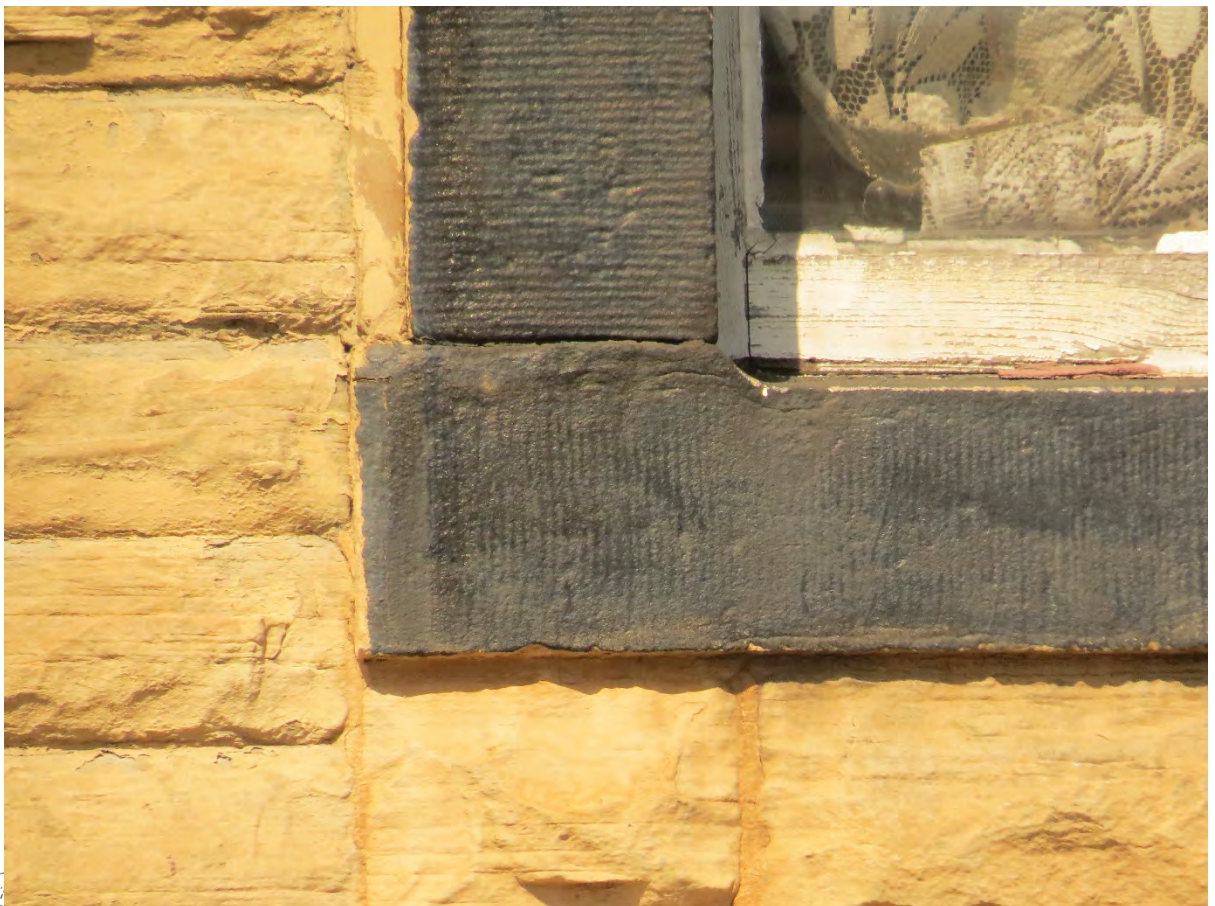
Stone lintels and window settings are in good condition with no cracks, or crevices which could be used by roosting bats.

8 – Stone lintels and window settings have no suitable gaps.

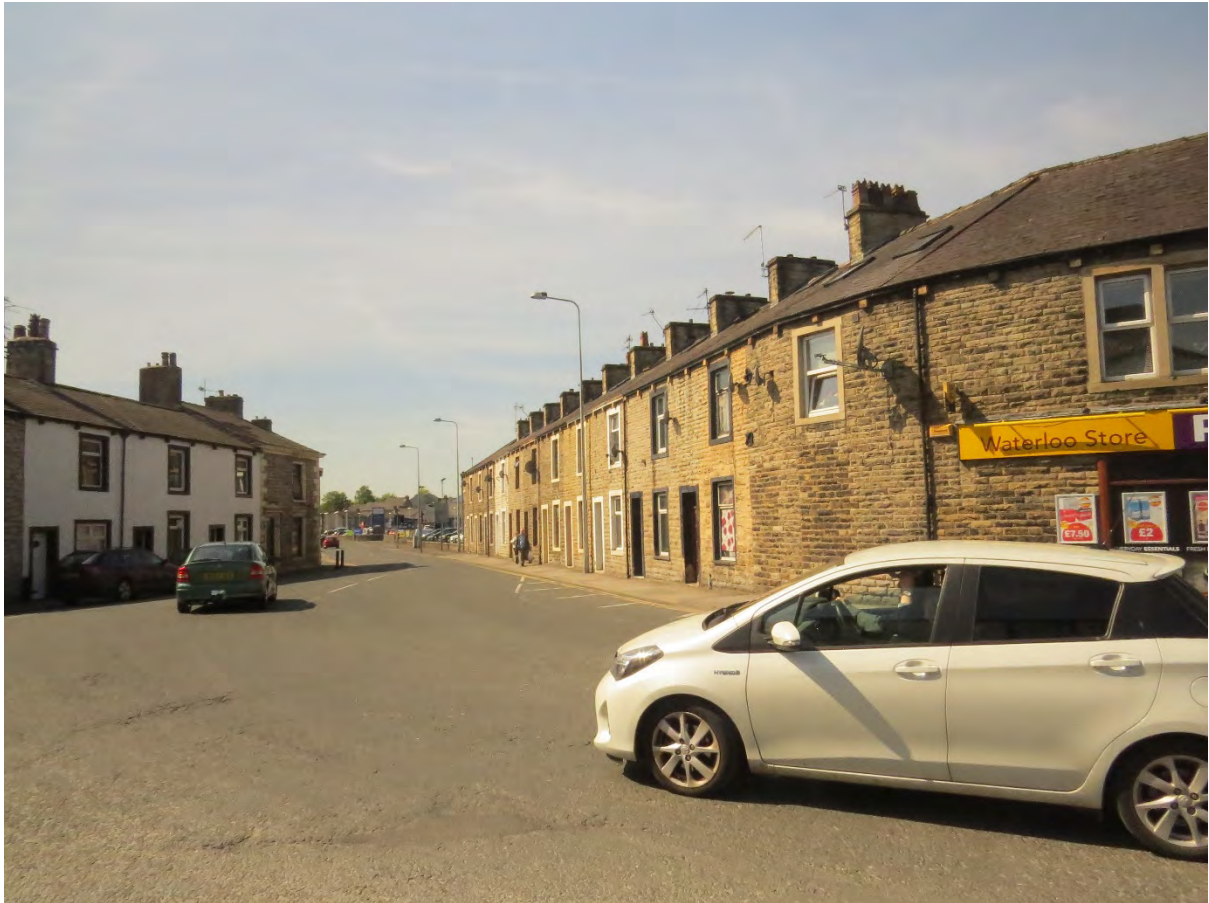
9 - The house is situated on the junction of a busy well-lit main road.

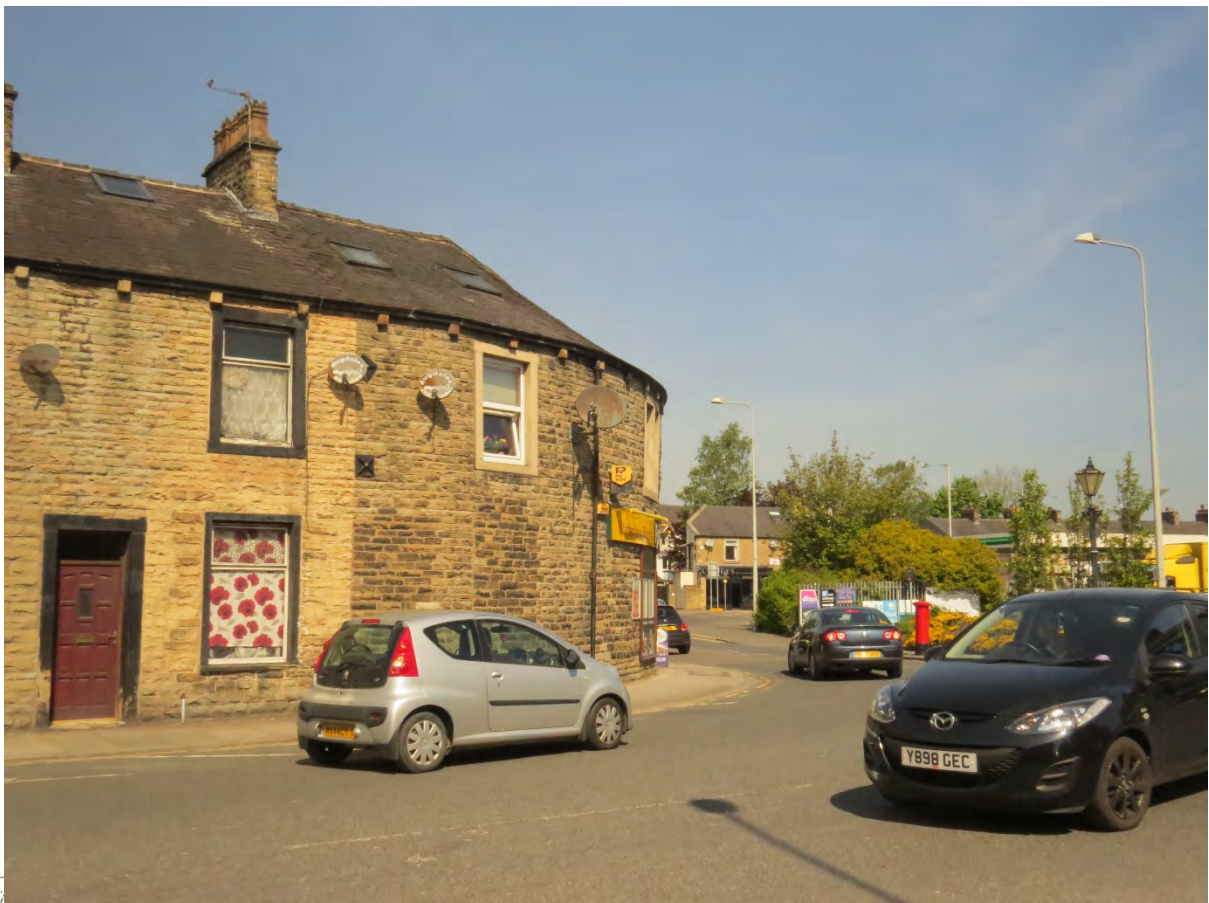
10 - Habitat surrounding the house is unlikely to be used by foraging or roosting bats.
