Arboricultural Constraints Appraisal

in Relation to Proposed Development of Residential Care Properties
at

**Alston Lodge, Lower Lane,
Longridge, Lancashire, PR3 2YH**

June 2019

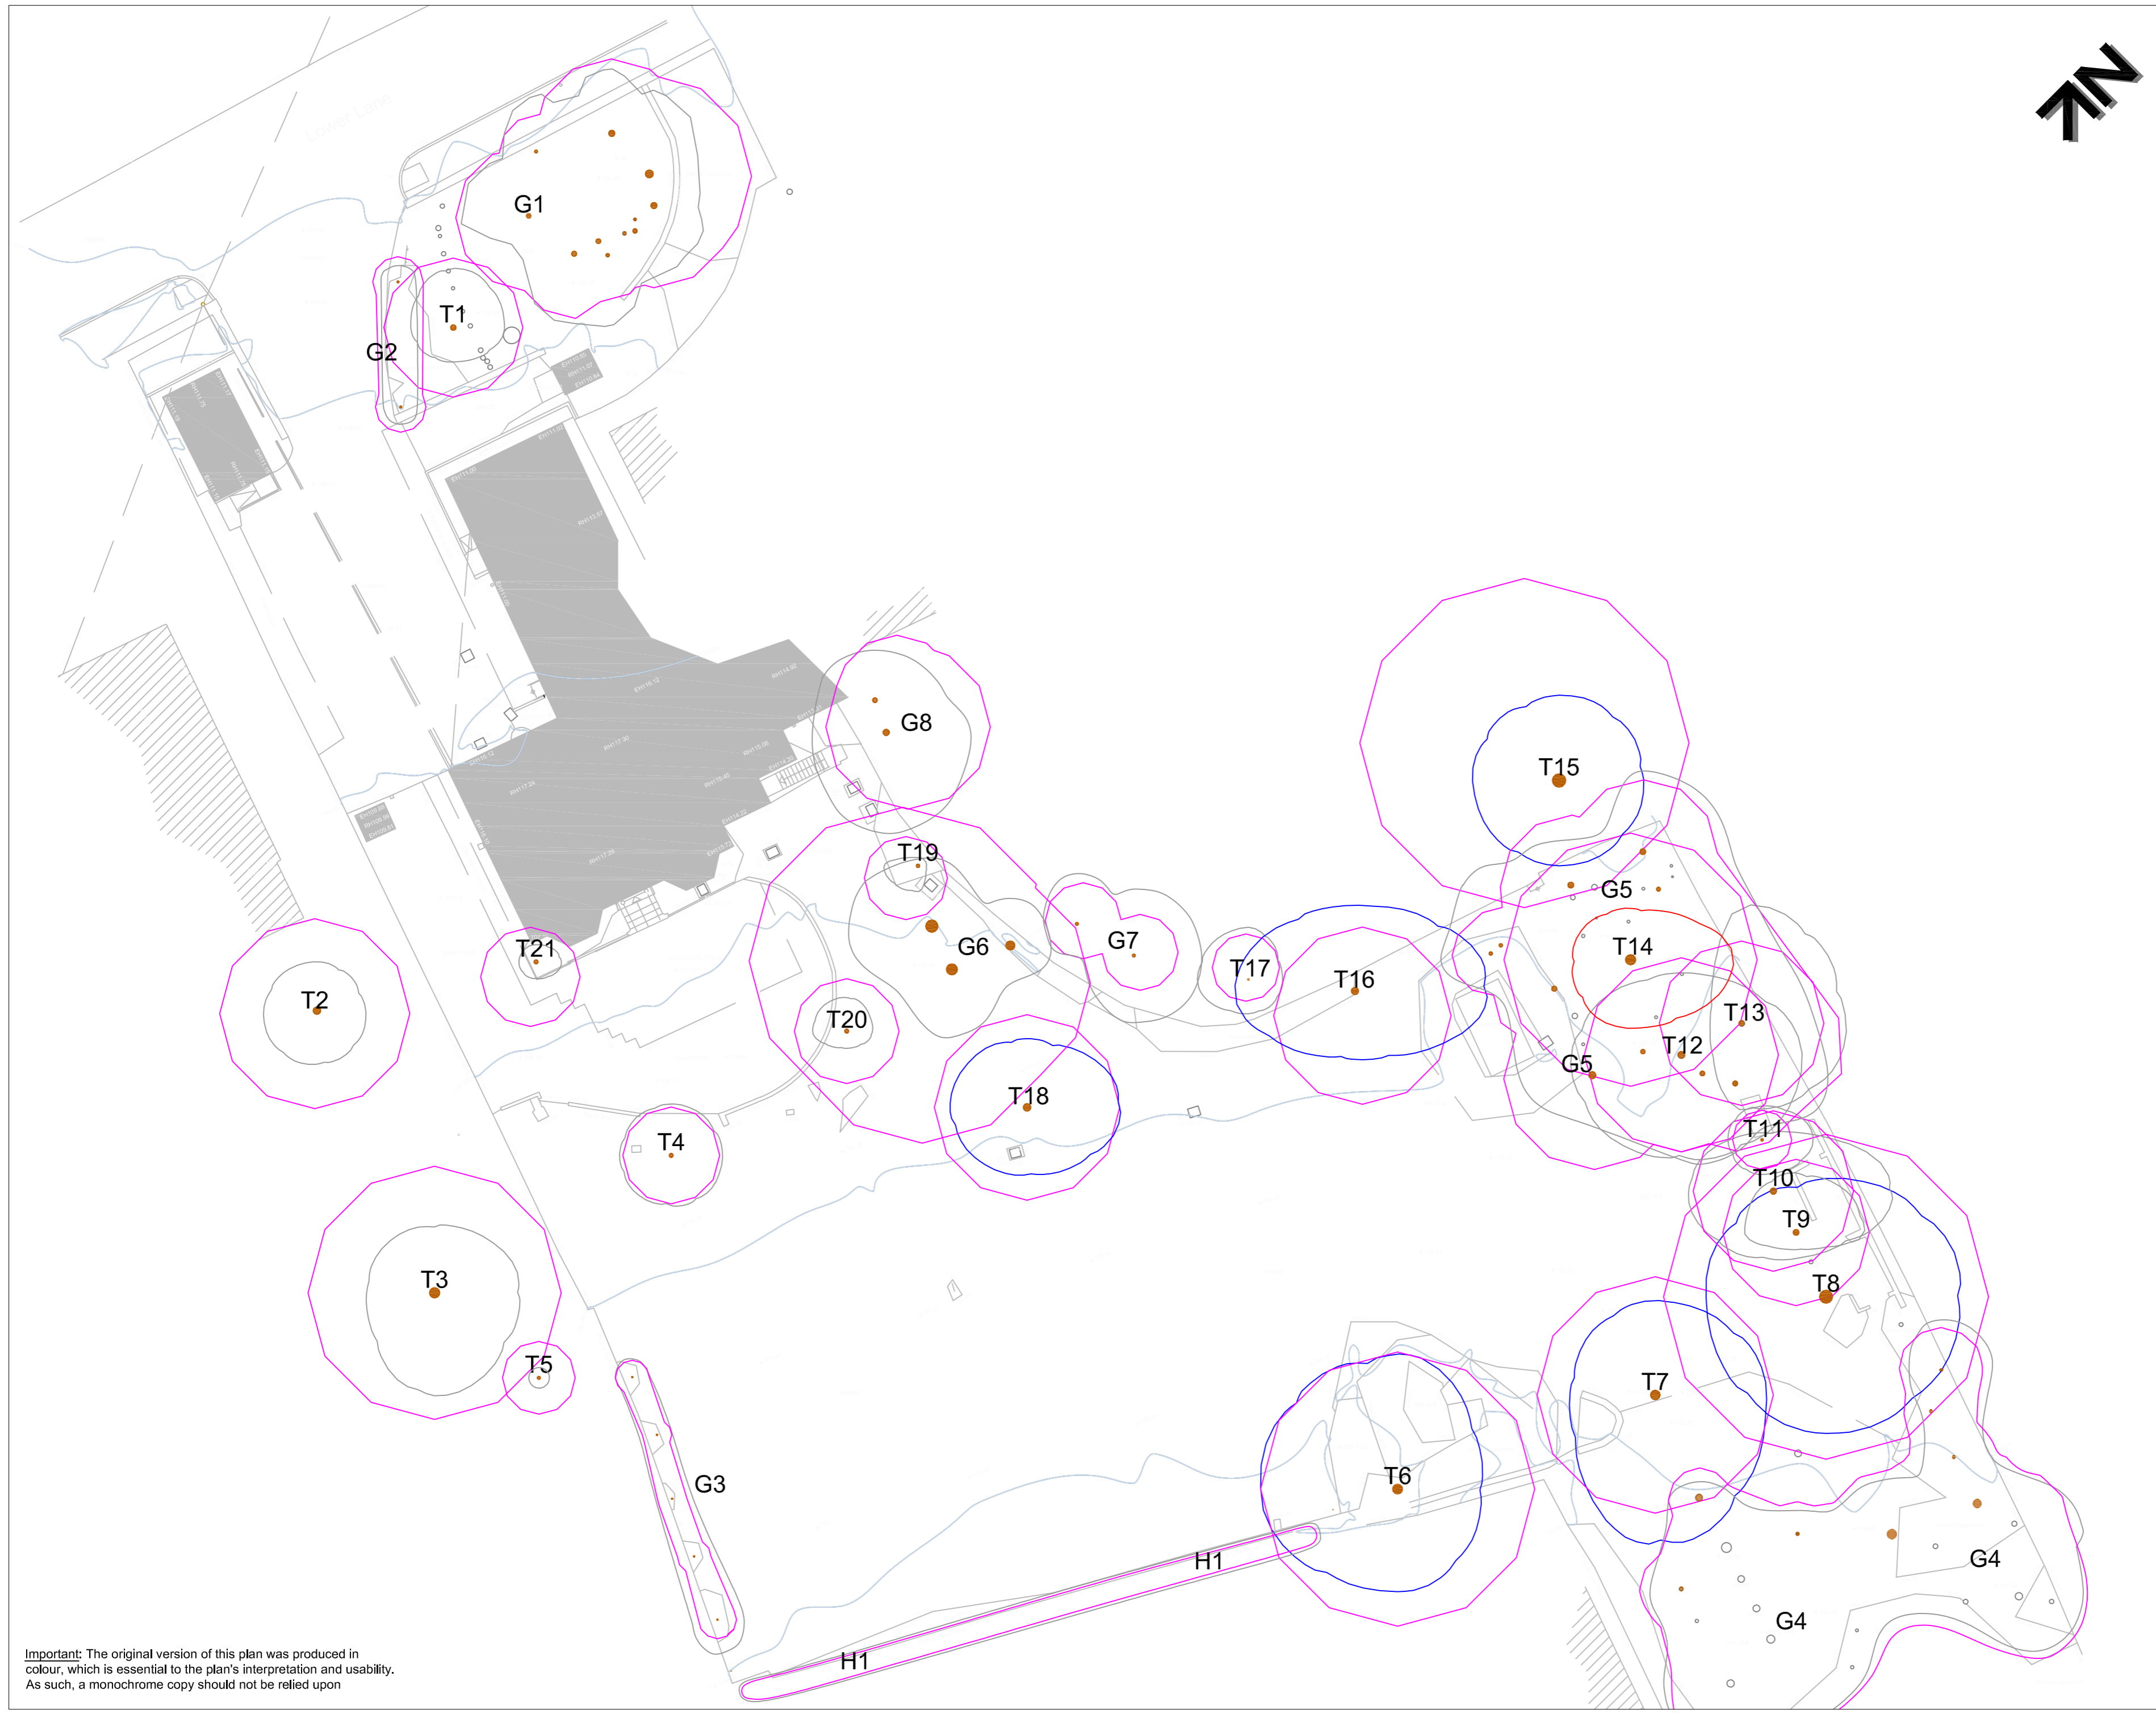
Title:
TREE CONSTRAINTS PLAN
 In Relation to Proposed Development of Residential Care Properties

Note 1: The stem locations of trees T1, T2 and T19, and groups G2 and G6 were not included on the topographical survey based site plan provided, and were subsequently plotted by the arboricultural surveyor at the time of the survey using GPS staking and, where possible, measurement from existing land features. As such, the locations of these trees cannot be considered to be entirely accurate

Note 2: The RPAs of trees T15, T16, T17 and T19, and groups G5 to G8 have been offset accordingly in order to take into consideration their locations close to the existing stone boundary wall
