# **Arboricultural Constraints Appraisal**

in Relation to Demolition of Existing Property  
and Erection of Replacement Residential Property at

**Greenacre, Whiteacre Lane,  
Wiswell, Lancashire, BB7 9BL**

September 2019

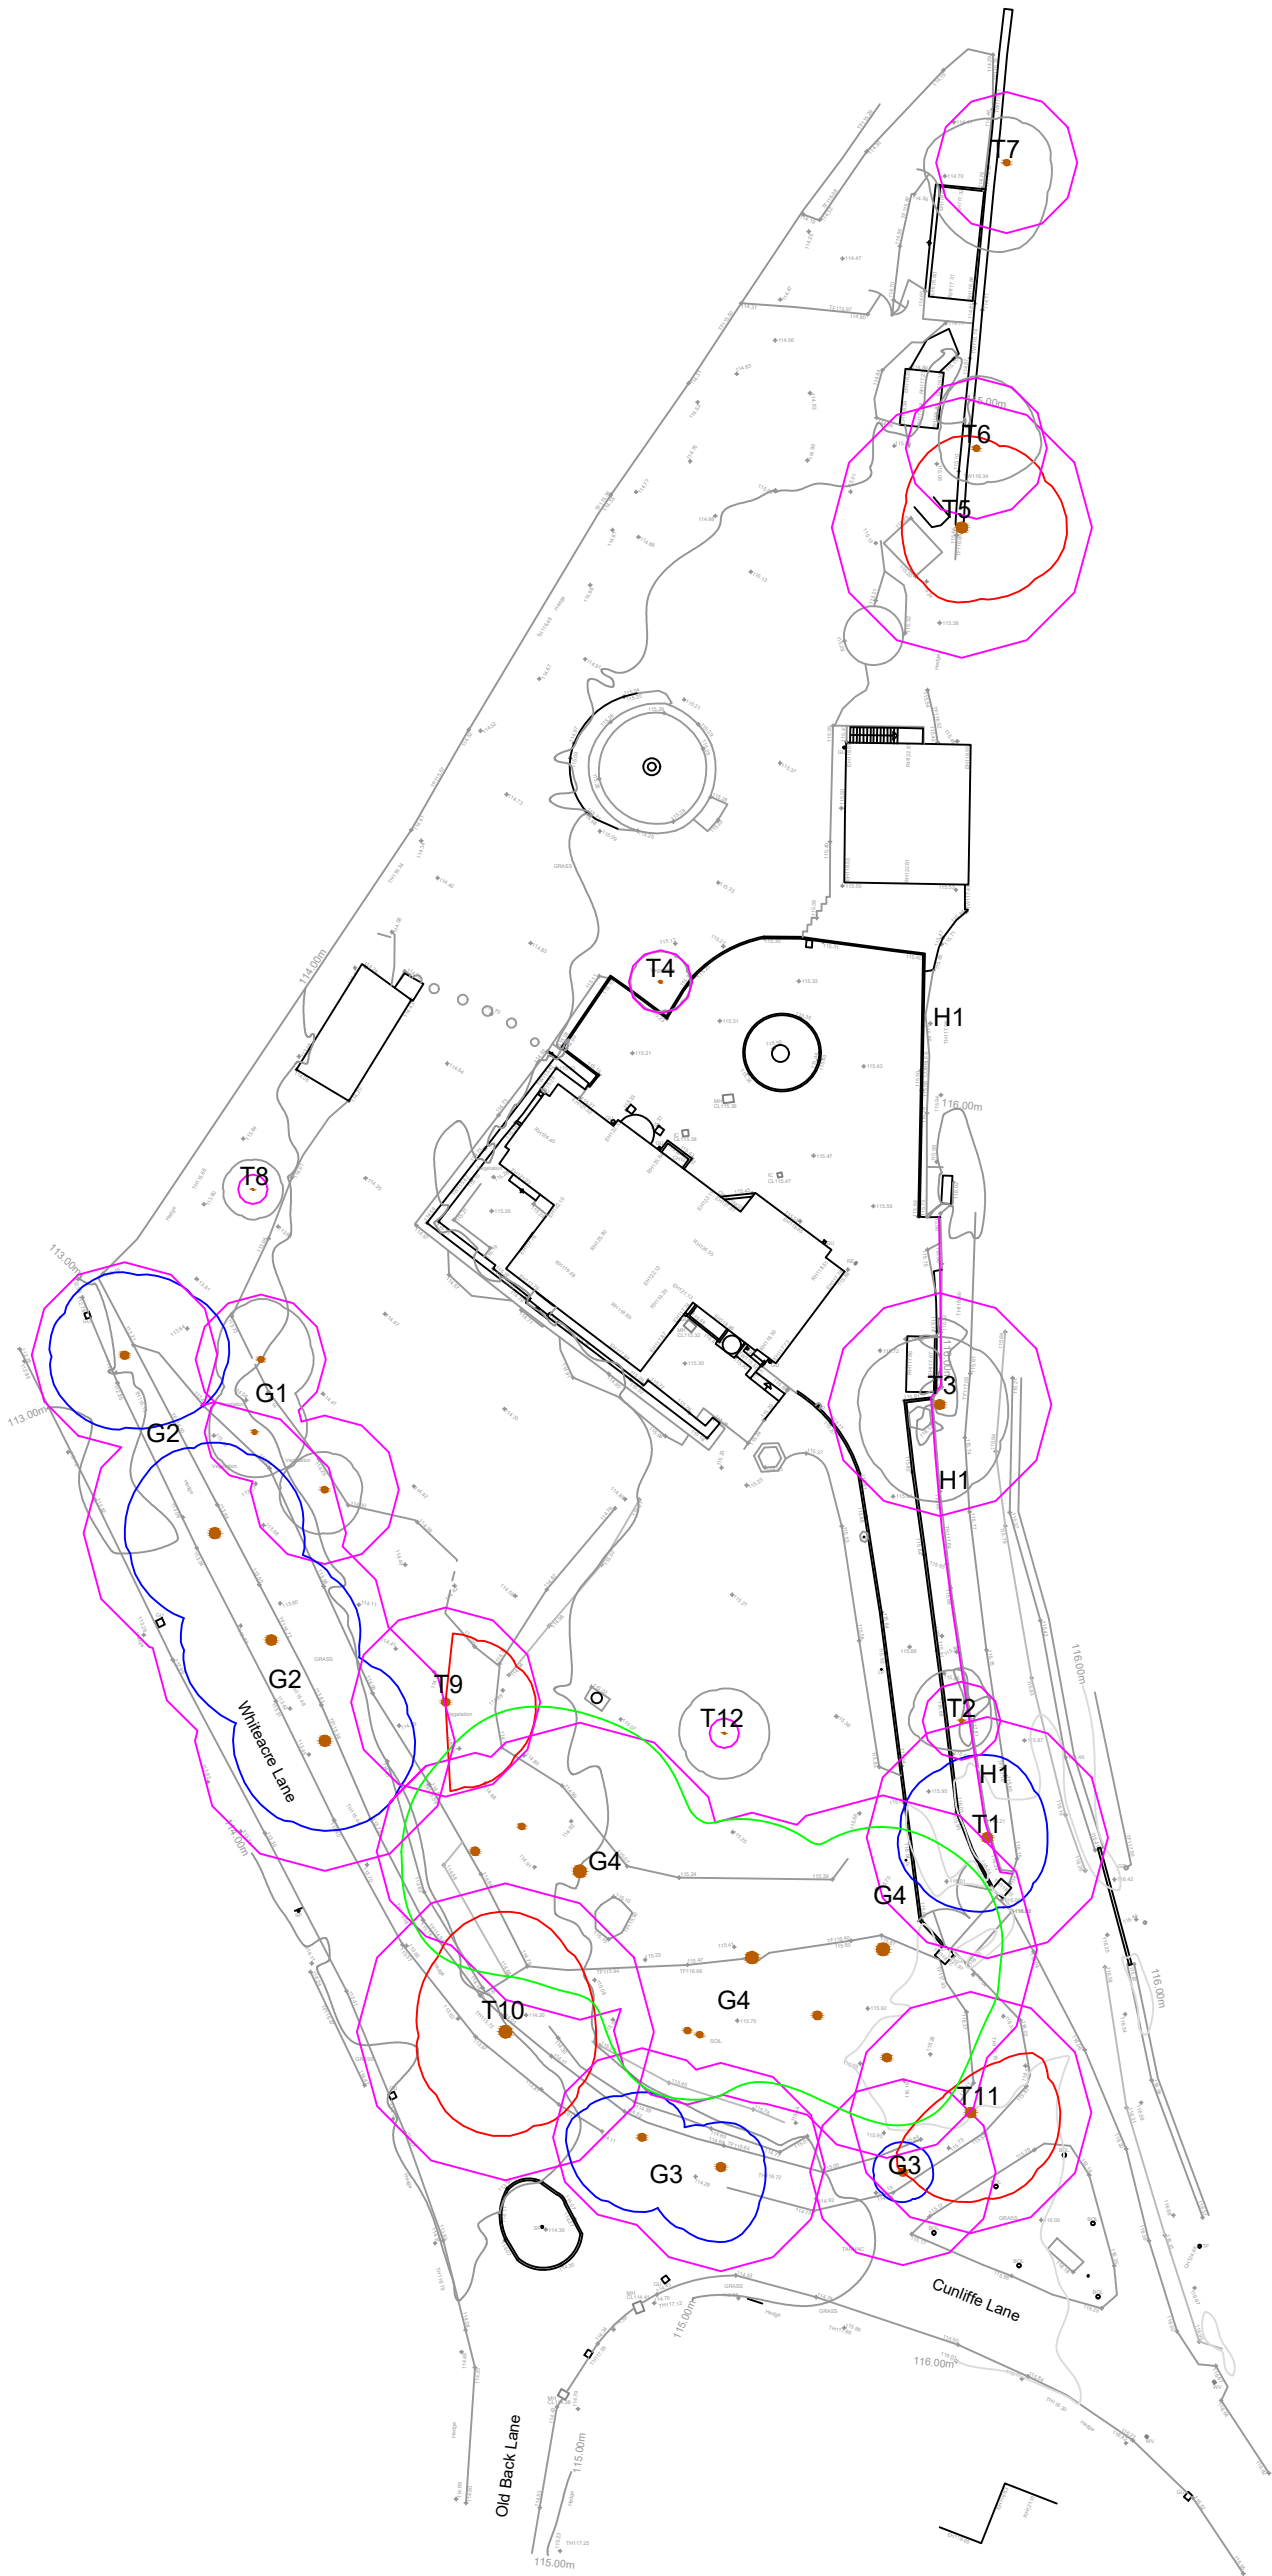
**Title:**  
**TREE CONSTRAINTS PLAN**  
in Relation to Demolition of Existing Property and Erection of Replacement Residential Property

Note: The stem location of tree T4 was not plotted on the topographical survey based site plan provided, and their locations were subsequently plotted by the arboricultural surveyor using GPS siting and estimation at the time of the survey. As such, the plotted location of this tree cannot therefore be considered to be wholly accurate
