Arboricultural Impact Assessment (AIA)

Pendle Road

Clitheroe BB7 1LN

Project No.:	UG 132			
Project:	Pendle Road, Clithe	roe – Phases 2, 3 &4		
Location:	Standen Farm, High	er Standen, Clitheroe, BB7 1	LN	
Title:	Arboricultural Impa	ct Assessment		
Document Type:	BS5837			
Date:	19/06/2019			
Prepared By:	Russel Pearce			
Checked By:	Greg Thorne			
Revision Status:				
Rev:	Date:	Issue/Purpose/	Prepared:	Checked:
		Comment:		
02	10/07/2019	Drawing update	GT	RP
03	17/09/2019	Drawing update - Fixed	GT	RP

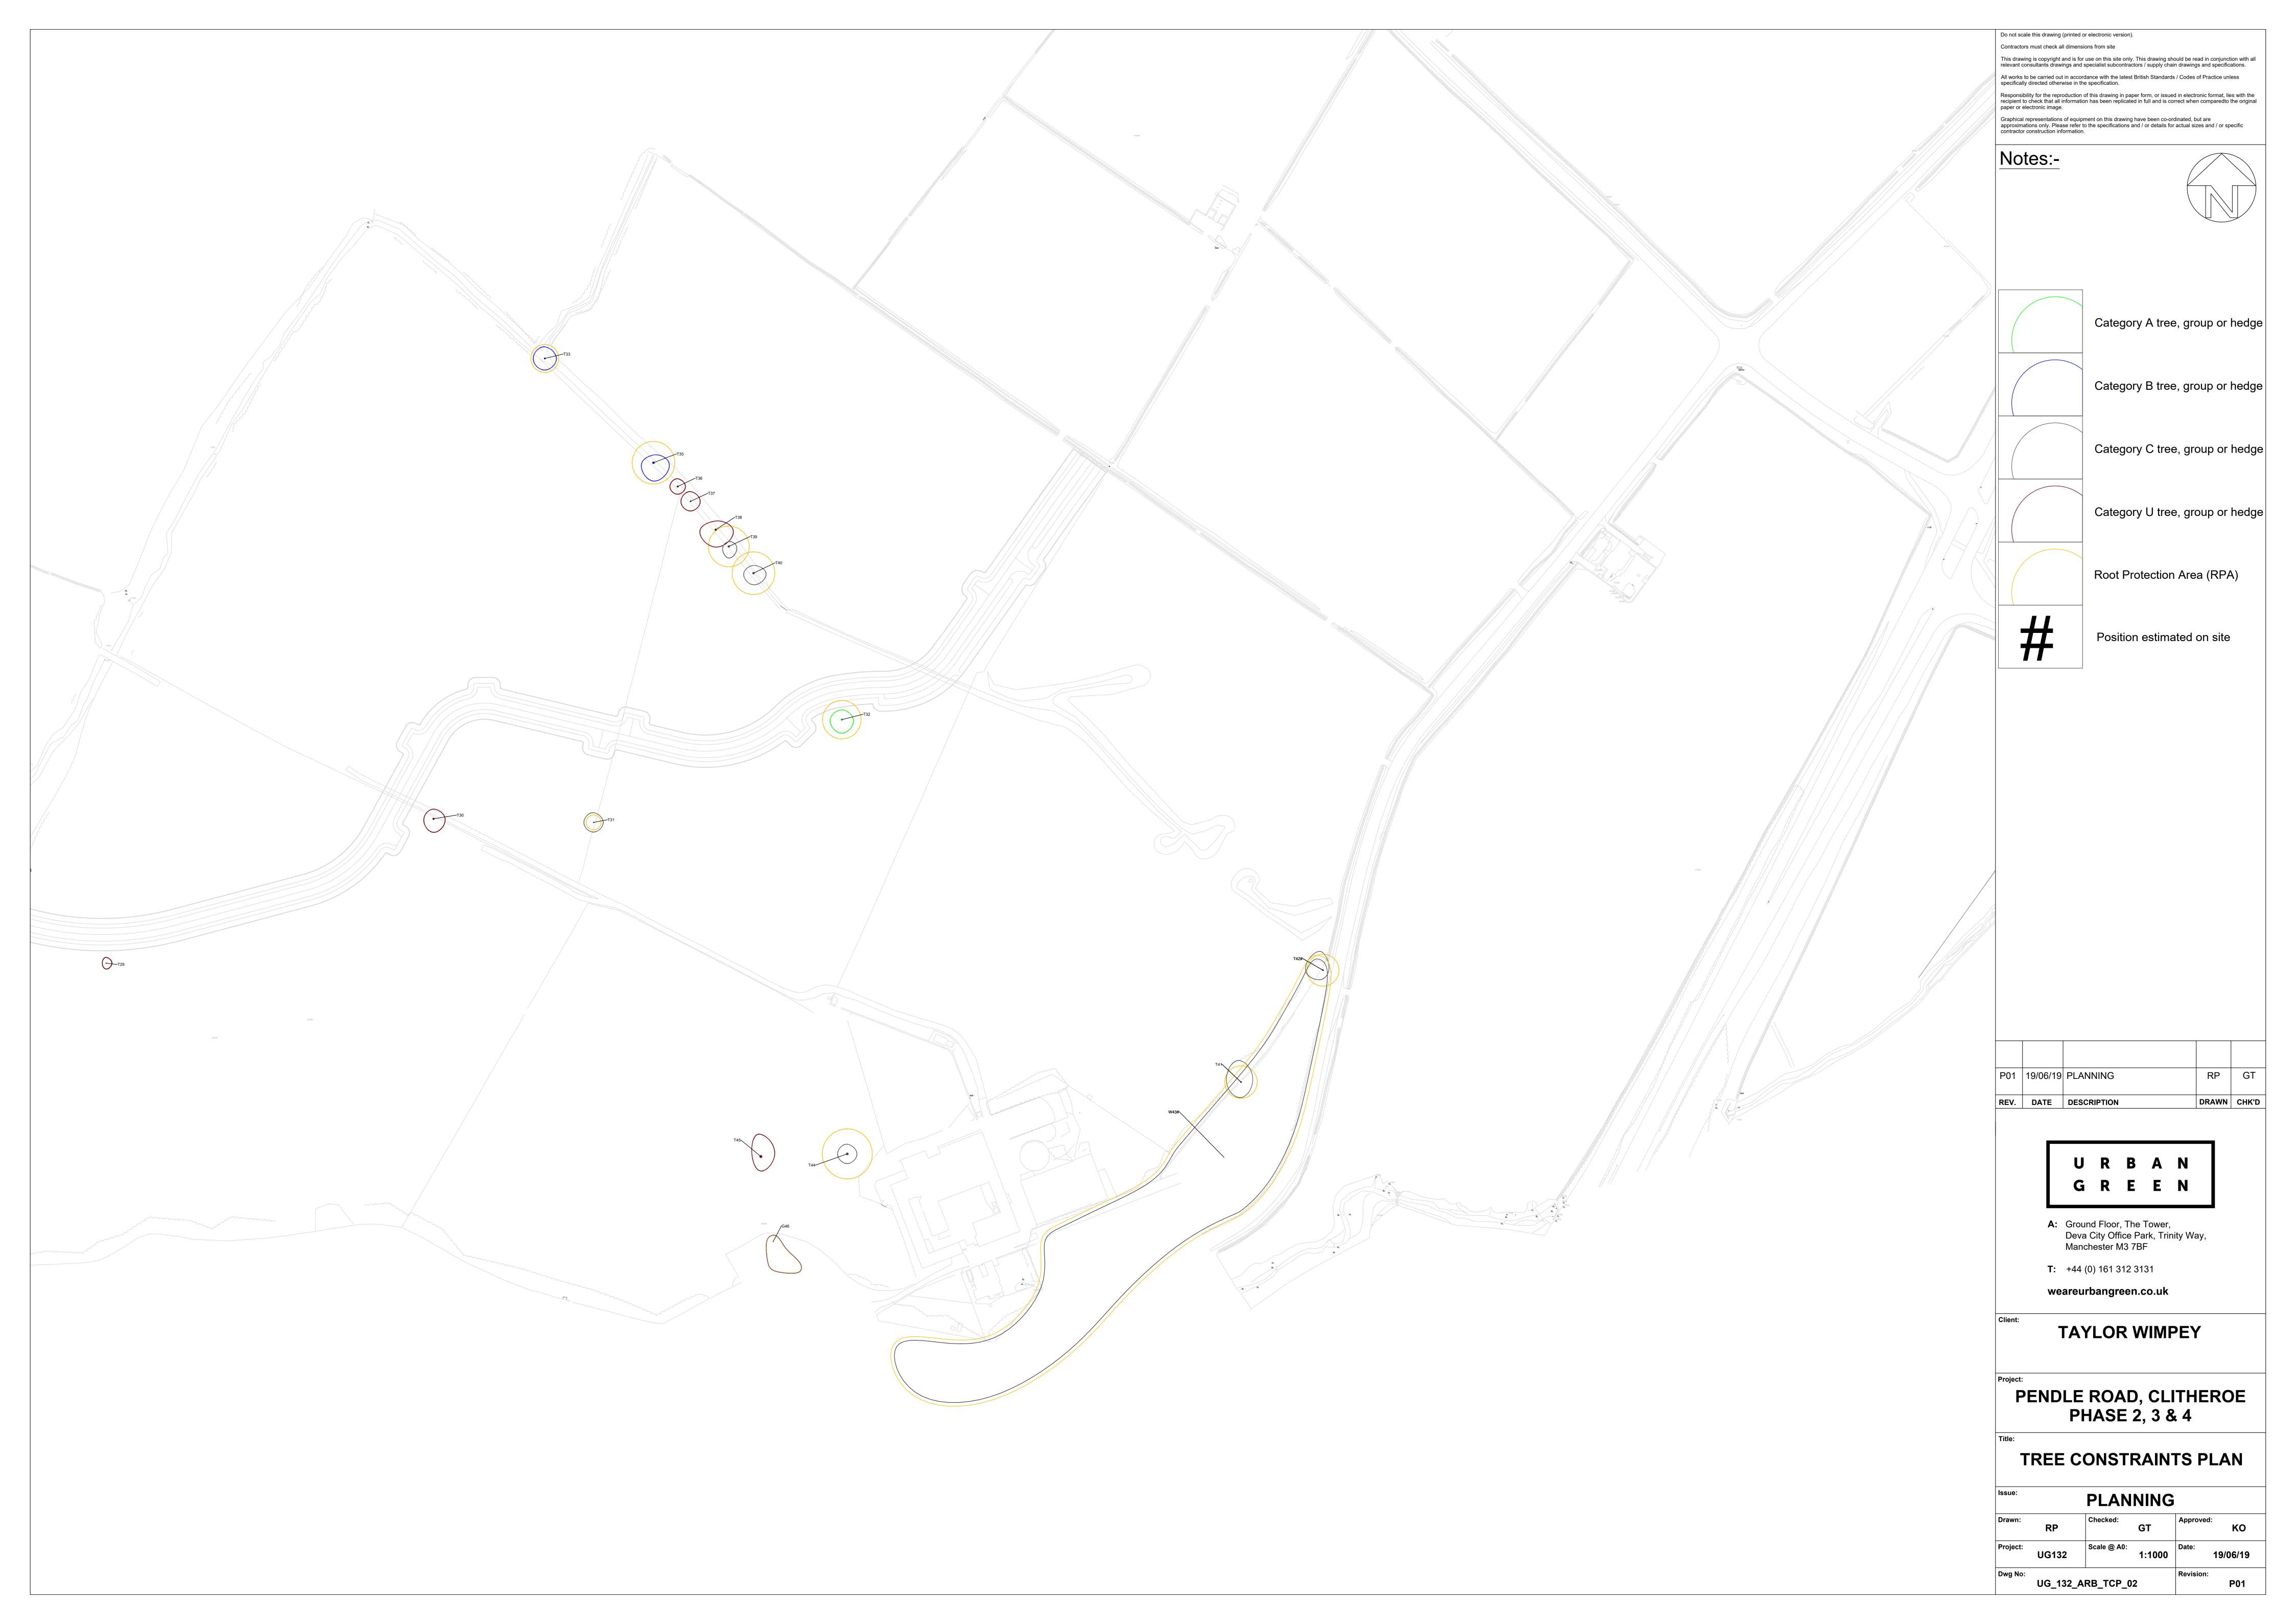
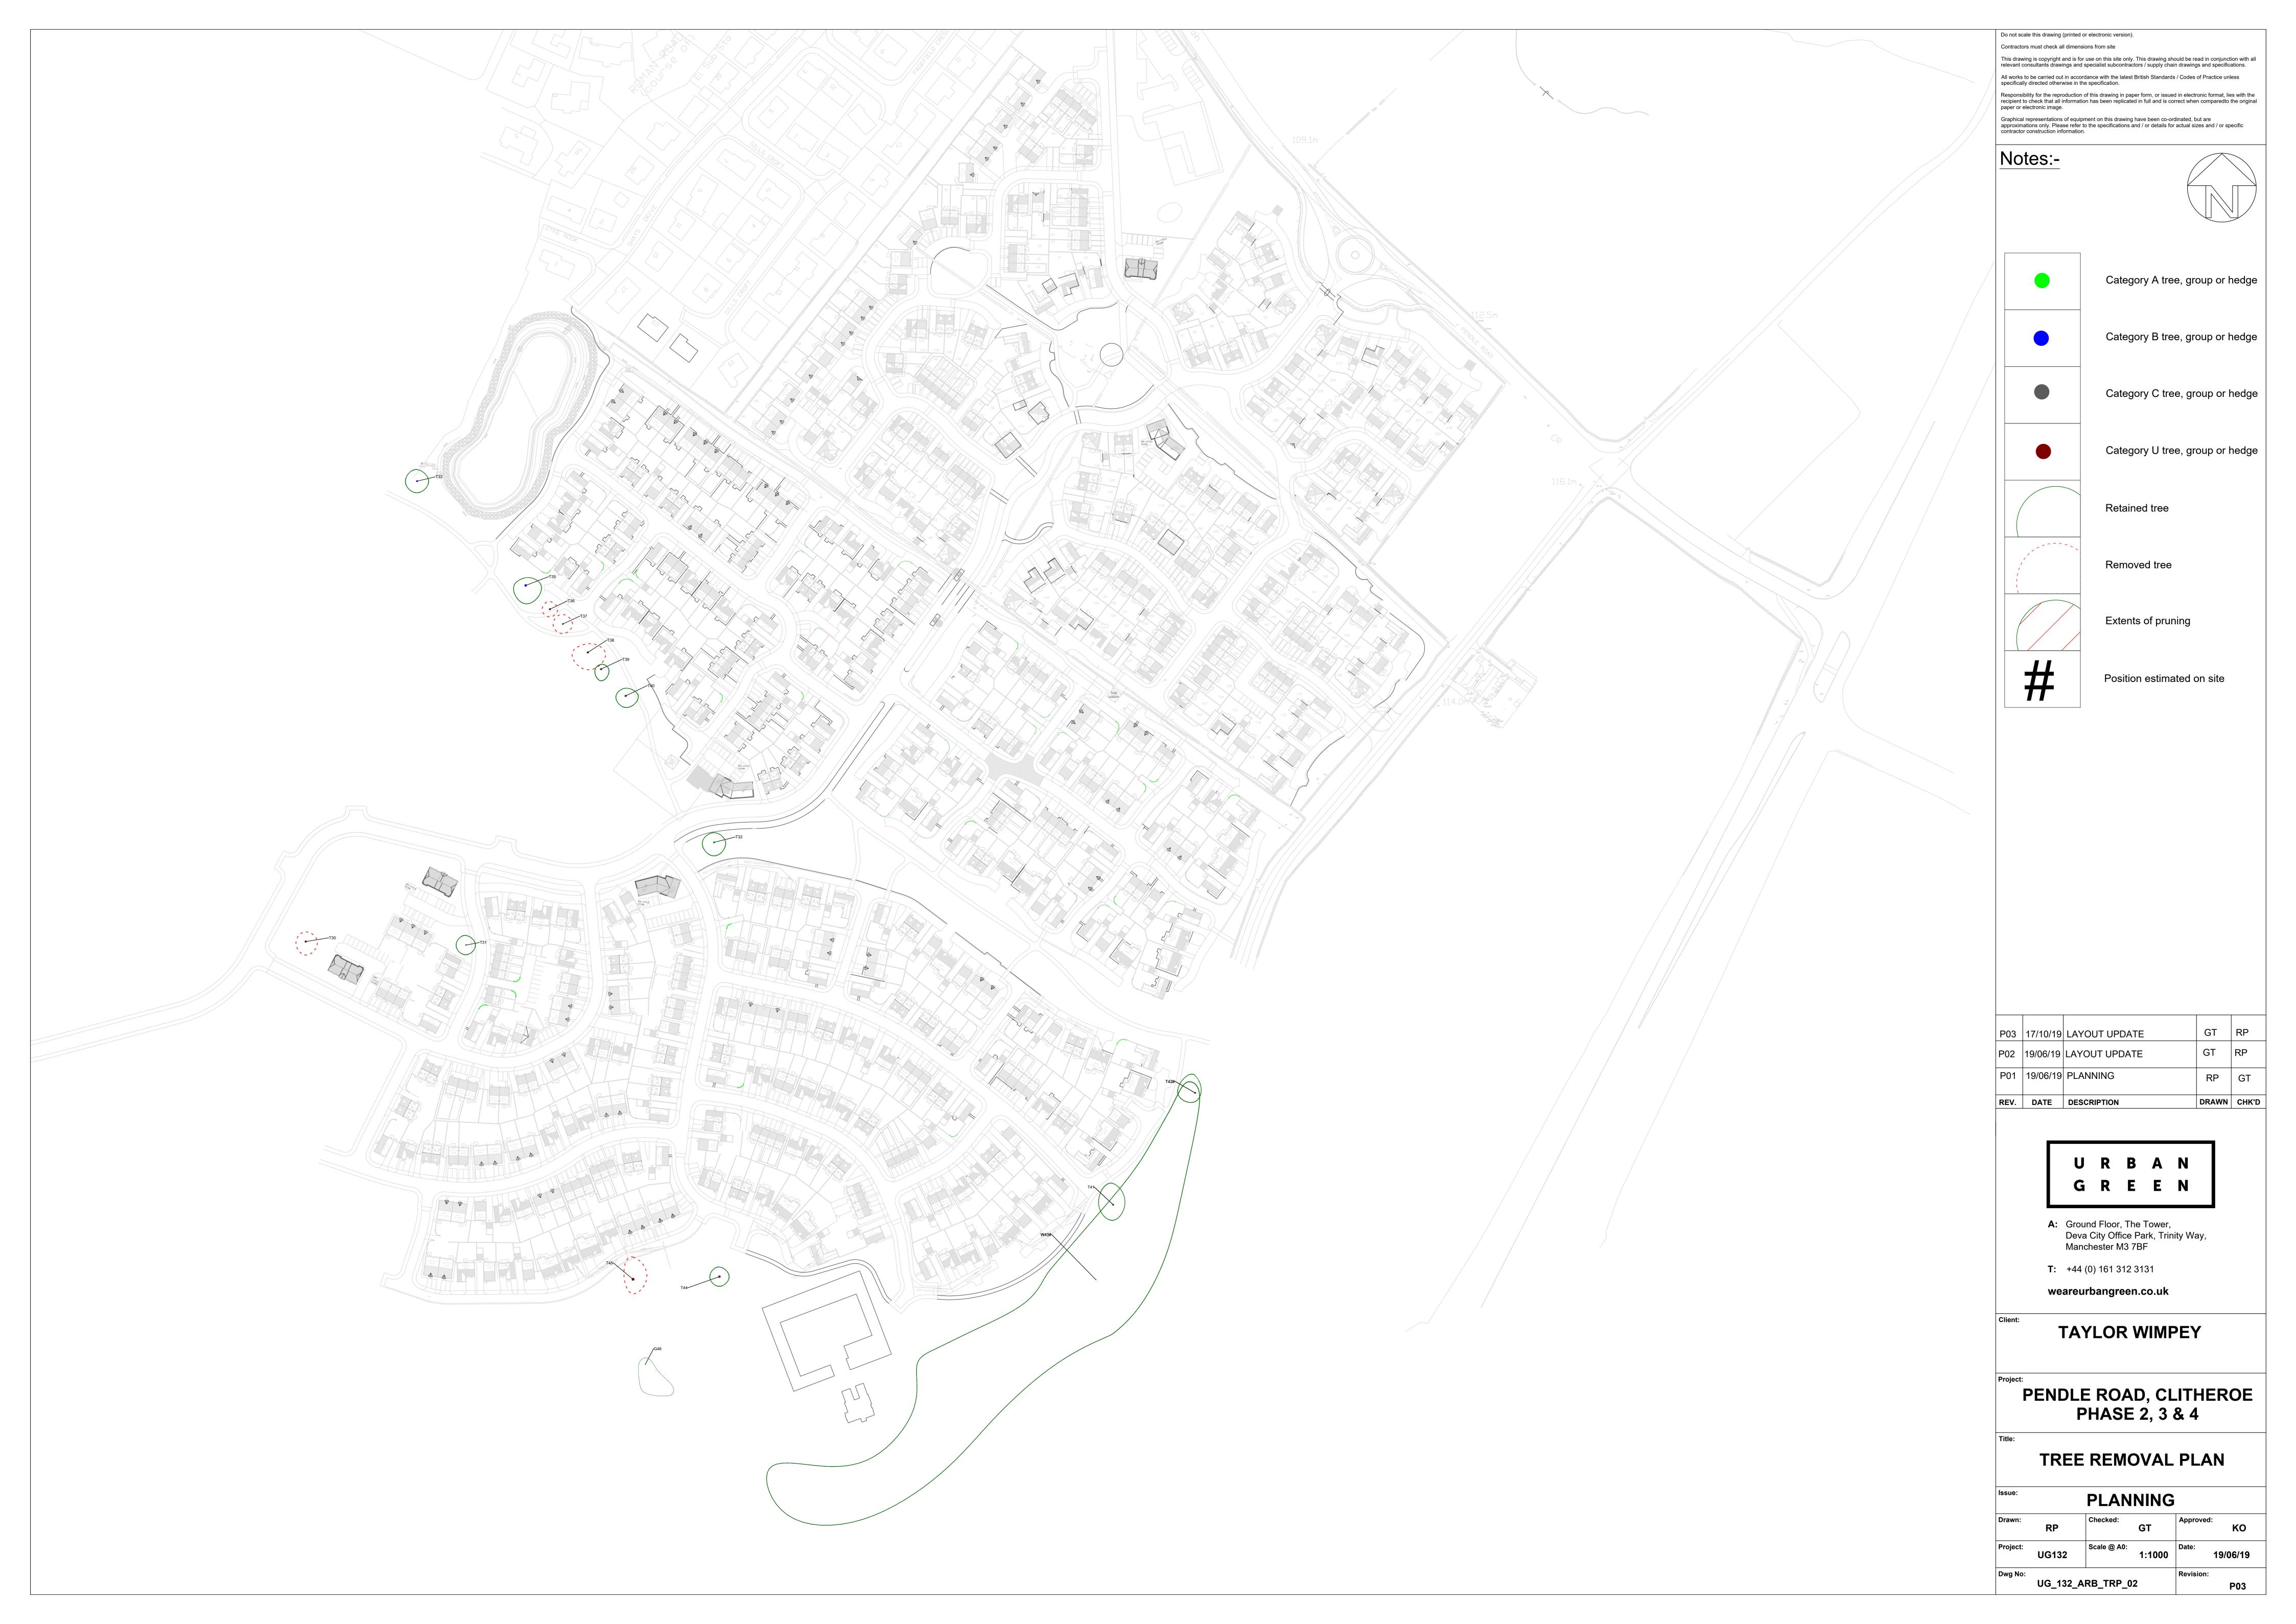
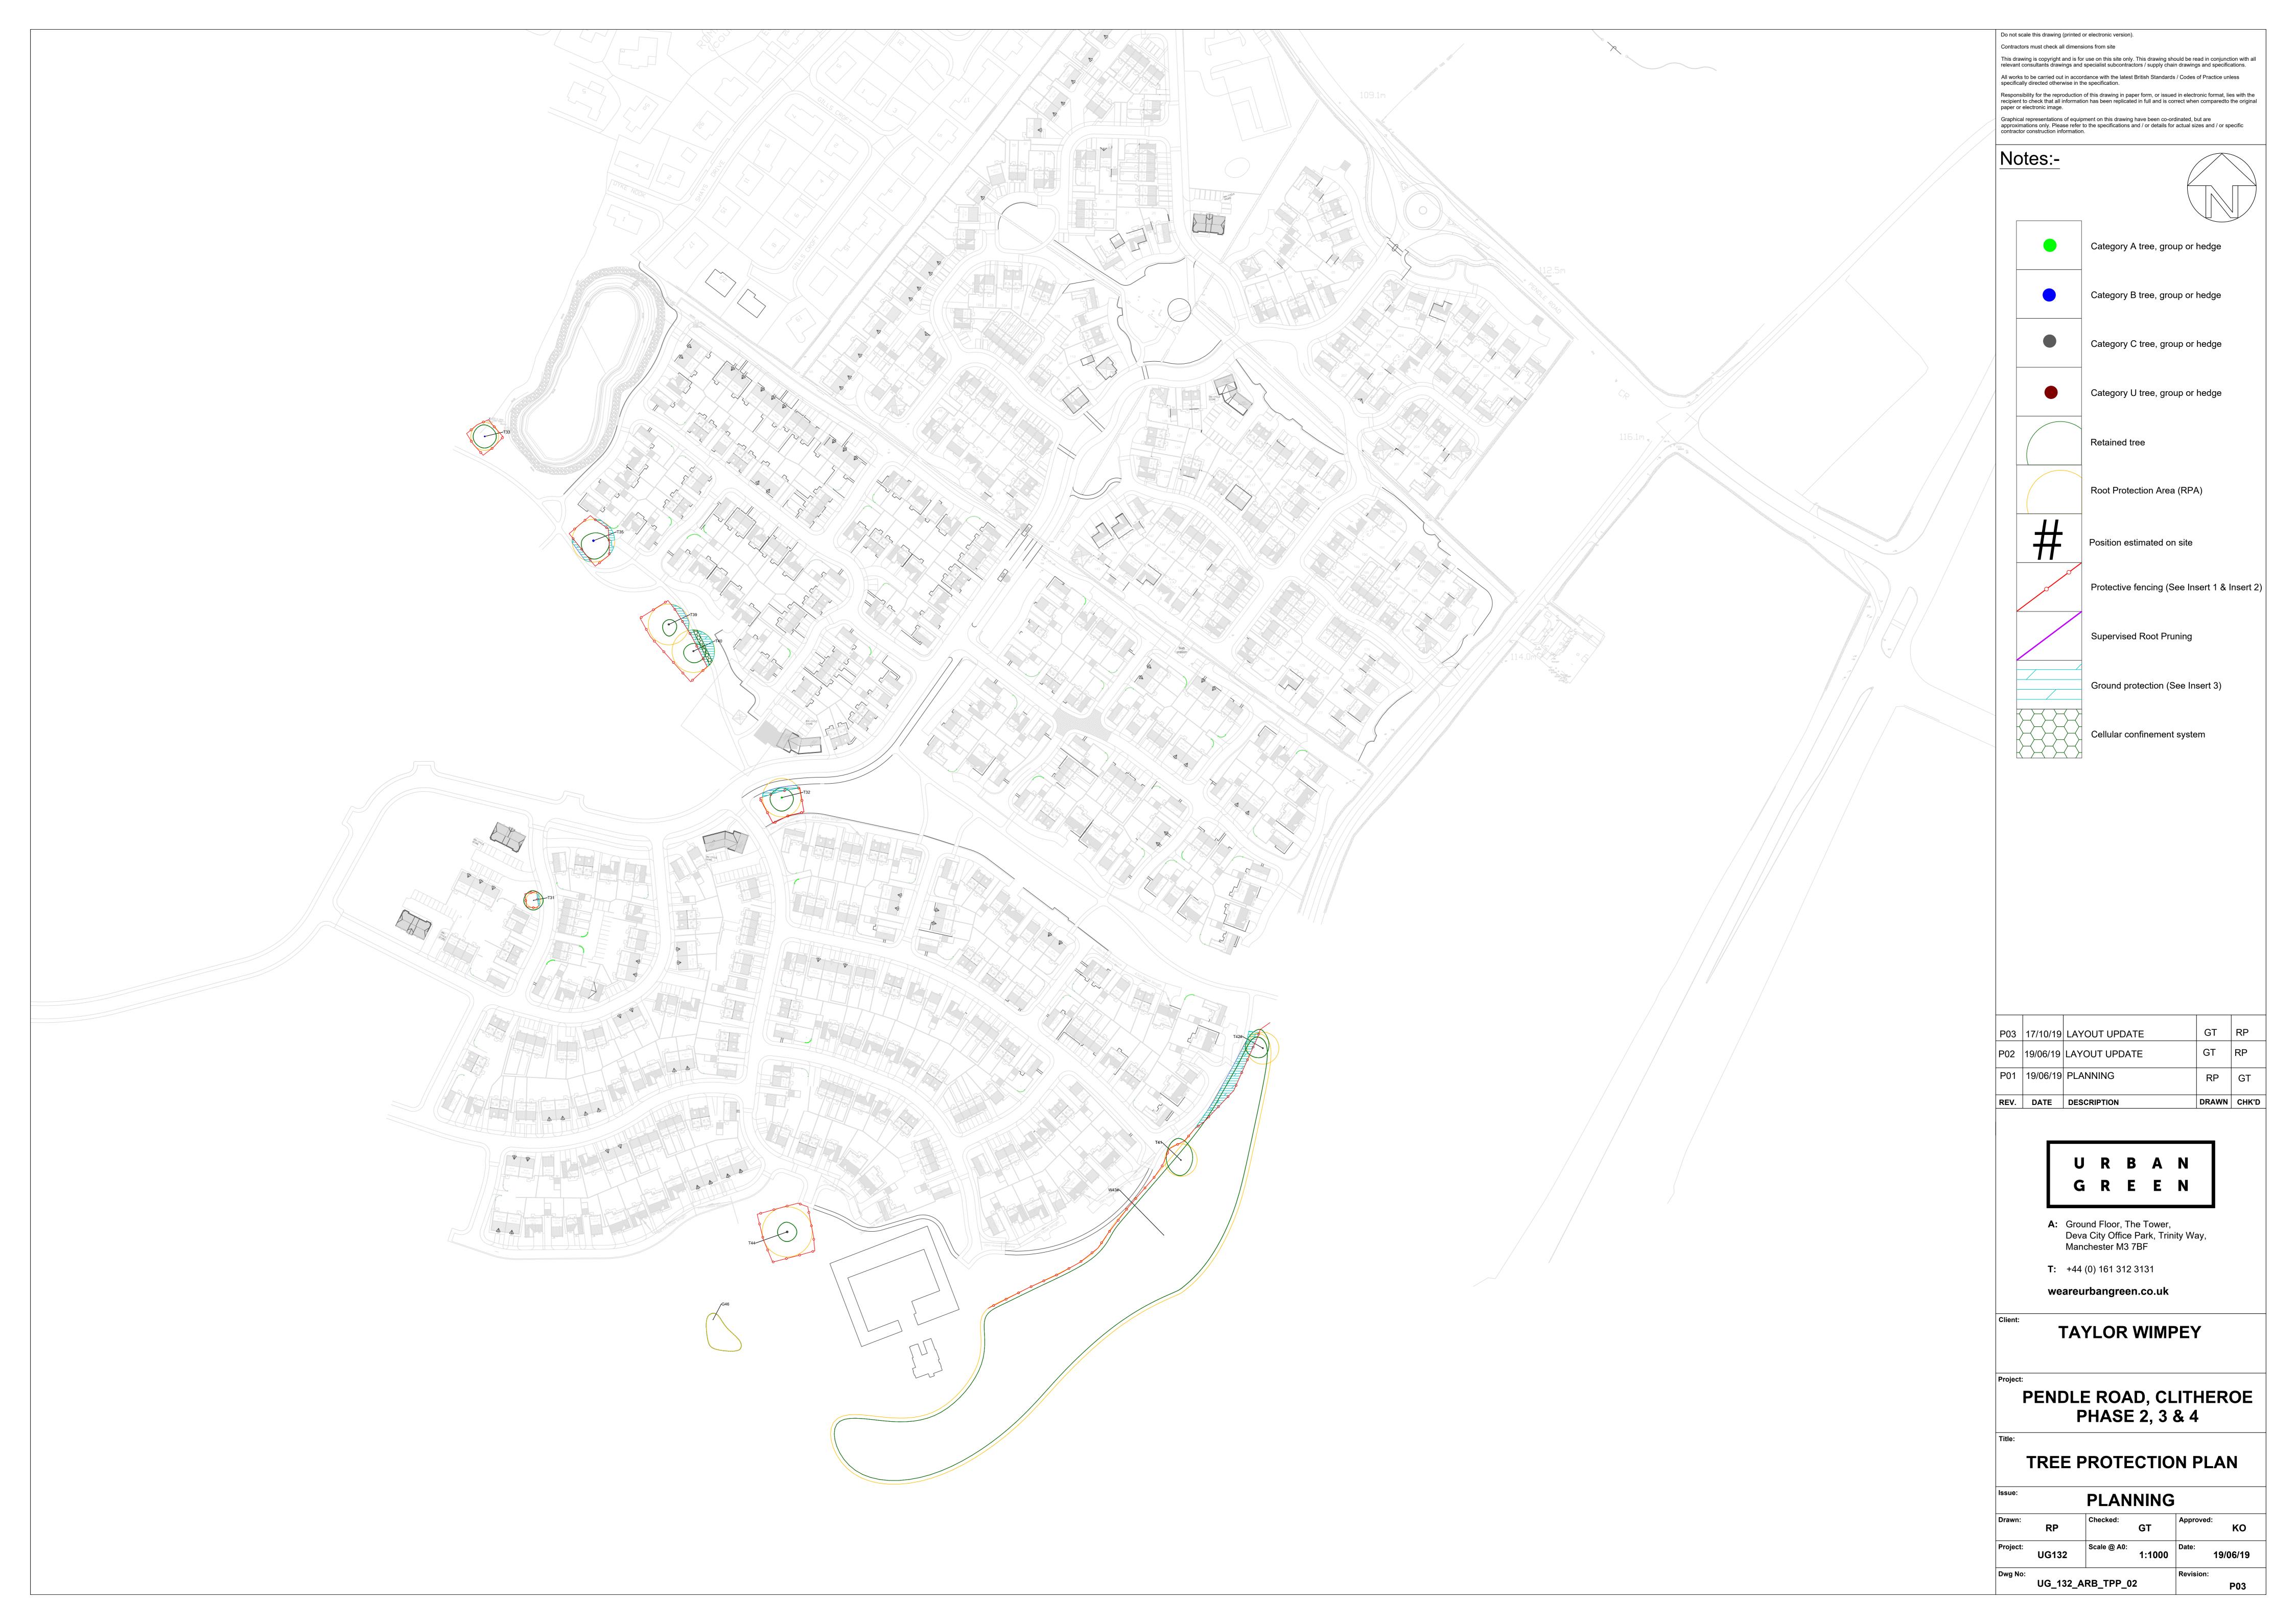
- 4.4.1. This part of the proposed development necessitates the removal of 5 trees. T30 (dead), T36 (dead), T37 (in decline), T38 (history of major snap-outs) and T45 (significant decay) are category U trees, and as such are unsuitable for retention. It is recommended that the tree loss is mitigated for by replacement tree planting and the production of a robust soft landscaping scheme.
- 4.4.2. It will be necessary to carry out supervised root pruning of T₃₁, T₃₂, T₃₅, T₃₉, T₄₂# & W₄₃# as indicated on the Tree Protection Plan in appendix 4. This will allow for construction of hard surfacing within the Root Protection Areas.
- 4.4.3. Ground protection will need to be installed within the alignment specified in the Tree Protection Plan (in Appendix 4) to protect the RPAs of T31, T32, T35, T39, T40, T42# & W43#.

- 4.4.4. If the location of the proposed footpath intersecting the RPA of T40 is fixed, this section must be constructed using a no dig, cell web system to mitigate against potential compaction of the rooting system. However, it is advised that this footpath is relocated outside of the RPA of this tree to mitigate any risk of damage to the rooting system.
- 4.4.5. T33 & T41 can be retained as the development will have little or no effect on these trees. T44 should be retained at present as it would make an interesting feature by the development; it appears to be an old pollard or historically failed at 3.25m with an open hollow stem giving at unusual aesthetic value. If land use were to change in close proximity to the stem it should be re-evaluated for retention. G46 is on third party land and unaffected by the proposed development.

- 1.1.6. Tree protection fencing, and ground protection will need to be installed at the alignment shown on the Tree Protection Plan in Appendix 4 before any construction activity takes place.

- 1.1.8. It will also be necessary to carry out supervised root pruning of T31, T32, T35, T42# & W43# as indicated on the Tree Protection Plan.
- 1.1.9. Information regarding the layout of new utilities and drainage and final site levels should be submitted to the Arboricultural Consultant so that the impact of these on the retained trees can be assessed.

Tree Works Schedule						
Tree Number	Species	Works Required	Reason			
T30, T36, T37, T38	English Oak	Remove	Arboricultural management.			
T45	Ash	Remove	Arboricultural management.			
T33	English Oak	Decay Detection	Arboricultural management.			
T35, T40	English Oak	Crown clean and deadwood	Arboricultural management.			
T41, T42	Ash	Remove ivy and reinspect Arboricultura	Arboricultural management.			
W43	Mixed	Remove ivy throughout and sanitation fell, remove standing deadwood within falling distance of woodland edge	Arboricultural management.
