# STRUCTURAL INSPECTION REPORT

# **BARN, TOWN FARM, PENDLETON**

## **Mr & Mrs J FILDES**

Project No.: 10310					
Issue Date	Revision	Status	Issued By	Checked By	
20.02.2020	A		E Jones	JED

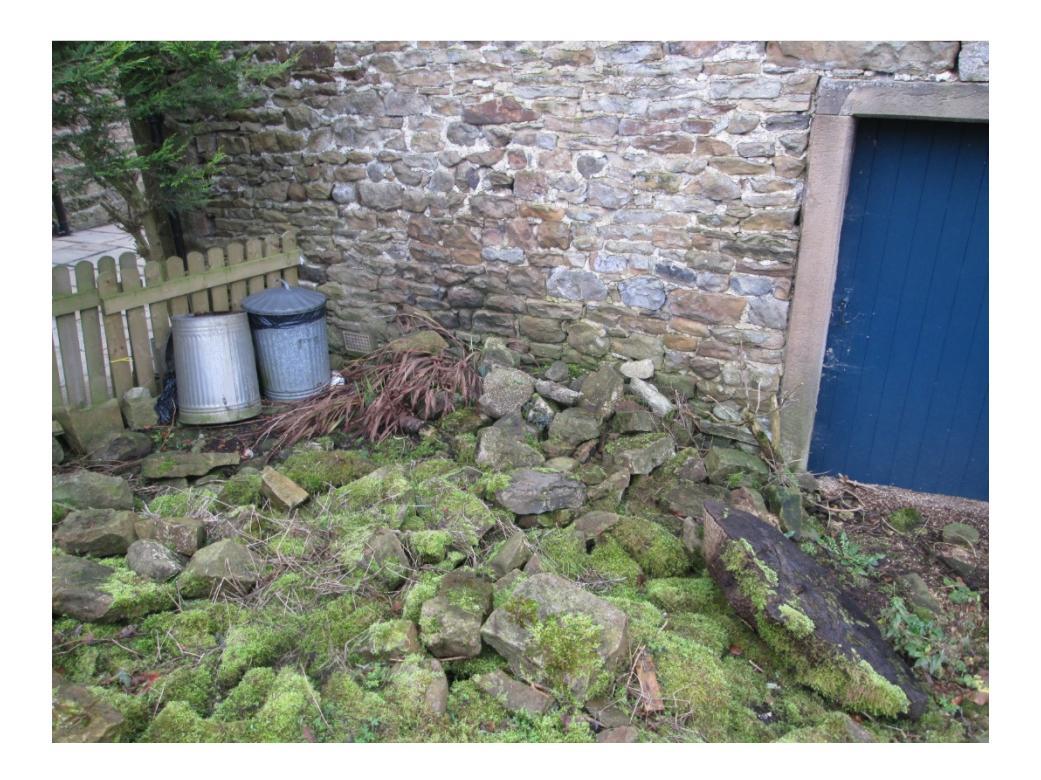
The ground level along the rear elevation is high compared to the internal floor level.

PHOTO 4 – LOW LEVEL VIEW TO LEFT SIDE OF REAR ELEVATION

To the rear elevation the ground levels are high compared to the internal floor level. The external ground level will require lowering to prevent damp ingress. The tree to the rear right corner is within 2m of the corner of the barn. There are no indications of any damage due to tree roots on the barn walls, however, consideration should be given to removal of this tree.

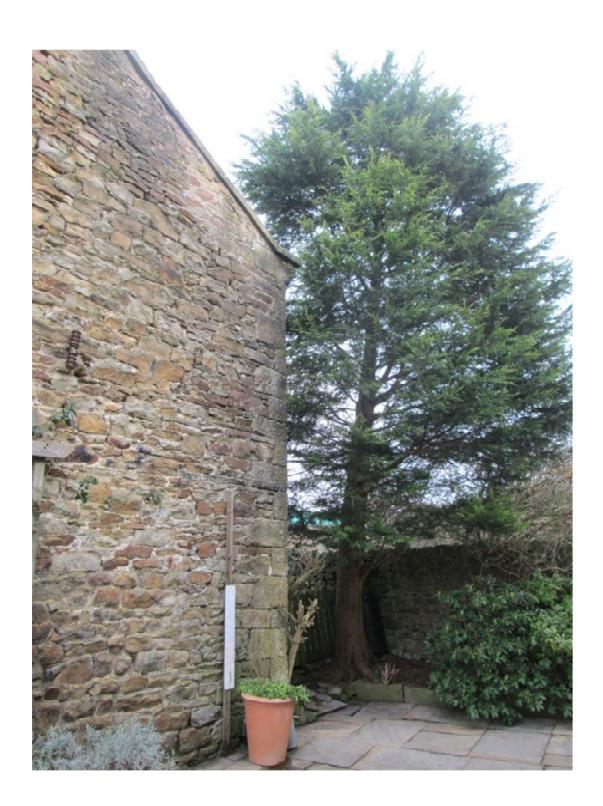
There is a mature tree in close proximity to the rear right hand corner of the barn.

PHOTO 8 – RIGHT HAND END OF RIGHT-HAND GABLE SHOWING PROXIMITY OF TREE

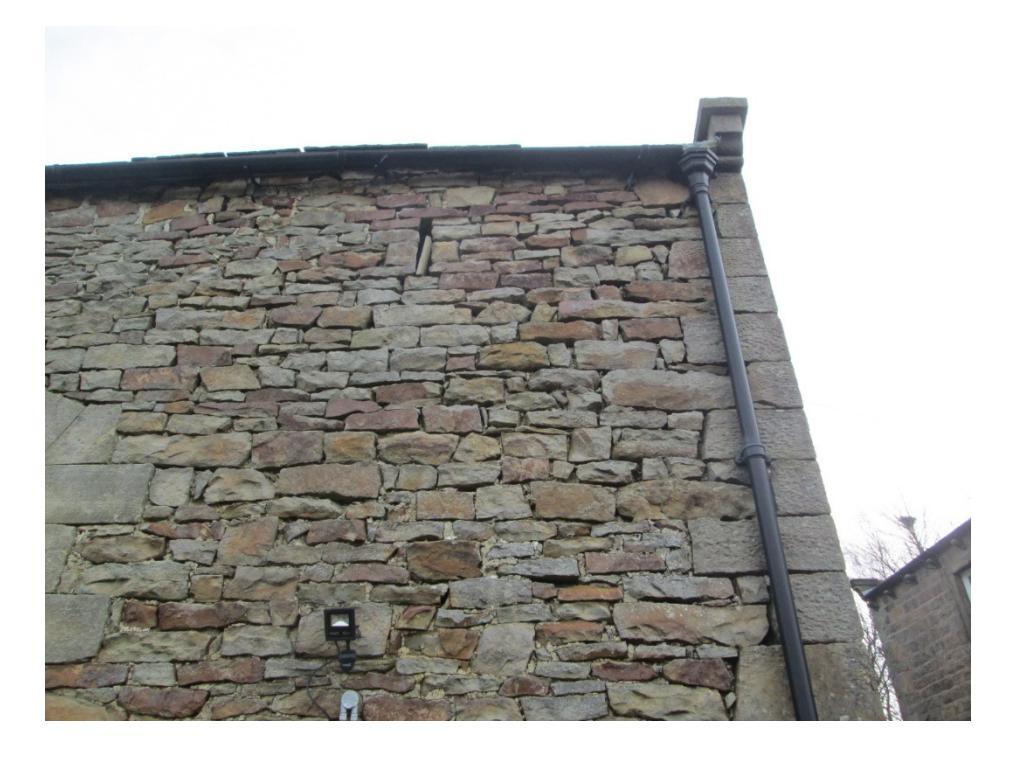
There are several areas of 'open' joints in the masonry.

### PHOTO 9 – CLOSE VIEW OF RIGHT SIDE OF FRONT ELEVATION INDICATING OPEN JOINTS IN THE MASONRY

Externally, there are several areas of open joints in the masonry. These areas will require pointing with lime mortar.

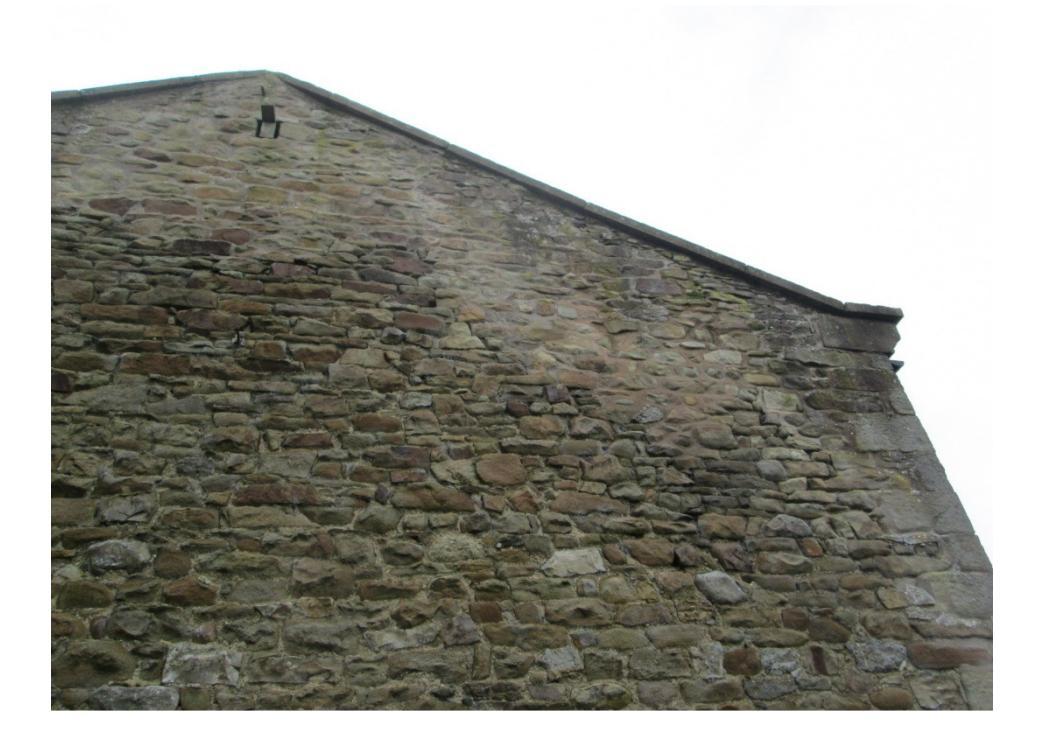
PHOTO 10 – CLOSE VIEW OF LEFT-HAND GABLE INDICATING PREVIOUS RE-POINTING AT HIGH LEVEL

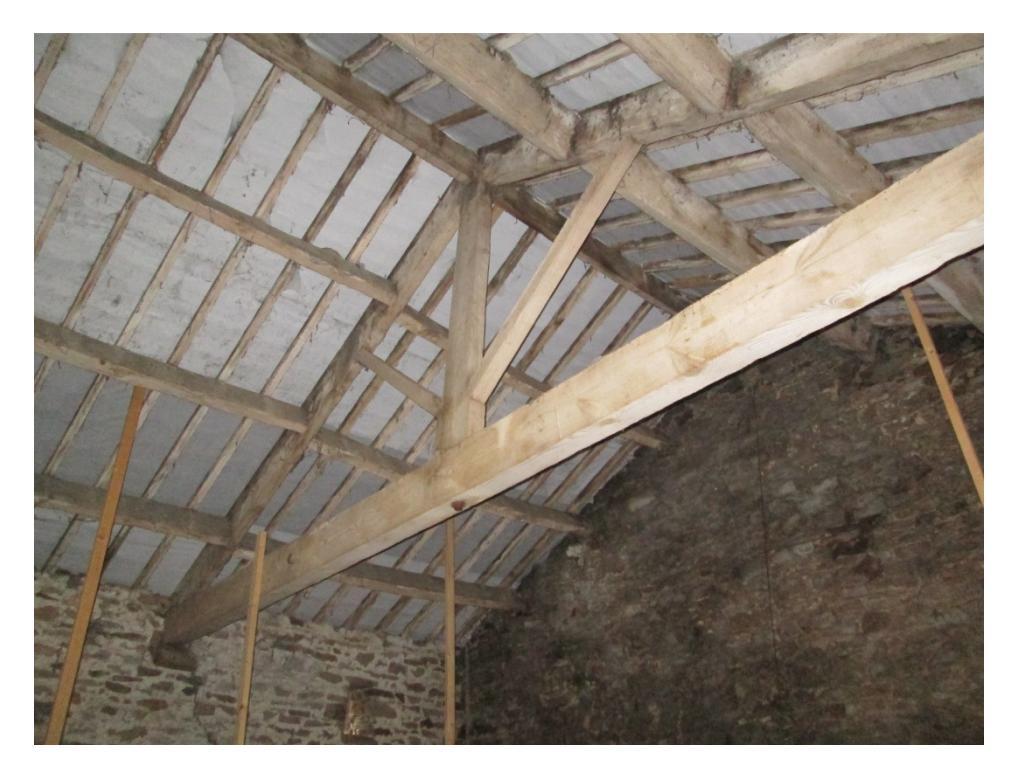
All timber rafters and purlins and truss members appeared dry.

PHOTO 11 – TYPICAL VIEW OF ROOF TRUSS AND GENERAL CONSTRUCTION

The roof timbers appear in good overall condition with no signs of dampness. Due to access limitations we were not able to closely inspect the truss ends where they are built into the walls. As part of the early works of conversion we would recommend a timber specialist be asked to check on the truss ends to ensure there is no rot.

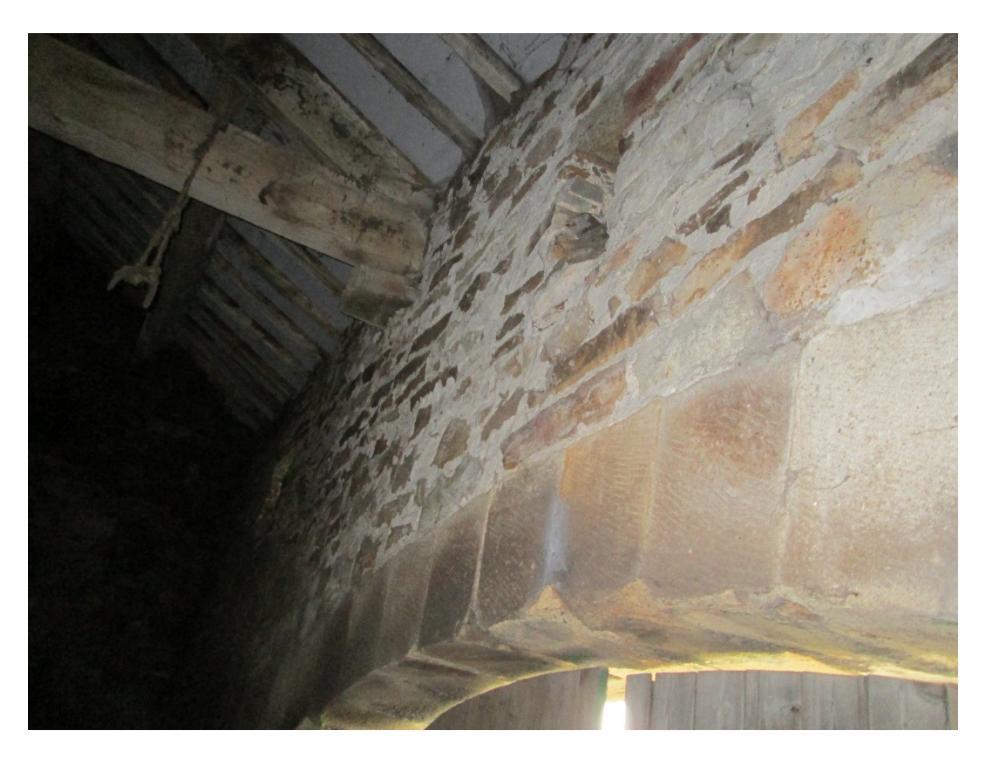
There is a diagonal crack above the right-hand side of the arch to the main entrance. The left-hand truss is supported close to the left-hand side of the arch.

PHOTO 13 – VIEW OF TRUSS SEATING ABOVE LEFT-HAND SIDE OF ARCH

The cracking noted to the main entrance arch is due to a slight drop in the arch stones. It was noted that one truss is supported on the wall partly over the arch adding a relatively large load onto the arch itself. We would recommend the arch stones be re-set and that bed joint reinforcement be inserted into the joints above the arch over its full width. This will help with spreading the load and provide a masonry lintel above the arch itself.

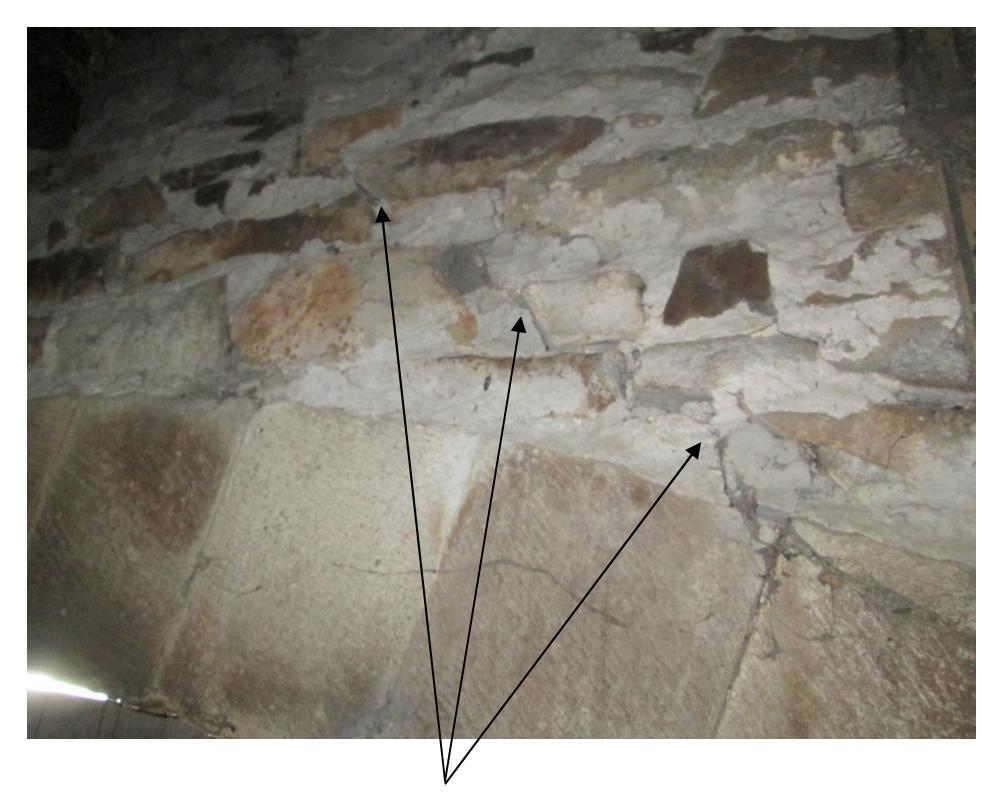
There is a slight drop in the arch over the entrance leading to cracking in the masonry above.

PHOTO 14 – VIEW OF CRACK TO RIGHT HAND SIDE OF ARCH

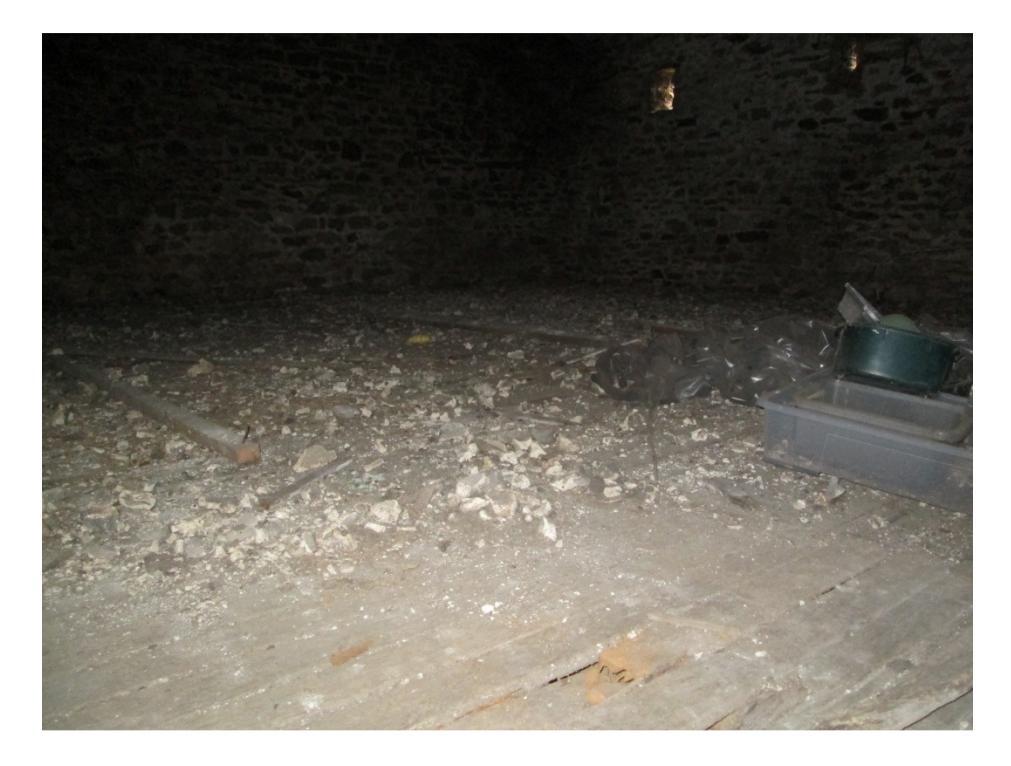
The condition of the timber bards over the first floor is poor in places with broken board visible.

PHOTO 15 – VIEW OF BOARDING TO HAYLOFT

The first floor boards and joists will require replacing as part of the conversion. Steel beams may well be required in lieu of the existing timber beams to provide adequate support for the first floor without the need for additional internal columns.

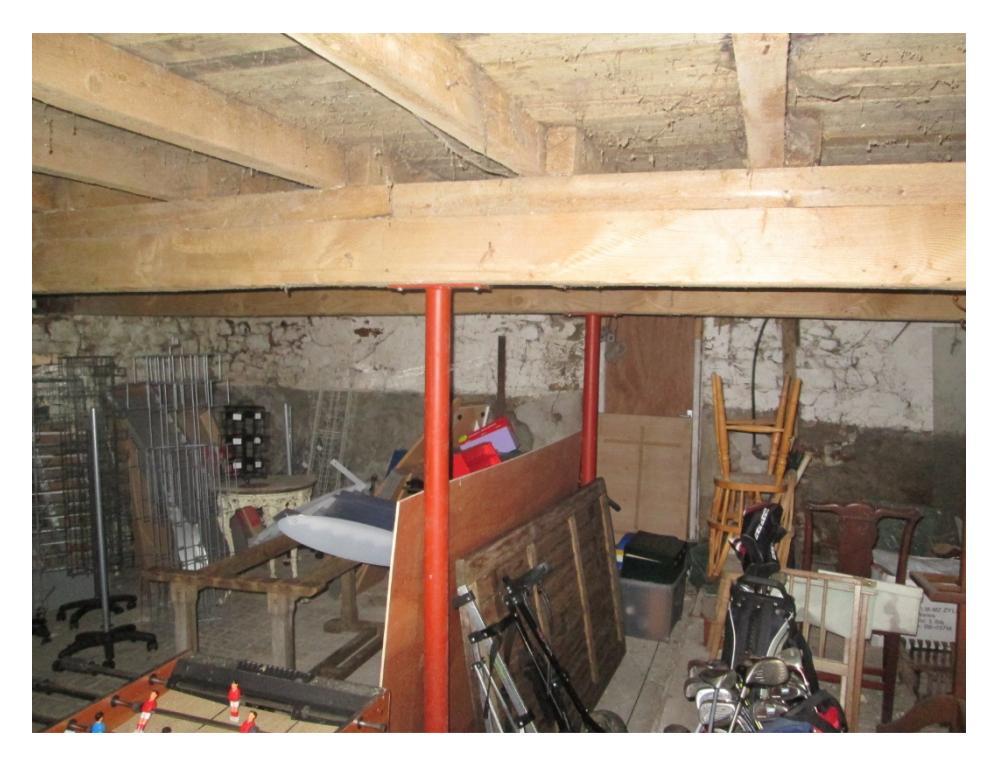
The beams supporting the first floor have a circular hollow section steel post providing added support at mid span. The posts are fixed to the concrete floor slab.

PHOTO 17 – VIEW OF ADDITIONAL STEEL POST SUPPORTS
