**26 CHURCH STREET, RIBCHESTER, LANCASHIRE, PR3 3XP:**

**ADDITIONAL STATEMENT REGARDING HERITAGE MATTERS**

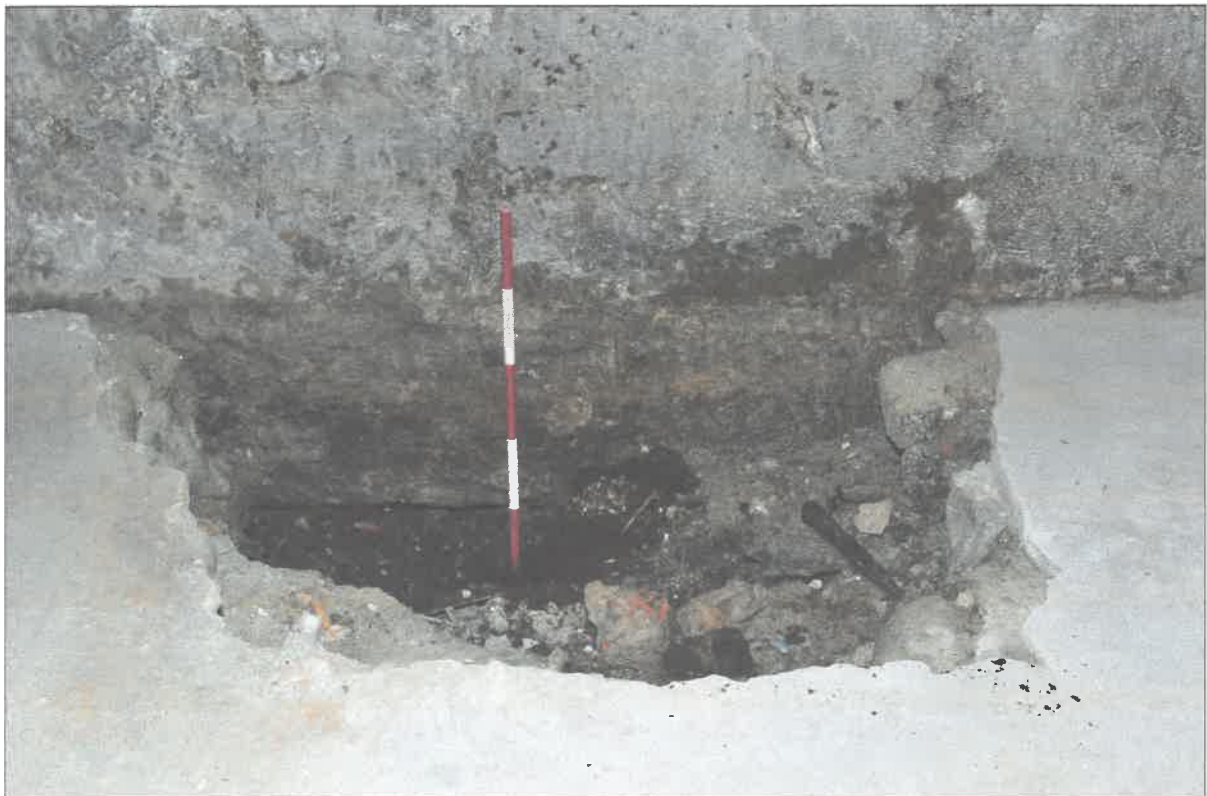
- 2.1 The existing concrete floor within the rear wing is twentieth century, and has been found to lie approximately 300mm above the likely historic floor level.
- 2.2 A test pit next to the north wall, dug by the owner, shows that limewash or plaster is present on the internal face of the wall, to at least 300mm below the existing concrete floor; the wall itself continues below this. The concrete floor itself is about 50mm deep, and overlies rubble and soil infill. No historic floor surface was identified below this, but the presence of limewash or plaster to the depth of 300mm is clear evidence that the historic floor level was at, or below, that level.

Photo 1: Test pit against north wall. Scale with 100mm markings.

- 2.3 It was previously surmised that the rear wing was built as a cotton loom-shop. Such workshops were commonly built below external ground levels, in order to maintain high humidity, and that would account for the low historic floor level here. Once the wing was no longer used for hand-loom weaving, it is likely that the floor level was raised to reduce its dampness.

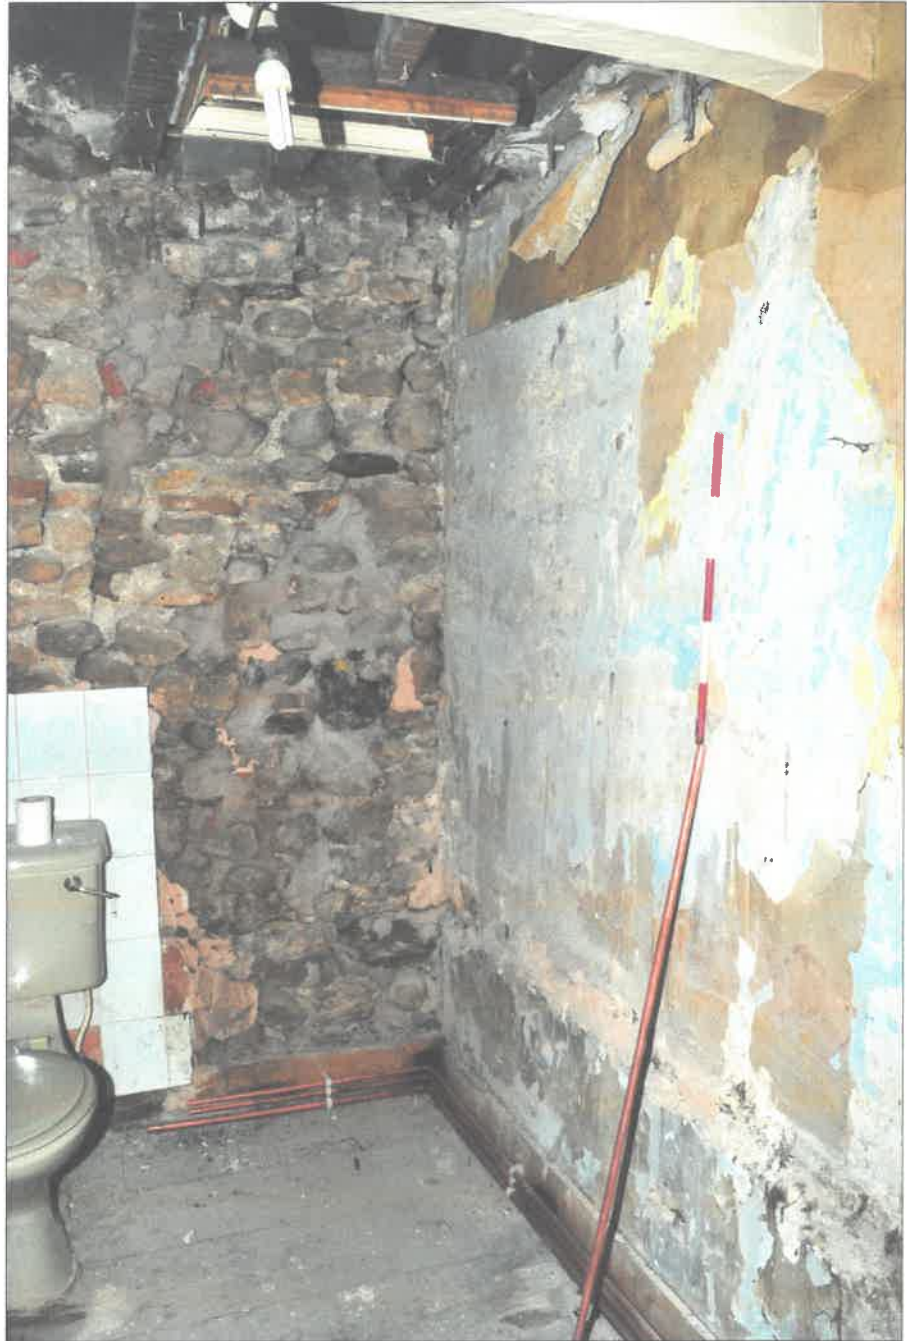
- 3.2 The former position of the stairs was not identified within the house in 2019, but since then, the removal of the ceiling around the trapdoor, and tiling to the bathroom walls, reveals good evidence that the staircase was situated within this room in the north-west corner of the house, so it was probably removed to accommodate the bathroom when that was put in, most likely in the 1950s or 1960s.

- 3.4 The stairs would most likely have been of dog-leg form, with half-landing against the west wall. A diagonal line in the plaster to the north wall appears to show the upper flight, and two marks in the floorboards below may be where posts supported it.

Photo 2: Location of former stairs to second floor. Now bathroom.  
Diagonal line in plaster immediately above red and white scale.

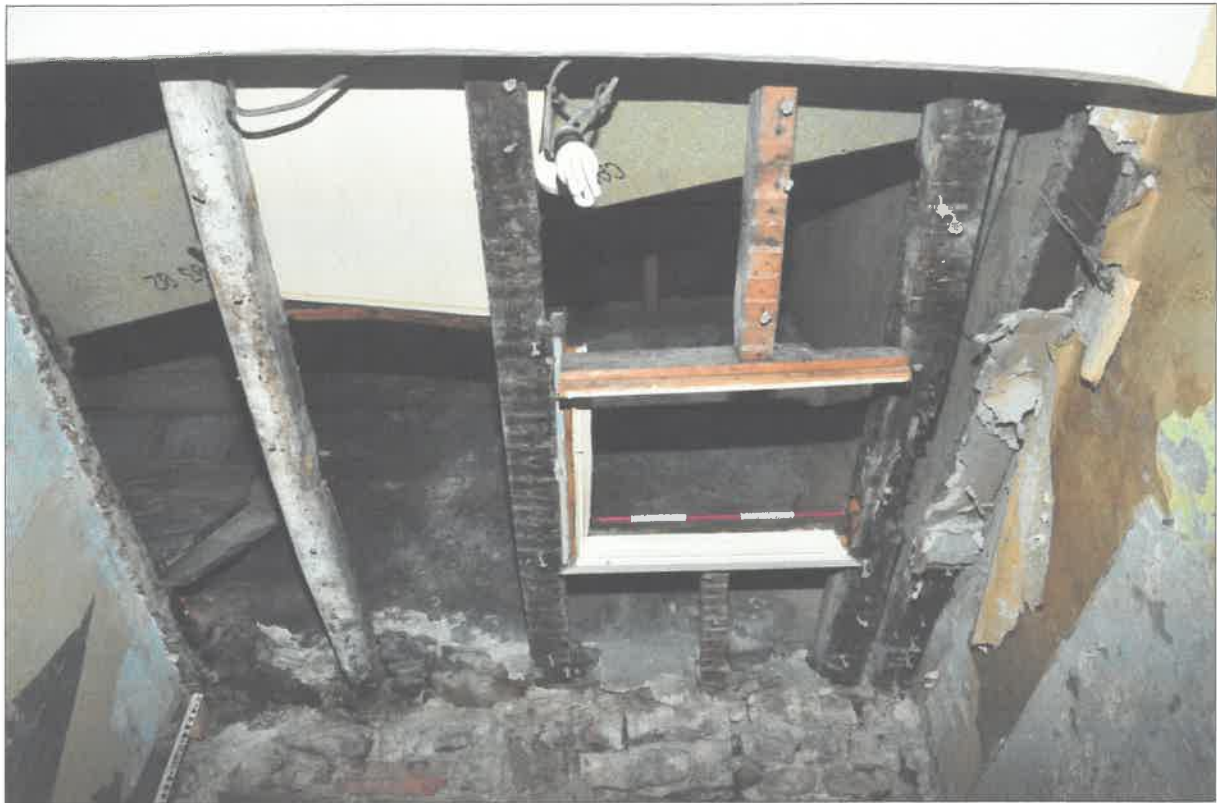
- 3.3 The ceiling joists immediately to either side of the modern trapdoor are of very mixed types, and notably lack any limewash, so are distinct from the original joists further south. The latter do not show any marks of re-use, and are limewashed on their soffits and sides (meaning there would have been no underdrawing to the ceiling originally, and that the present lath and plaster is later). This shows there to have been an historic opening in the north-west corner of the ceiling, measuring 1450mm between the west wall and a beam, and 1150mm between the north wall and the original ceiling joist, to accommodate the stairs. When they were removed, so the bathroom could be created, the opening was reduced to a trapdoor.

Photo 3: Modern trapdoor within infilled stairwell. Original limewashed joists at left.
