**Planning and Heritage Statement
For a Listed Building Consent Application
September 2020**

**Yew Tree Farmhouse
Ribchester
PR3 3YD**

YEW TREE FARMHOUSE, RIBCHESTER
PLANNING AND HERITAGE STATEMENT

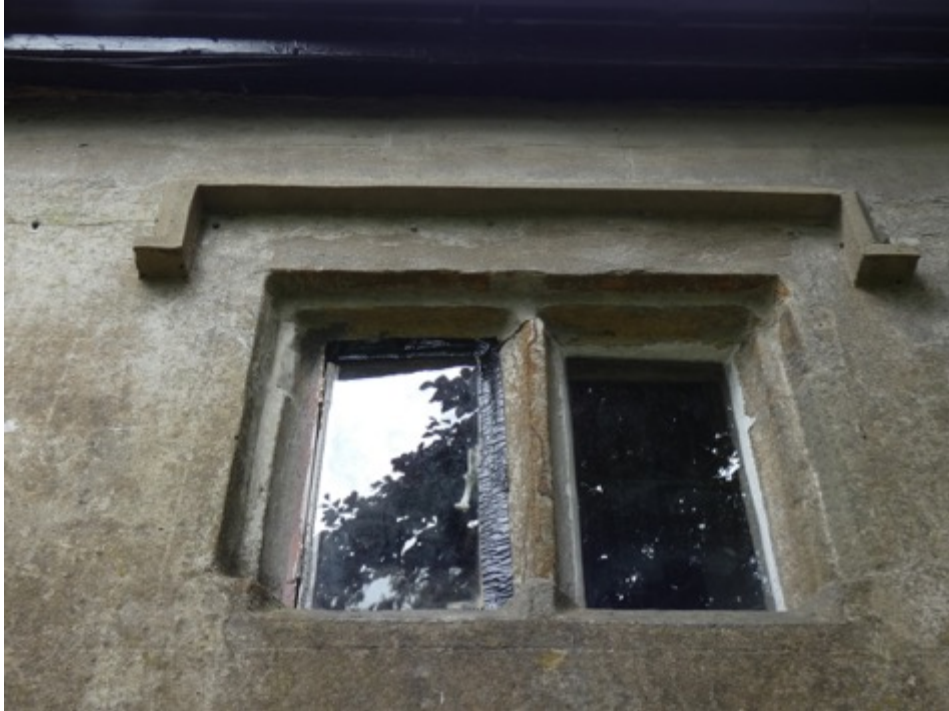
IMAGE 02 – FIRST FLOOR WINDOW
WITH OPENING LIGHT

Repairing corroded opening light painted metal windows. Replace modern float glass with insulated single-glazing to emulate drawn glass.

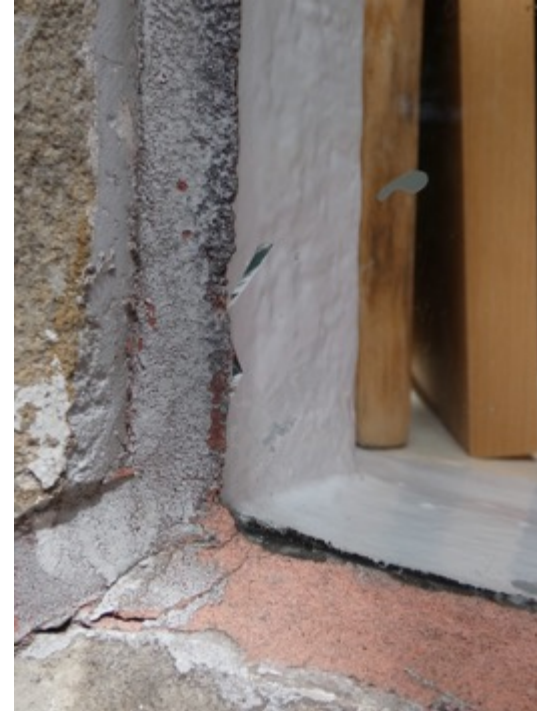
IMAGE 05 – CRACKED FLOAT GLASS TO GROUND FLOOR WINDOW

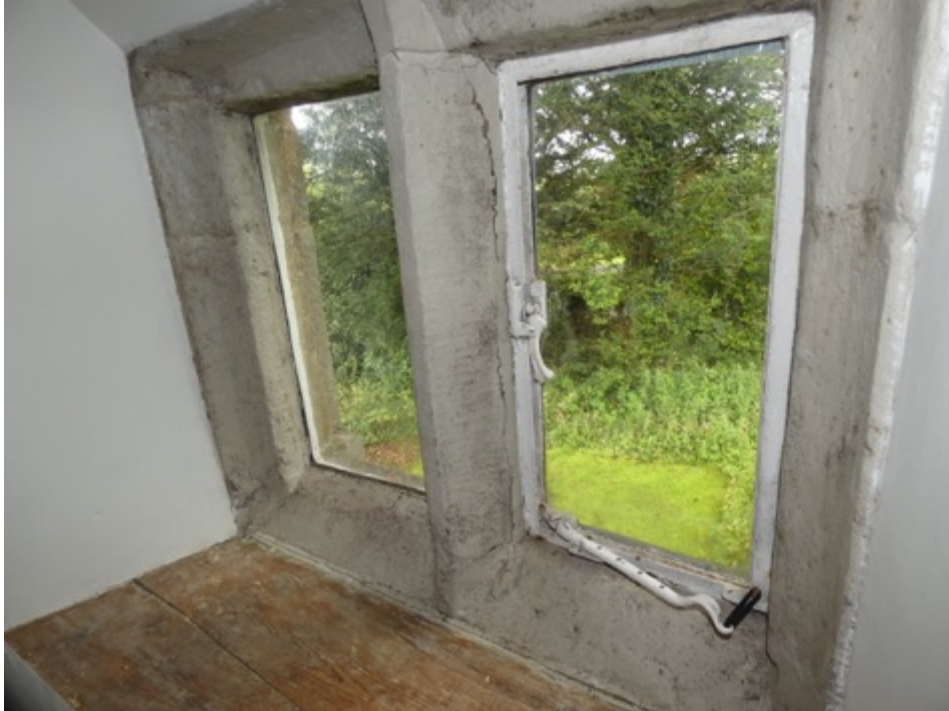
IMAGE 08 – FIRST FLOOR OPENING LIGHT WINDOW

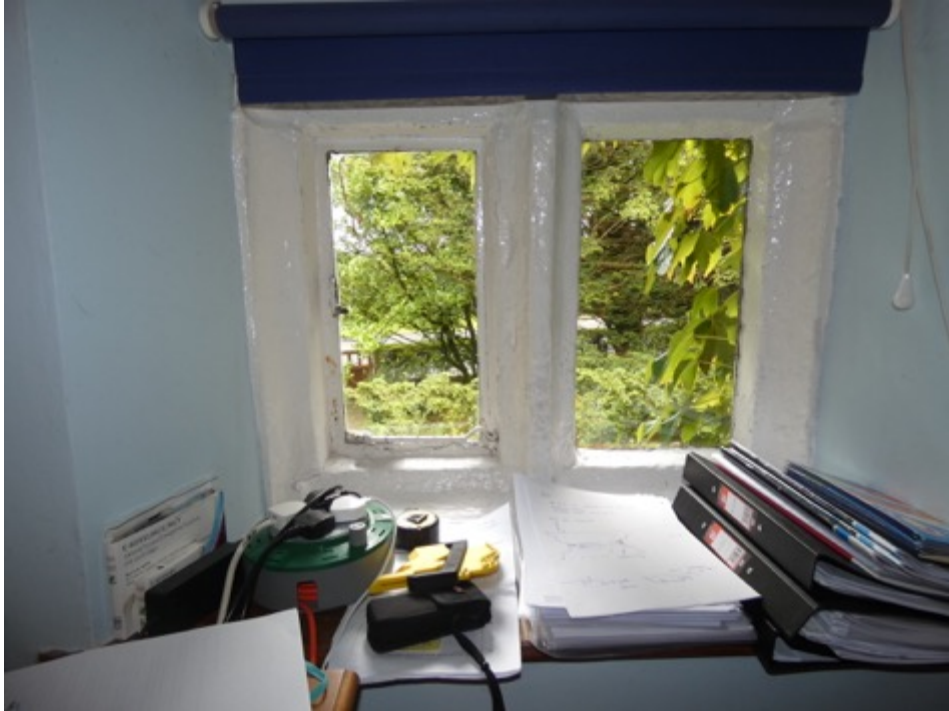
IMAGE 010 – THICK LAYERS OF PAINT TO STONE REVEALS

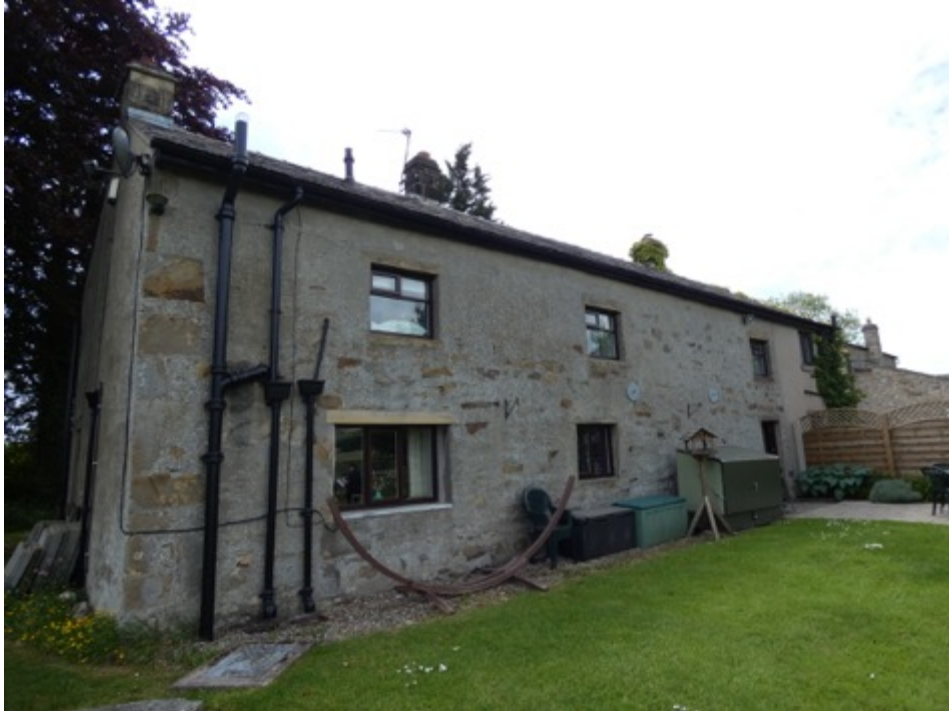
5.14 The parts of the rainwater system which are uPVC (some downpipes) harm the aesthetic value of the building and should be replaced. Some of the installation is cast iron which is better suited to a traditional building, and should be carried through to the whole rainwater disposal system.

IMAGE 015 – UPVC RAINWATER GOODS TO NORTH ELEVATION

Replacing the uPVC rainwater downpipes with painted cast iron to improve the maintenance profile and aesthetics of the listed building.

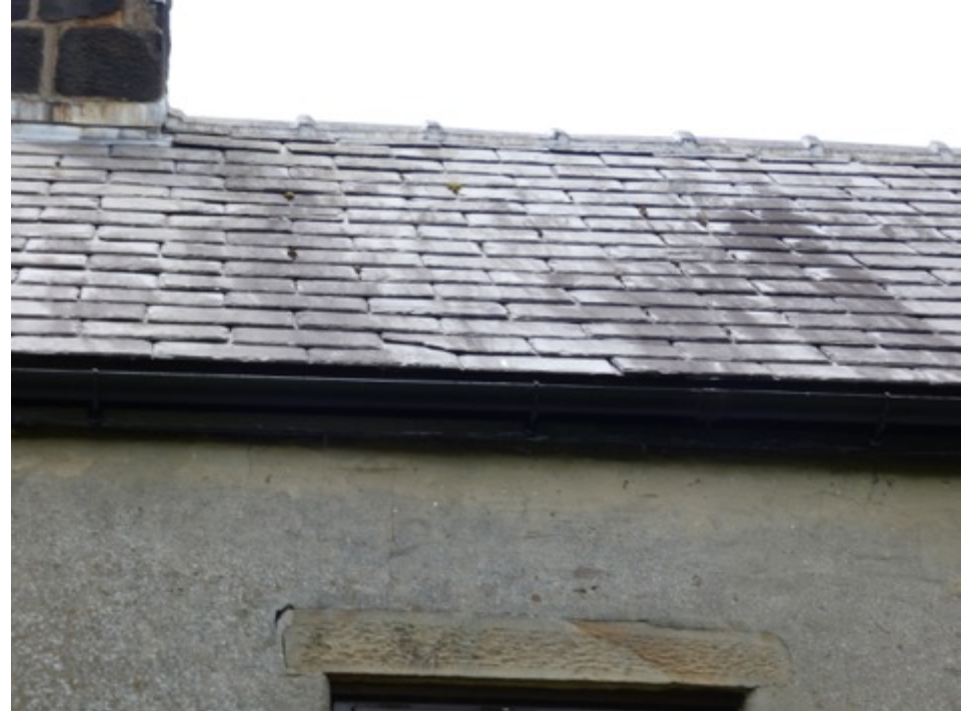
IMAGE 016 – UPVC GUTTER
