HERITAGE STATEMENT

13 YORK STREET

CLITHEROE

07th September 2020

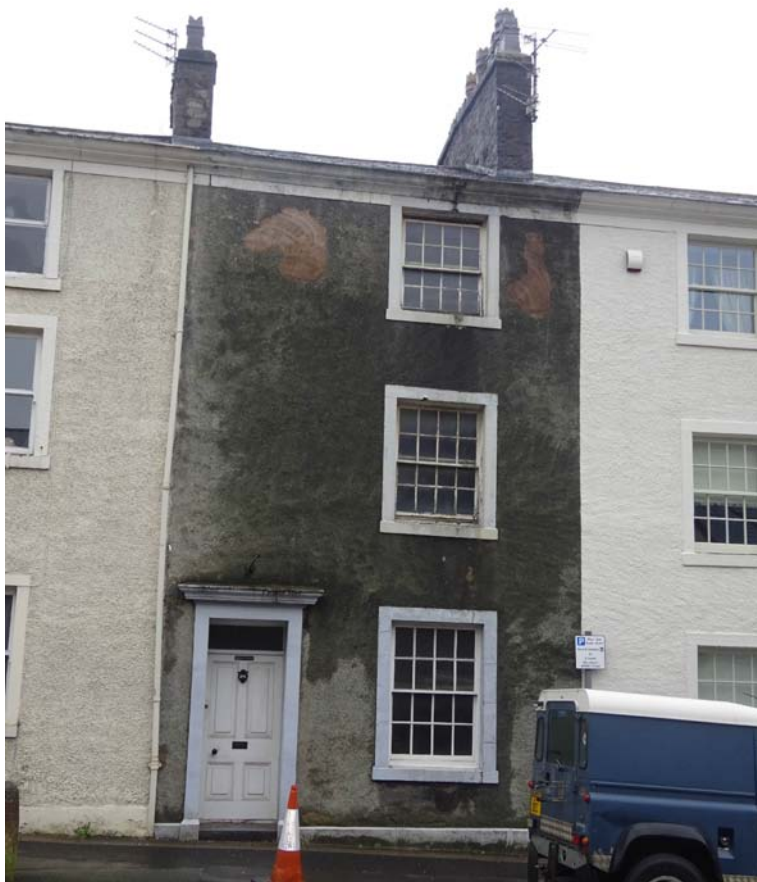
13 York Street – Front Elevation

- 6.29 The existing render finish is to be maintained. There are clearly several small areas where the render is deteriorated and will be patched up on a like for like basis. The wall is to be decorated to match the neighbouring property, number 15.

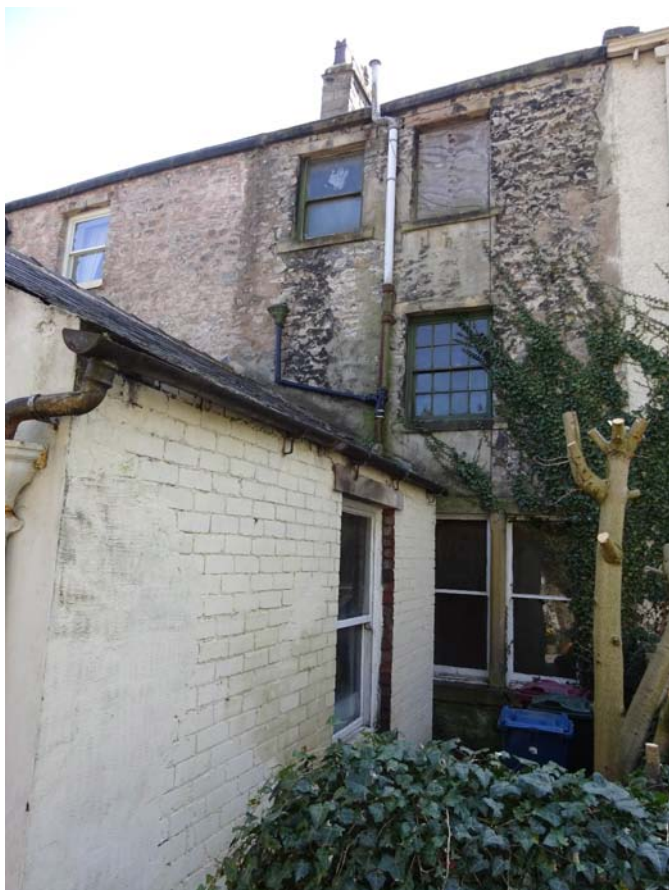
13 York Street – Rear Elevation

- 6.32 The existing unsuitable cement render / pointing is heavily smeared over the surface of the stone and is intended on being carefully removed followed by re-pointing using lime mortar as necessary. The ivy growth is also proposed to be carefully removed.

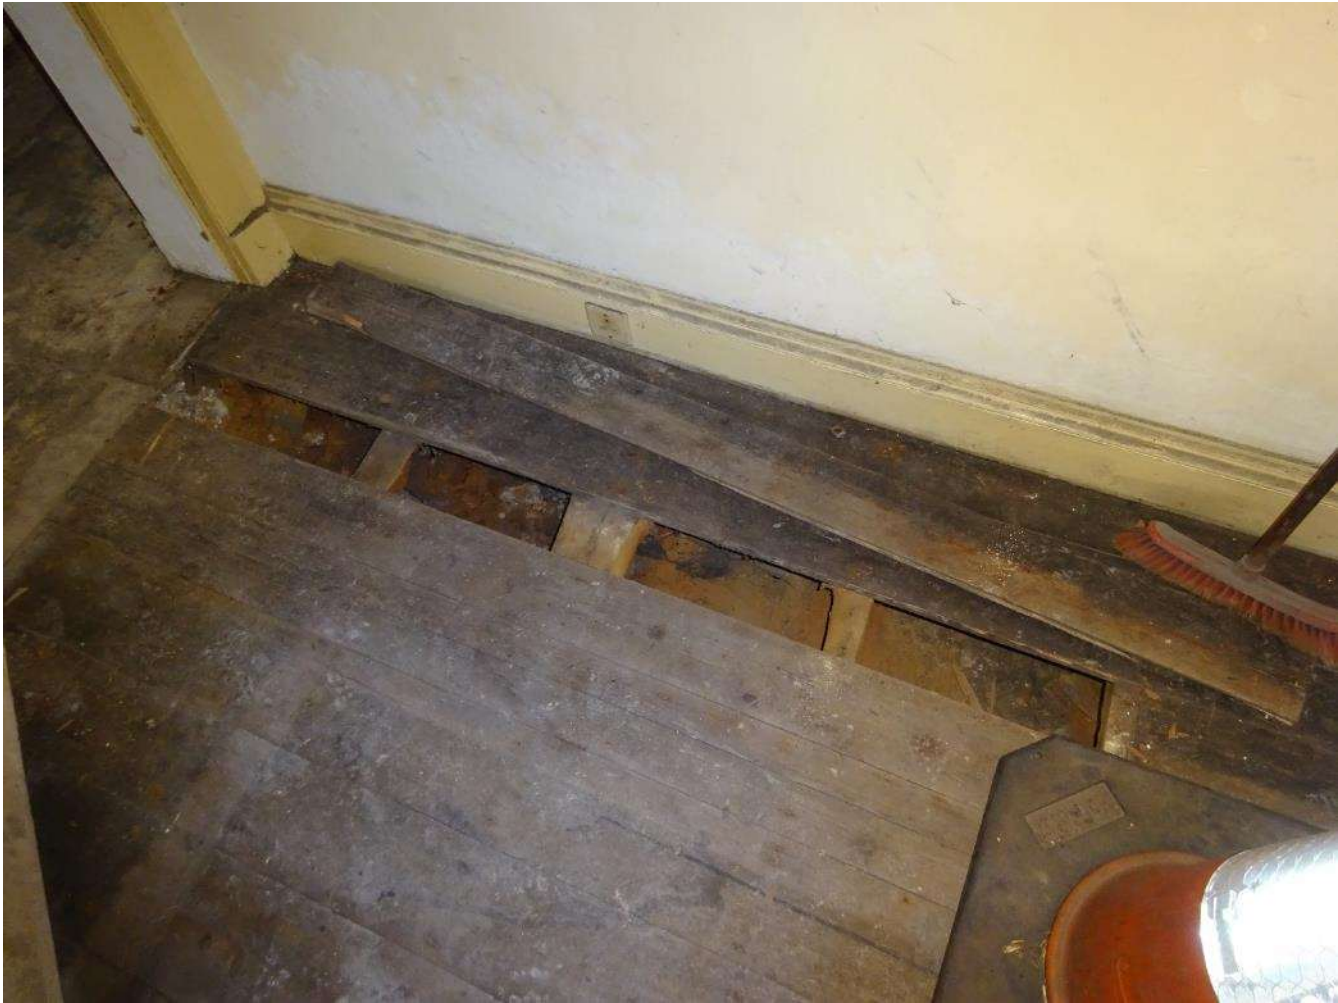
Front Room – Rotten floor joists

- 6.8 Several of the existing timber floor joists are rotten at the bearing end to the internal loadbearing wall. Elsewhere in the room the original floorboards have been replaced with narrower modern softwood floorboards which suggests that some repairs are likely to have been carried out at some point in the past relatively recently. It is considered likely that the joists have become rotten as there is no apparent means of ventilation to the floor void. It is proposed to maintain the existing joists which will be doubled up with new timber supported on steel hangers.

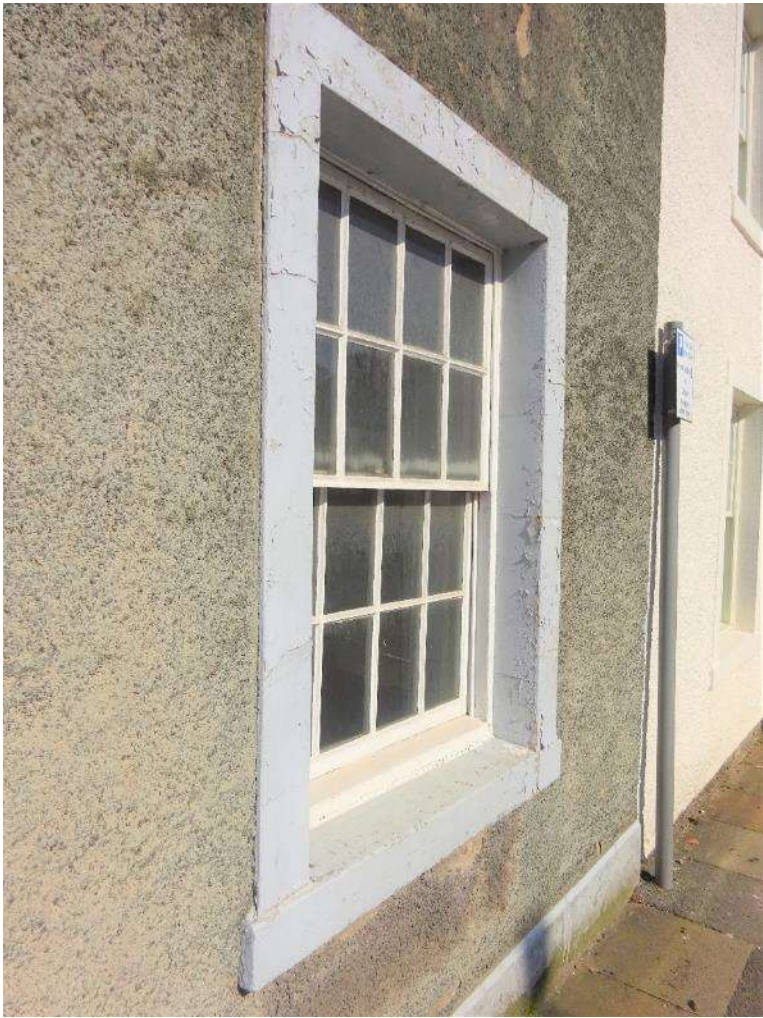
Sash window to front

- 6.30 The existing sash windows are in poor decorative condition but remain serviceable. It is intended to fully overhaul the windows as follows :freeing jammed casements or sashes and removing build-ups of paint which interfere with their effective operation, replacing broken sash cords, lubricating pulleys and hinges, replacing broken glass and defective putties, cleaning and repairing ironmongery and replacing missing or broken items, easing sticking sashes and casements, adjusting/packing hinges, replacing missing or worn beads, preparation and redecoration of previously painted surfaces (5-8 year cycle).

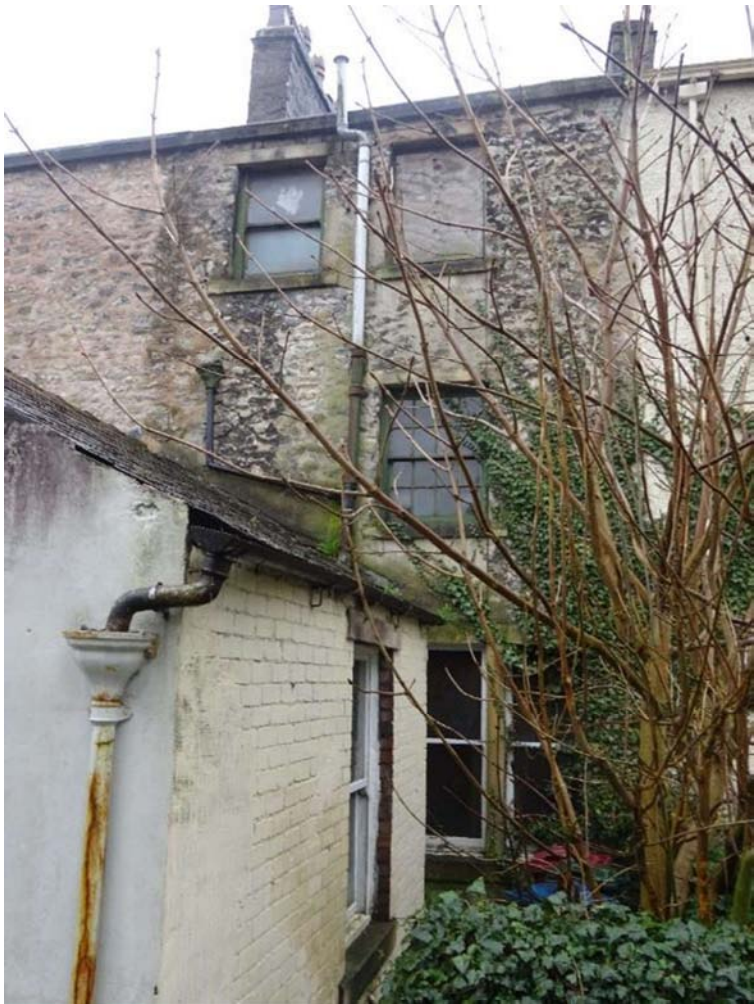
Rear Elevation

- 6.33 The soil pipe that serves the existing second floor bathroom is a mixture of uPVC and painted cast iron and currently penetrates the kitchen roof and is embedded in the wall of the kitchen. It is proposed to replace this with a new painted cast iron soil pipe to the right-hand side of the wall which will receive the foul drainage from the new en-suite and bathroom. A new connection will be required to the existing drainage installation below ground.
