ARBORICULTURAL DEVELOPMENT REPORT

**ON TREES LOCATED
ADJACENT TO SMITHFIELD RUGBY PITCH, STONYHURST COLLEGE
FOR**

October 2020

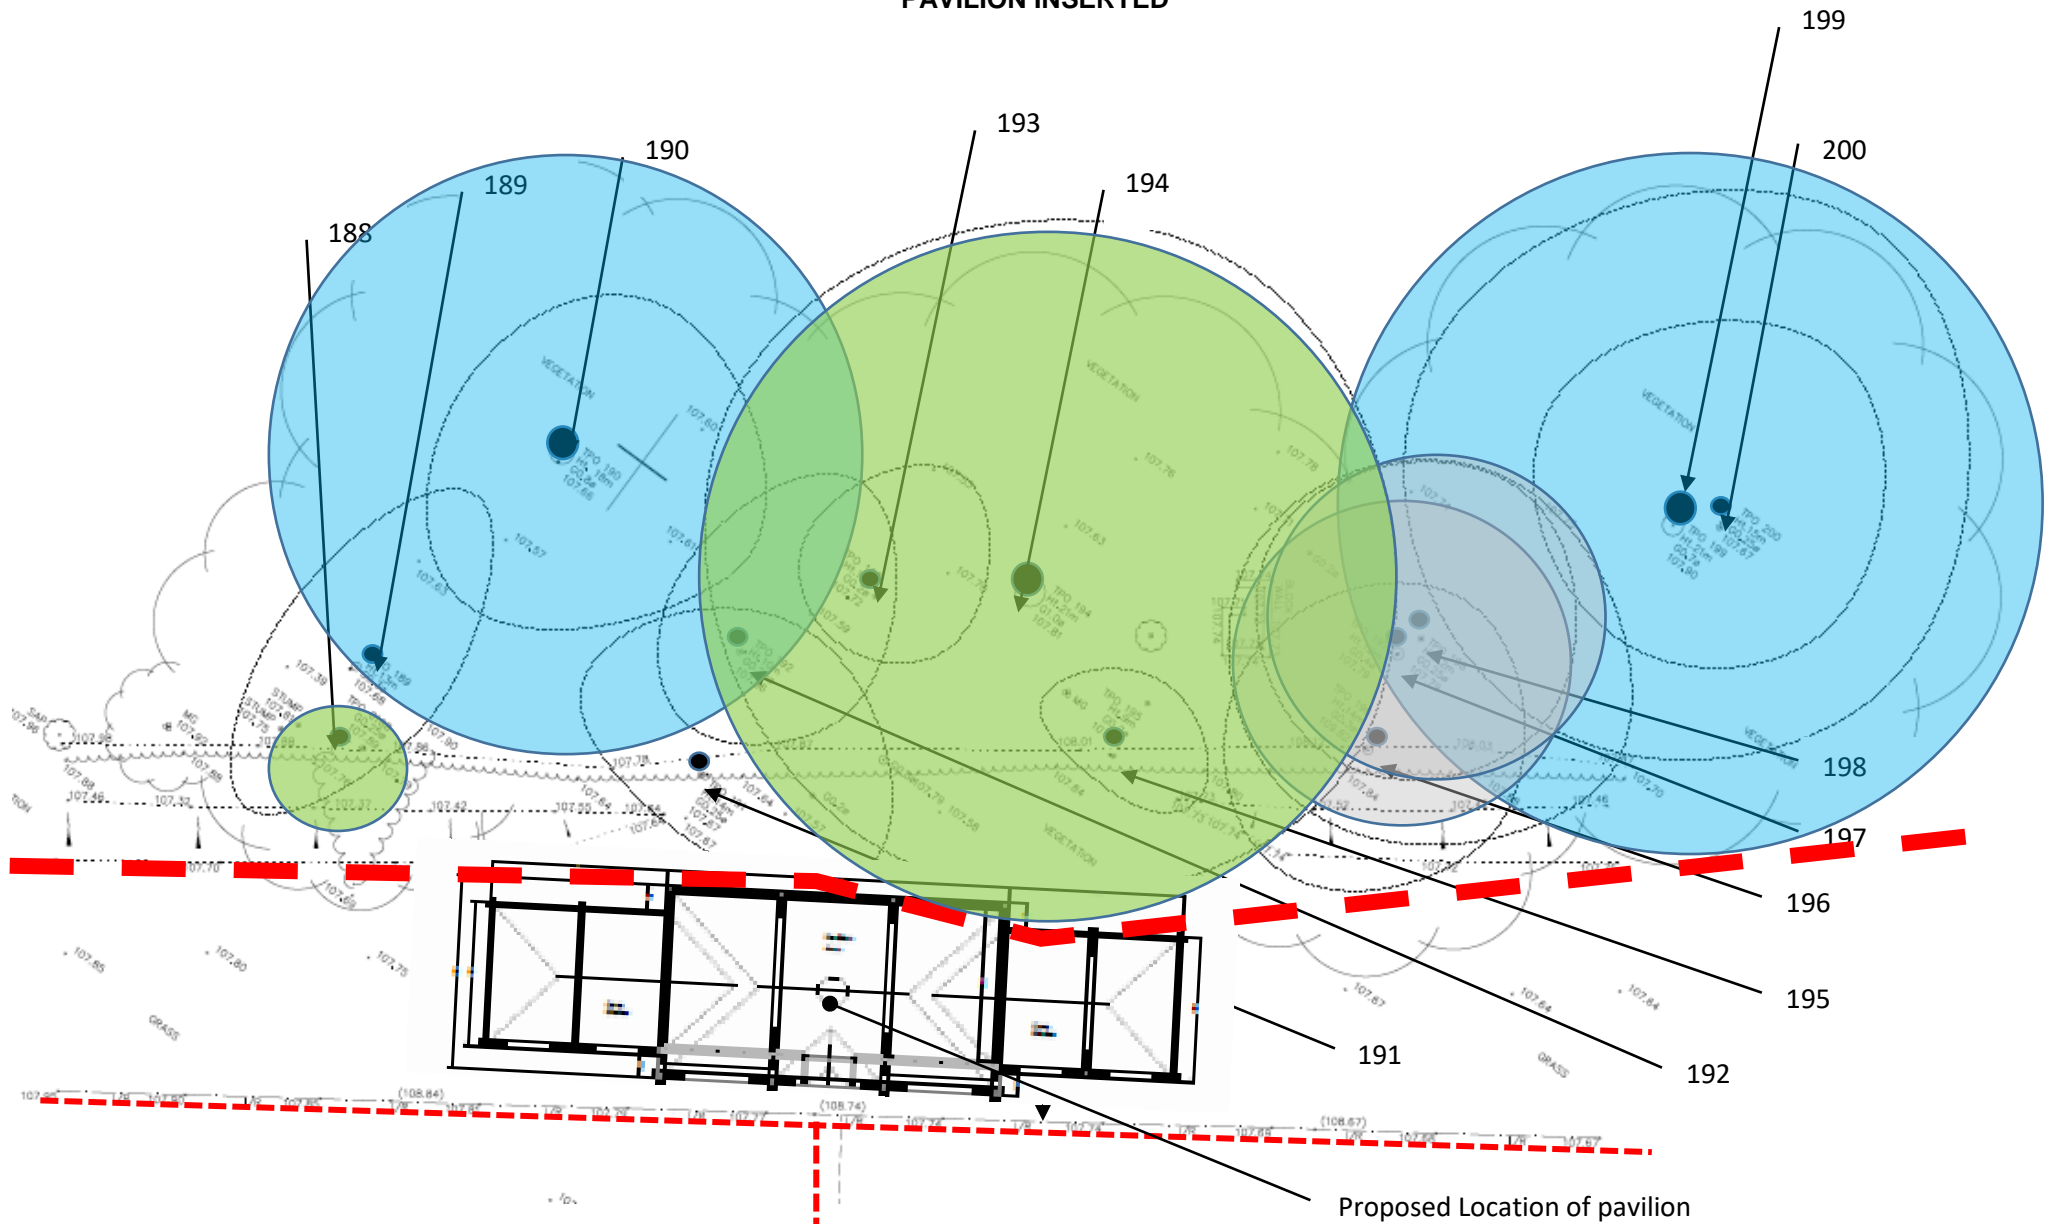
TREE LOCATION AND TREE CONSTRAINTS PLAN AT SMITHFIELD RUGBY PITCH, STONYHURST COLLEGE SHOWING ROOT PROTECTION AREAS WITH PAVILION INSERTED

The dominant and most important trees in the plantation are the original oaks 190, 194,199. The more recent planting was mixed species with a significant proportion of ash which are now failing to Ash Die Back disease. The birch ash and hazel have not been thinned in the past and many of the trees are suppressed. The ground is wet and waterlogged at times. The drain line along the edge of the woodland is blocked but will be taken up by the root zones of many of the trees. For this reason drain reconstruction is not recommended although if the ditch was piped at its present level and then soiled and seeded this would be acceptable and might help reduce the waterlogging..

The proposed location of the pavilion has been brought away from the tree screen by a metre. The RPA of 194 (Oak) intersects with the foundation line of the Pavilion as shown on the plan. Given that the ditch will provide an attraction to the tree roots a hand dug investigation on the foundation line to 500mm depth should identify if the root zone of the oak is present. If this is the case a pile or screw pile supported foundation could be considered. This could be conditioned by the planning authority

The heavy red dashed line on the constraints plan is the limit of the joint root protection area leaving a distance of 7.5m from the RPA line to the steel balustrade to the pitch.

1. The red dashed line on the plan indicates the extent of the Root protection area and the location of protection in Hares fencing mounted on **fixed posts or scaffold** to ensure that the protection area is not breached or used for material storage.

2. The fencing shall be erected on the south side of the ditch from the trees as shown on the plan
3. Full tree root zone protection should be implemented after any initial tree removal and pruning works and **before** any ground work and foundation work commence.

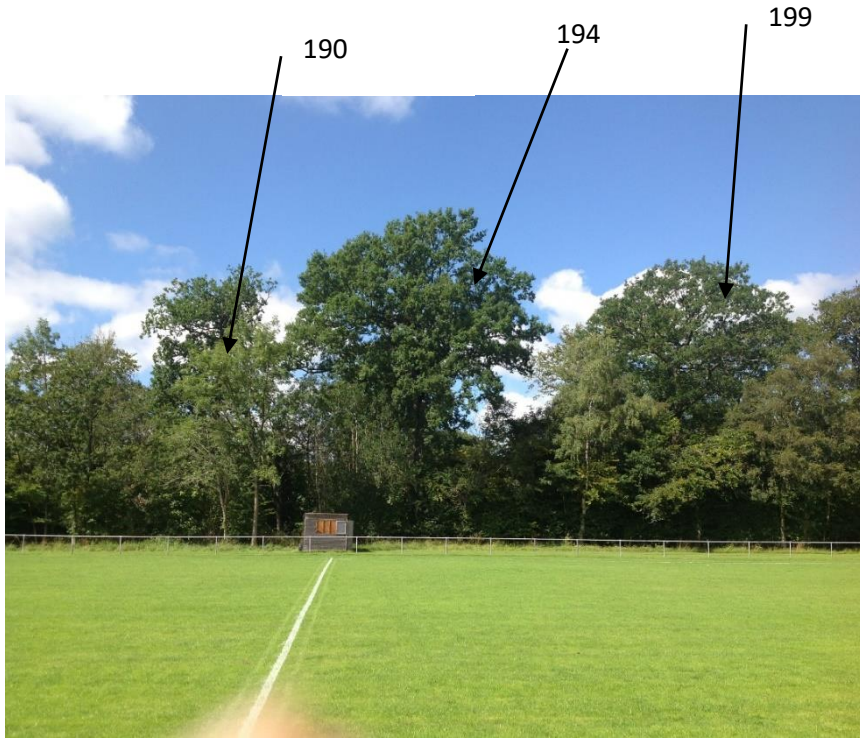
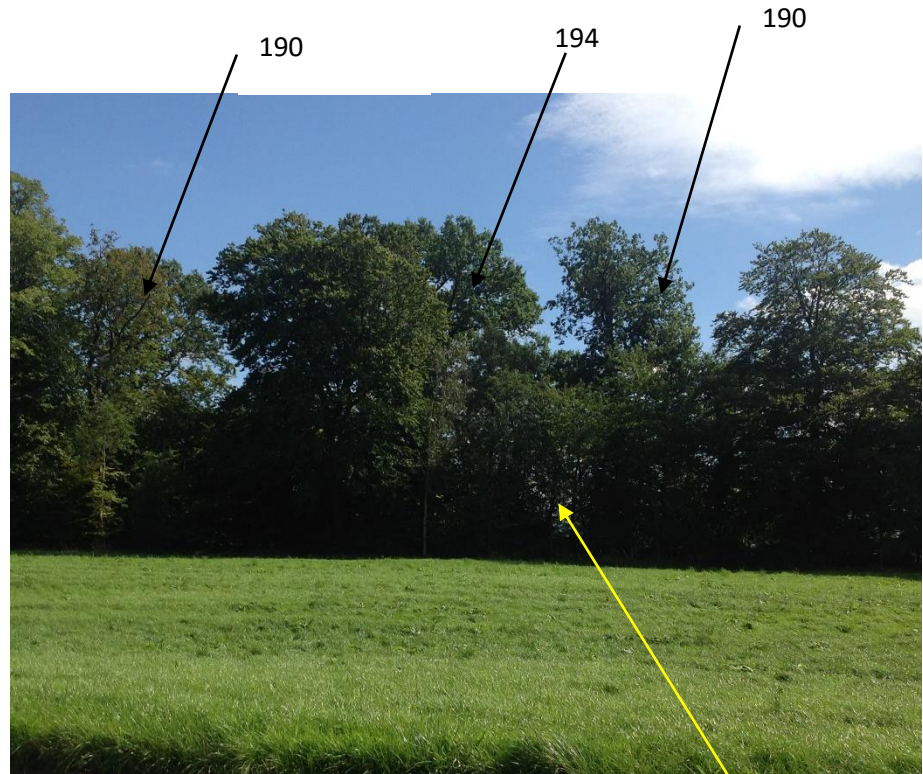
View to existing hut from drive side

The photos shown below are the summer and early autumn screening offered by the trees. This screen will be somewhat lost in winter when the trees lose their leaves. The woodland has few evergreen species. The pavilion profile will be visible from the main drive between October and May.
