## Alston / Spade Mill Pipeline, Longridge: Ecological Constraints Table

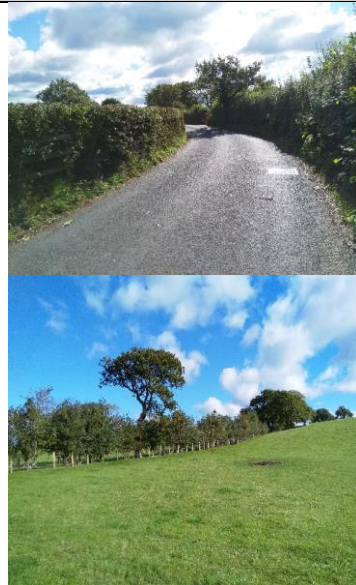
| Constraint | Description and map reference | Photographs | Potential Impact | Measures required | |
|---|---|---|---|---|---|
| <b>Priority Habitat: Hedgerows</b> | Numerous hedgerows are located throughout the survey area, most of which are located along boundaries diving fields and along roadsides. Some were species-rich, whilst others were dominated by one species and scattered mature trees were located in many of the field boundary hedgerows. The majority of hedgerows were dominated by hawthorn ( <i>Crataegus monogyna</i> ), typically with a mixture of blackthorn ( <i>Prunus spinosa</i> ), holly ( <i>Ilex aquifolium</i> ), hazel ( <i>Corylus avellana</i> ), elder ( <i>Sambucus nigra</i> ), bramble ( <i>Rubus fruticosus</i> ), hornbeam ( <i>Carpinus betulus</i> ), dog rose ( <i>Rosa canina</i> ), willow ( <i>Salix sp.</i> ) and sycamore ( <i>Acer pseudoplatanus</i> ). Hedgerows were predominantly native, intact and most fall within criteria to be Habitats of Principal Importance (HPI). Many had dry ditches or shallow field drains at their base. | | Habitat loss - Numerous hedgerows intersect the route and are likely to be directly impacted by the works.<br><br>Direct impacts from branch damage and root compaction | Pre-construction surveys of affected hedgerows to inform replanting proposals and identify 'Important Hedgerows' that may require removal notices.<br><br>Minimise length of hedgerow to be directly impacted, where possible. Mitigation for the loss of hedgerows should comprise the replacement planting of native species of at least the same length that is to be removed.<br><br>Adopt tree protection measures. Measures to safeguard the canopy and Root Protection Area (RPA) of hedgerows to be retained should be in line with BS 5837:2012 (British Standard: BS5837). | Hedgerow surveys to be undertaken ideally between May-July.<br><br>See also timescales relating to nesting birds. |

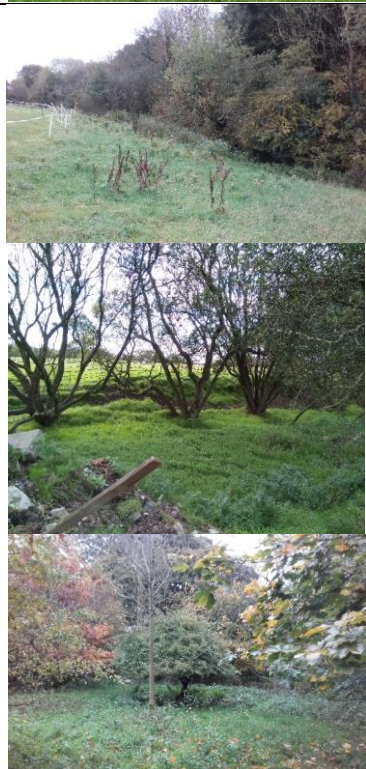
| Constraint | Description and map reference | Photographs | Potential Impact | Measures required | |
|---|---|---|---|---|---|
| <b>Priority Habitat: Semi-natural woodland</b> | Narrow strips of semi-natural broadleaf woodland are present surrounding some of the main watercourses within the survey area. These areas are dominated by semi-mature to mature trees with saplings and young trees also present. Typical species include sycamore, ash ( <i>Fraxinus excelsior</i> ), oak ( <i>Quercus robur</i> ), alder ( <i>Alnus glutinosa</i> ) and beech ( <i>Fagus sylvatica</i> ), with occasional silver birch ( <i>Betula pendula</i> ), wych elm ( <i>Ulmus glabra</i> ), Norway maple ( <i>Acer platanoides</i> ), rowan ( <i>Sorbus aucuparia</i> ) and horse chestnut ( <i>Aesculus hippocastanum</i> ). These woodlands have a fairly open understorey, with scattered hawthorn, hazel, elder and holly present, and a varied ground flora.<br><br>Other smaller wooded stands are present, including a small stand of woodland to the south of Whittingham Lane (Target Note 17) and a wooded marshy depression dominated by willow in Section 9 (Target Note 5). | | Habitat loss - The majority of woodland areas are not located in proximity to the route. However, minor pruning / felling works may be required, such as in the west of Section 10.<br><br>Direct impacts from branch damage and root compaction | Pre-construction surveys to advise on impact reduction, mitigation and reinstatement.<br><br>Avoid loss / direct impact of this priority habitat where possible. If this is not possible, mitigation for the loss should comprise the replacement planting of native species on a 2:1 basis.<br><br>Adopt tree protection measures. Measures to safeguard the canopy and Root Protection Area (RPA) of trees in woodland to be retained should be in line with BS 5837:2012 (British Standard: BS5837). | Woodland surveys ideally between May-June to allow an assessment of spring ground flora.<br><br>See also timing relating to nesting birds. |

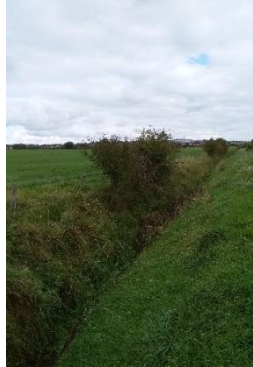
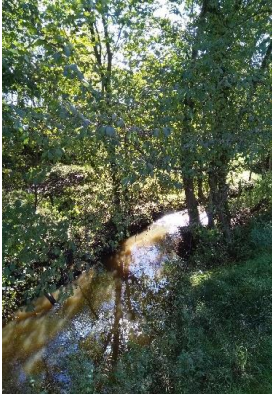
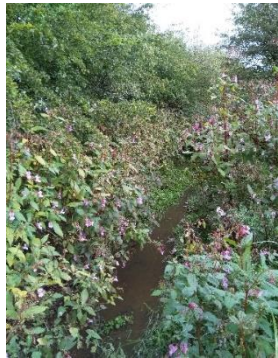
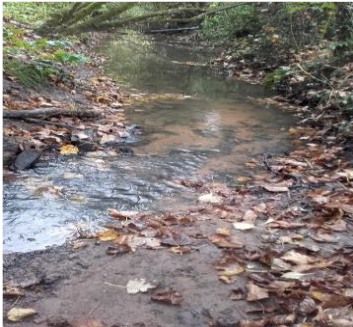
| Constraint | Description and map reference | Photographs | Potential Impact | Measures required | |
|---|---|---|---|---|---|
| <b>Priority Habitat: Watercourses</b> | <p>Several watercourses are present throughout the survey area. These comprise a few main brooks and several smaller streams and drains along field boundaries. The brooks are likely HPI, however the smaller watercourses hold less intrinsic ecological value and likely do not meet the HPI criteria as most are not near-natural.</p> <p>The first brook is an extension of <b>Dean Brook</b>, running parallel to the pipeline route in Sections 4 &amp; 5 and situated within in a wooded clough (Target Note 1). The second is <b>Blundel Brook</b> which runs through Sections 6, 7 &amp; 8. In Section 6 it is situated between improved fields with only some scattered trees and scrub along its banks, which are dominated by grasses and tall ruderal vegetation (Target Note 2). In Sections 7 and 8, trees are continuously present along the brook but the understorey is very open, dominated by improved grassland or tall ruderal vegetation, and overall forms a narrow vegetated corridor (Target Note 19). <b>Savick Brook</b> is situated in Section 10 of the route, within a narrow wooded clough (Target Note 3) and the pipeline appears to intersect it. A tributary of Savick Brook also extends into Section 11 (Target Note 4), where the pipeline route intersects the watercourse again. This section is located in a deep ditch running along hedgerows and passes adjacent to an access road and improved fields.</p> <p>The brooks are all approximately 1 – 2.5 m wide and up to 60 cm deep, with a slow to moderate flow. They have a muddy, sandy and slightly rocky substrate and the water appeared turbid at the time of survey, with lots of litter noted within them. Mature and semi-mature trees are located along their length and some sections are located within wooded cloughs, so are heavily shaded, whilst other sections pass through open areas between fields. Banks range from near vertical to near horizontal, from approximately 10 cm high to 2 m high, and are predominantly muddy with adjacent tall ruderal vegetation.</p> <p>The remainder of the watercourses are smaller streams and field drains. Most of which are located below or adjacent to hedgerows, from 20 cm - 1 m wide and approximately 2 cm - 20 cm deep. Most of these channels are similar in nature, featuring a very shallow, narrow and slow flow with a muddy substrate. Sloping banks are typically dominated by a hedgerow on one side with tall ruderal and grasses on the other. Occasional aquatic plants present include brooklime (<i>Veronica beccabunga</i>) and soft rush (<i>Juncus effusus</i>). Most drains were very shallow at the time of survey and are considered likely to become completely dry during the summer months. Some sections of watercourses were culverted over a short distance, such as beneath roads or access tracks between fields (Target Note 16).</p> | | <p>Habitat loss / direct damage - The pipeline route will pass through a few brooks and several smaller streams / field drains.</p> <p>Pollution of watercourses – Works in proximity to watercourses may result in pollution, such as from silt and/ or fuel.</p> | <p>Pre-construction surveys to advise on impact reduction, mitigation and reinstatement.</p> <p>Minimise direct impacts to any watercourse, particularly the brooks. Where this is not possible, habitat enhancement measures should be incorporated following completion of works.</p> <p>Pollution control measures should be adopted</p> | <p>None.</p> |

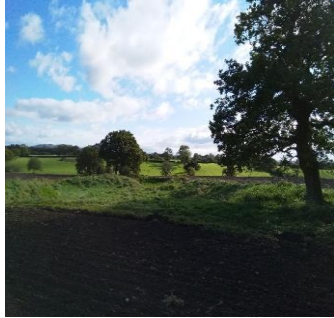
| Constraint | Description and map reference | Photographs | Potential Impact | Measures required | |
|---|---|---|---|---|---|
| <b>Semi-mature to mature trees</b> | Semi-mature and mature trees are located along field boundaries throughout the survey area, many within hedgerows, and some individuals are located around ponds and watercourses, with a few also situated centrally within improved fields. Species present included; oak, sycamore, alder, ash, rowan and willow. | | Habitat loss – Felling of several trees is likely, whilst pruning may also be required<br><br>Damage to branches and roots of trees – where works are to be located in proximity to trees to be retained. | Avoid tree felling where possible. Where this is not possible, mitigation for the loss of semi-mature to mature trees should comprise the replacement planting of native species on a 2:1 basis once works are complete, or in a suitable alternative area in the locality.<br><br>Adopt tree protection measures. Measures to safeguard the canopy and Root Protection Area (RPA) of trees to be retained should be in line with BS 5837:2012 (British Standard: BS5837). | None, but see timescales relating to nesting birds. |

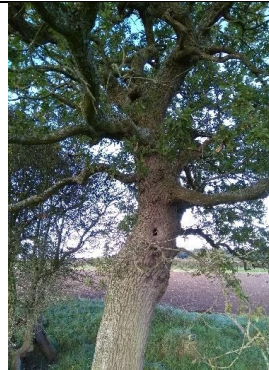
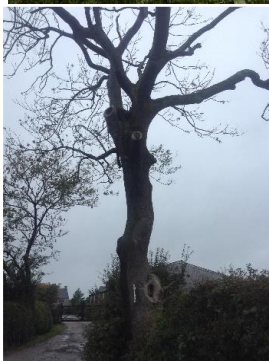
| Constraint | Description and map reference | Photographs | Potential Impact | Measures required | |
|---|---|---|---|---|---|
| <b>Bats</b> | <p>Semi-mature to mature trees throughout the survey area provide potential roosting habitat for bats. These trees are predominantly located within hedgerows, along field boundaries or within areas of woodland*. Potential roosting features include knot holes, hazard beams, cavities within the main stem, broken limbs and woodpecker holes. Additionally, a few trees along the route have bat boxes attached to them. Trees that were assessed to hold moderate or high potential for roosting bats (in line with Collins, 2016) are labelled on the Ecological Constraints Plan.</p> <p>None of the buildings were assessed for their potential to support roosting bats as it is understood that none are to be directly impacted by the works.</p> <p>The woodland edges, hedgerows, watercourses and bodies of water provide good foraging and commuting habitat for bats. However, it is understood that works will be temporary in nature and only very small sections of suitable foraging / commuting habitat for bats will be directly impacted. Therefore, it is unlikely that foraging and commuting bats will be significantly impacted by the works in the long term.</p> <p>*: Trees within woodlands were not individually assessed for their potential to support roosting bats so further survey of these trees will be required if any direct impacts are anticipated</p> | | <p>Disturbance/harm of roosting bats during tree felling / pruning</p> <p>Loss of suitable roosting habitat</p> | <p>Ground level assessment of bat roost potential for any of the bat roost potential trees affected by the proposals. If tree or tree limb removal is required of a tree with moderate / high potential for roosting bats, it is advised that an aerial inspection is undertaken by a suitably qualified ecologist, using a torch and an endoscope to thoroughly search any features prior to commencement of works. This will assess the likely presence of bats and determine the best course of action considering any licensing requirements.</p> <p>If closer inspection of the PRFs verifies they are of moderate or high suitability, or evidence of bats is confirmed, further presence/absence and roost characterisation surveys may be required, involving dusk or dawn re-entry surveys.</p> <p>Compensation for the loss of suitable bat roosting habitat should be provided in the form of bat boxes where trees are to be felled.</p> | None, unless dusk or dawn re-entry surveys are required which can only be completed between May and September (weather dependant). |

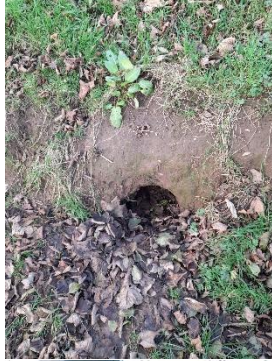
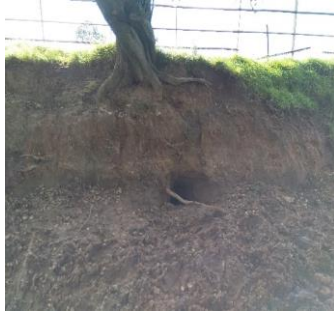
| Constraint | Description and map reference | Photographs | Potential Impact | Measures required | |
|---|---|---|---|---|---|
| <b>Badgers</b> | <p>Two badger setts were identified within Sections 7 and 9 of the route and evidence of badger including latrines, hairs and old, inactive setts were also recorded elsewhere within the survey area.</p> <p>The sett in Section 7 was likely an outlier sett and comprised one hole, located to the north of Blundel Brook within an improved field, on a south-facing bank close to the watercourse. Old claw marks were observed around the entrance of the sett and leaf litter was present inside, indicating no recent usage.</p> <p>The sett in Section 9 was located within a marshy depression along the route of the disused railway, surrounded by willow woodland (Target Note 5). This comprised two holes, one of which was potentially inactive as old bedding was found in the entrance and was generally untidy, indicating no recent usage. Claw marks and badger hair was found in the entrance of the second hole, which was tidier and also appeared to have fresher spoil outside. The ground outside both holes was heavily poached by cattle at the time of survey, indicating heavy disturbance directly outside the sett. This is likely an outlier sett, but potentially inactive.</p> <p>The wooded cloughs around the brooks and the wooded motorway verge provide good badger habitat, including sett building opportunities. A badger print was recorded along the banks of the brook in Section 10 and an old, disused badger sett was observed along the banks of the brook in Section 4 (Target Note 8). A badger latrine was also recorded within the woodland in Section 5, with both fresh and old badger faeces recorded, and a second fresh badger latrine was observed within the woodland in Section 4. Finally, badger hairs and a push-through were recorded beneath the scrub / hedge in Section 7 (Target Note 31).</p> | | <p>Disturbance of a sett – if construction works are required within 30 m of an active sett</p> <p>Direct harm / injury from open excavations badgers could fall into.</p> | <p>A pre-commencement walkover survey will be conducted of suitable sett-building habitat for badger which is to be directly impacted. This can be conducted during the watercourse, woodland and hedgerow surveys detailed above.</p> <p>If any works are required within 30 m of a badger hole, a sett monitoring survey may be required. Camera traps will be placed and sticks will be placed in the entrance to monitor use of the sett.</p> <p>Any excavations should be covered / fitted with mammal ramps if left overnight to ensure that any animals that enter can safely escape. Excavations will be backfilled as soon as possible to minimise the potential for animals to become trapped.</p> | <p>None. If required, sett monitoring surveys should be conducted over a minimum period of 28 days</p> |

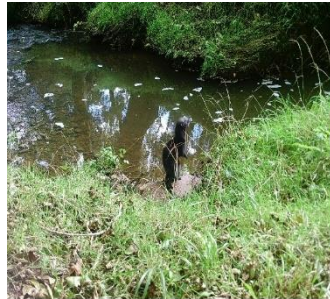
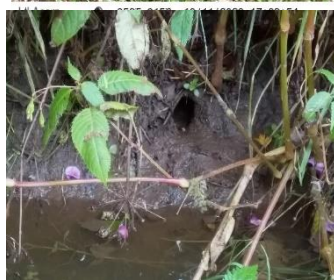
| Constraint | Description and map reference | Photographs | Potential Impact | Measures required | |
|---|---|---|---|---|---|
| <b>Otter and water vole</b> | <p>All watercourses within the survey area were fully inspected for signs of otter and water vole, where accessible, and were assessed for their suitability for each species. Camera traps were also installed along suitable watercourses.</p> <p><i>Otter</i></p> <p>In general, the brooks (see descriptions above) provide suitable habitat for otter, particularly the watercourses within wooded cloughs at Target Notes 1 and 3. Although a little shallow, they are mostly well sheltered with vegetated muddy banks and surrounded by woodland vegetation, with many overhanging roots / root buttresses noted. This habitat provides holt opportunities as well as commuting and foraging opportunities for otter, however no evidence of holts were observed during the survey.</p> <p>The smaller streams and field drains located between grazed and arable fields were considered sub-optimal for otter as they are too narrow, shallow and they are more exposed, with only hedgerows and</p> | | <p>Disturbance and direct impact to otter resting and feeding habitat- The pipeline route intersects a watercourse that otters are known to pass through. Depending on construction methodology, direct impacts are possible.</p> <p>Destruction or disturbance of water vole burrows – The pipeline route intersects a few brooks and several smaller streams / field drains. Depending on construction methodology, direct impacts are possible.</p> | <p>Further surveys to confirm the presence of water vole and otter. Pre-construction surveys to advise on impact reduction, mitigation including licensing if required and reinstatement.</p> <p>Avoid direct impacts to suitable otter habitat (the brooks) and water vole habitat (brooks and smaller streams / field drains). Avoid works within a 10 m buffer of these watercourses. Where this is not possible, further otter and water vole surveys may be required.</p> <p>Pollution control measures should be adopted</p> | <p>Further otter and water vole surveys should be conducted between April and June.</p> |

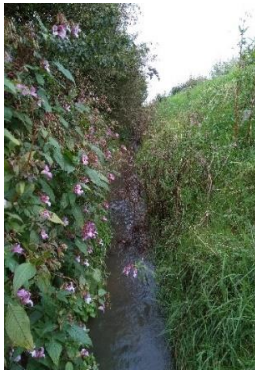
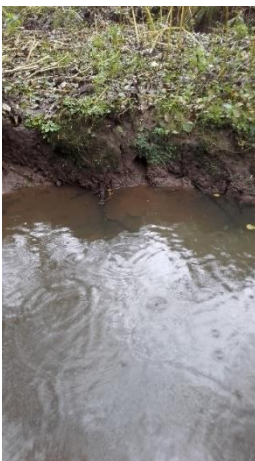
| Constraint | Description and map reference | Photographs | Potential Impact | Measures required | |
|---|---|---|---|---|---|
| | <p>tall ruderal vegetation for shelter. Most are located adjacent to grazed or arable fields which are subject to disturbances. These smaller watercourses provide sub-optimal habitat for otter, but they could occasionally commute through some.</p> <p>Otter footprints were identified on a shallow sandy bank of the brook passing through Section 10 and camera traps confirmed presence of otter in this location. Prints likely associated with otter were also observed on the banks of the brook in Section 7 / 8. However these prints were indistinct so could not be confirmed. Additional small mammal prints have also been recorded along other watercourses (Target Note 15), but these were very unclear so could not be identified.</p> <p><i>Water vole</i></p> <p>The brooks and many of the smaller streams and field drains provide suitable habitat for water vole. The brooks have steep muddy banks which are well vegetated and provided many burrowing, shelter and foraging opportunities. Additionally, many of the smaller streams are located within ditches adjacent to hedgerows and have banks dominated by tall ruderal vegetation which provide sufficient shelter and burrowing opportunities in muddy banks. Although sections of some of the streams are exposed, with grassy banks located between improved / grazed fields, water vole could still commute through.</p> <p>Burrows were observed within the banks of watercourses in a few locations that had a size and shape consistent with water vole. Additionally, small mammal prints were recorded in a few locations which are potentially associated with water vole (Target Note 10). However, rats have very similar burrows and footprints to water vole so these field signs are not conclusive of water vole. Even so, droppings consistent with water vole were also found in two locations adjacent to watercourses (Target Note 9).</p> <p>The camera traps did not identify any water vole throughout the surveys, but other small mammal species recorded include rat, mouse and stoat. Given the evidence found during the field surveys and the abundance of suitable habitat within the surrounding area, water vole could potentially utilise the brooks and smaller streams within the survey area and so it should be assumed that the burrows observed are associated with water vole.</p> | | <p>Works in proximity to the watercourses (within 10 m) have the potential to cause indirect disturbance of otter and water vole, for example through vibration or pollution</p> | | |

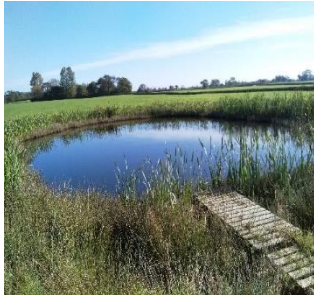
| Constraint | Description and map reference | Photographs | Potential Impact | Measures required | |
|---|---|---|---|---|---|
| <b>Amphibians including great crested newts</b> | <p>Several ponds are located within the survey area, all with different characteristics such as size, water quality and surrounding habitat. Some were assessed to provide good habitat suitability for GCN, whilst others provide limited breeding opportunities for this species.</p> <p>Previous great crested newt (GCN) eDNA surveys have been completed of these ponds to determine presence / absence of GCN. Results are detailed within Bowland Ecology Ltd report BOW20_345: Great Crested Newt eDNA Results. For any pond not previously surveyed for GCN (due to access constraints etc.), it should be assumed that it supports GCN.</p> <p>Three previously unmapped ponds were discovered during the field survey (Target Notes 24, 25 and 33) which have not been previously assessed for their potential to support GCN. It should be assumed that both ponds do support GCN populations.</p> <p>Suitable terrestrial habitat for amphibians includes woodlands (particularly those surrounding watercourses / waterbodies), hedgerows and scattered scrub. Additionally, a few small areas of tall ruderal vegetation (Target Note 11), marshy grassland (Target Note 13) and piles of hibernacula (Target Note 12) are present throughout the survey area, such as in the corner of improved fields.</p> | | <p>Direct harm / injury if any works directly impact suitable ponds and during clearance of suitable terrestrial habitat</p> <p>Loss of suitable breeding and terrestrial habitat</p> | <p>Ponds with confirmed GCN presence will not be directly impacted by the works.</p> <p>Ponds which were previously unsurveyed for GCN should be subject to an eDNA survey where possible.</p> <p>Clearance of suitable terrestrial habitat and excavations within 50 m of breeding GCN ponds should be minimised. Where this is not possible, a licence from Natural England and population assessment surveys may be required.</p> <p>Avoid loss and direct impact of all other ponds where possible. If this is not possible, compensatory habitat should be provided.</p> <p>Reasonable avoidance measures will be adopted during clearance of suitable amphibian habitat.</p> | <p>eDNA surveys can be undertaken between 15th April and 30th June</p> <p>Clearance of suitable terrestrial amphibian habitat within GCN active season (April to October).</p> <p>If required, a suite of GCN population assessment surveys should be undertaken between March and June.</p> |

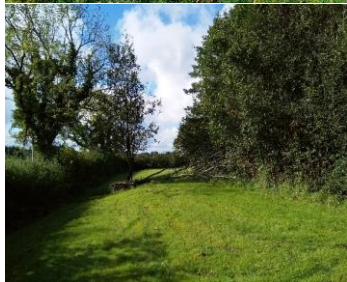
| Constraint | Description and map reference | Photographs | Potential Impact | Measures required | |
|---|---|---|---|---|---|
| <b>Nesting birds</b> | <p>Hedgerows, woodland, scattered trees, scrub and open grassland are present throughout the survey area which all provide suitable nesting habitat for a range of bird species, including ground nesting birds. Additionally, sand martin burrows were noted in the banks of one of the brooks in Section 6 (Target Note 14).</p> <p>Additionally, a kingfisher (<i>Alcedo atthis</i>) was observed during the field survey, flying along the brook in Section 7 (Target Note 18). This species is listed on the Wildlife and Countryside Act 1981 (as amended). Given the temporary nature of the works and as only a small section of watercourse will be impacted by the pipeline route, it is unlikely that the works will impact kingfisher.</p> | | <p>Direct harm / injury and disturbance of nesting birds during vegetation clearance</p> <p>Destruction of sand martin burrows during direct works to watercourse</p> | <p>Breeding bird surveys to identify possible presence of notable bird territories and ground nesting bird habitat.</p> <p>Where vegetation clearance is required, this is to be carried out between September and February to avoid harm to any breeding birds or nests present. If nesting season (March - August inclusive) cannot be avoided a pre-works check undertaken by a suitability experienced ecologist will be required. If a nesting bird is identified, this nest will be left <i>in situ</i> until dependent young have fledged.</p> <p>No works will be permitted within 10 m of sand martin burrows. If this is not possible, a nesting bird survey should be undertaken to confirm presence of sand martins and inform the best course of action.</p> | <p>Breeding bird survey 2-3 visits. March to June.</p> <p>Vegetation clearance: September – February.</p> |

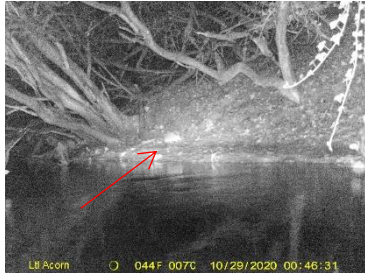
| Constraint | Description and map reference | Photographs | Potential Impact | Measures required | |
|---|---|---|---|---|---|
| <b>Small mammals including hedgehog</b> | <p>A hedgehog (<i>Erinaceus europaeus</i>) was recorded during the trail camera surveys along the banks of the brook in Section 4. This is a Species of Principal importance (SPI). Additionally, a brown hare (<i>Lepus europaeus</i>) was observed during the field survey in Section 7 which is also a SPI (Target Note 32). Other small mammal species recorded during the trail camera surveys include mouse (likely <i>Apodemus sylvaticus</i>) and stoat (<i>Mustela erminea</i>).</p> <p>Suitable habitat for small mammals including hedgehogs comprise woodlands, wood / brash piles, hedgerows and scrub. Additionally, the improved grassland fields and hedgerow network in the agricultural landscape provide suitable habitat for brown hare.</p> | | <p>Direct harm / injury from open excavations small mammals could fall into.</p> <p>Direct harm / injury to hedgehogs during clearance of potential refugia</p> | <p>Any excavations should be covered / fitted with mammal ramps if left overnight to ensure that any animals that enter can safely escape. Excavations will be backfilled as soon as possible to minimise the potential for animals to become trapped.</p> <p>Clearance of suitable hedgehog refugia to be undertaken using hand-held machinery. Small mammals encountered at any time during works should be moved to a safe location away from the works and placed within a similar habitat to which they were found. Additionally, storage of materials must be contained within sub-optimal habitat (bare ground or hard standing, or raised off the ground) and any soil/spoil stored on the site must be compacted so no voids are present.</p> | None. |

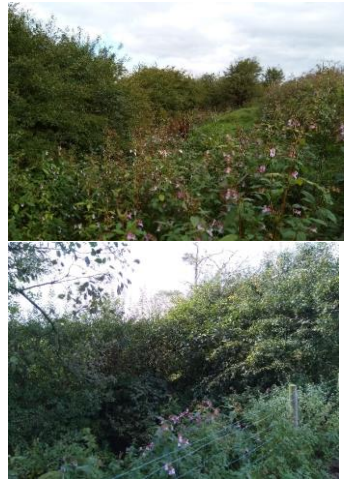
| Constraint | Description and map reference | Photographs | Potential Impact | Measures required | |
|---|---|---|---|---|---|
| <b>Invasive plant species</b> | <p>Himalayan balsam (<i>Impatiens glandulifera</i>) is widespread across the survey area, predominantly located around watercourses and field boundaries. This is a non-native invasive plant species, listed in Section 9 of the Wildlife and Countryside Act 1981 (as amended), for which it is illegal to cause the spread of in the wild.</p> <p>Montbretia was identified within Section 8 within an arable field. This species is also listed on Schedule 9 of the Wildlife and Countryside Act 1981 (as amended).</p> <p>Cotoneaster is also present within some residential gardens and adjacent to an access track. Certain species of Cotoneaster are also listed on Schedule 9 of the Wildlife and Countryside Act 1981 (as amended); the specimens present within the site could not be identified to a species level at the time of survey and so, as a precaution, should be treated as being listed on Schedule 9. It is unlikely that any ground disturbance will be required within proximity to this species given its location.</p> | | <p>Spread of invasive species in wild - Excavation and vegetation clearance in proximity to areas colonised by Himalayan balsam or the stand of Montbretia have potential to spread this species in the absence of mitigation.</p> | <p>Pre-works surveys and monitoring during construction.</p> <p>If vegetation clearance or excavation is required within proximity of Himalayan balsam, care should be taken not to cause the spread of this species. Reasonable avoidance measures should be implemented.</p> <p>If works directly affect areas of Cotoneaster or Montbretia, no excavated material is to be taken off site. This should be disposed of responsibly.</p> | <p>Pre-works surveys and monitoring during the growing season March-October.</p> <p>Control measures can be seasonally dependent for different species.</p> |
