ARBORICULTURAL REPORT (BS 5837:2012)

FOR
PROPOSED DEVELOPMENT
AT
STANLEY HOUSE HOTEL
FURTHER LANE
MELLOR
BLACKBURN
BB12 7NP

December 2020

Job Number 4688

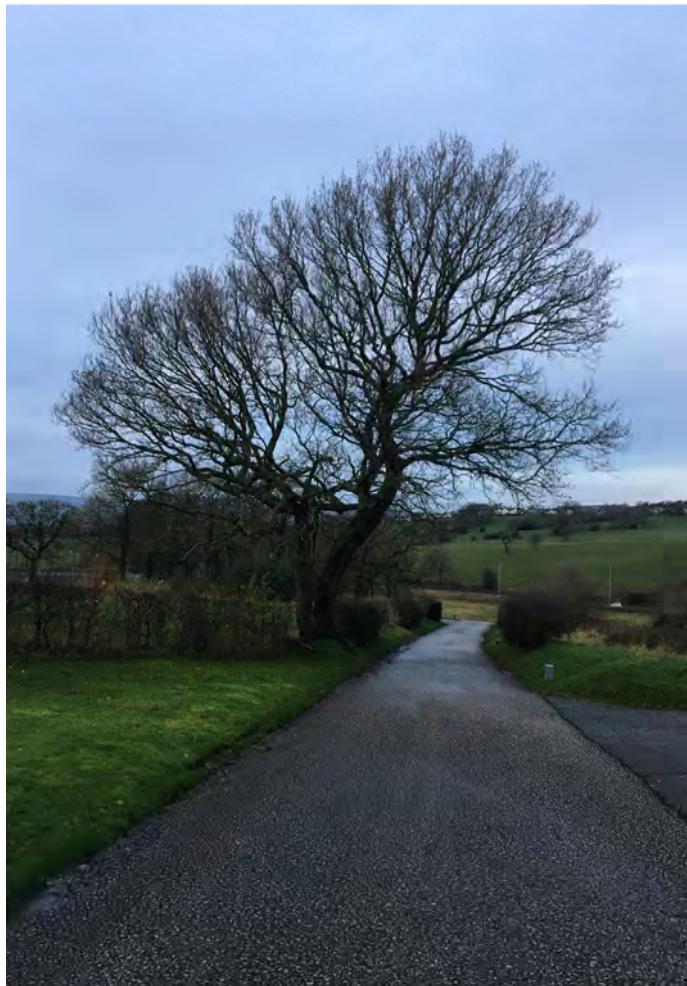
G14	Group - 16 Apple	120	3	SM	2	2	2	2	1.5	A/B	A formally planted area of young fruit trees still at their stakes. Several commemorative trees.			n/a
T10	Oak	1000	13	M	8	8	8	8	3	B	A typical roadside rural tree forked at base with two co-dominant stems. Minor deadwood and branch stubs and old wounds present. Good vigour.			n/a

Tree No.	Trees to be Retained		Trees to be removed	
	With No Impact	With Impact within RPA	Due to Condition	Due to Development
T10	G2, G3, T2, G4, T3, G7, G8, T5, G9, T6, T7, G10, G11, T8, T9 & G12	G5	T1	G1, T4, G5 (40%) G6, G14 & T10

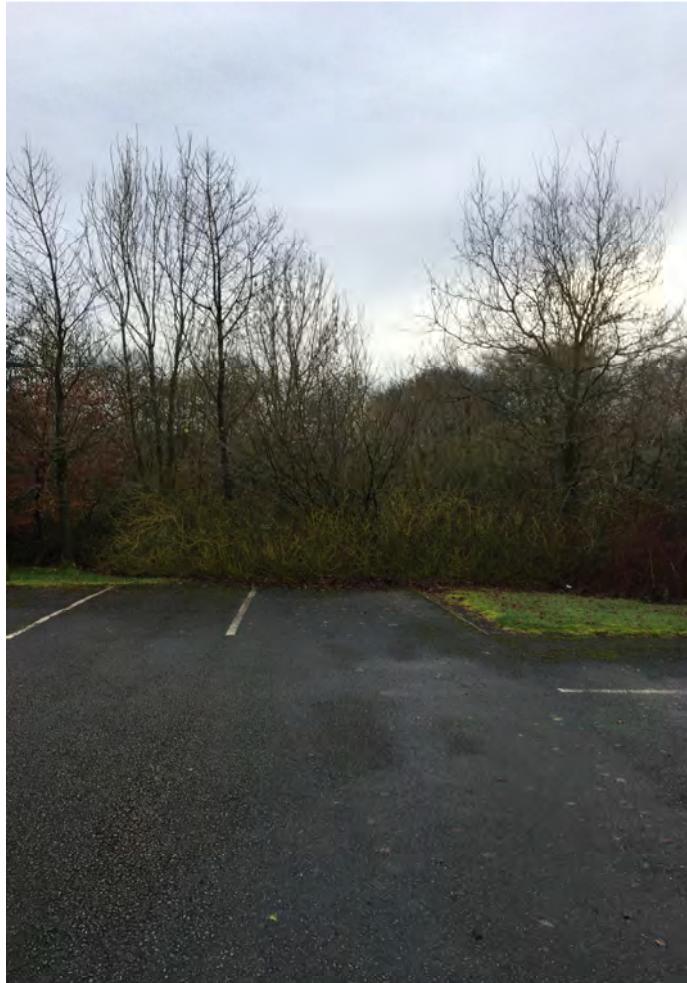
G5 areas for new access points

- 4.2.1 The above data table identifies that only G5 should have any impact on trees due to development being within or near Root Protection Areas (RPAs). Some of this group is to be removed for the access and the new accommodation block.
- 4.2.2 Therefore, as a guide when setting out the site all trees within 2m of any excavation should be removed to avoid retaining trees that have been root damaged.
- 4.2.3 No significant development is proposed adjacent to any of the existing mature trees of the site and the existing hard surfacing will protect many of their root zones during construction, particularly with regard to G4.
- 4.2.4 A clear tree works specification and details of all tree protective measures can be found in the following Arboricultural Method Statement (Section 6.0).

Tree No.	Proposed Works
G1, T1, T4, G5 (40%) G6, G14 & T10	Fell to ground level and remove stumps where necessary.
G3	Sever Ivy at base.
G13	Remove the two Sycamore with severe basal decay.

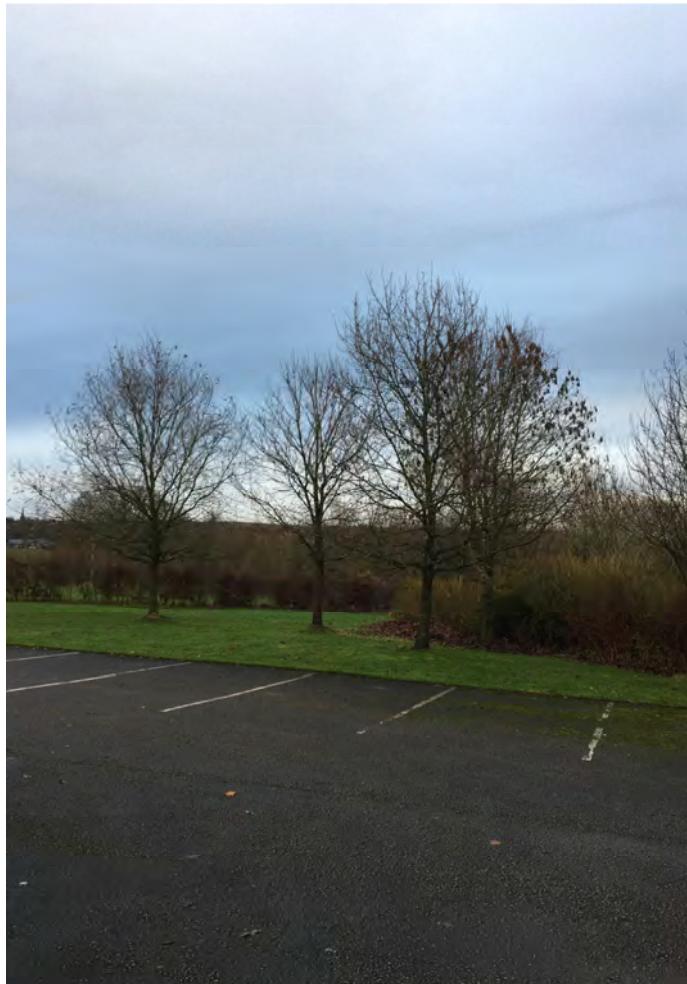
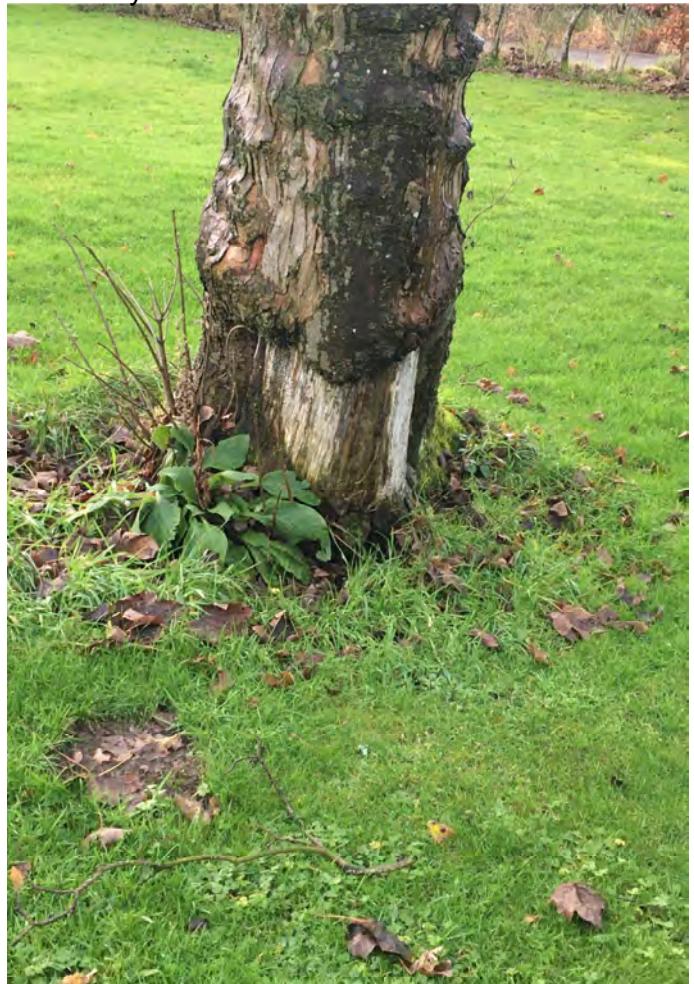
Sycamore in G13

Arboricultural Data Sheet: Stanley House Hotel, Further Lane, Mellor, Blackburn, BB12 7NP											Date of Survey: 09/12/20	Weather: Dry & overcast	Surveyor: PM	
Crown C = Crown Clearance; Cond R = Condition Rating; ERC (Yrs) = Estimated Remaining Contribution; TQCR = Tree Quality Category Rating; RPA (m ²) = Root Protection Area (m ²)														
Recommended works should be carried out to the <i>British Standard Recommendations for Tree Work, BS 3998:2010</i>														
Tree No.	Species	Dbh (mm)	Height (m)	Age	Crown Spread				Crown C	Cond R	Observations and Comments			Preliminary Recommendations
					N	E	S	W						
G13	Group - 3 Sycamore & 1 Ash	550	<14	M	5	5	5	5	1.5	C	A close group of trees exhibiting poor form and in poor condition. Two of the Sycamore have severe bases decay and rot and require removal. Consideration should be given to replacing them all.			Remove the two Sycamore with severe basal decay.
