## Alston / Spade Mill Pipeline, Longridge: Ecological Constraints Table

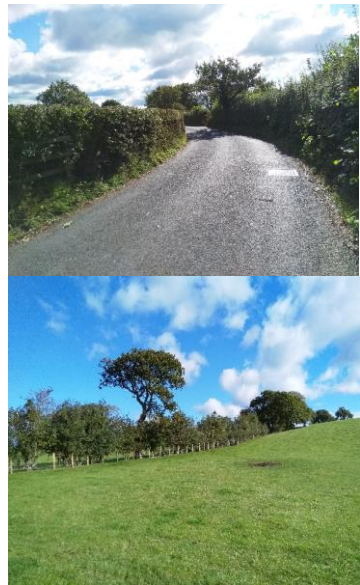
| Constraint | Description and map reference | Photographs | Potential Impact | Measures required | |
|---|---|---|---|---|---|
| <b>Priority Habitat: Hedgerows</b> | Numerous hedgerows are located throughout the survey area, most of which are located along boundaries dividing fields and along roadsides. Some were species-rich, whilst others were dominated by one species and scattered mature trees were located in many of the field boundary hedgerows. The majority of hedgerows were dominated by hawthorn ( <i>Crataegus monogyna</i> ), typically with a mixture of blackthorn ( <i>Prunus spinosa</i> ), holly ( <i>Ilex aquifolium</i> ), hazel ( <i>Corylus avellana</i> ), elder ( <i>Sambucus nigra</i> ), bramble ( <i>Rubus fruticosus</i> ), hornbeam ( <i>Carpinus betulus</i> ), dog rose ( <i>Rosa canina</i> ), willow ( <i>Salix sp.</i> ) and sycamore ( <i>Acer pseudoplatanus</i> ). Hedgerows were predominantly native, intact and most fall within criteria to be Habitats of Principal Importance (HPI). | | Habitat loss - Numerous hedgerows intersect the route and are likely to be directly impacted by the works.<br><br>Direct impacts from branch damage and root compaction | Pre-construction surveys of affected hedgerows to inform replanting proposals and identify 'Important Hedgerows' that may require removal notices.<br><br>Minimise length of hedgerow to be directly impacted, where possible. Mitigation for the loss of hedgerows should comprise the replacement planting of native species of at least the same length that is to be removed.<br><br>Adopt tree protection measures. Advice from The National Joint Utilities Group should be adhered to, including avoiding excavations within 1 m of the trunk and implementing measures to protect roots from damage (e.g. trenchless techniques, careful backfilling, hand excavating and preventing plant and material storage close to trees). | Hedgerow surveys to be undertaken ideally between May-July.<br><br>See also timescales relating to nesting birds. |

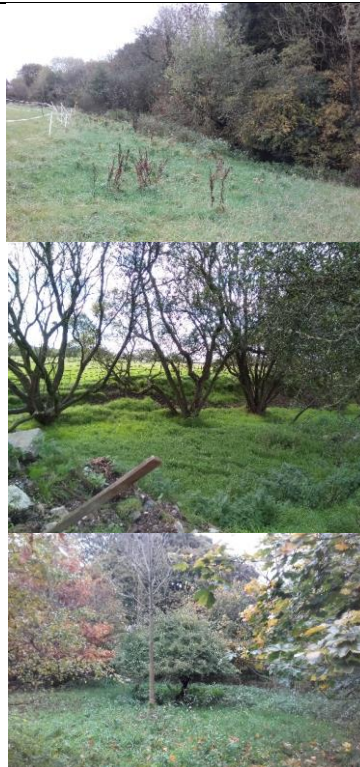
| Constraint | Description and map reference | Photographs | Potential Impact | Measures required | |
|---|---|---|---|---|---|
| <b>Priority Habitat: Semi-natural woodland</b> | Narrow strips of semi-natural broadleaf woodland are present surrounding some of the main watercourses within the survey area. These areas are dominated by semi-mature to mature trees with saplings and young trees also present. Typical species include sycamore, ash ( <i>Fraxinus excelsior</i> ), oak ( <i>Quercus robur</i> ), alder ( <i>Alnus glutinosa</i> ) and beech ( <i>Fagus sylvatica</i> ), with occasional silver birch ( <i>Betula pendula</i> ), wych elm ( <i>Ulmus glabra</i> ), Norway maple ( <i>Acer platanoides</i> ), rowan ( <i>Sorbus aucuparia</i> ) and horse chestnut ( <i>Aesculus hippocastanum</i> ). These woodlands have a fairly open understorey, with scattered hawthorn, hazel, elder and holly present, and a varied ground flora.<br><br>Other smaller wooded stands are present, including a small stand of woodland to the south of Whittingham Lane (Target Note 20) and a wooded marshy depression dominated by willow in Section 9 (Target Note 21). | | Habitat loss - The majority of woodland areas are not located in proximity to the route. However, minor pruning / felling works may be required, such as in the west of Section 10.<br><br>Direct impacts from branch damage and root compaction | Pre-construction surveys to advise on impact reduction, mitigation and reinstatement.<br><br>Avoid loss / direct impact of this priority habitat where possible. If this is not possible, mitigation for the loss should comprise the replacement planting of native species on a 2:1 basis.<br><br>Adopt tree protection measures. Advice from The National Joint Utilities Group should be adhered to, including avoiding excavations within 1 m of the trunk and implementing measures to protect roots from damage (e.g. trenchless techniques, careful backfilling, hand excavating and preventing plant and material storage close to trees). | Woodland surveys ideally between May-June to allow an assessment of spring ground flora.<br><br>See also timing relating to nesting birds. |

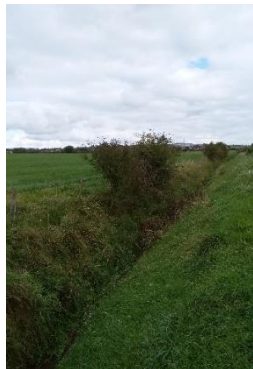
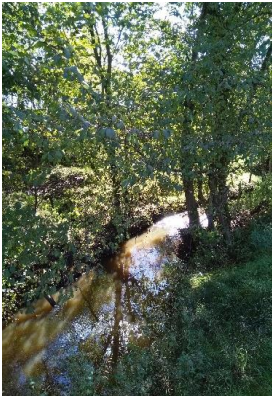
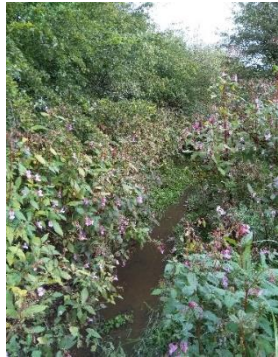
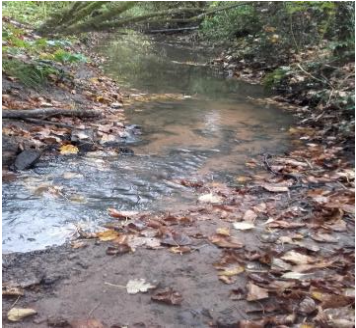
| Constraint | Description and map reference | Photographs | Potential Impact | Measures required | |
|---|---|---|---|---|---|
| <b>Priority Habitat: Watercourses</b> | <p>Several watercourses are present throughout the survey area. These comprise a few main brooks and several smaller streams and drains along field boundaries. The brooks are likely HPI, however the smaller watercourses hold less intrinsic ecological value and likely do not meet the HPI criteria as most are not near-natural.</p> <p>The first brook is an extension of <b>Dean Brook</b>, running parallel to the pipeline route in Sections 4 &amp; 5 and situated within in a wooded clough (Target Note 1). The second is <b>Blundel Brook</b> which runs through Sections 6, 7 &amp; 8. In Section 6 it is situated between improved fields with only some scattered trees and scrub along its banks, which are dominated by grasses and tall ruderal vegetation (Target Note 2). Sections 7 and 8 have not yet been surveyed, but the watercourse appears to enter continuous tree cover. <b>Savick Brook</b> is situated in Section 10 of the route, within a narrow wooded clough (Target Note 3) and the pipeline appears to intersect it. A tributary of Savick Brook also extends into Section 11 (Target Note 4), where the pipeline route intersects the watercourse again. This section is located in a deep ditch running along hedgerows and passes adjacent to an access road and improved fields.</p> <p>The brooks are all approximately 1 – 2.5 m wide and up to 60 cm deep, with a slow to moderate flow. They have a muddy, sandy and slightly rocky substrate and the water appeared turbid at the time of survey, with lots of litter noted within them. Mature and semi-mature trees are located along their length and some sections are located within wooded cloughs, so are heavily shaded, whilst other sections pass through open areas between fields. Banks range from near vertical to near horizontal, from approximately 10 cm high to 2 m high, and are predominantly muddy with adjacent tall ruderal vegetation.</p> <p>The remainder of the watercourses are smaller streams and field drains. Most of which are located below or adjacent to hedgerows, from 20 cm - 1 m wide and up approximately 2 cm - 20 cm deep. Most of these channels are similar in nature, featuring a very shallow, narrow and slow flow with a muddy substrate. Sloping banks are typically dominated by a hedgerow on one side with tall ruderal and grasses on the other. Occasional aquatic plants present include brooklime (<i>Veronica beccabunga</i>) and soft rush (<i>Juncus effusus</i>). Most drains were very shallow at the time of survey and are considered likely to become completely dry during the summer months. Some sections of watercourses were culverted over a short distance, such as beneath roads or access tracks between fields (Target Note 16).</p> | | <p>Habitat loss / direct damage - The pipeline route will pass through a few brooks and several smaller streams / field drains.</p> <p>Pollution of watercourses – Works in proximity to watercourses may result in pollution, such as from silt and/ or fuel.</p> | <p>Pre-construction surveys to advise on impact reduction, mitigation and reinstatement.</p> <p>Minimise direct impacts to any watercourse, particularly the brooks. Where this is not possible, habitat enhancement measures should be incorporated following completion of works.</p> <p>Pollution control measures should be adopted</p> | None. |

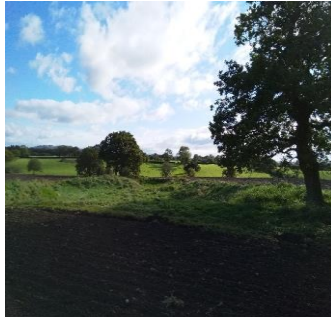
| Constraint | Description and map reference | Photographs | Potential Impact | Measures required | |
|---|---|---|---|---|---|
| <b>Semi-mature to mature trees</b> | Semi-mature and mature trees are located along field boundaries throughout the survey area, many within hedgerows, and some individuals are located around ponds and watercourses, with a few also situated centrally within improved fields. Species present included; oak, sycamore, alder, ash, rowan and willow. | | <p>Habitat loss – Felling of several trees is likely, whilst pruning may also be required</p> <p>Damage to branches and roots of trees – where works are to be located in proximity to trees to be retained.</p> | <p>Avoid tree felling where possible. Where this is not possible, mitigation for the loss of semi-mature to mature trees should comprise the replacement planting of native species on a 2:1 basis once works are complete, or in a suitable alternative area in the locality.</p> <p>Adopt tree protection measures. Advice from The National Joint Utilities Group should be adhered to, including avoiding excavations within 1 m of the trunk and implementing measures to protect roots from damage (e.g. trenchless techniques, careful backfilling, hand excavating and preventing plant and material storage close to trees).</p> | None, but see timescales relating to nesting birds. |

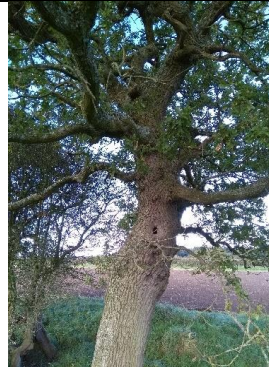
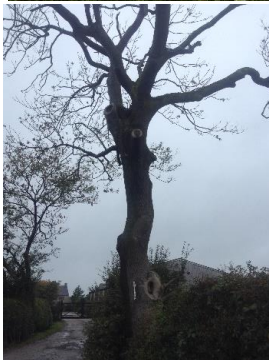
| Constraint | Description and map reference | Photographs | Potential Impact | Measures required | |
|---|---|---|---|---|---|
| <b>Bat habitat</b> | <p>Semi-mature to mature trees throughout the survey area provide potential roosting habitat for bats. These trees are predominantly located within hedgerows, along field boundaries or within areas of woodland. Potential roosting features include knot holes, hazard beams, cavities within the main stem, broken limbs and woodpecker holes. Additionally, a few trees along the route have bat boxes attached to them. Trees that were assessed to hold moderate or high potential for roosting bats (in line with Collins, 2016) are labelled on the Ecological Constraints Plan.</p> <p>None of the buildings were assessed for their potential to support roosting bats as it is understood that none are to be directly impacted by the works.</p> <p>The woodland edges, hedgerows, watercourses and bodies of water provide good foraging and commuting habitat for bats. However, it is understood that works will be temporary in nature and only very small sections of suitable foraging / commuting habitat for bats will be directly impacted. Therefore, it is unlikely that foraging and commuting bats will be significantly impacted by the works in the long term.</p> | | <p>Disturbance/harm of roosting bats during tree felling / pruning</p> <p>Loss of suitable roosting habitat</p> | <p>Ground level assessment of bat roost potential for any of the bat roost potential trees affected by the proposals. If tree or tree limb removal is required of a tree with moderate / high potential for roosting bats, it is advised that an aerial inspection is undertaken by a suitably qualified ecologist, using a torch and an endoscope to thoroughly search any features prior to commencement of works. This will assess the likely presence of bats and determine the best course of action considering any licensing requirements.</p> <p>If closer inspection of the PRFs verifies they are of moderate or high suitability, or evidence of bats is confirmed, further presence/absence and roost characterisation surveys may be required, involving dusk or dawn re-entry surveys.</p> <p>Compensation for the loss of suitable bat roosting habitat should be provided in the form of bat boxes where trees are to be felled.</p> | None, unless dusk or dawn re-entry surveys are required which can only be completed between May and September (weather dependant). |

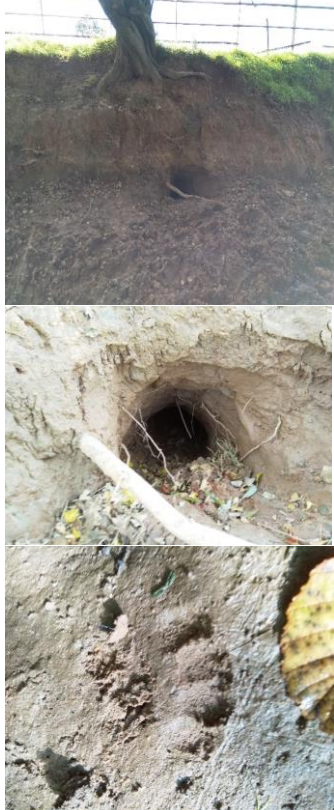
| Constraint | Description and map reference | Photographs | Potential Impact | Measures required | |
|---|---|---|---|---|---|
| <b>Badger habitat</b> | <p>A badger sett was identified within Section 9 of the route and evidence of badger including latrines, hairs and old, inactive setts were also recorded elsewhere within the survey area.</p> <p>The sett was likely an outlier sett and comprised one hole, located within a marshy depression along the route of the disused railway, surrounded by willow woodland (Target Note 5). Claw marks and badger hair was found in the entrance, however leaf litter was piled in the entrance indicating no recent usage. The ground outside the sett was heavily poached by cattle at the time of survey, indicating heavy disturbance directly outside the sett.</p> <p>The wooded cloughs around the brooks and the wooded motorway verge provide good badger habitat, including sett building opportunities. A badger print was recorded along the banks of the brook in Section 10 (Target Note 6) and an old, disused badger sett was observed along the banks of the brook in Section 4 (Target Note 8). A badger latrine was also recorded within the woodland in Section 5, with both fresh and old badger faeces recorded, and a second fresh badger latrine was observed within the woodland in Section 4 (Target Note 7).</p> | | <p>Disturbance of a sett – if construction works are required within 30 m of an active sett</p> <p>Direct harm / injury from open excavations badgers could fall into.</p> | <p>If any works are required within 30 m of a badger hole, a sett monitoring survey may be required. Camera traps will be placed and sticks will be placed in the entrance to monitor use of the sett.</p> <p>Any excavations should be covered / fitted with mammal ramps if left overnight to ensure that any animals that enter can safely escape. Excavations will be backfilled as soon as possible to minimise the potential for animals to become trapped.</p> | <p>None. If required, sett monitoring surveys should be conducted over a minimum period of 28 days</p> |

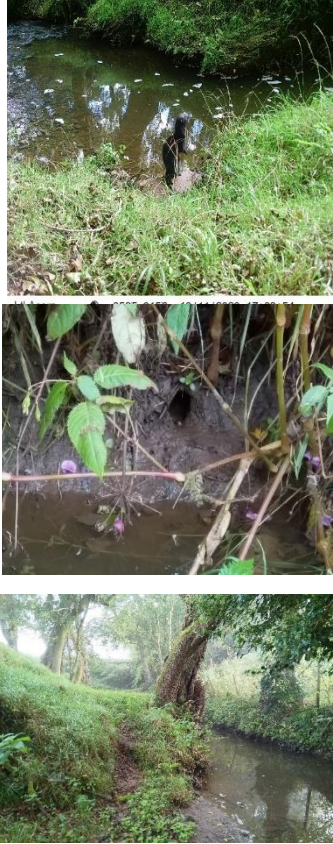
| Constraint | Description and map reference | Photographs | Potential Impact | Measures required | |
|---|---|---|---|---|---|
| <b>Water vole and otter habitat</b> | <p>All watercourses within the survey area were fully inspected for signs of otter and water vole, where accessible, and were assessed for their suitability for each species. Camera traps were also installed along suitable watercourses.</p> <p><i>Otter</i></p> <p>In general, the brooks (see descriptions above) provide suitable habitat for otter, particularly the watercourses within wooded cloughs at Target Notes 1 and 3. Although a little shallow, they are well sheltered with vegetated muddy banks and surrounded by woodland vegetation, with many overhanging roots / root buttresses noted. This habitat provides holt opportunities as well as commuting and foraging opportunities for otter, however no evidence of holts were observed during the survey.</p> <p>The smaller streams and field drains located between grazed and arable fields were considered sub-optimal for otter as they are too narrow, shallow and they are more exposed, with only hedgerows and tall ruderal vegetation for shelter. Most are located adjacent to grazed or arable fields which are subject to disturbances. These smaller watercourses provide sub-optimal habitat for otter, but they could occasionally commute through.</p> <p>Otter footprints were identified on a shallow sandy bank of the brook passing through Section 10 and camera traps confirmed presence of otter in this location. Small mammal prints have also been recorded</p> | | <p>Disturbance and direct impact to otter resting and feeding habitat- The pipeline route intersects a watercourse that otters are known to pass through. Depending on construction methodology, direct impacts are possible.</p> <p>Destruction or disturbance of water vole burrows – The pipeline route intersects a few brooks and several smaller streams / field drains. Depending on construction methodology, direct impacts are possible.</p> <p>Works in proximity to the watercourses (within 10 m) have the potential to cause indirect disturbance of otter and water vole, for example through vibration or pollution</p> | <p>Further surveys to confirm the presence of water vole and otter. Pre-construction surveys to advise on impact reduction, mitigation including licensing if required and reinstatement.</p> <p>Avoid direct impacts to suitable otter habitat (the brooks) and water vole habitat (brooks and smaller streams / field drains). Avoid works within a 10 m buffer of these watercourses. Where this is not possible, further otter and water vole surveys may be required.</p> <p>Pollution control measures should be adopted</p> | <p>Further otter and water vole surveys should be conducted between April and June.</p> |

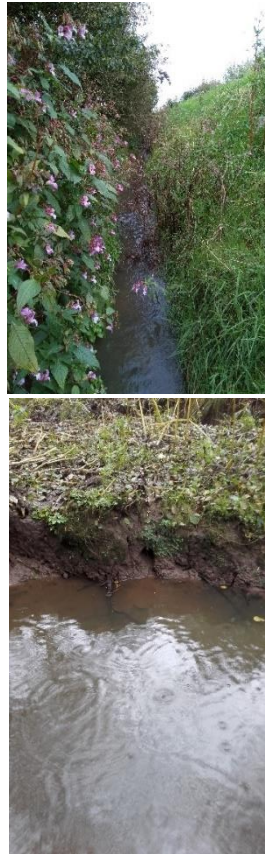
| Constraint | Description and map reference | Photographs | Potential Impact | Measures required | |
|---|---|---|---|---|---|
| | <p>along other watercourses (Target Note 15), but these were indistinct so could not be identified. No other evidence of otter was recorded during the survey.</p> <p><i>Water vole</i></p> <p>The brooks and many of the smaller streams and field drains provide suitable habitat for water vole. The brooks have steep muddy banks which are well vegetated and provided many burrowing, shelter and foraging opportunities. Additionally, many of the smaller streams are located within ditches adjacent to hedgerows and have banks dominated by tall ruderal vegetation which provide sufficient shelter and burrowing opportunities in muddy banks. Although sections of some of the streams are exposed, with grassy banks located between improved / grazed fields, water vole could still commute through.</p> <p>Burrows were observed within the banks of watercourses in several locations that had a size and shape consistent with water vole. Additionally, small mammal prints were recorded in a few locations which are potentially associated with water vole (Target Note 10). However, rats have very similar burrows and footprints to water vole so these field signs are not conclusive of water vole. Even so, droppings consistent with water vole were also found in a few locations adjacent to both brooks and streams (Target Note 9).</p> <p>The camera traps did not identify any water vole throughout the surveys, but other small mammal species recorded include mouse and stoat. Given the evidence found during the field surveys and the abundance of suitable habitat within the surrounding area, it is likely that water vole do utilise the brooks and smaller streams within the survey area and so it should be assumed that the burrows observed are associated with water vole.</p> | | | | |

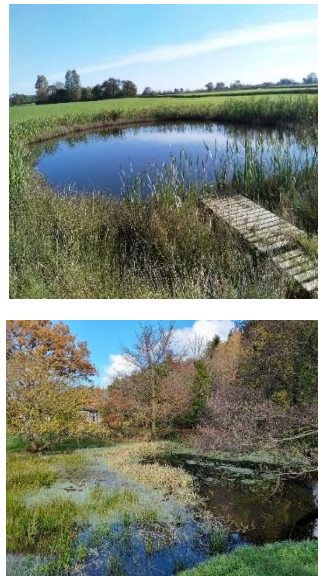
| Constraint | Description and map reference | Photographs | Potential Impact | Measures required | |
|---|---|---|---|---|---|
| <b>Great crested newt habitat</b> | <p>Several ponds are located within the survey area, all with different characteristics such as size, water quality and surrounding habitat. Some were assessed to provide good habitat suitability for GCN, whilst others provide limited breeding opportunities for this species.</p> <p>Previous great crested newt (GCN) eDNA surveys have been completed of these ponds to determine presence / absence of GCN. Results are detailed within Bowland Ecology Ltd report BOW20_345: Great Crested Newt eDNA Results. For any pond not previously surveyed for GCN (due to access constraints etc.), it should be assumed that it supports GCN.</p> <p>Suitable terrestrial habitat for amphibians includes woodlands (particularly those surrounding watercourses / waterbodies), hedgerows and scattered scrub. Additionally, a few small areas of tall ruderal vegetation (Target Note 11), marshy grassland (Target Note 13) and piles of hibernacula (Target Note 12) are present throughout the survey area, such as in the corner of improved fields.</p> | | <p>Direct harm / injury if any works directly impact suitable ponds and during clearance of suitable terrestrial habitat</p> <p>Loss of suitable breeding and terrestrial habitat</p> | <p>Ponds with confirmed GCN presence will not be directly impacted by the works.</p> <p>Clearance of suitable terrestrial habitat and excavations within 50 m of breeding GCN ponds should be minimised. Where this is not possible, a licence from Natural England and population assessment surveys may be required.</p> <p>Avoid loss and direct impact of all other ponds where possible. If this is not possible, compensatory habitat should be provided.</p> <p>Reasonable avoidance measures will be adopted during clearance of suitable amphibian habitat.</p> | <p>Clearance of suitable terrestrial amphibian habitat within GCN active season (April to October).</p> <p>If required, a suite of GCN population assessment surveys should be undertaken between March and June.</p> |

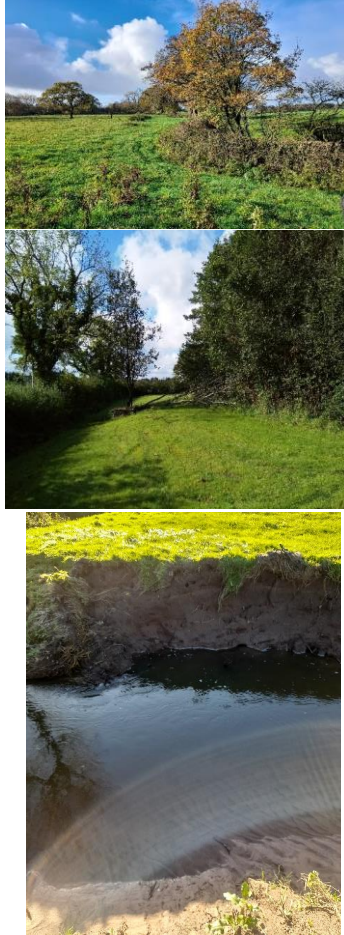
| Constraint | Description and map reference | Photographs | Potential Impact | Measures required | |
|---|---|---|---|---|---|
| <b>Nesting bird habitat</b> | Hedgerows, woodland, scattered trees, scrub and open grassland are present throughout the survey area which all provide suitable nesting habitat for a range of bird species, including ground nesting birds. Additionally, sand martin burrows were noted in the banks of one of the brooks in Section 6 (Target Note 14). | | <p>Direct harm / injury and disturbance of nesting birds during vegetation clearance</p> <p>Destruction of sand martin burrows during direct works to watercourse</p> | <p>Breeding bird surveys to identify possible presence of notable bird territories and ground nesting bird habitat.</p> <p>Where vegetation clearance is required, this is to be carried out between September and February to avoid harm to any breeding birds or nests present. If nesting season (March - August inclusive) cannot be avoided a pre-works check undertaken by a suitability experienced ecologist will be required. If a nesting bird is identified, this nest will be left <i>in situ</i> until dependent young have fledged.</p> <p>No works will be permitted within 10 m of sand martin burrows. If this is not possible, a nesting bird survey should be undertaken to confirm presence of sand martins and inform the best course of action.</p> | <p>Breeding bird survey 2-3 visits. March to June.</p> <p>Vegetation clearance: September – February.</p> |

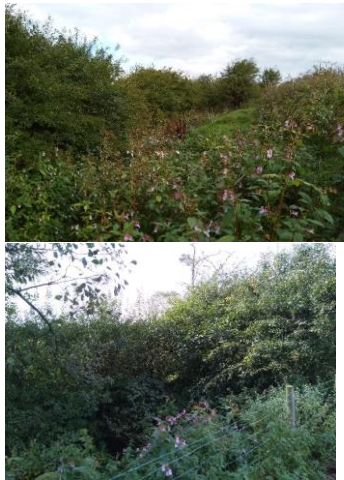
| Constraint | Description and map reference | Photographs | Potential Impact | Measures required | |
|---|---|---|---|---|---|
| <b>Invasive plant species</b> | <p>Himalayan balsam (<i>Impatiens glandulifera</i>) is widespread across the survey area, predominantly located around watercourses and field boundaries. This is a non-native invasive plant species, listed in Section 9 of the Wildlife and Countryside Act 1981 (as amended), for which it is illegal to cause the spread of in the wild.</p> <p>Cotoneaster is also present within some residential gardens and adjacent to an access track. Certain species of Cotoneaster are also listed on Schedule 9 of the Wildlife and Countryside Act 1981 (as amended); the specimens present within the site could not be identified to a species level at the time of survey and so, as a precaution, should be treated as being listed on Schedule 9. It is unlikely that any ground disturbance will be required within proximity to this species given its location.</p> | | <p>Spread of invasive species in wild - Excavation and vegetation clearance in proximity to areas colonised by Himalayan balsam have potential to spread this species in the absence of mitigation.</p> | <p>Pre-works surveys and monitoring during construction.</p> <p>If vegetation clearance or excavation is required within proximity of Himalayan balsam, care should be taken not to cause the spread of this species. Reasonable avoidance measures should be implemented.</p> <p>If works directly affect areas of Cotoneaster, no excavated material is to be taken off site.</p> | <p>Pre-works surveys and monitoring during the growing season March-October.</p> <p>Control measures can be seasonally dependent for different species.</p> |
