# Preliminary Roost Assessment

35 College Close  
Longridge  
Preston  
PR3 3AX

For  
Chris Dover

## Gritstone Ecology

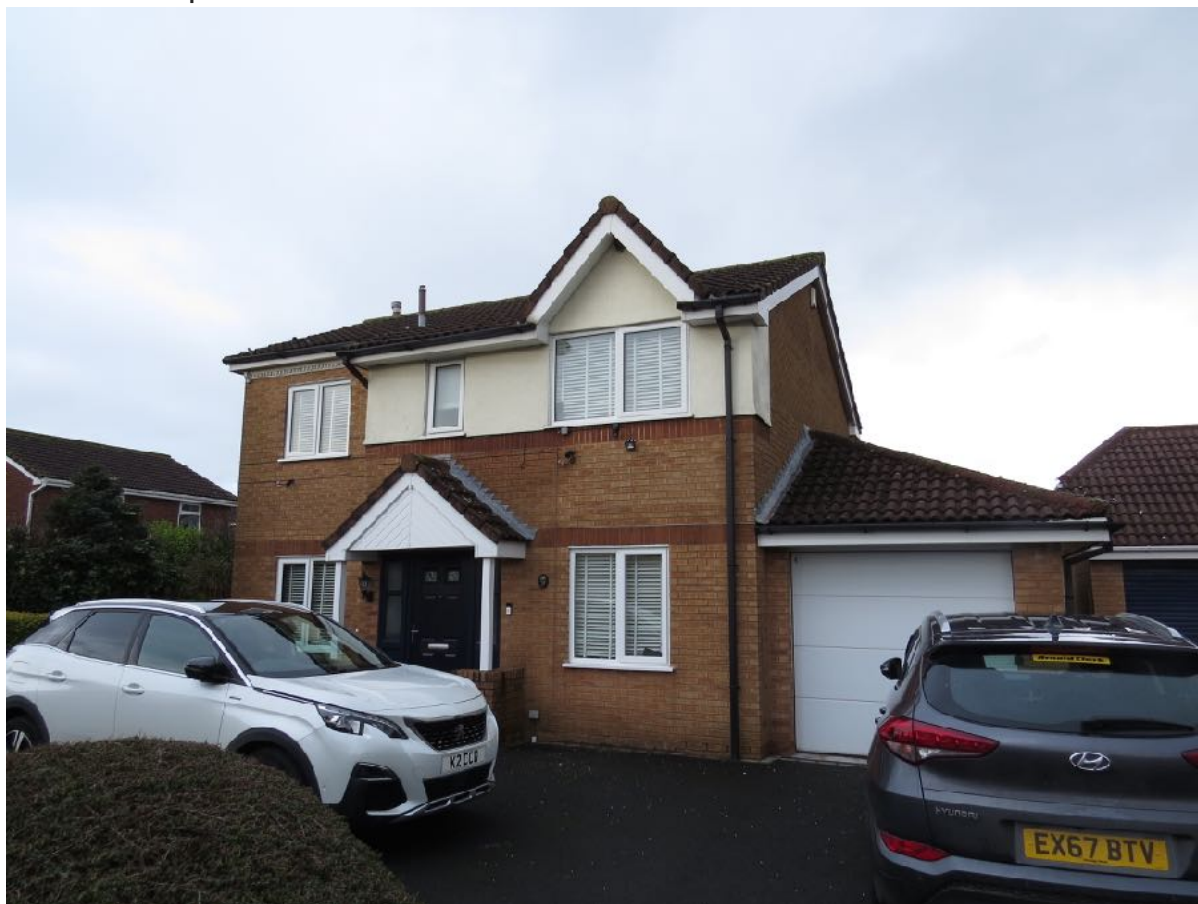
3.1a – The front of the house from the driveway.

The building is modern, was constructed to a high standard, is well maintained, and in good condition. Cement between ridge tiles is intact, with no viable gaps, there are no missing or damaged ridge tiles. Roof tiles are tightly fitted, with no gaps between tiles. UPVC fascia boards & soffits are fitted tightly against the walls gaps are filled with sealant.

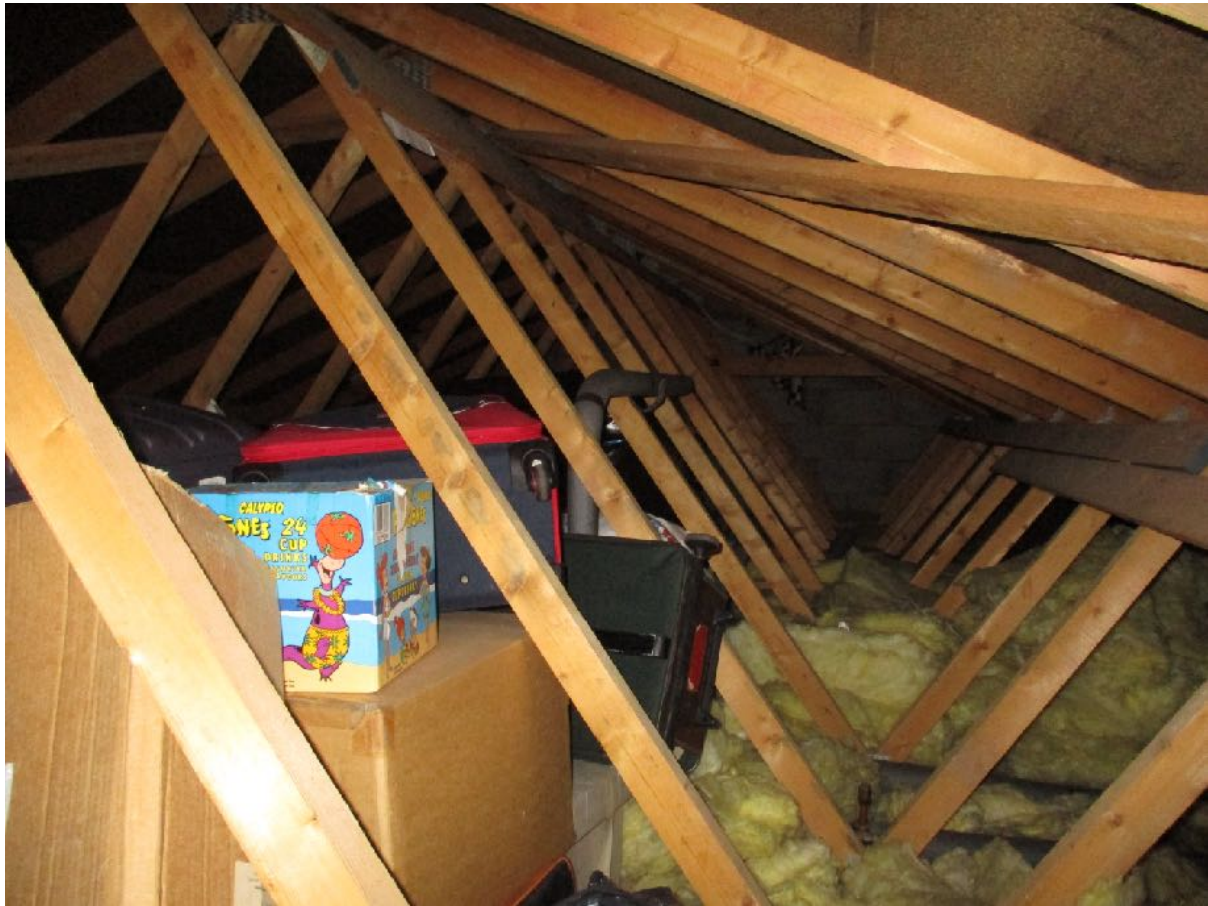
3.2a – The main roof void.

The house and garage have separate roof voids. The voids are used for storage, and accessed for essential maintenance. The roof has a modern timber trussed structure lined with bitumen roofing felt, and insulated between ceiling joists with mineral wool.

Roof lining is intact with no tears. There are no gaps at the wall-plate; and there are no gaps which give direct access to the roof void from the outside.

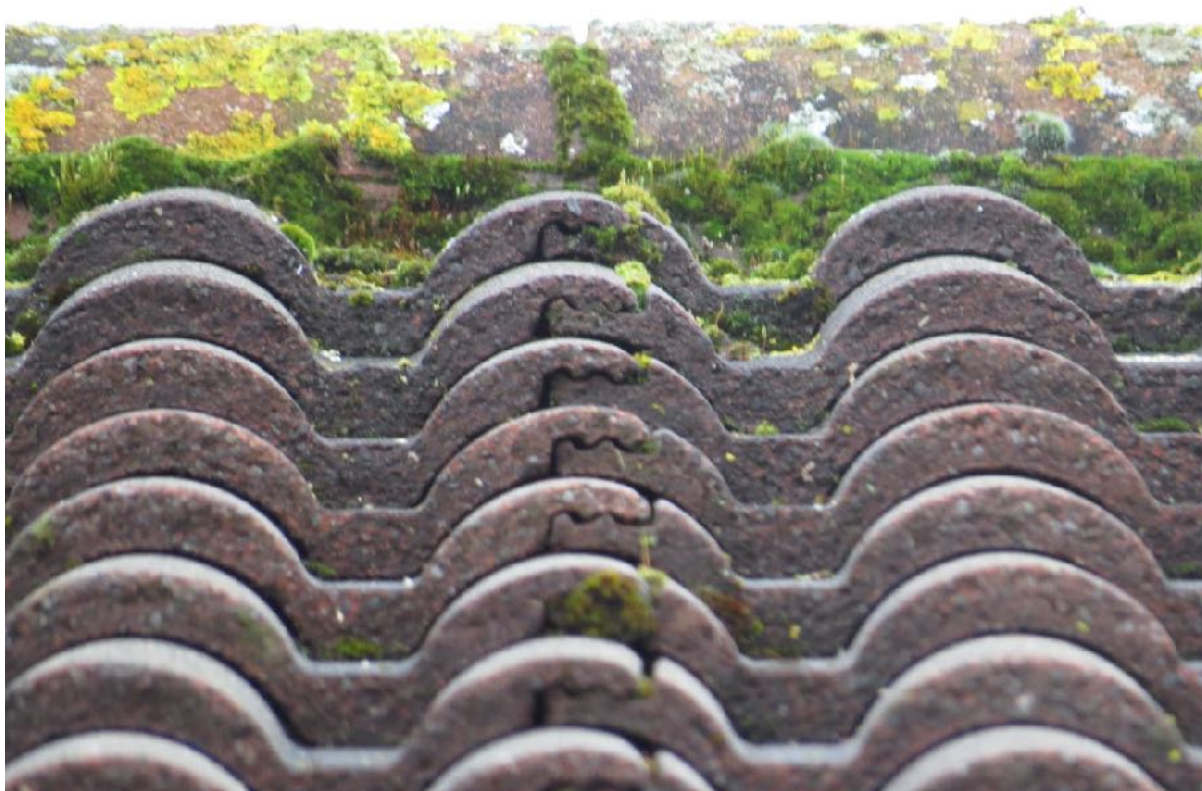
Roof and ridge tiles are in good condition, and ridge tiles are sealed with cement. There are no gaps between roofing materials which could be used by roosting bats.

3 – Ridge tiles are sealed with cement, roof tiles are tightly fitted.

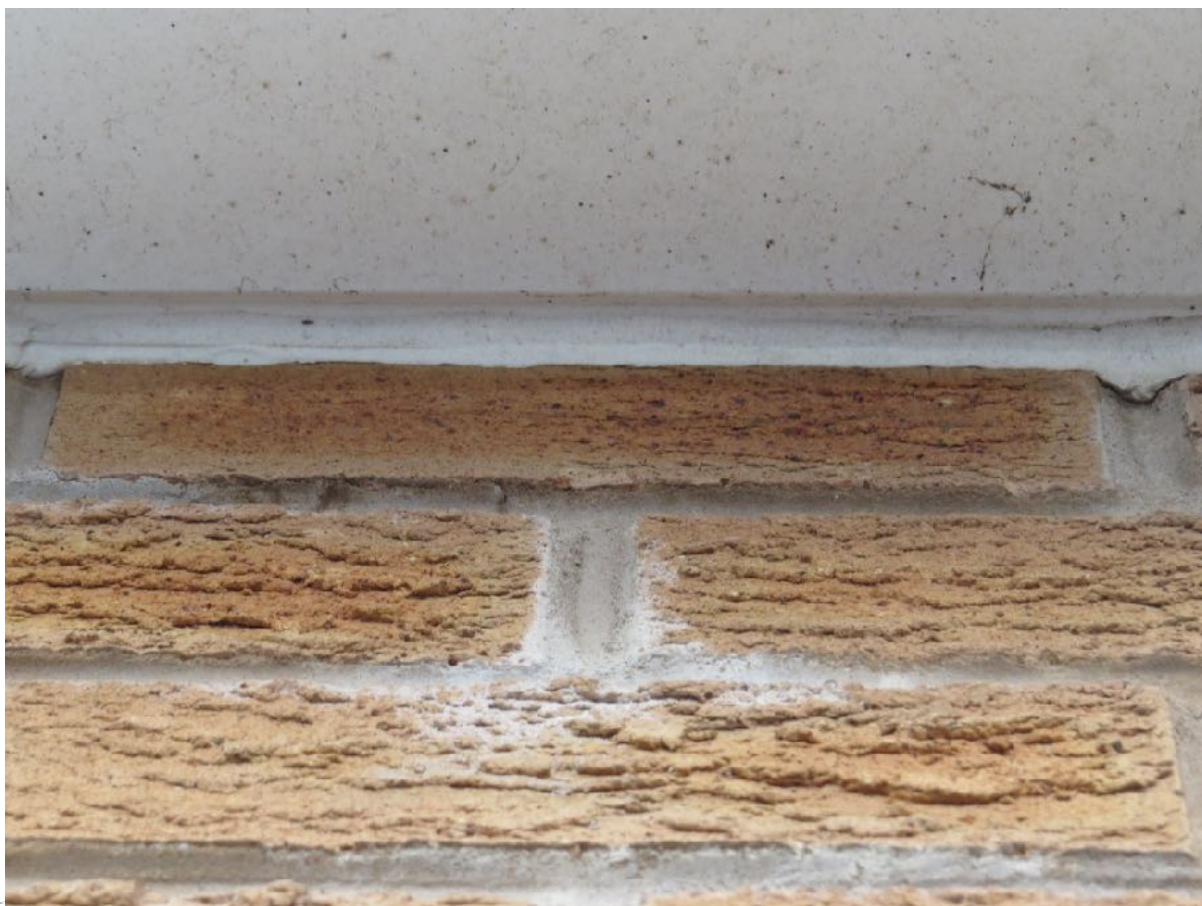
Fascia boards & boxed soffits at the eaves and gables are tightly fixed against brickwork, with no suitable gaps; wall cavities open into the roof void, and were inspected from above.

4 – Gaps between UPVC boxed soffits and brickwork are filled with sealant.

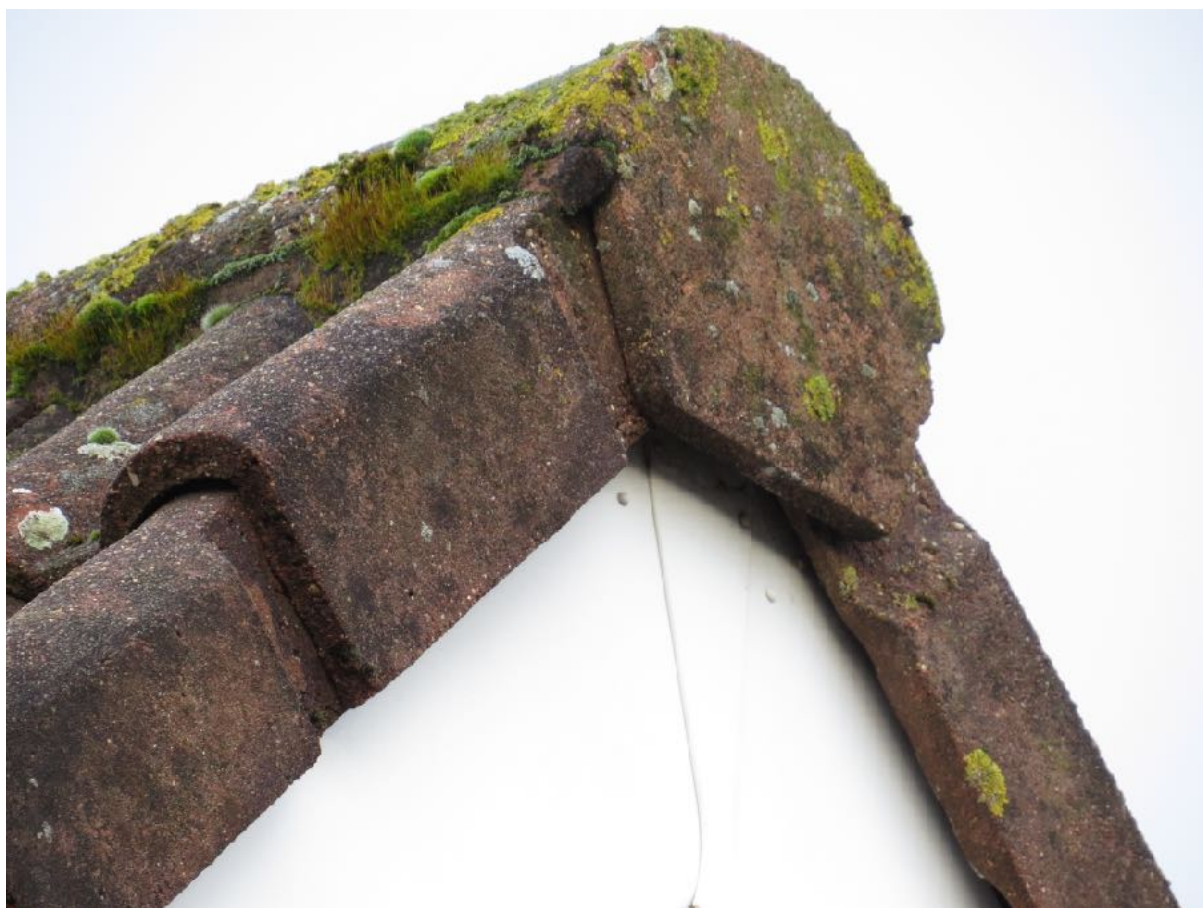
5 –End tiles at the gable end verges are sealed with no suitable gaps.

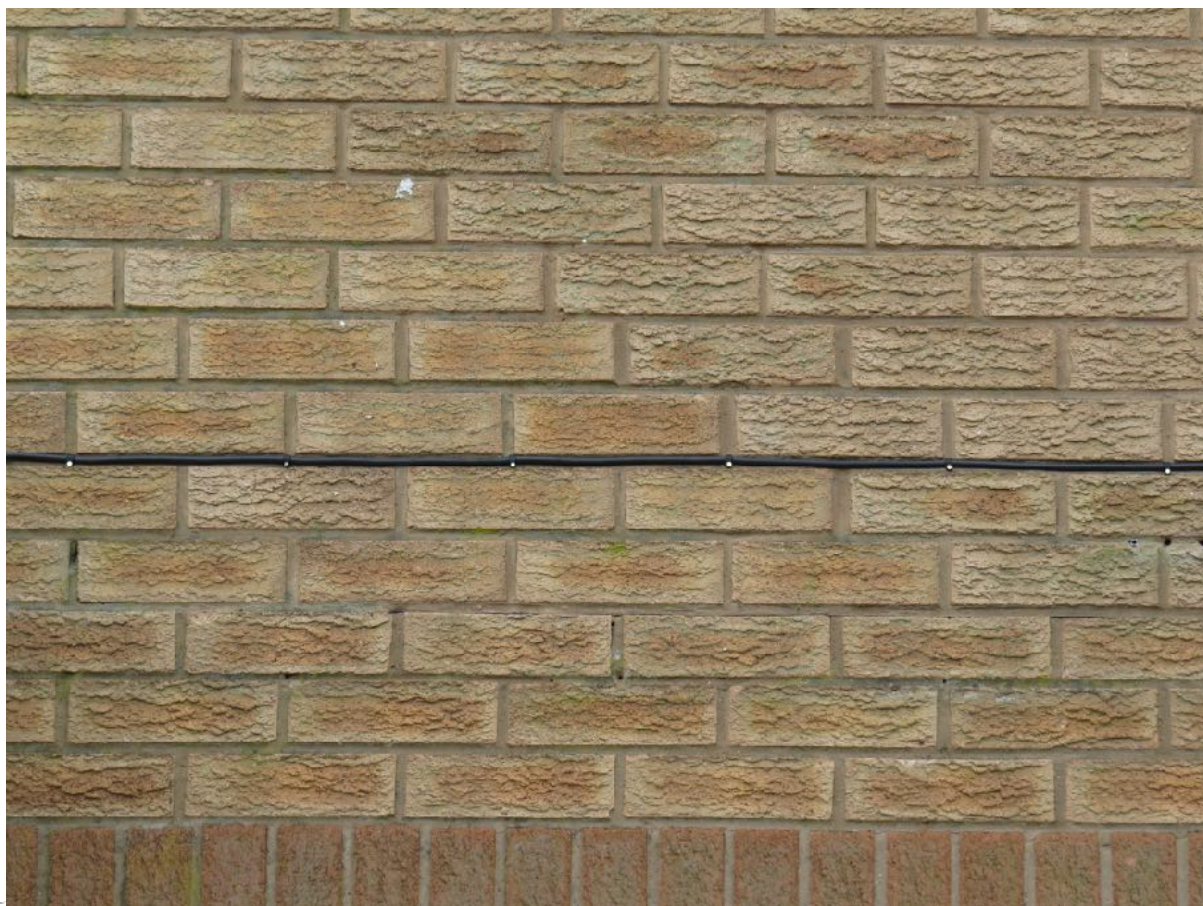
The walls are brick with an insulating cavity. The wall cavity has been filled with insulation. Walls are in good condition, with no cracks, or missing mortar which could be used by crevice dwelling bats.

6 – Brickwork is in good condition with no gaps in mortar.

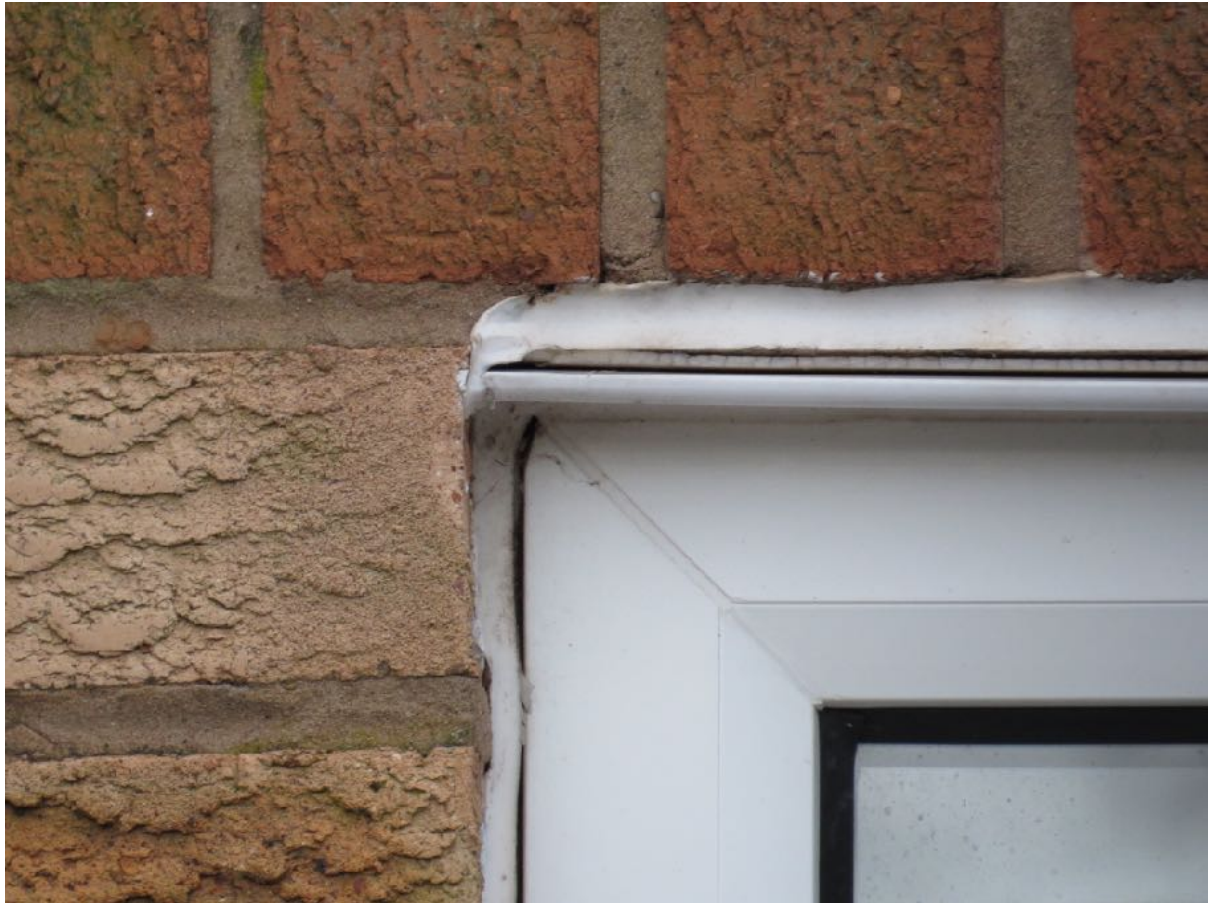
Window and door frames are fixed into the brickwork, gaps are filled with sealant, and offer no suitable roosting opportunities.

7 – Window and door frames are tightly sealed into brickwork with no suitable gaps.

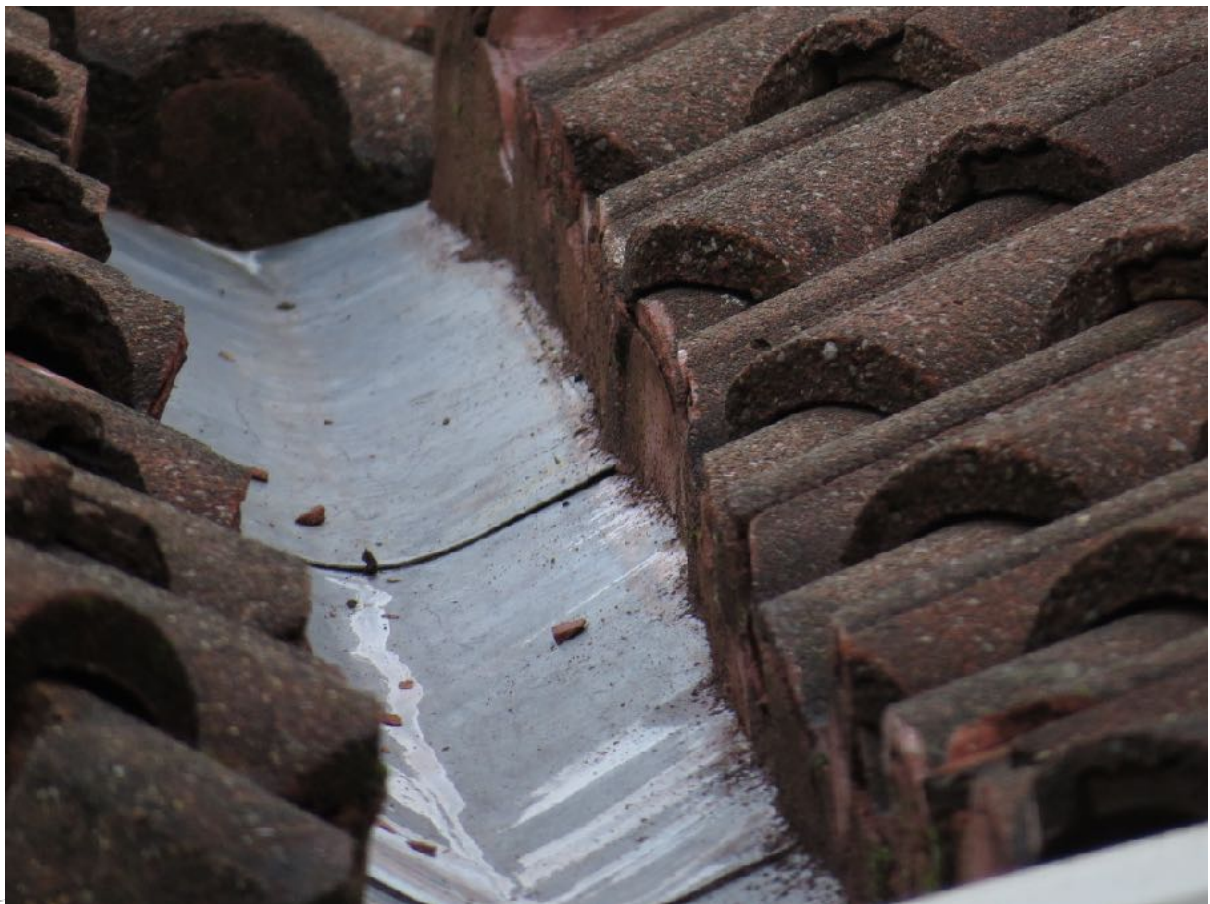
8 – End tiles in the roof valleys are filled with cement, with no suitable gaps.

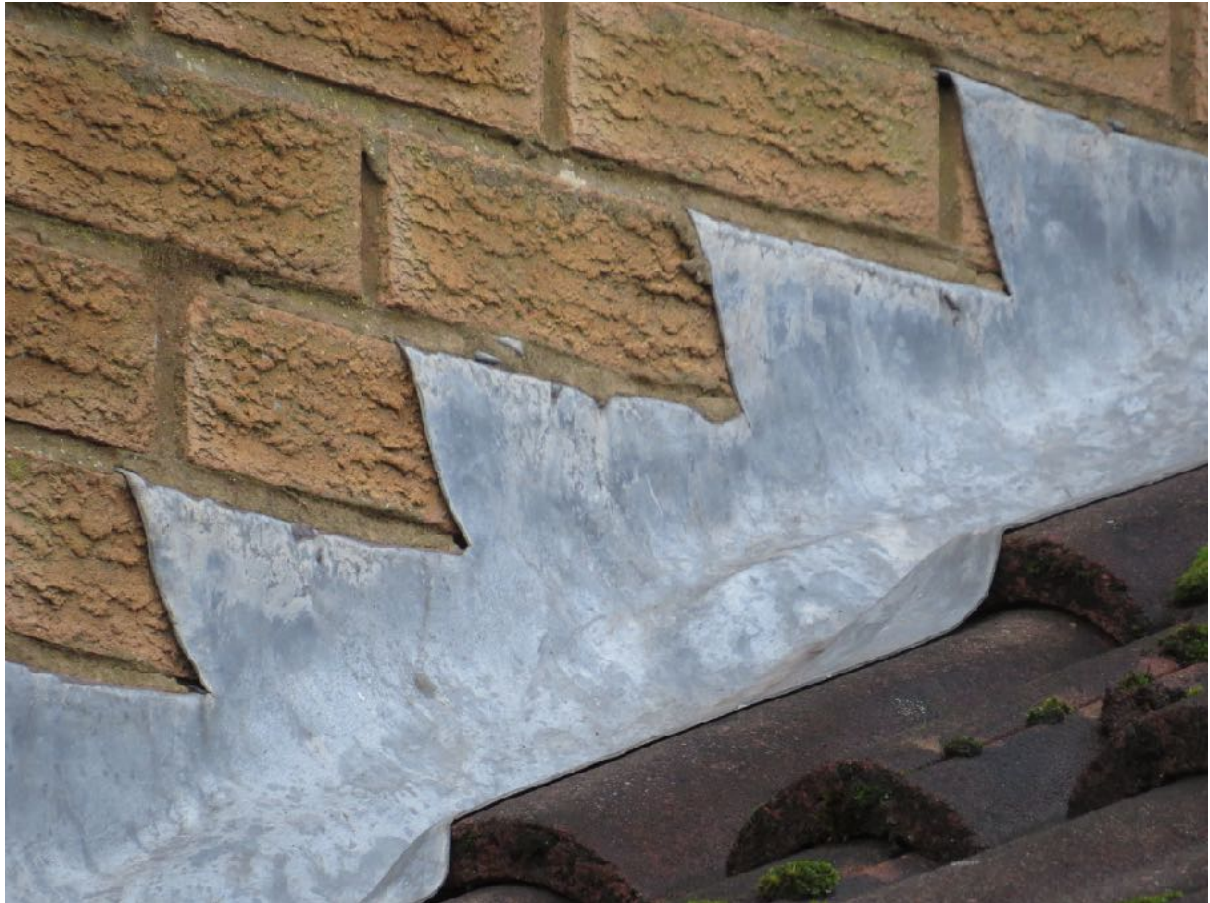
Lead flashing is tightly fixed against roof tiles and brickwork and offers no suitable roosting opportunities.

9 – Lead flashing is tightly fitted with no suitable gaps.

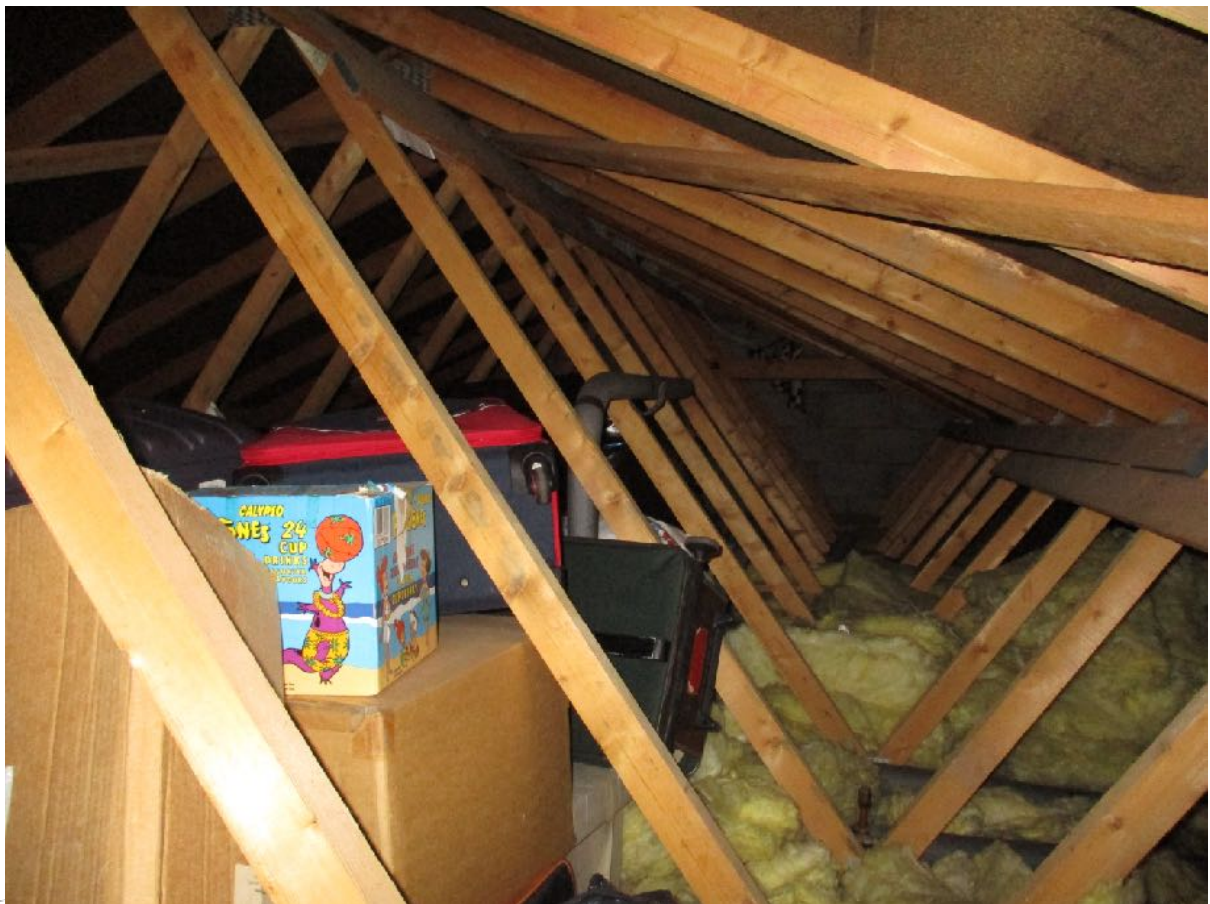
10 – The house has a single roof void lined with bitumen felt.

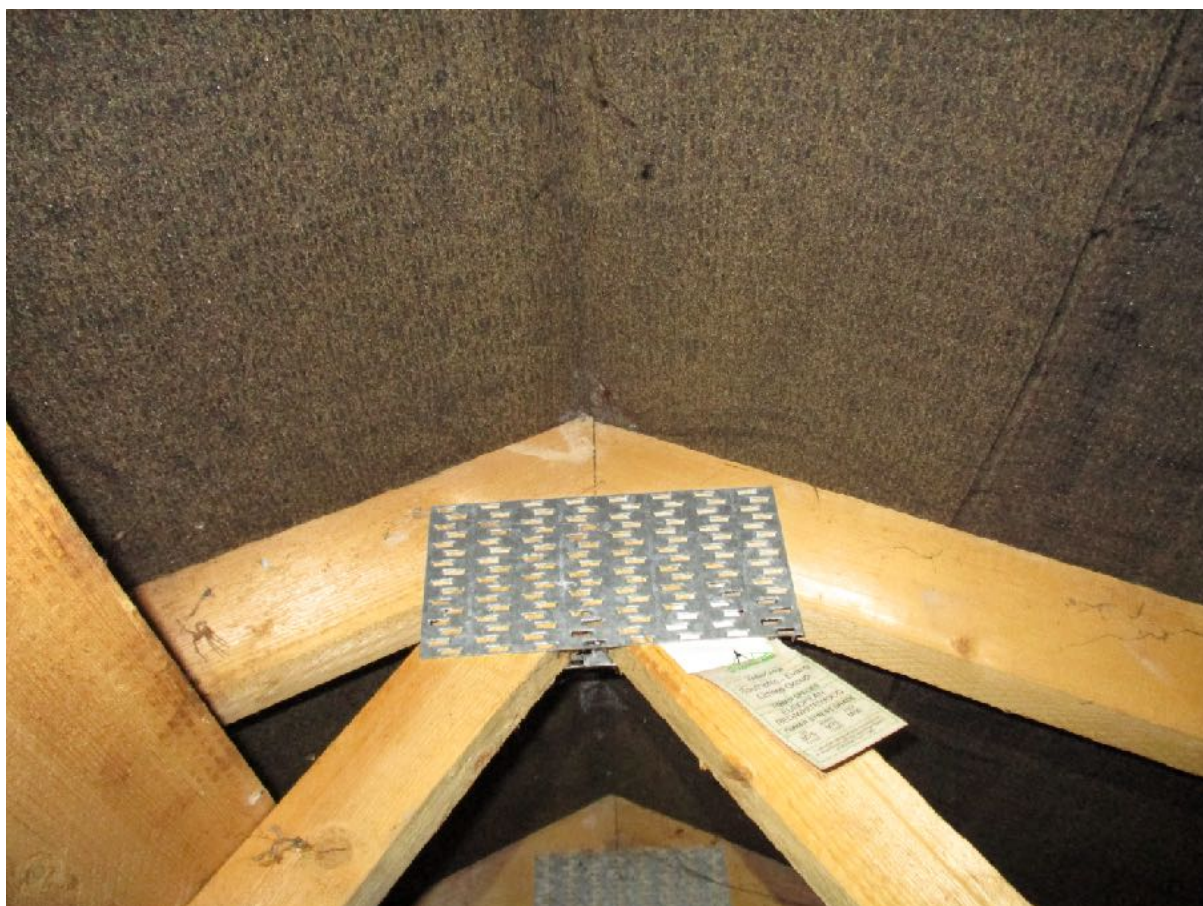
11 – The roof lining is in good condition with no gaps or tears.

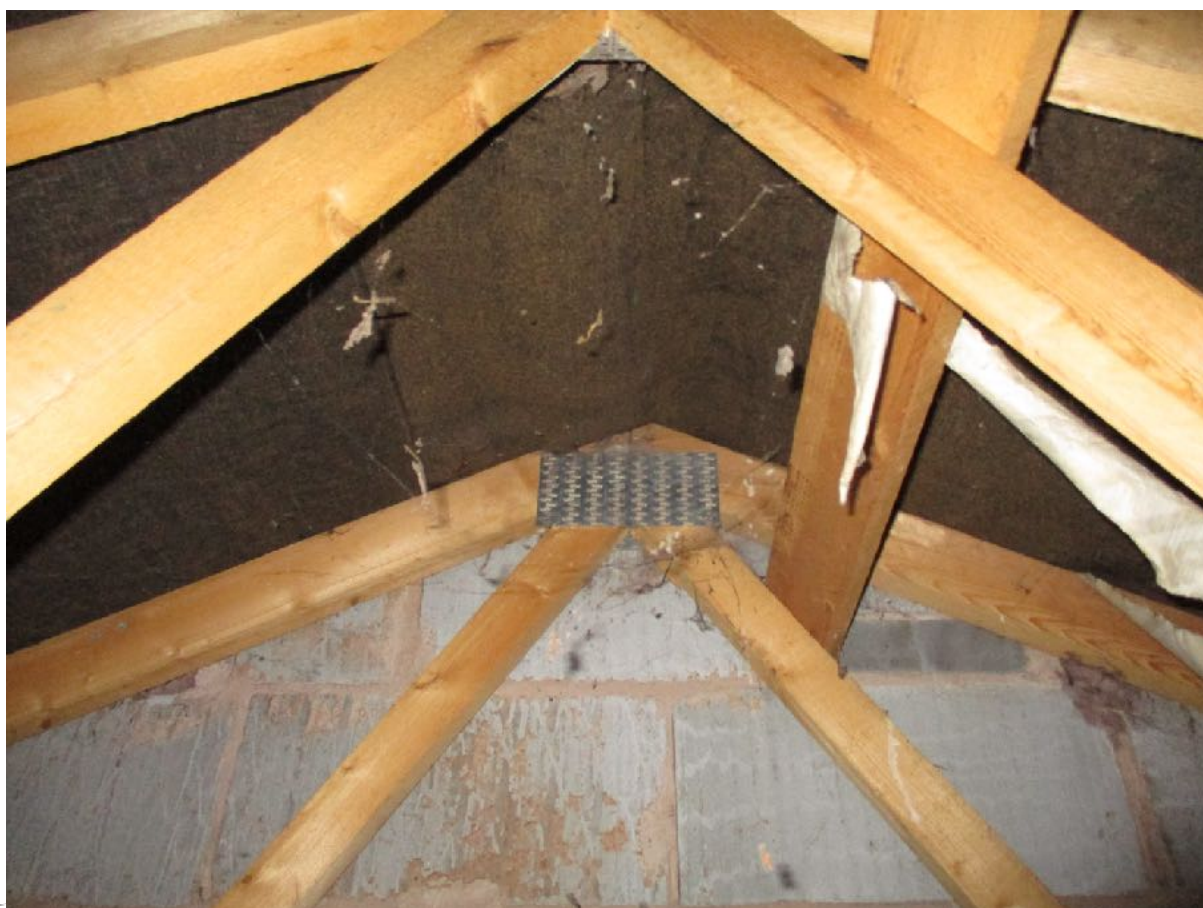
The small gaps between brickwork, roof timbers, and roofing materials, in the roof void were inspected in detail using an endoscope. These areas were dusty and cobwebbed. No droppings were found, and no suitable gaps were present which could give access, or shelter to roosting bats.

12 – Joints in timbers are filled with dusty cobwebs.
