Arboricultural Impact Assessment

Proposed remodelling and extension of existing dwelling

Whins Lodge
Whalley Old Road
Langho
BB6 8DU

January 2021

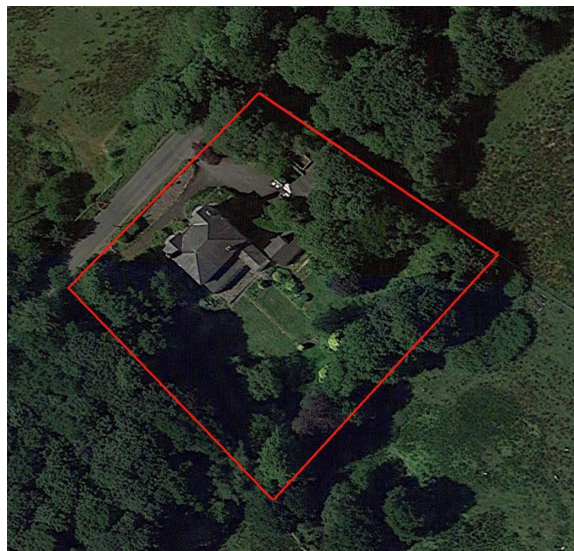
Figure 1: Application site

3.1 The site is located to the east of the village of Langho, Lancashire, and is currently comprised of a detached dwelling and its surrounding gardens (Figure 1). It is bounded to the north-east and south-west by woodland, to the south-east by agricultural pasture and to the north-west by Whalley Old Road, from which there are two existing vehicular access points.

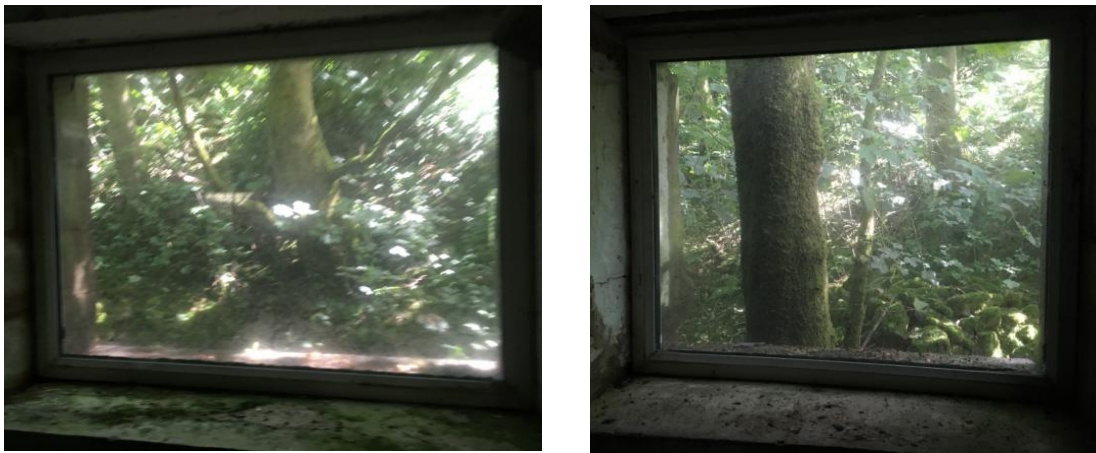
4.4 The B-category group requiring partial removal is G4, which could not be accessed during the tree survey, as it is fully enclosed by existing buildings and a steep slope. The trees within the group could, however, be adequately viewed from the windows of the existing garage (see photos a) and b), below) and from the upper level of the rear garden. There are estimated to be twelve trees within the group and their approximate stem locations are shown on the appended tree plans. Some of the trees are noted to have stems growing very close to the existing structure. Approximately six trees from the group are projected to require removal in order to facilitate the proposed demolition and construction works.

Photos a) and b), looking east into group G4 from inside the existing garage. The group was inaccessible during the tree survey, so could not be inspected in detail.
