RE: TPO application to remove 1x Oak tree: 2 Barley Close, Whalley, Clitheroe.

TREE LOCATION PLAN

VTA Site Survey

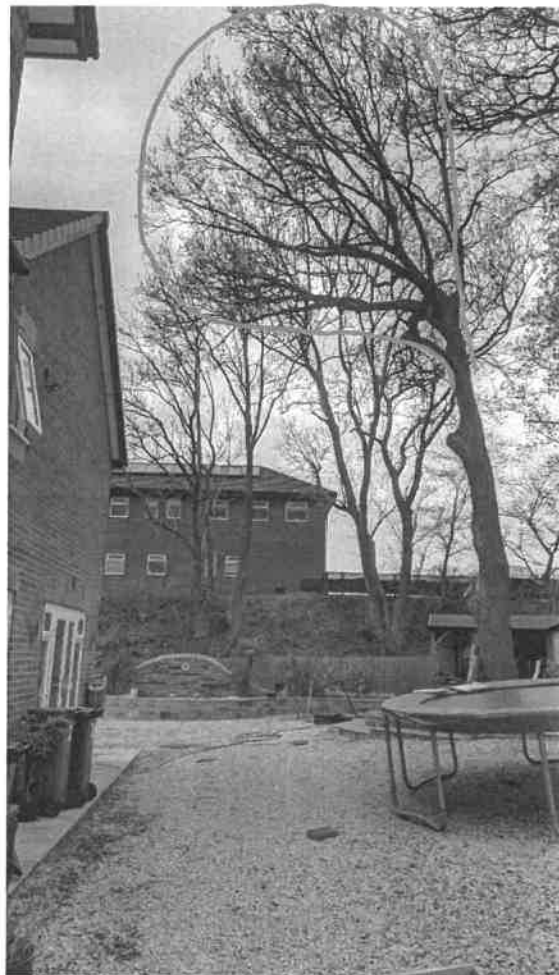
The tree was at the time of assessment in good condition but had not yet come into leaf, the canopy is heavily suppressed with a dominant canopy leaning towards the house, this suppressed growth is due to the existing trees located to the north, T274 and T275.

A recent application was submitted and give consent to remove several trees to the land parcel to the north, this is to allow again extensive land drains to be installed and again with the impact on the tree roots, consent was given to remove several trees, this includes T274 and T275, the removal of these 2 trees will leave T269 exposed.

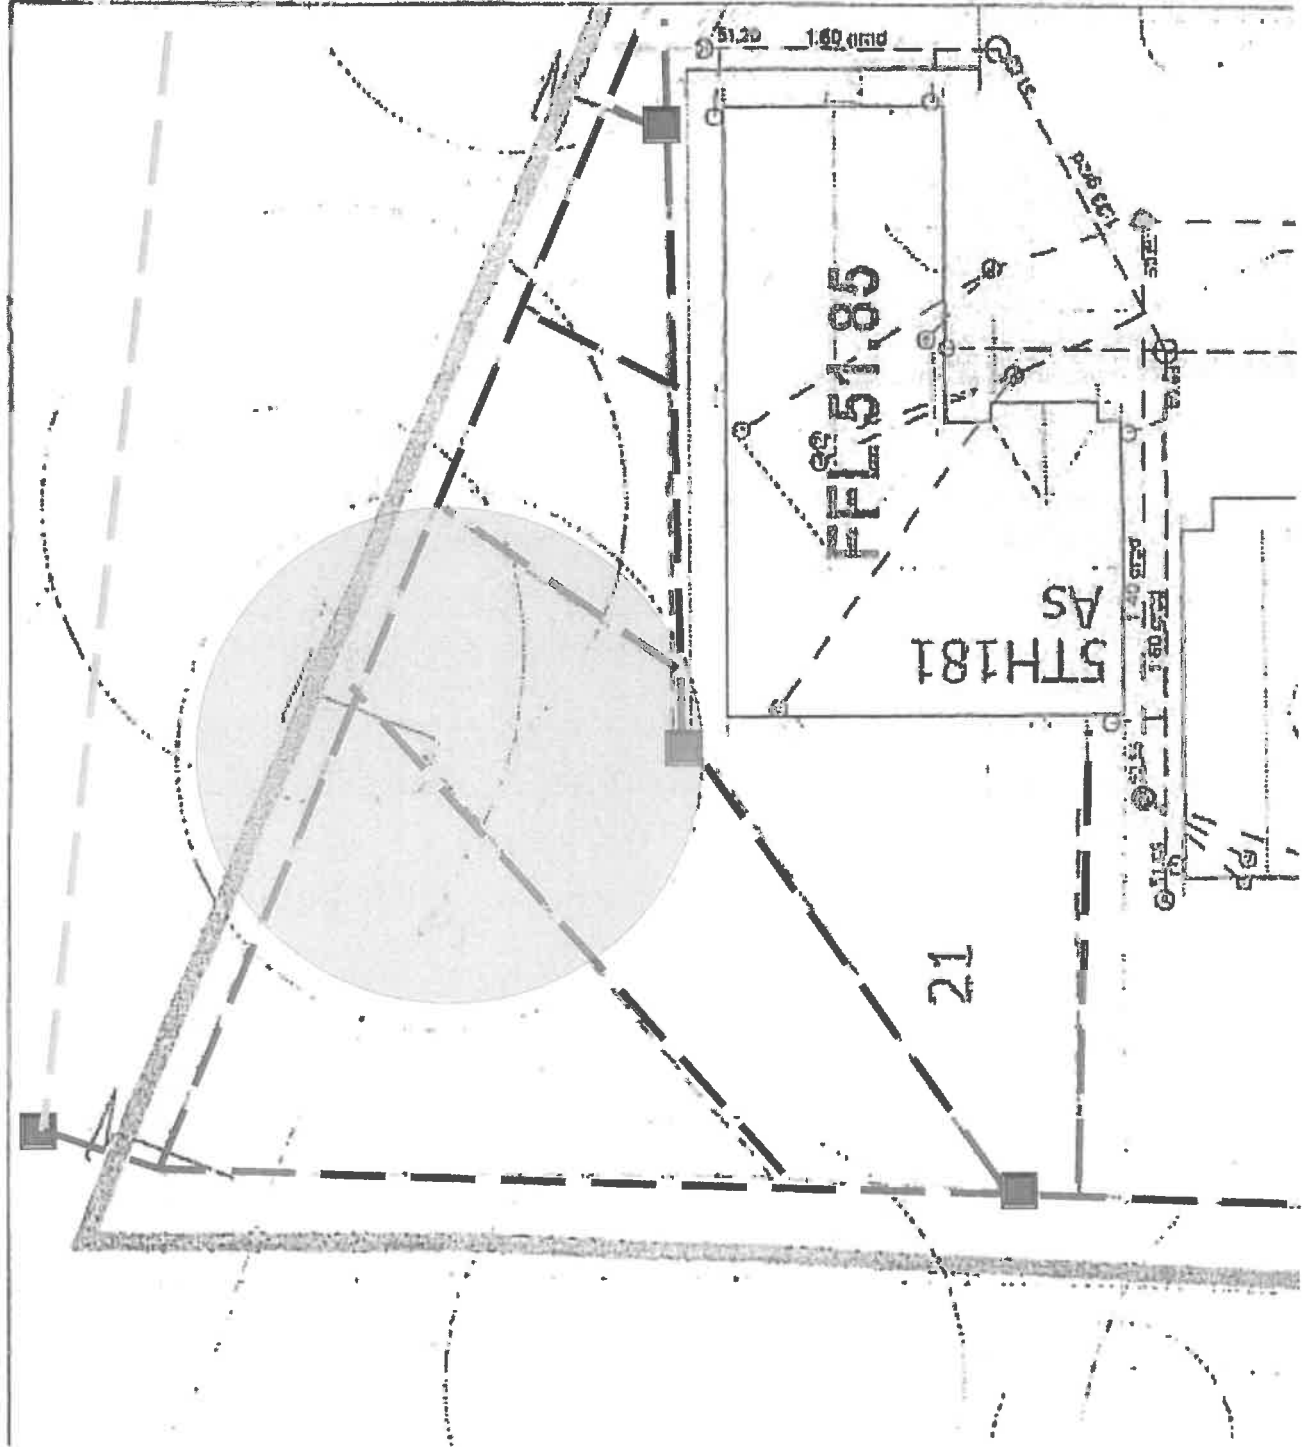
Existing inspection chambers

Existing land drainage as per provided site drawing – blue lines have been overlaid to add clarity to scanned image.

Existing tree location – approximate root protection area

New drain to be installed with consent from planning – not exact location.

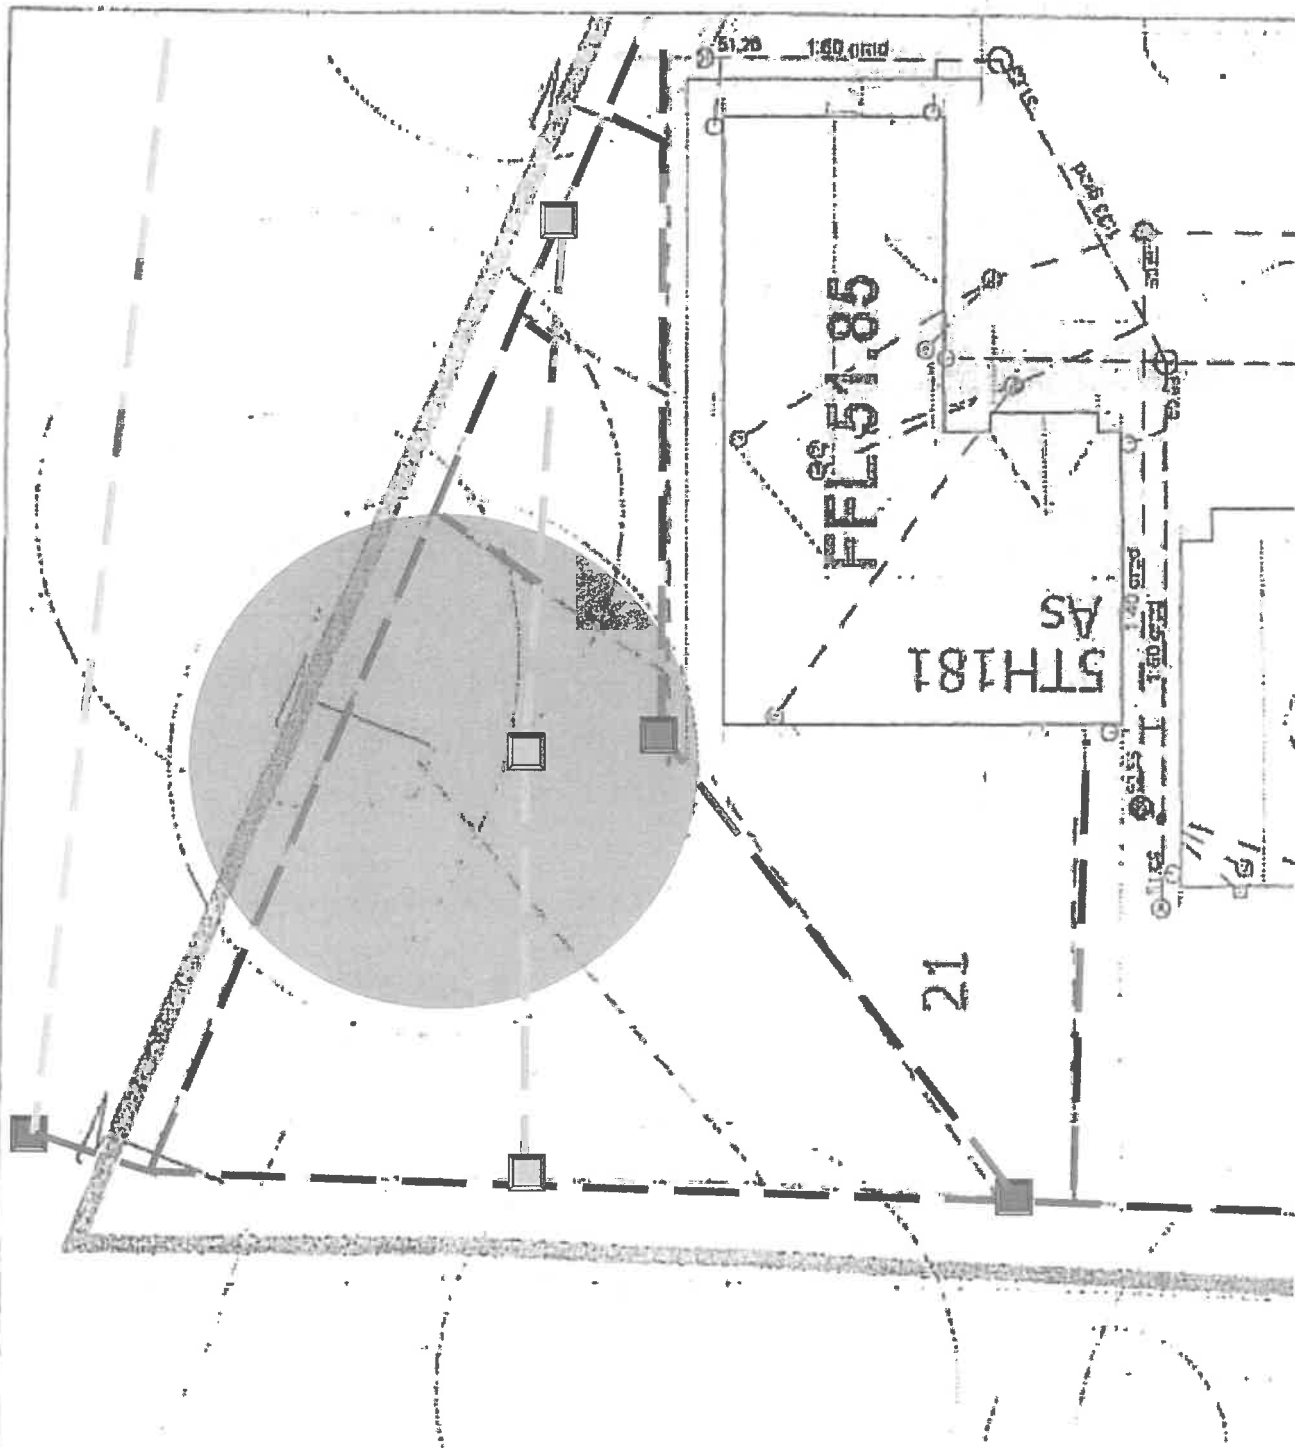
Existing inspection chambers

Existing land drainage as per provided site drawing – blue lines have been overlaid to add clarity to scanned image.

Existing tree to be removed due to extensive ground excavations impacting on tree roots and stability.

Existing land drain and inspection chamber that has failed and needs replacing with larger diameter drain.

New drain to be installed with consent from planning – not exact location.

New larger land drain and inspection chambers that are proposed to be installed to capture any water ingress onto garden from woodland above to the north
