**HERITAGE STATEMENT  
FOR REFURBISHMENT WORKS TO  
11 RAILWAY VIEW ROAD, CLITHEROE**

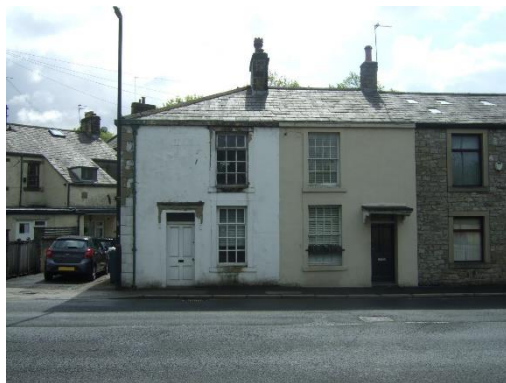
- 2.6 The render has feature horizontal coursing lines scored into the finish which match the rusticated quoin coursing but with an additional line providing narrower banding.

- 2.8 The render to both elevations appears to be a hard cement-based product with evidence of cracking to the surface finish.
- 2.9 Unusually, the demise of 11 Railway View Road only extends to  $\frac{3}{4}$  width of the gable end with the final  $\frac{1}{4}$  occupied by 13 Railway View Road.

*Picture 4 – West elevation along Railway View Road*

- 3.2 The existing render finish will be removed completely and replaced with a lime based insulating lime render, which will then be finished with a mineral based masonry paint, such as Keim Granital, to provide breathability to the stone walls. The existing detailing with the coursing lines will be replicated.

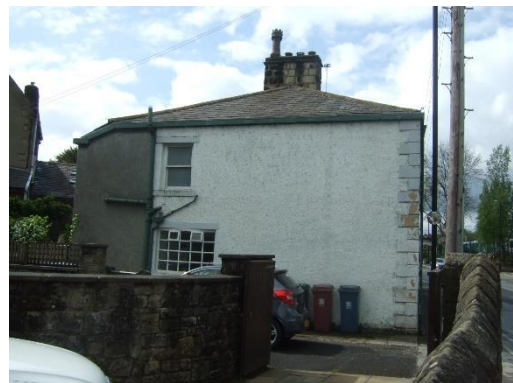
- 2.7 The northern elevation is more utilitarian in appearance with two windows; the ground floor bowed window being a C20 intervention whilst the first floor sliding sash window appears to be original. The render finish is also less ornate on this elevation being standard roughcast render with a paint finish and no applied coursing.

*Picture 5 - North elevation*

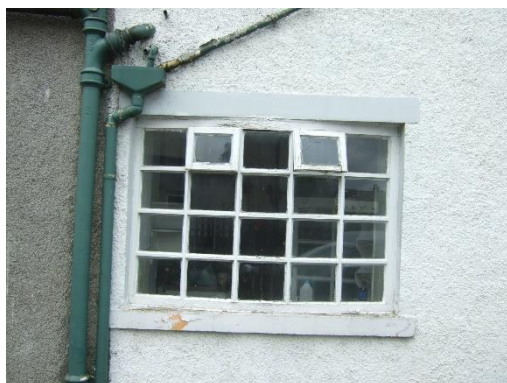
*Picture 6 - Bow window to kitchen*

- 4.6 The existing building is in need of renovation and repair. The windows in particular require replacement. The current arrangement, with the exception of the bathroom window to the northern elevation, are C20 interventions with top hung casements. The bow window to the kitchen in particular appears incongruous and causes visual HARM.

- 3.7 The original sliding sash window and bow fronted window to the kitchen will be removed and replaced with new double glazed sliding sash windows.
- 3.8 Rainwater goods will either be renovated and re-decorated or replaced with new cast iron to match existing.

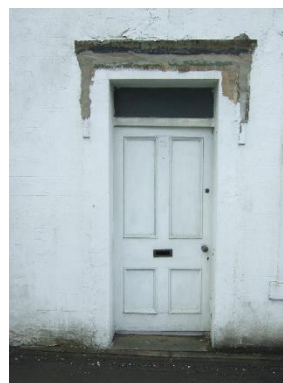
- 2.2 The timber hood referenced in the Listing has fallen off the building due to rot but has been retained. Unfortunately, the timber hood is on very poor condition and beyond repair therefore an exact replica has been manufactured copying details, size etc.

- 2.4 A 4 panelled timber door, assumed to be original, with glazed fan light over provides the only access into the property.
- 2.5 As noted in the Listing, the property has rusticated quoins and stone surrounds to the windows and doors. These appear to have been painted with a modern paint which is flaking and in poor condition generally.

*Picture 7 - Original front door with hood missing*

- 3.4 The replica timber hood will be reinstated over the door to match the retained feature at #13.
- 3.5 An exact replica of the existing front entrance door will be manufactured using Accoya and factory finished with new weather seals, thresholds etc.

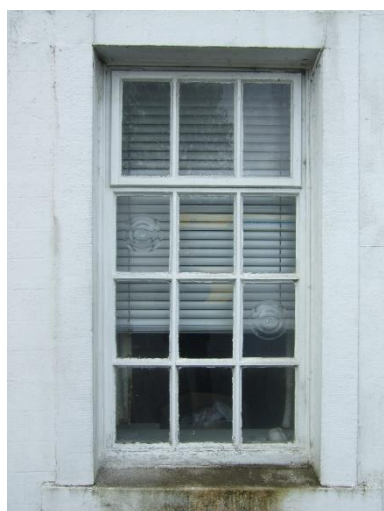
- 2.3 The simple façade is punctuated with a pair of narrow timber window openings providing light to the living room and bedroom above. These windows are not original and we would estimate their age to be around 1960. Although replicating the traditional glazing bar patterns one would expect for this period of property, they are in fact top hung hinged casements.

*Picture 8 - Mock sash window with top hung casement*

- 3.6 Existing top hung casement windows to the west (front) elevation will be removed and replaced with Accoya factory finished double glazed sliding sash windows to both the western and northern elevations. Refer to application drawings 5561 (PL) 02 & 03 for details.

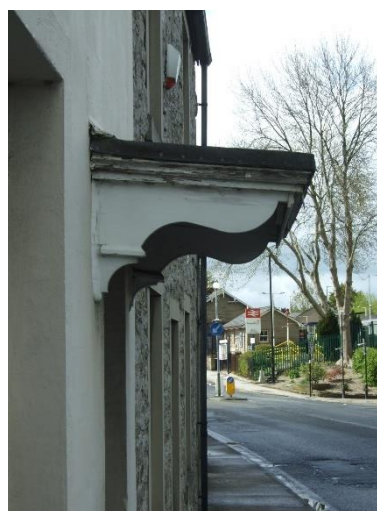
*Picture 9 - Timber hood to #13*
