# **Haweswater Aqueduct Resilience Programme - Proposed Bowland Section**

**Proposed Ribble Crossing**

**Appendix 6.5: Arboricultural Impact Assessment**

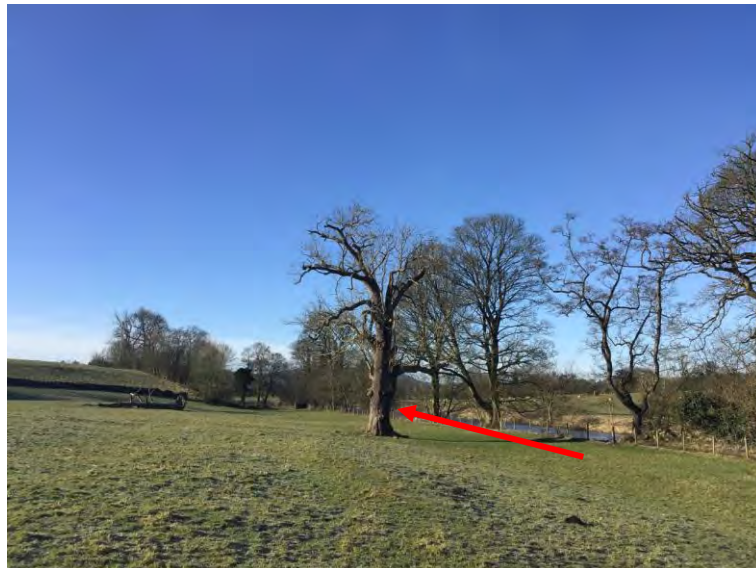
**Illustration 1: Potential veteran ash (red arrowed) located in an agricultural field south of the River Ribble**

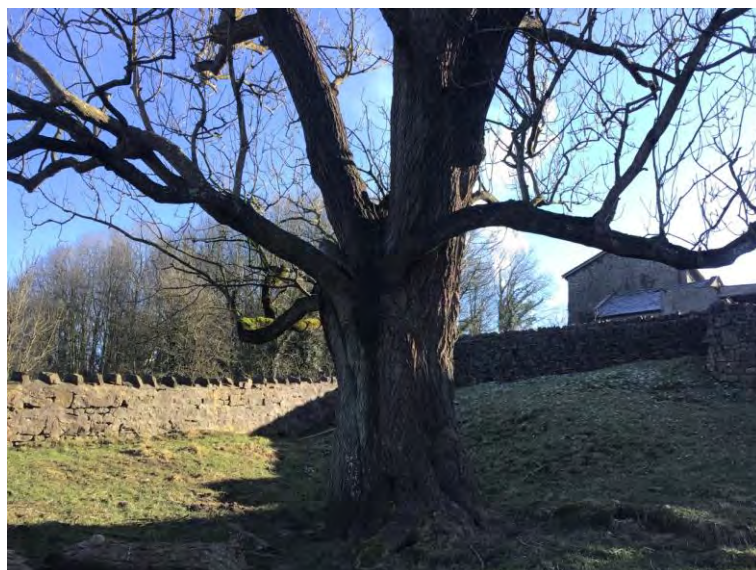
**Illustration 2: Potential veteran ash located in an agricultural field immediately south of the River Ribble/west of adjoining West Bradford Road**

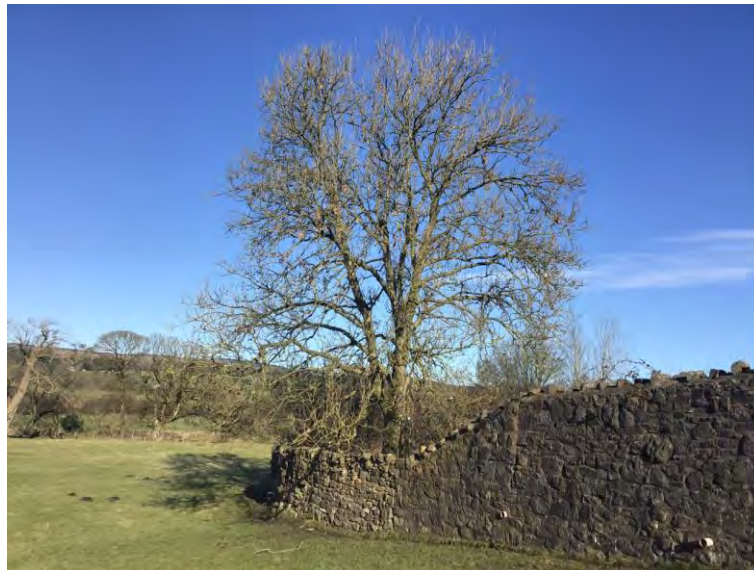
**Illustration 3: Low quality ash tree to be removed due to new road proposals south of the river. The tree has advanced symptoms of ash dieback.**

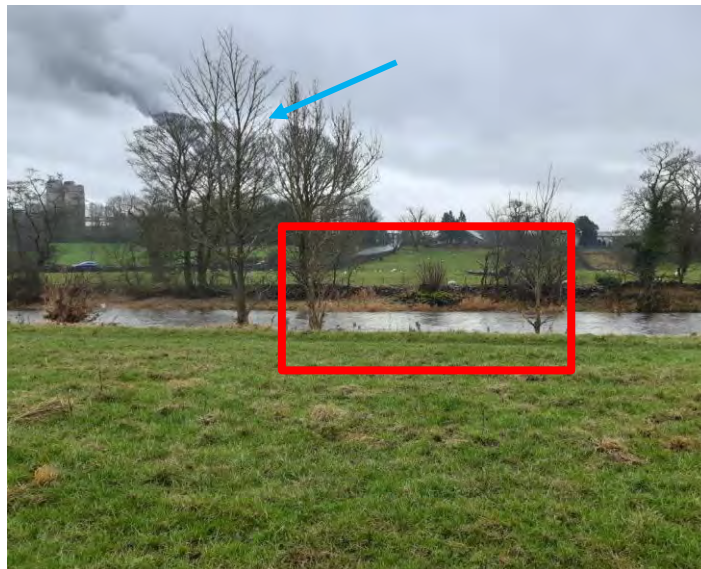
- 45) Three low quality riverside features would require removal in order to facilitate the proposed bridge crossing. The proposed bridge alignment, as indicated by Illustration 4, targets an existing gap between two prominent individual trees on the southern side of the riverbank. A moderate quality tree, blue arrowed in Illustration 4, is reported as at risk of removal due to its proximity to likely excavation required for the bridge footing on the southern side of the riverbank.

**Illustration 4: The proposed bridge crossing alignment targets a gap (red boxed) between established individual trees. Looking south, this gap is approximately 50 m wide and contains young low quality vegetation. The at risk moderate quality tree is approximately 3m from proposed works.**

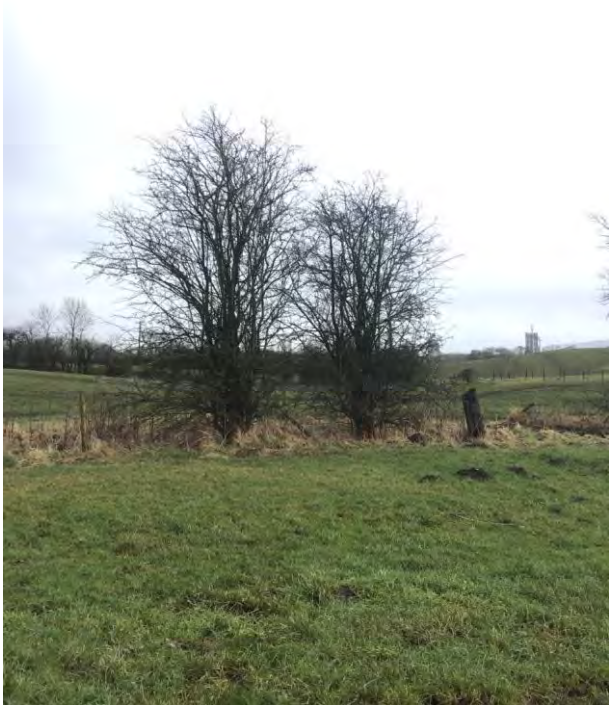
- 46) Three low quality boundary features are requiring varying extents of removal due to their encroachment within the proposed new road alignment and associated earthworks footprint. Features include boundary features located by minor watercourses (Illustration 5) or field boundary vegetation (Illustration 6).

**Illustration 5: Brookside feature to be removed**

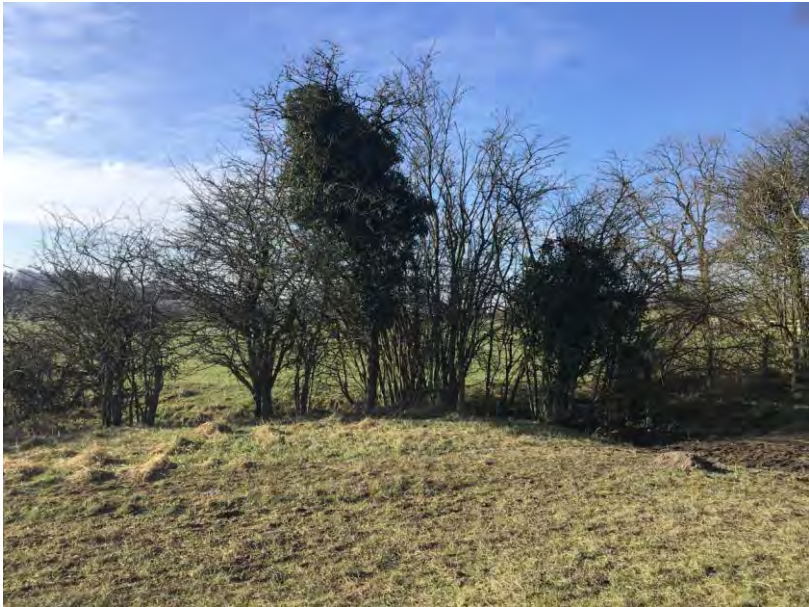
**Illustration 6: Field boundary feature to be removed**
