**Haweswater Aqueduct Resilience Programme - Proposed Bowland
Section**

Appendix 7.3: Geomorphology Proformas

June 2021

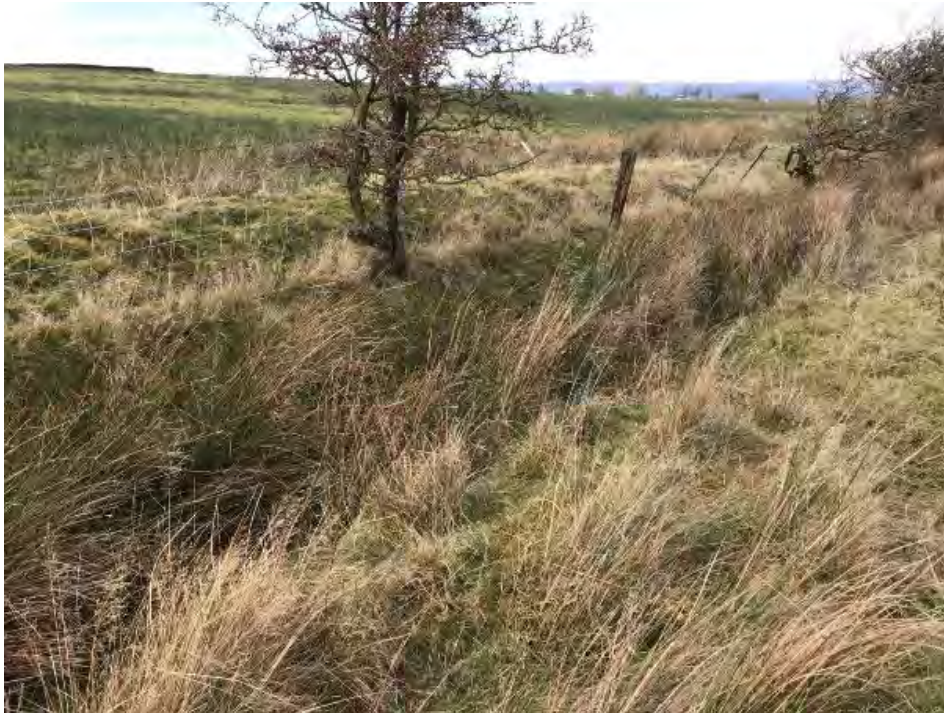
Illustration 1: Downstream view from right bank. Embankment on left bank

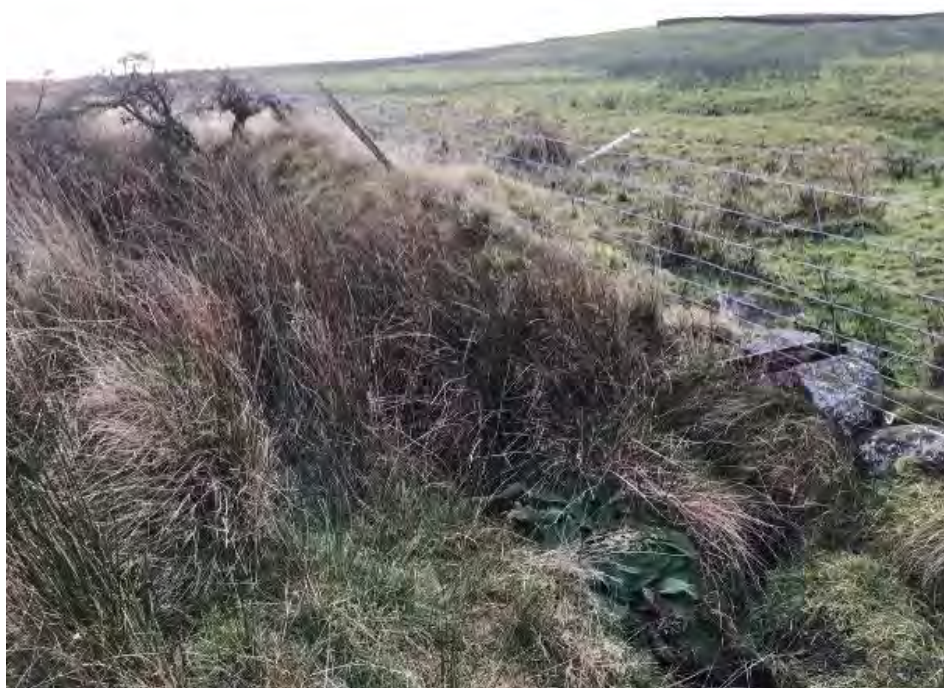
Illustration 2: Upstream view from right bank showing riparian vegetation

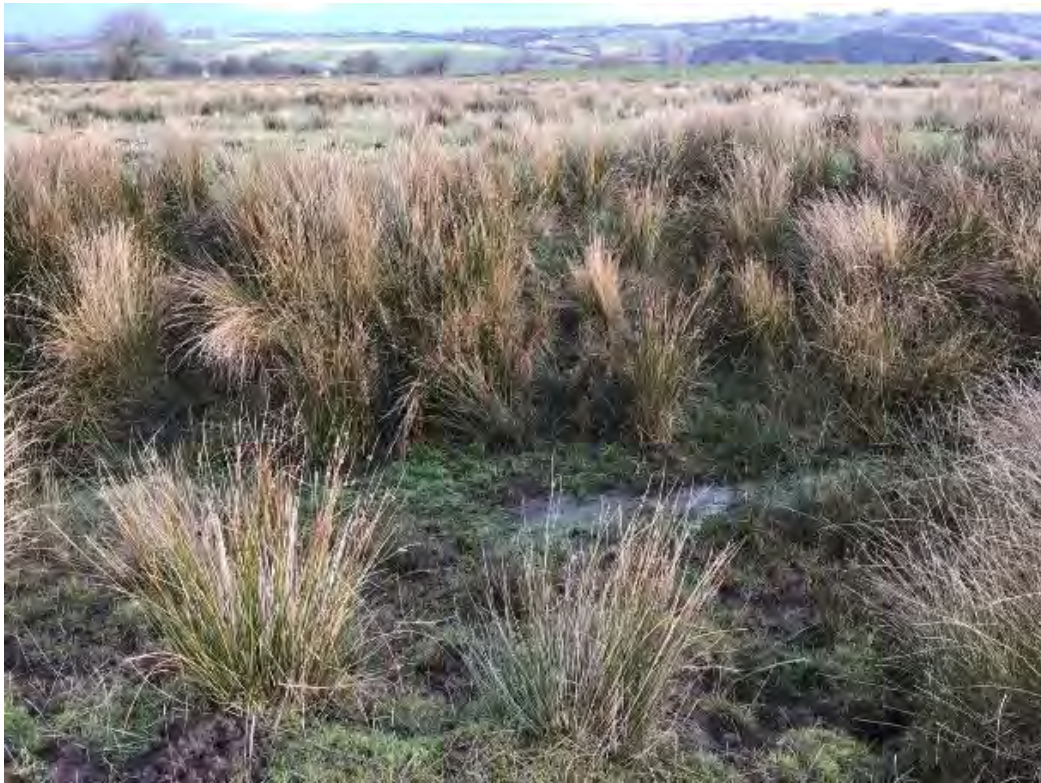
Watercourse baseline	
Value	Low
WFD Surface Water Body	Hindburn
Reach function	Source
Reach process	Stable
Flow	Uniform – smooth flow
Substrate	Consolidated silt. No sorting
Features observed	Natural: 3 m of erosion on left bank (Illustration 3) Artificial: None
Land use	Rough pasture on both banks
Riparian vegetation	Continuous sedge and grass coverage along both banks
Scheme Interaction	
Scheme components	Construction access route
Mitigation requirements (Enabling)	Mitigation measures would be required for the impact the access road crossing of Unnamed Watercourse 169 has on the River Hindburn. These measures would be employed following the removal of the culvert (see reinstatement requirements)
Mitigation requirements (Construction)	Mitigation measures would be required for the impact the access road crossing has on the River Hindburn. These measures would be employed following the removal of the culvert (see reinstatement requirements)

Illustration 3: View from left bank to right bank of bank erosion

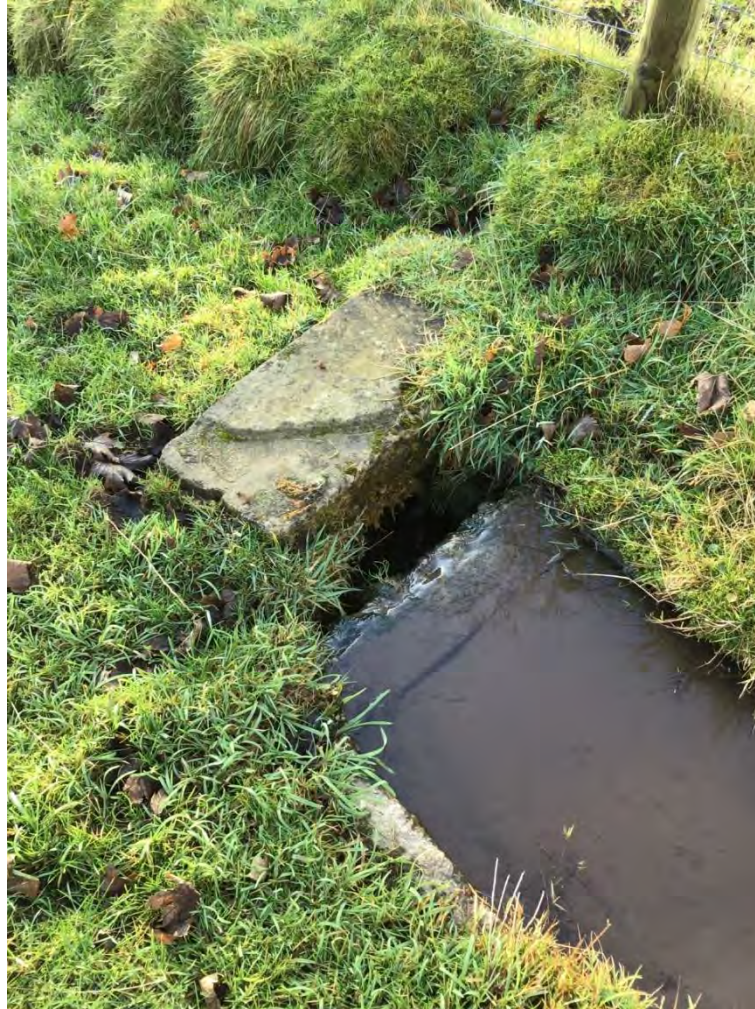
Illustration 4: Downstream view of culvert inlet

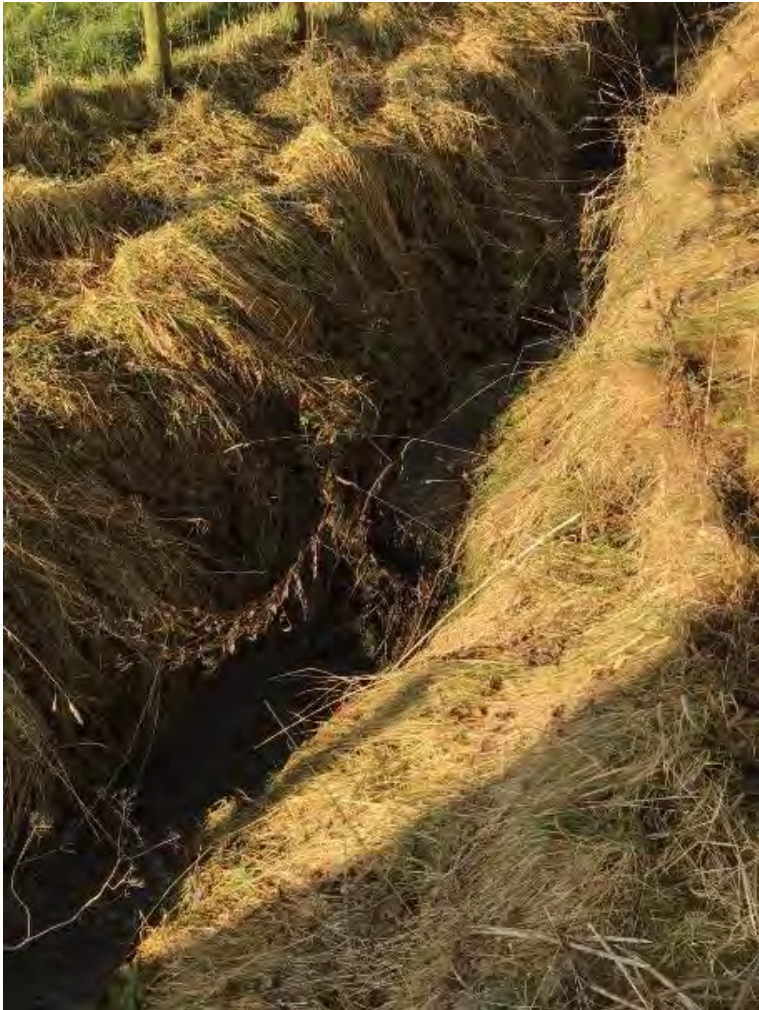
Illustration 5: Upstream reach - downstream view of riparian vegetation

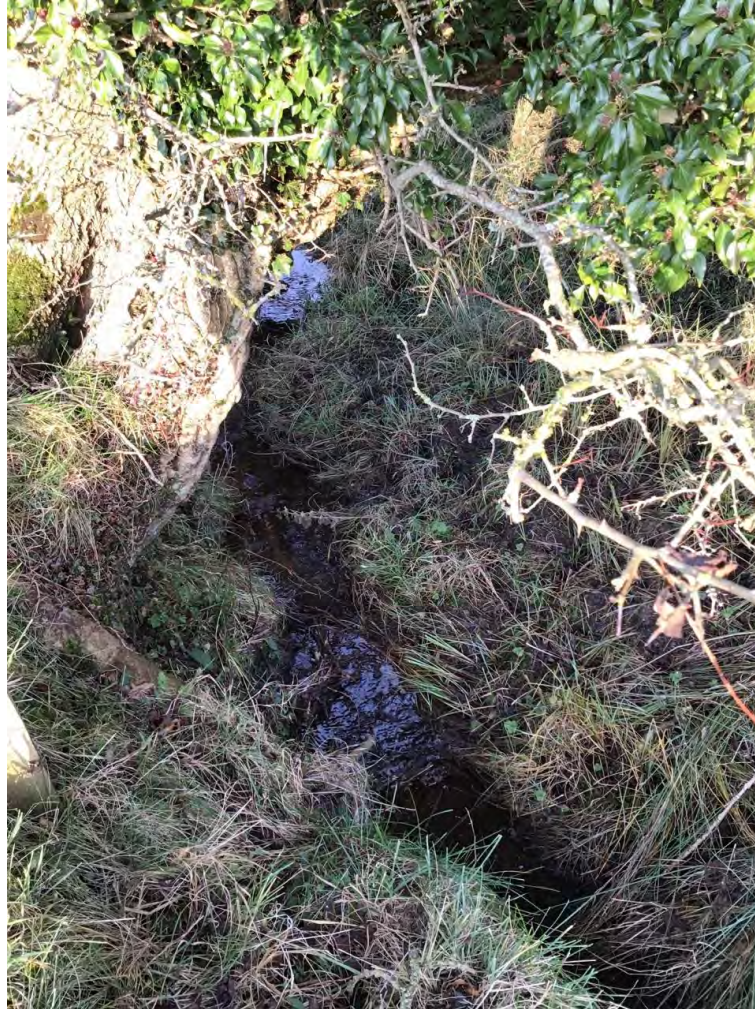
Illustration 6: Downstream view of fine sediment berms

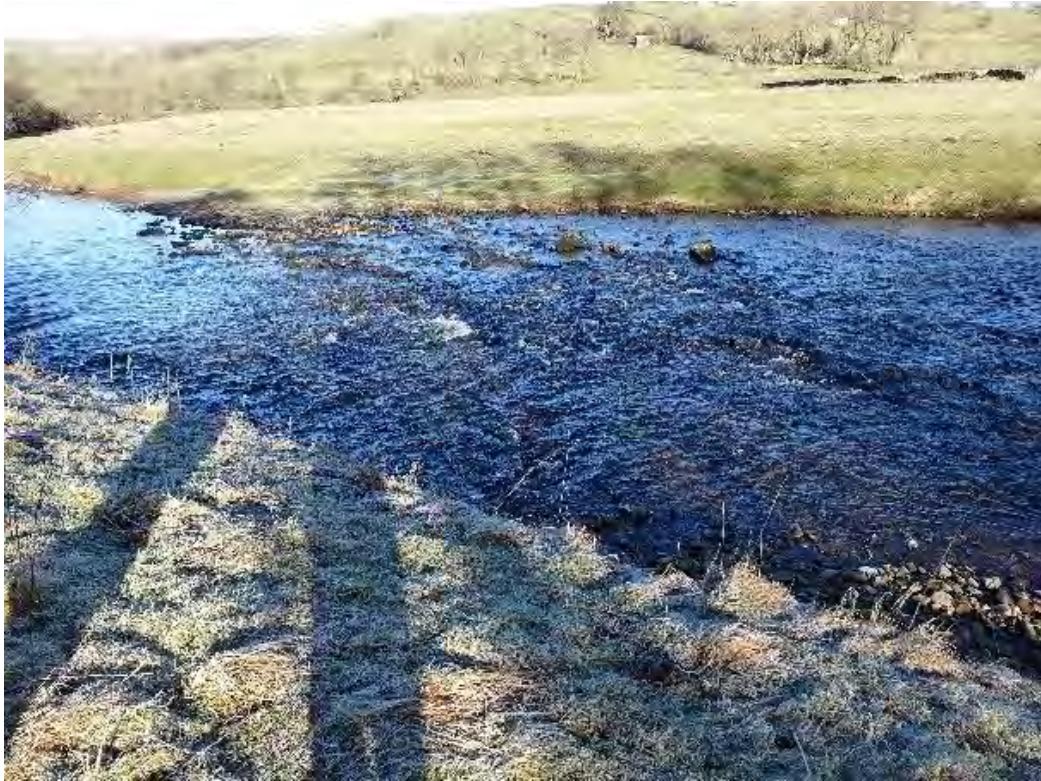
Illustration 7: View from left bank to right bank showing rippled flow

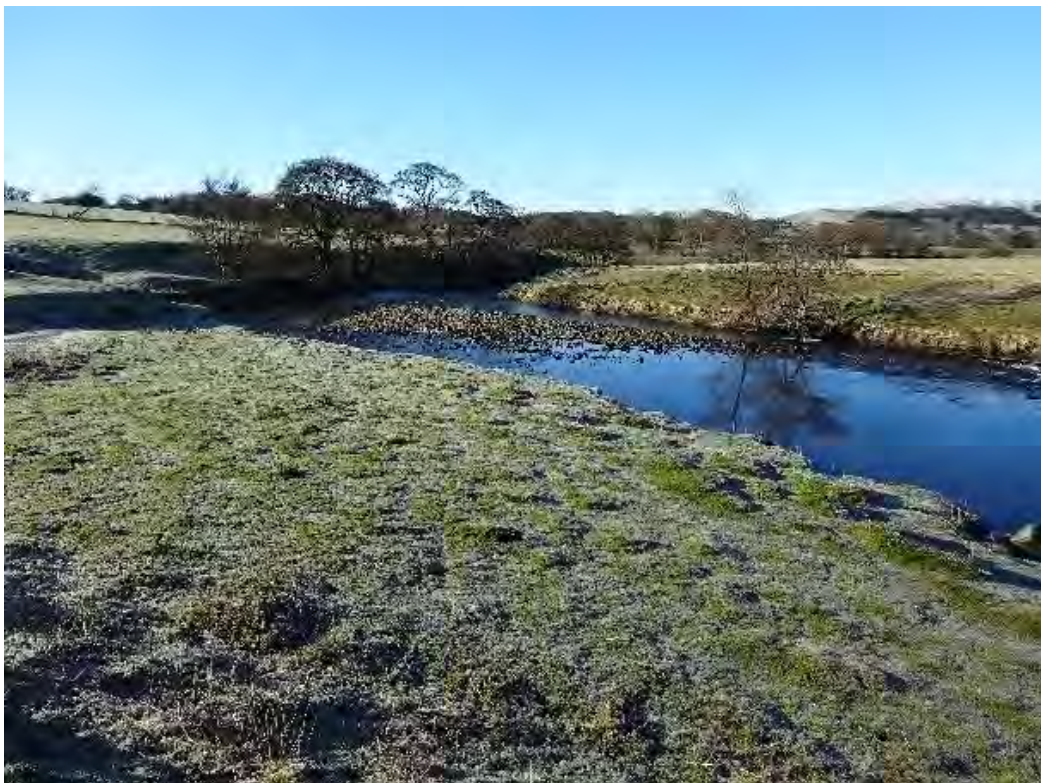
Illustration 8: Downstream view of a medial bar

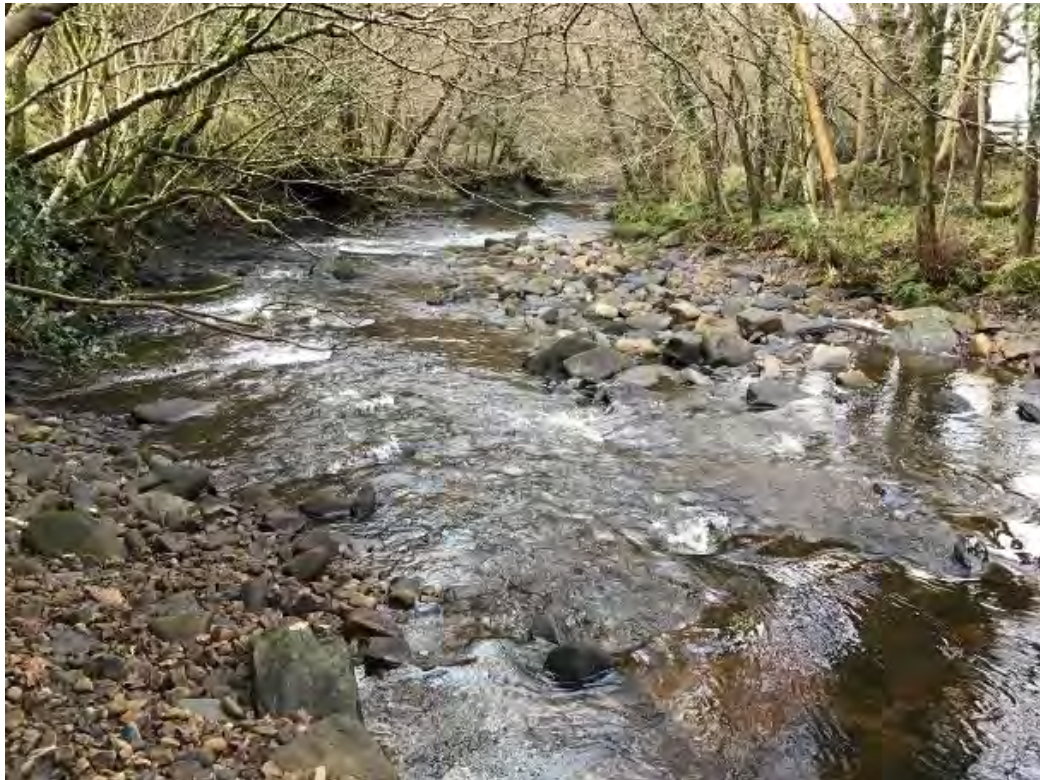
Illustration 9: Downstream view of the channel showing a bedrock, boulder, and cobble bed

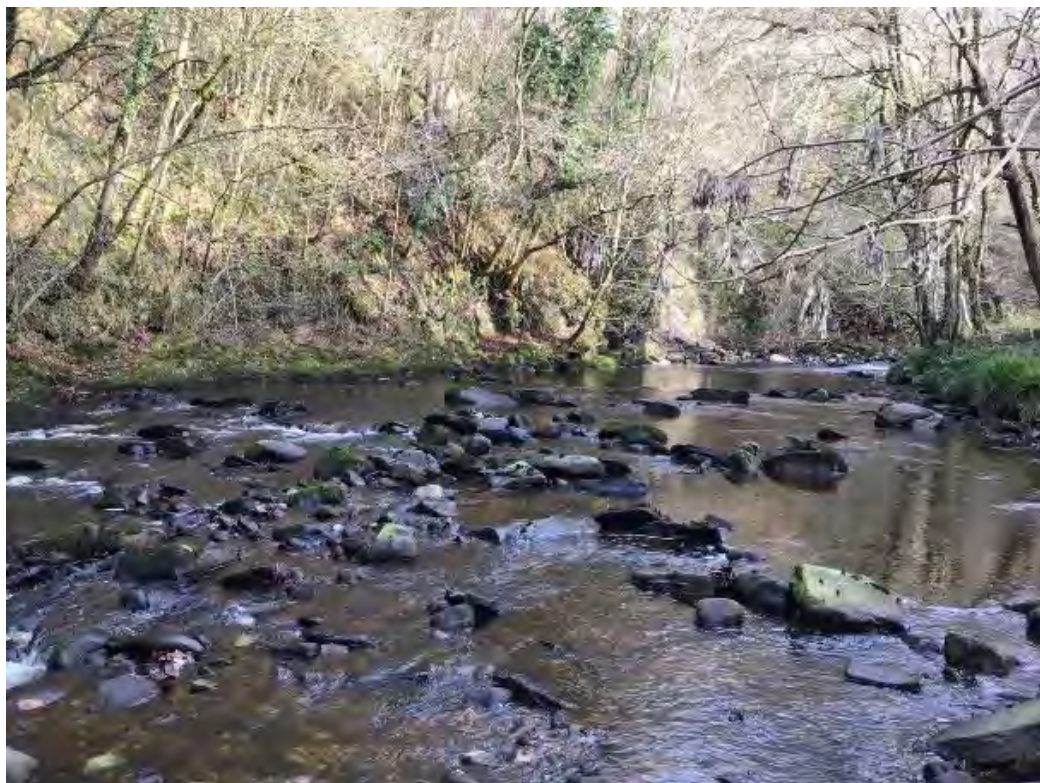
Illustration 10: Upstream view of the channel showing bank erosion on right bank
