# **Haweswater Aqueduct Resilience Programme - Proposed Bowland Section**

**Proposed Ribble Crossing**

**Technical Appendix 9A.3: Bats**

June 2021

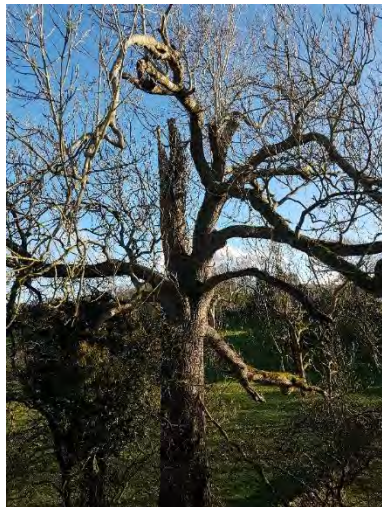
TEP ID	Unique Arb ID	Grid Ref	Description	
BT4	T130	SD 74440 43772	<p>Large ash around 12m high, growing towards the bottom of a steep embankment. Split limb leading to large cavities / decay at top. Aerial survey would be required to determine if possibly too wet to be a suitable potential roost features (PRF).</p> <p>Roost Suitability: High</p>

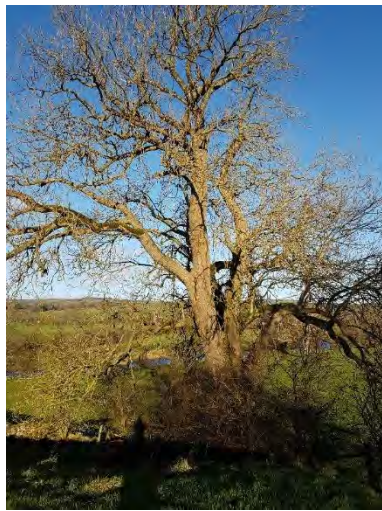
BT5	T120	SD 74433 43780	<p>Very large ash tree. Primary limb and secondary branch failures has resulted in a split in the main trunk providing high PRF. Number of knot holes also present.</p> <p>Roost Suitability: High</p>

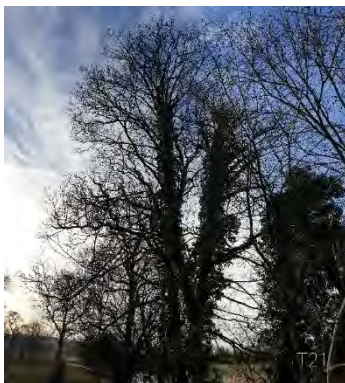
TEP ID	Unique Arb ID	Grid Ref	Description	
BT21	T89	SD 74378 43829	Dense ivy-clad sycamore, up to around 11m high. Ivy may be obscuring potential roost features and have therefore precautionary categorised as low potential.  Roost Suitability: Low

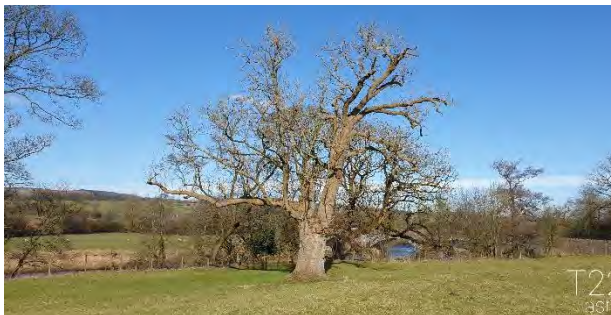
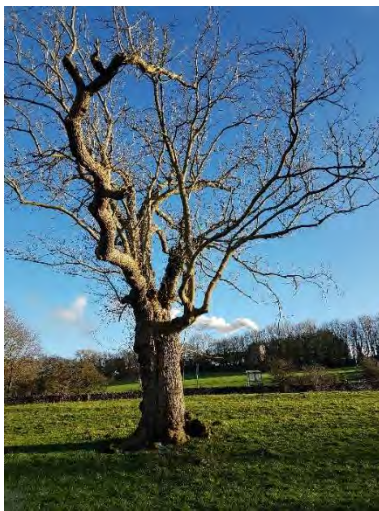
BT22	T67	SD 74464 43875	Large ash tree within field, south of river. Developing veteran features including large cavities and decay, providing high PRF. There are also transverse splits within the top branches and butt rot creating an internal cavity from then base.  Roost Suitability: High

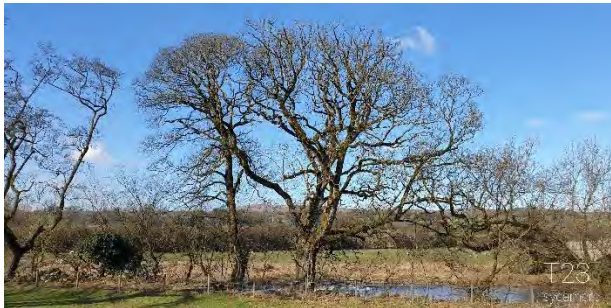
BT23	T54	SD 74478 43899	Mature sycamore, along riverside. Severe canopy dieback. Split in south facing branch around 3m from the ground. Limited access to view fully.  Roost Suitability: Moderate.

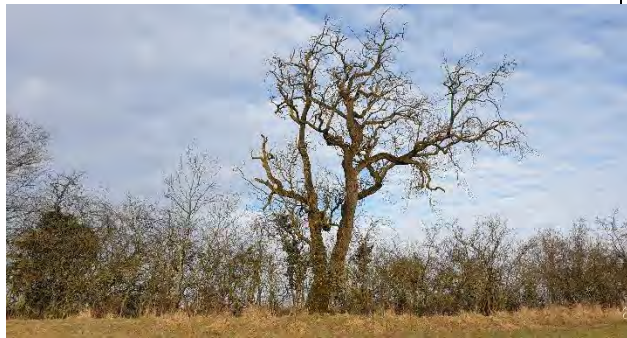
BT29	T39	SD 74186 43926	<p>Ivy clad oak tree in dense understorey vegetation / hedge Inspection limited as the trees are fenced off. Ivy may be obscuring defects and potential roost features. Categorised as low on a precautionary basis.</p> <p>Roost Suitability: Low.</p>	No photo available.
BT30	T49	SD 74292 43908	<p>Large ash tree in hedgerow / at field boundary. In severe decline with desiccations resulting in number of branches with holes.</p> <p>Roost Suitability: Moderate.</p>

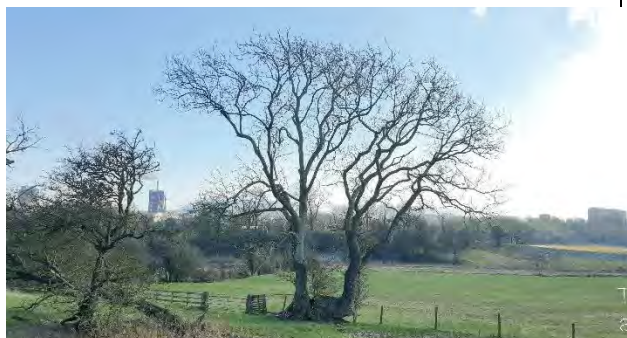
BT31	T95	SD 74151 43824	<p>Twin stemmed ash tree around 10m high. Located along a field boundary / fence line that was likely from remnant historic hedgerow. Tree decayed and few knot holes in the western stem about 4m from the ground.</p> <p>Roost Suitability: Moderate.</p>

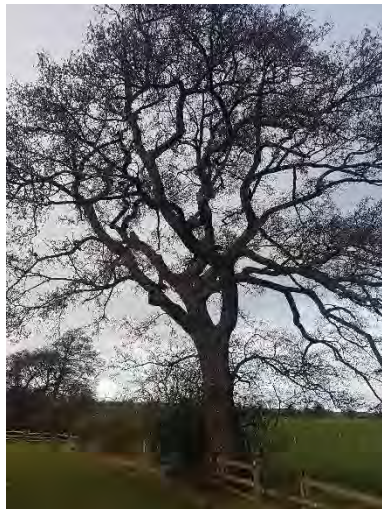
TEP ID	Unique Arb ID	Grid Ref	Description	
BT34	T118	SD 74036 43786	<p>North of stream. Reasonably balanced canopy, slight bias east. No significant defects Young alder, on stream edge. Stem cavitation and decay resulting in butt rot and split in trunk from ground to around 2m. Broken branches.</p> <p>Roost Suitability: Moderate/ High.</p>	No photo available
BT35	T134	SD 74060 43751	<p>Mature alder in fence line. Stem cavitation and decay. 2 PRFs; one south face and one north facing; cankers at branch junction</p> <p>Roost Suitability: Moderate</p>

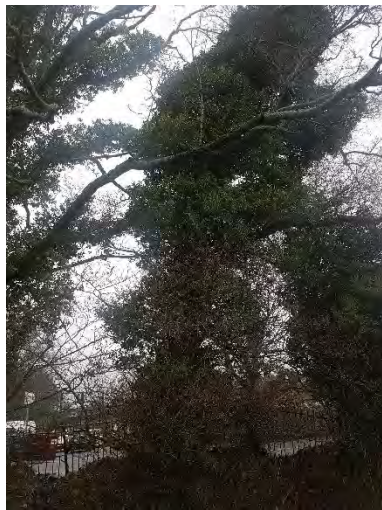
BT45	T13	SD 73475 44012	<p>Icy clad alder along roadside, north of a stream. Due to icy cover potentially covering PRF, a precautionary approach has been taken with categorisation.</p> <p>Roost Suitability: Low</p>

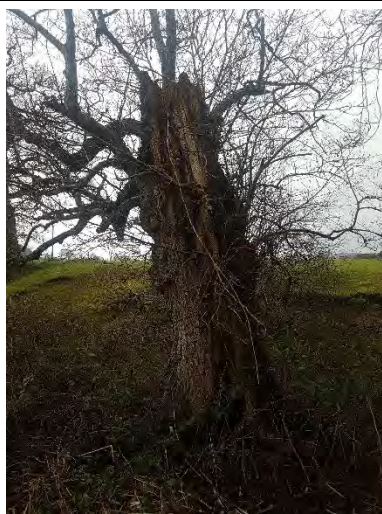
TEP ID	Unique Arb ID	Grid Ref	Description	
BT49	G13	SD 73465 43999	<p>Alder that has been flailed. Large open wound in trunk resulting in northern cavity.</p> <p>Roost Suitability: High</p>

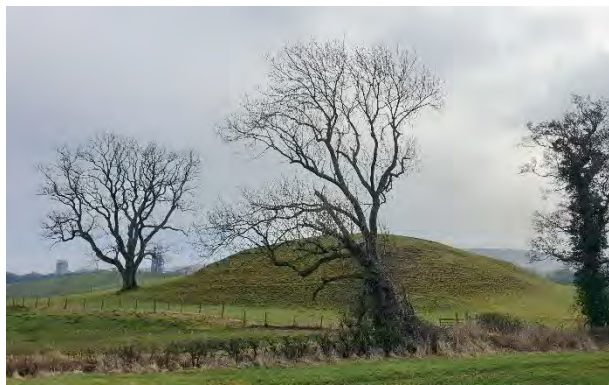
BT50	T128	SD 73550 43769	<p>An ash tree of around 14m high on western side of brook, overhanging. Transverse split on first east facing branch and desiccation fissures within south facing branch.</p> <p>Roost Suitability: Moderate</p>

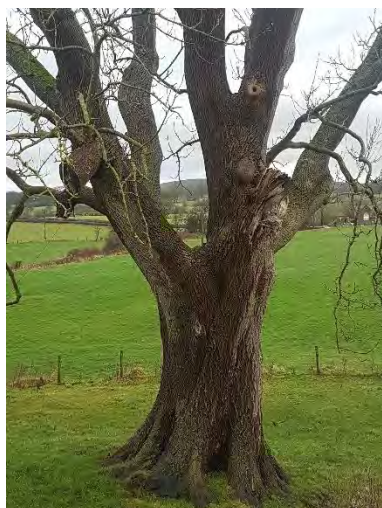
BT51	T126	SD 73605 43769	<p>Veteran ash tree at base of hilled field. Large tear out in south east trunk with hollowing providing suitable hibernation / maternity roosting opportunities, transverse splits in number of branches, pruning cuts at desiccated removed limbs, and lots of large knot holes.</p> <p>Roost Suitability: High</p>

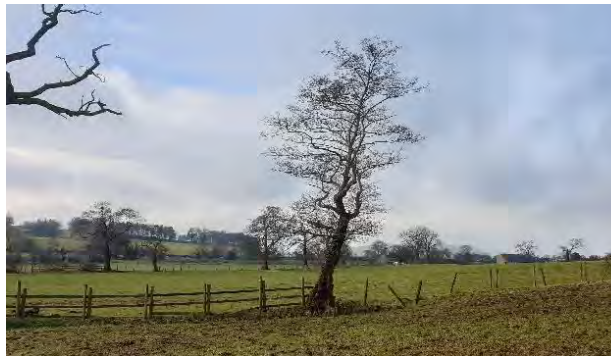
TEP ID	Unique Arb ID	Grid Ref	Description	
BT55	T150	SD 73900 43702	Ash tree along field boundary with transverse split in southern branch.  Roost Suitability: Moderate

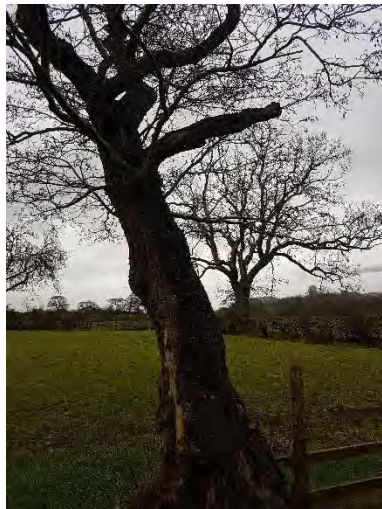
BT56	T152	SD 73912 43692	A mature decaying / predominantly dead alder on field boundary with a cavity split in first south west trunk.  Roost Suitability: High

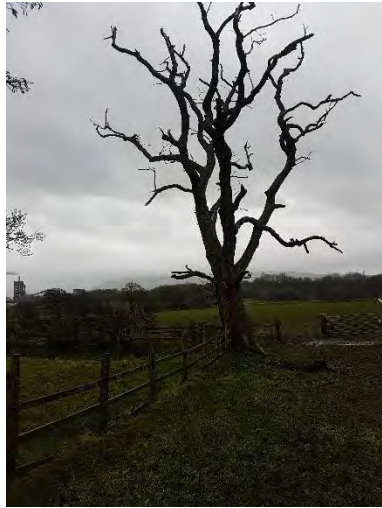
BT57	T149	SD 79811 22191	Large ash tree within corner of field boundaries. Tree is in decline with large crevice in main trunk, large limb failure / split and several knot holes.  Roost Suitability: High

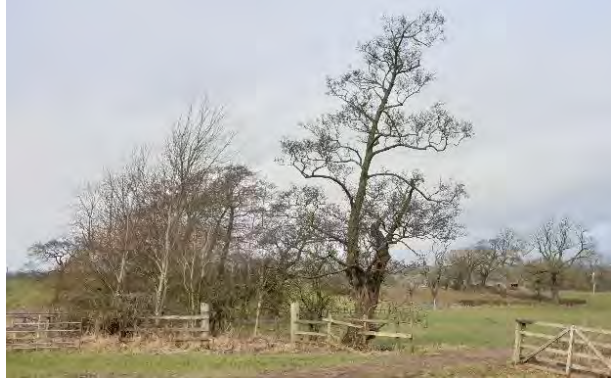
BT67	T121	SD 74035 43782	Alder on stream edge. Stem cavitation and decay.  Roost Suitability: High	No photo available
BT68, 68A & 68B	T116	SD 74035 43794	Cluster of 3 alder trees with knot holes present.  Roost Suitability: Low	No photo available
BT72	T196	SD 73946 43589	Alder on field boundary corner, adjacent to stream. Some branches subject on ash dieback resulting in large cavity in eastern limb, suitable for hibernation / maternity roosts.  Roost Suitability: High

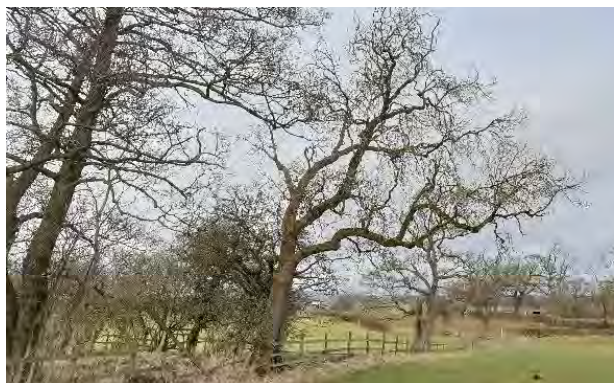
TEP ID	Unique Arb ID	Grid Ref	Description	
BT74	T183	SD 79815 22190	Ash tree with limb failure leading to large cavity in south facing top limb.  Roost Suitability: High

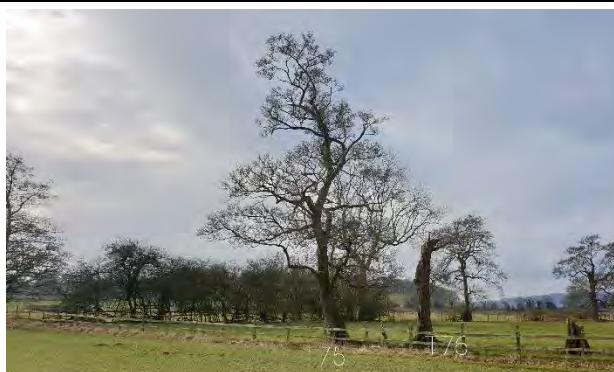
BT75	T166	SD 73919 43646	Alder tree on field boundary with occasional branches dying back. Butt rot / basal cavity resulting in large cavity in main stem extending up trunk <0.5m.  Roost Suitability: High

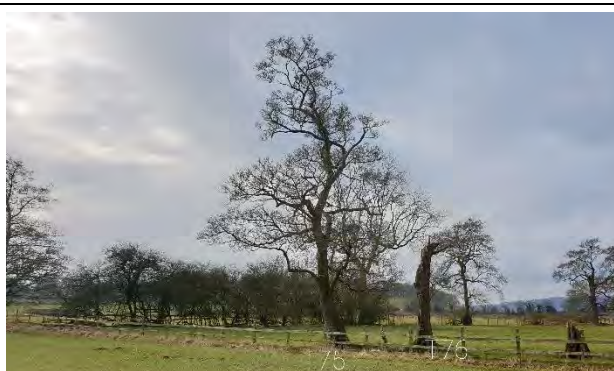
BT76	T165	SD 73914 43643	Alder with stem failed up to around 5m but two small diameter branches growing to north. Deadwood / wood decay up length of the trunk providing PRFs.  Roost Suitability: High

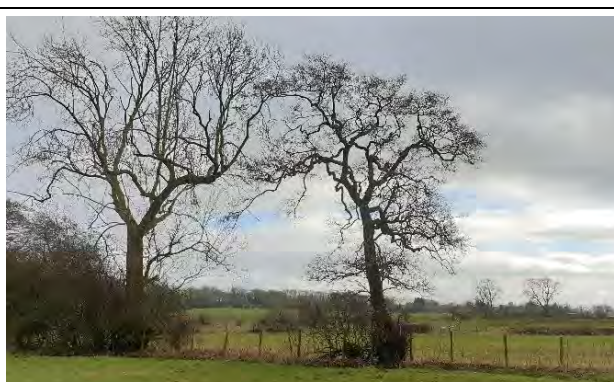
BT77	T177	SD 73882 43629	Alder on east side of stream. Canker forming internal crevice. While large, due to position on trunk categorised as Moderate.  Roost Suitability: Moderate

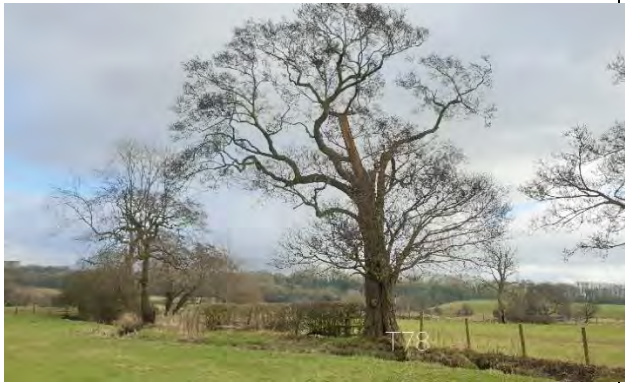
TEP ID	Unique Arb ID	Grid Ref	Description	
BT78	T176	SD 73841 43632	Larger alder within line of trees on field boundary edge. Subject to storm damage with large split all the way up main trunk to main bifurcations. Potentially hollow trunk with cankers, knot holes, branch splits.  Roost Suitability: High

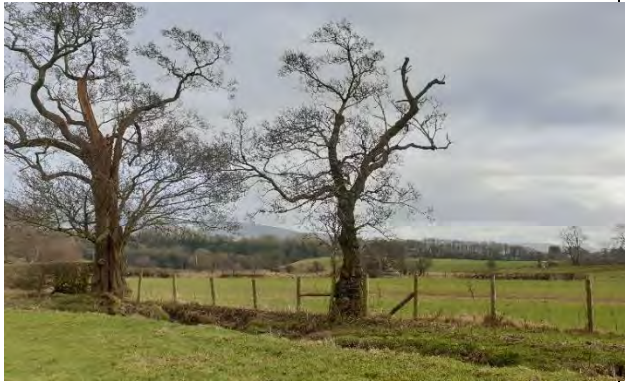
BT79	T174	SD 73841 43632	Alder with branch split near top southern limb.  Roost Suitability: Moderate

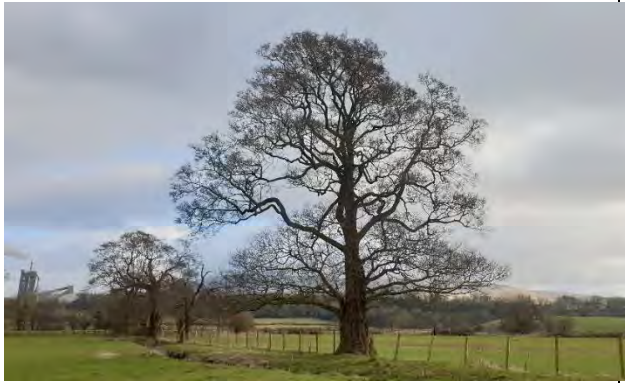
BT80	T175	SD 73813 43634	Large, mature alder with number of small crevices in main stem.  Roost Suitability: Moderate

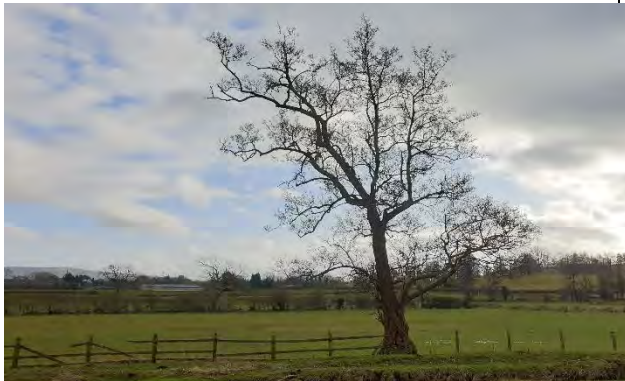
BT81	T179	SD 73786 43624	Mature alder with open wound in north facing branch and small open fissure on main stem. Some deadwood present.  Roost Suitability: Moderate

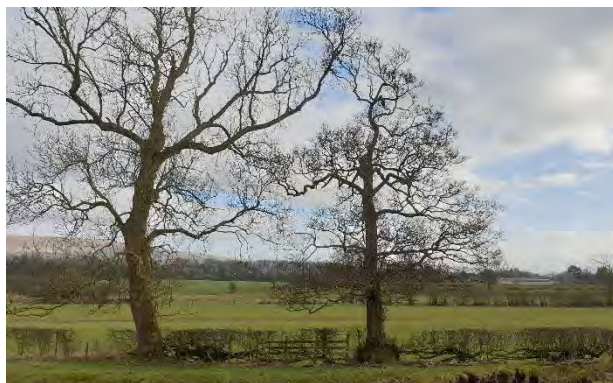
TEP ID	Unique Arb ID	Grid Ref	Description	
BT82	T182	SD 73767 43617	Ash east of stream with ash dieback. Limb split open resulting in cavities. Cankers and large knot hole towards the top of the tree also present.  Roosting Suitability: High

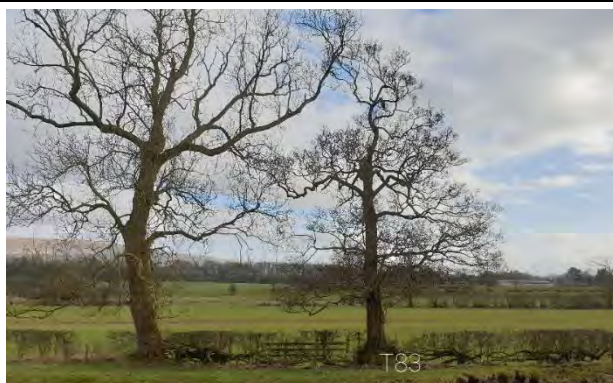
BT83	T185	SD 73759 43613	Alder, east of stream within hedge with split branch at top of the tree and decay resulting in small cavities at point of stem failure.  Roosting Suitability: Low

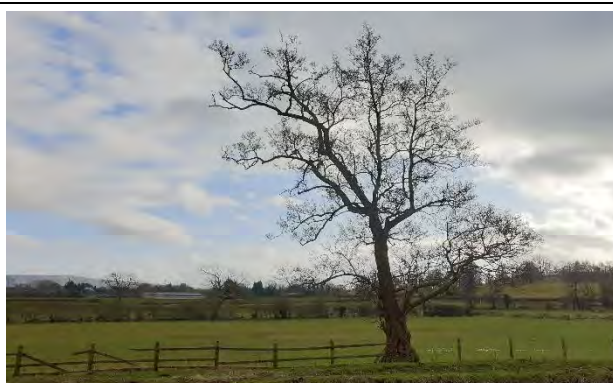
BT84	T194	SD 73728 43600	Alder east of stream with canker hole at branch junction and small cavity at from basal wound.  Roosting Suitability: Low

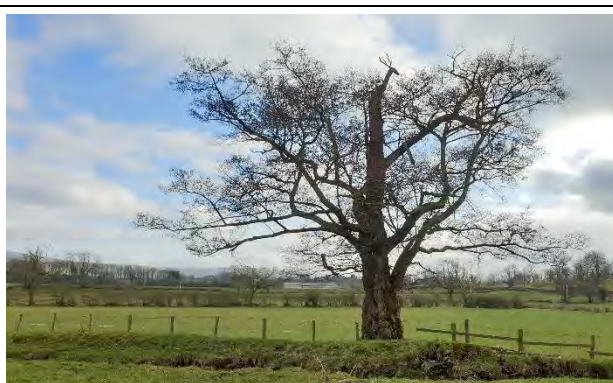
BT85	T192	SD 82165 12654	Large alder on south side of stream with contorted stem. Storm damage resulting in decaying stem and large compression fork crevice; the top of the trunk is rotting and the lifting bark also providing a roosting feature.  Roost Suitability: High

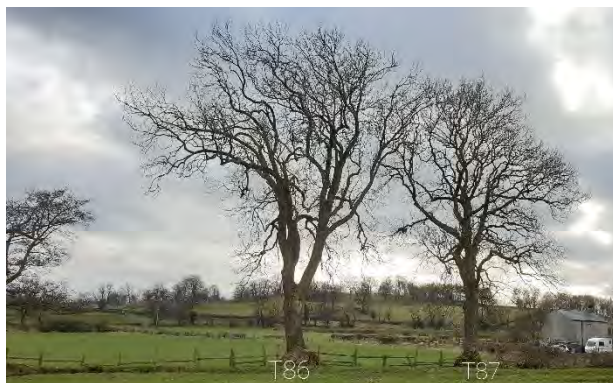
TEP ID	Unique Arb ID	Grid Ref	Description	
BT86	T190	SD 82135 12638	Mature ash with open canker hole at base of branch junction and occasional limbs with longitudinal cracks towards base.  Roost Suitability: Moderate.

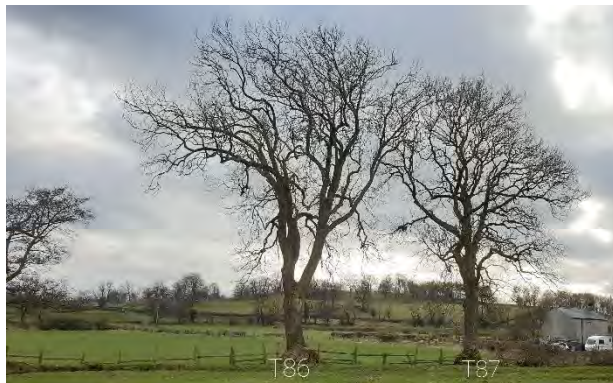
BT87	T188	SD 82161 12638	Ash with small branch splits and knot holes.  Roost Suitability: Moderate

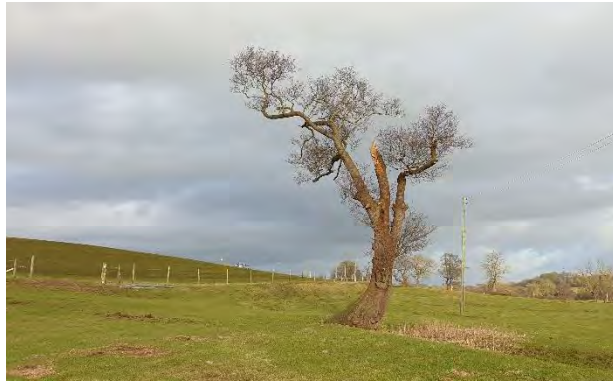
BT88	T157	SD 73685 43674	Alder subject to storm damage and decay, resulting in large split / failures in main stem.  Roost Suitability: High

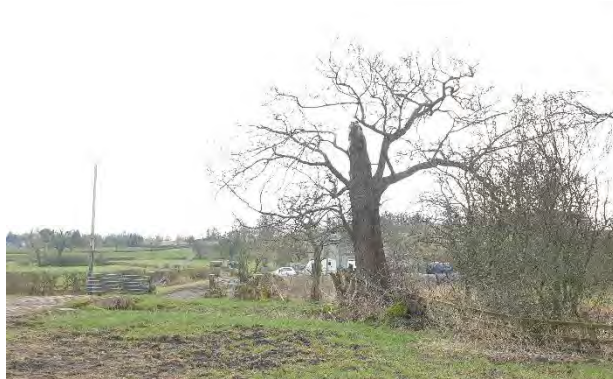
BT95	T170	SD 73622 43636	Alder on eastern side of stream bank with open trunk forming internal crevice. Small branch and stem cavities, in addition to lifting bark; all providing PRFs.  Roost Suitability: High

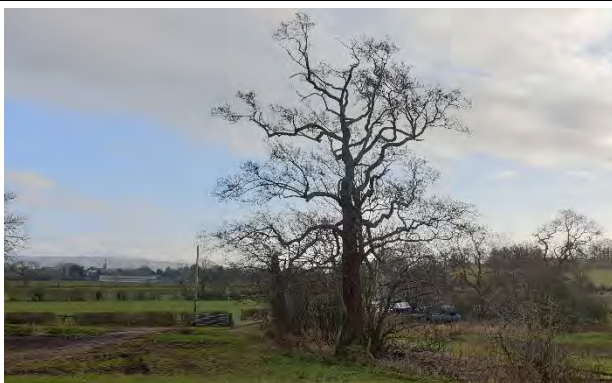
TEP ID	Unique Arb ID	Grid Ref	Description	
BT96	T167	SD 73617 43646	Alder on eastern side of stream with failed stem; decay within large open wound, cavitation north and number of holes throughout the tree.  Roost Suitability: High

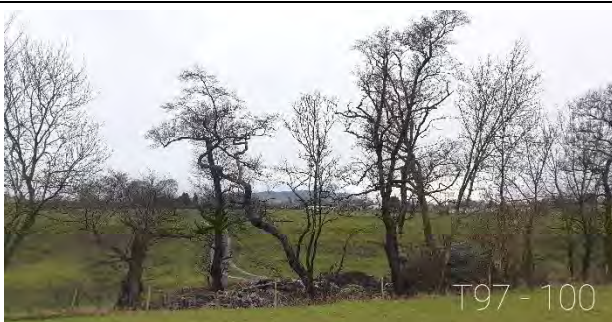
BT97	G76	SD 73575 43692	Alder overhanging west side of stream. Due to storm damage, cavity at point of stem failure at around 4m high, and large transverse break in west limb.  Roost Suitability: High

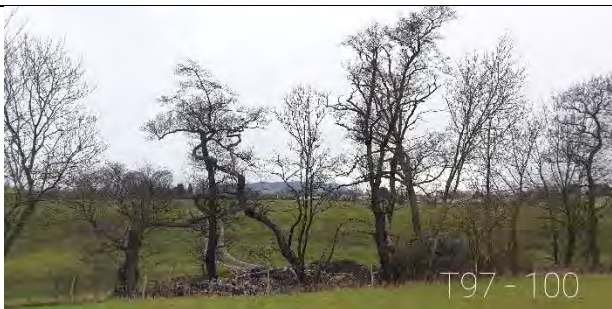
BT98	G76	SD 73573 43695	Fairly young alder tree overhanging west side of stream with decaying trunk resulting in a number of open holes throughout structure.  Roost Suitability: Moderate

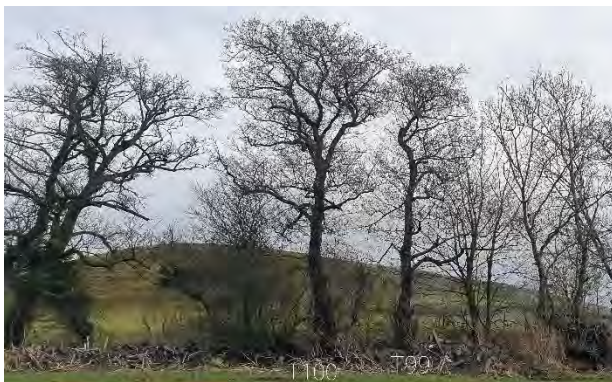
BT99	G76	SD 73568 43701	Fairly young alder tree overhanging west side of stream with small split in main trunk.  Roost Suitability: Low

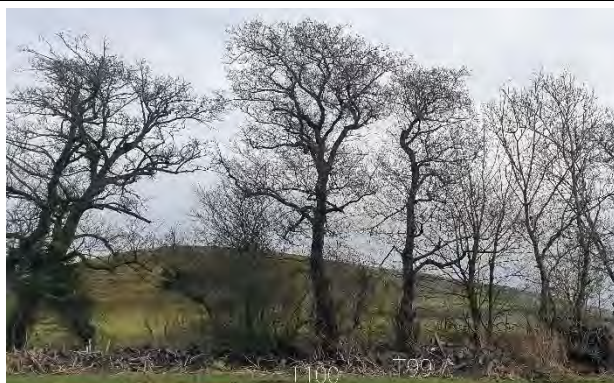
TEP ID	Unique Arb ID	Grid Ref	Description	
BT 100	G73	SD 73568 43701	Fairly young alder growing on / around manmade rubble pile on western side of stream, with transverse split in branch.  Roost Suitability: Moderate.

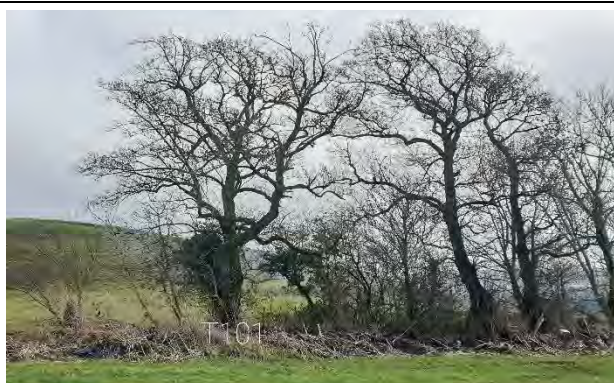
BT 101	G69	SD 73565 43705	Alder on west side of stream with few knot holes.  Roost Suitability: Low

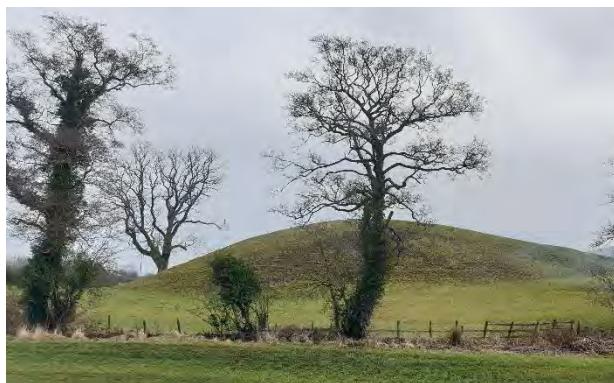
BT 102	T141	SD 73545 43737	Ivy clad alder on eastern side of stream. Ivy possibly obscuring potential roost features.  Roost Suitability: Low	No photo available
BT 103	T135	SD 73549 43754	Ivy clad alder on eastern side of stream, possibly obscuring potential roost feature.  Roost Suitability: Low

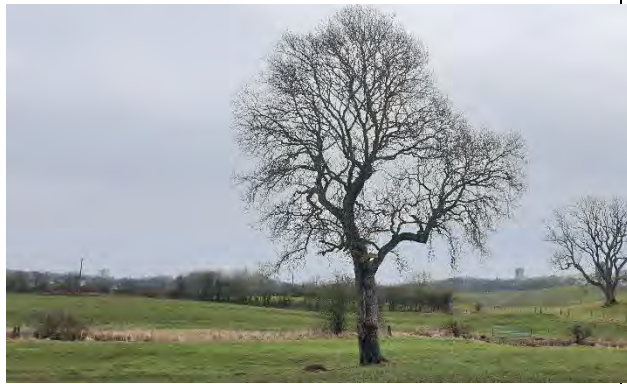
TEP ID	Unique Arb ID	Grid Ref	Description	
BT 104	T115	SD 73506 43795	Mature pedunculate oak within open field. Large wound on trunk leading to large central cavity in main stem, west facing. Split limbs and crevices.  Roost Suitability: High
