1 Project Details			
Project Name:	Haweswater Aqueduct Resilience Programme	Project Number:	80061155
Written:	Mark Breaks, Senior Field Ecologist	Approved:	Alice Helyar, Principal Ecologist
Report reference:	TR3 Ecology Survey Data Report_2022_Bat tree assessment Phase 2	Date:	13/10/2022
2 Project Drawings			
Bat Tree Assessment Phase 2		BOW167_HARP_TR3 Bat tree assessment Phase 2_Oct 2022 (Plans 3 of 3)	
4 Ecology Surveys			
Surveyors:	Mark Breaks (NE licence: 2016-26712-CLS-CLS) Paula Hollings (NE licence: 2015- 16053-CLS-CLS) Ryan Knight (NE licence holder) Non Scott (NE licence: 2019-39208-CLS-CLS) Curtis Blank Luke Hall Sam Robinson Jordan Simpson Jack Taylor		
Additional dusk emergence surveyors:	Dave Anderson (NE licence: 2015-15784-CLS-CLS) Dave Fisher (NE licence: 2015-12106-CLS-CLS) Jack Sykes (NE licence: 2015-16340-CLS-CLS) Lucy Brookfield Felicity Cunliffe Davies Joanna Day Anielia James Nina Morris Vinny Smith

4.1 Survey Results – Table of Phase 2 High and Moderate Trees (Including Survey Dates)

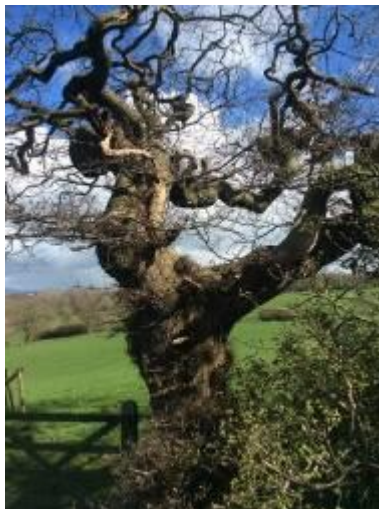
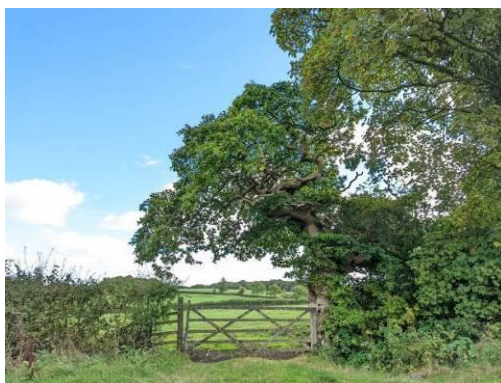
TR3.BT3

Butt-rott - small entrance 15x15 cm, at ground level behind gate facing NW, internal 100 cm height, 10cm width, 0 cm depth. Rough, chambered, debris.

Knot-hole on limb at 4 m N, 7x7 cm entrance, internal 0 cm height, 7 cm width, 30 cm depth, rough and dry with old bird nest present.

Cavity - 30 x 5 cm entrance, internal 2 cm height, 10 cm width, 1.5 m depth, damp, rough, horizontal tube and no smell.

Numerous branch cavities and crevices with split heartwood and lifted bark creating numerous opportunities for crevice dwelling species at 3-5 m.

- 29th Jul – close inspection (ladder) – no evidence of bats noted;
- 23rd Aug – dusk emergence – no bat emergence; and
- 5th Sep – dusk emergence – no bat emergence.

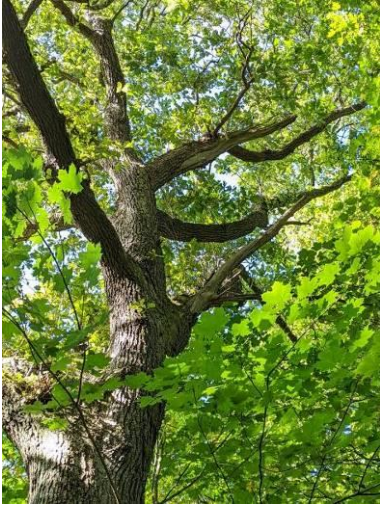
TR3.BT17

<p>NGR: SD 62113 66417</p> <p>Species: Oak species</p> <p>Categorisation: Moderate potential</p> <p><u>2022 Inspection</u></p> <p>Mature oak, 70 cm Diameter at Breast Height (DBH), 20+m, multiple dead limbs in cavity with exposed heartwood though only limited lifted bark on low limb at 4 m, 30 cm Diameter at PRF Height (DPH) facing SE, knot-hole at 7 m SE, 10x10 cm entrance hidden within remaining heartwood, internal 0 cm height, 20 cm width and 20 cm depth. Rough, dry, no smell, no apex and slugs present.</p> <p>Lightning strike, 50 cm DPH at 12 m N. Entrance 60x10 cm, internal 60 cm height tube that is open to the top, 12 cm width and 0 cm depth. Damp, rough, no smell, tube, occasional sheltered location in tube/ramshorn.</p> <p><u>2022 Results</u></p> <ul style="list-style-type: none"> • 29th Jul – close inspection (climb) – no evidence of bats noted; and • 27th Sep – close inspection (climb) – no evidence of bats noted.

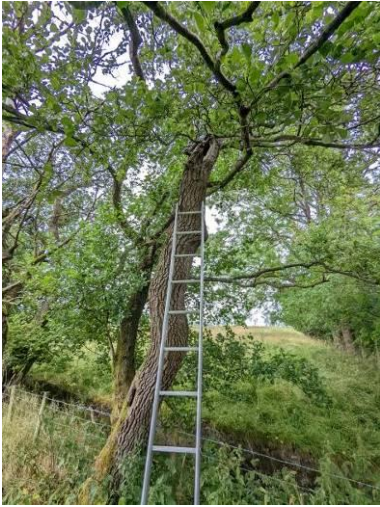
TR3.BT110

<p>NGR: SD 69076 49954</p> <p>Species: Alder</p> <p>Categorisation: High potential</p> <p><u>2022 Inspection</u></p> <p>Tear-out at 5m west with entrance 40x10 cm, internal 130 cm height, 10 cm width and 500 cm depth. Feature extends to ground with additional three access points. Smooth, no smell, dry, dome, no evidence of bats. Upgrade to High potential.</p> <p><u>2022 Results</u></p> <ul style="list-style-type: none"> • 22nd Jul – close inspection (ladder) – no evidence of bats noted; • 26th Aug – close inspection (ladder) – no evidence of bats noted; and • 27th Sep – close inspection (ladder) – no evidence of bats noted.

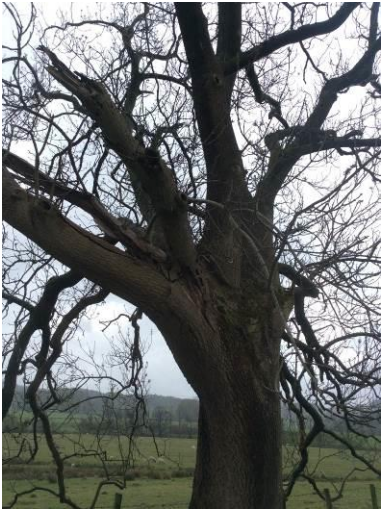
TR3.BT124

<p>NGR: SD 69293 49934</p> <p>Species: Ash</p> <p>Categorisation: Moderate potential</p> <p><u>2022 Inspection</u></p> <p>Knot-hole at 8m N with entrance 20x35 cm and internally 150+ cm height, 20 cm width and 0 cm depth. Hazard-beam on limb at 6 m N with entrance 3x100 cm and internally 100 cm height, 10 cm width and 12 cm depth. Additional knot-hole at 5 m N and 4 m NW offer no potential.</p> <p><u>2022 Results</u></p> <ul style="list-style-type: none"> • 21st Jul – close inspection (climb) – no evidence of bats noted; and • 15th Aug – dusk emergence – no bat emergence.
TR3.BT125

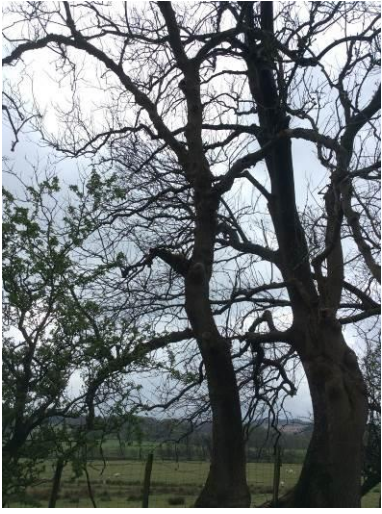
<p>NGR: SD 69303 49931</p> <p>Species: Ash</p> <p>Categorisation: High potential</p> <p><u>2022 Inspection</u></p> <p>Tear-out at 7 m E with entrance 20x12 cm and internally 0 cm height, 12 cm width and 100+ cm depth. Knot-hole on limb at 5 m W with entrance 5x12 cm and internally 100+ cm height, 20 cm width and 0 cm depth. Wound on limb at 6 m E with entrance 20x8 cm and internally 25 cm height, 8 cm width and 35 cm depth. Additional butt-rot present. Upgrade to High potential.</p> <p><u>2022 Results</u></p> <ul style="list-style-type: none"> • 21st Jul – close inspection (climb) – no evidence of bats noted; • 15th Aug – dusk emergence – no bat emergence; and • 29th Aug – dusk emergence – no bat emergence.

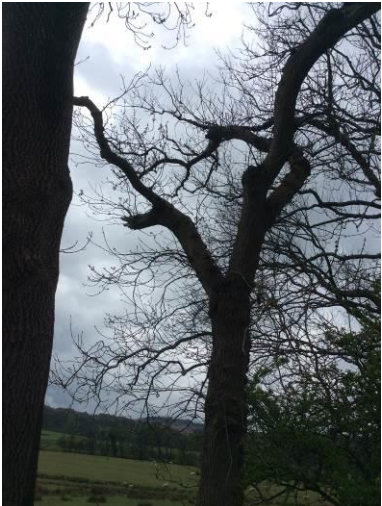
TR3.BT126

<p>NGR: SD 69315 49929</p> <p>Species: Ash</p> <p>Categorisation: Moderate potential</p> <p><u>2022 Inspection</u></p> <p>Butt-rot at 0-1 m.</p> <p><u>2022 Results</u></p> <ul style="list-style-type: none"> • 21st Jul – close inspection (ground) – no evidence of bats noted; and • 15th Aug – dusk emergence – no bat emergence.
TR3.BT127

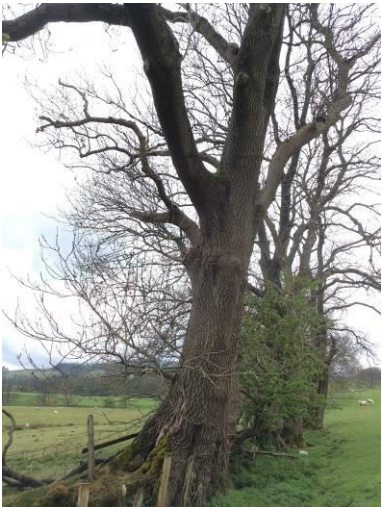
<p>NGR: SD 69324 49928</p> <p>Species: Ash</p> <p>Categorisation: Moderate potential</p> <p><u>2022 Inspection</u></p> <p>Butt-rot at 1 m NW with entrance 20x6 cm and internally 1 cm height, 150 cm width and 20 cm depth.</p> <p><u>2022 Results</u></p> <ul style="list-style-type: none"> • 21st Jul – close inspection (ground) – no evidence of bats noted; and • 15th Aug – dusk emergence – no bat emergence.
TR3.BT142

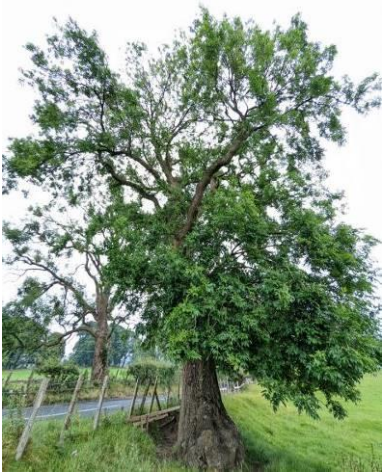
<p>NGR: SD 69972 50190</p> <p>Species: Ash</p> <p>Categorisation: Moderate potential</p> <p><u>2022 Inspection</u></p> <p>Knot-hole at 8 m NW with entrance 25x9 cm and internally 55 cm height, 23 cm width and 2 cm depth.</p> <p><u>2022 Results</u></p> <ul style="list-style-type: none"> • 26th Jul – close inspection (climb) – no evidence of bats noted; and • 27th Sep – close inspection (climb) – no evidence of bats noted.

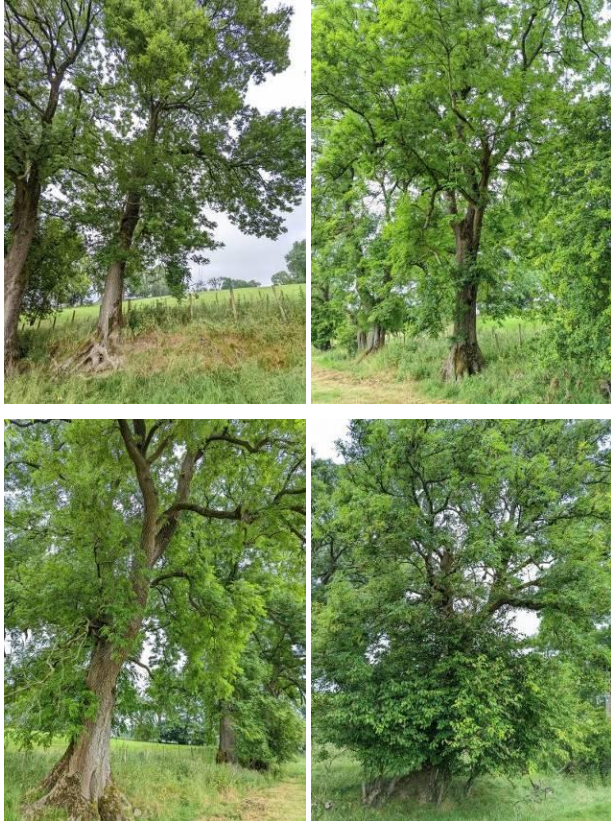
TR3.BG32	
<p>Trees 1-4</p>

<p>Species: Ash's</p> <p>Categorisation: Moderate potential</p> <p>Number of trees: four</p> <p><u>2022 Inspection</u></p> <p>Moderate potential trees on edge of redline boundary.</p> <p>Tree 1 – Ash (NGR: SD 69671 50099), 90 cm DBH, knot-hole at 5 m SW and 10 m E.</p> <p>Tree 2 – Ash (NGR: SD 69661 50086), 120 cm DBH, knot-holes at 8 m N, 10 m S, 16 m E.</p> <p>Tree 3 – Ash (NGR: SD 69658 50078), 160 cm DBH, knot-hole at 18 m W.</p> <p>Tree 4 – Ash (NGR: SD 69640 50065), 70 cm DBH, knot-hole at 11 m SW.</p> <p><u>2022 Results</u></p> <ul style="list-style-type: none"> • 4th Aug – dusk emergence – no bat emergence; and • 7th Sep – dusk emergence – no bat emergence.
TR3.BG33.T2

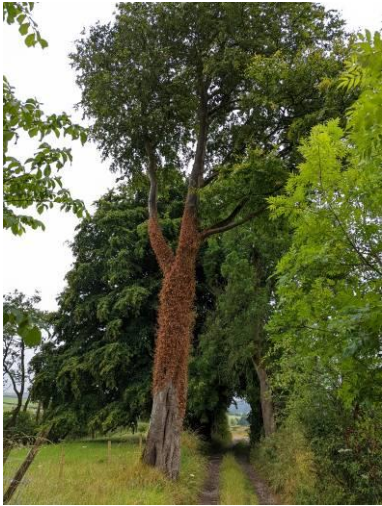
<p>Species: Beech</p> <p>Categorisation: Moderate potential</p> <p><u>2022 Inspection</u></p> <p>Tree 2 – Beech (NGR: SD 69750 50131), 110 cm DBH, fluting leading to truck cavity at 1 m, 2 m and 3 m E. Bottom two flutes connect with internal 15 cm height and 10 cm width and 40 cm depth. Entrance 30x 5 cm. Third flutes offers shallow crevice. Dead ivy cladding is a low potential feature.</p> <p><u>2022 Results</u></p> <ul style="list-style-type: none"> • 22nd Jul – close inspection (ladder) – no evidence of bats noted; and • 26th Aug – close inspection (ladder) – no evidence of bats noted.

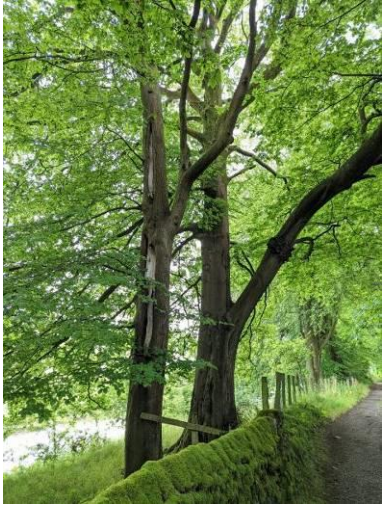
TR3.BG34.T1

<p>Species: Beech</p> <p>Categorisation: Moderate potential</p> <p><u>2022 Inspection</u></p> <p>Tree 1 – Beech (NGR: SD 69809 50259), 40 cm DBH, wound on main stem from 2-9 m East.</p> <p><u>2022 Results</u></p> <ul style="list-style-type: none"> • 11th Aug – dusk emergence – no bat emergence; and • 31st Aug – dusk emergence – no bat emergence.
TR3.HBG15.T1-T3	
<p style="text-align: center;">Trees 1-3</p> <div style="display: flex; justify-content: space-around;">

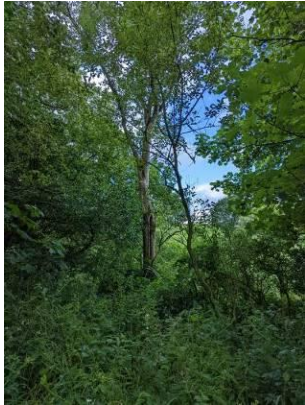
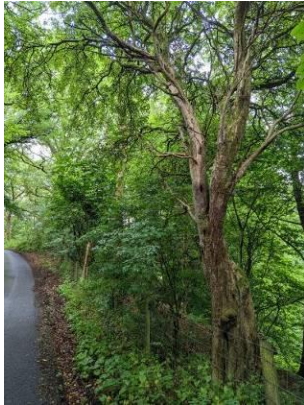
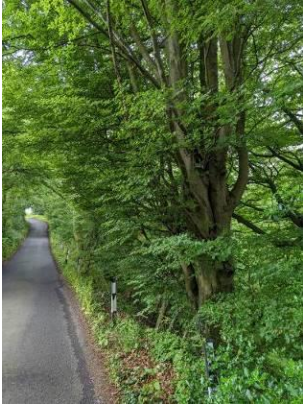
</div>	<p>Species: Ash, crab apple & beech</p> <p>Categorisation: Moderate potential</p> <p>Number of trees: three</p> <p><u>2022 Inspection</u></p> <p>Tree 1 – Ash (NGR: SD 62059 66407), DBH 40cm, on edge of field. Butt-rott, entrance 2.5 m by 10 cm, internal 40 cm height, 20 cm width, 0 cm depth with narrow tube going up. Dry, rough, dome, woodlice. Moderate potential</p> <p>Tree 2 – Crab apple (NGR: SD 62130 66396), DBH 40 cm, knot-hole at 2.5 m facing north. Entrance 10 cm high by 3 cm wide, internal 10 cm height, 10 cm width, 5 cm depth. Rough, dry, dome, slugs and woodlice. Moderate Potential</p> <p>Tree 3 – Beech (NGR: SD 62141 66339), 90 cm DBH with compression fork at 3 m E, entrance 30x2 cm, with 25 cm depth and shallow fluting on the SE elevation offer PRF. Ladder/climb. Moderate Potential</p> <p><u>2022 Results</u></p> <ul style="list-style-type: none"> • 14th Jul – close inspection of T1 & T2 (ladder) – no evidence of bats noted; • 29th Jul – close inspection of all (ladder) – no evidence of bats noted; and • 27th Sep – close inspection of all (ladder) – no evidence of bats noted.

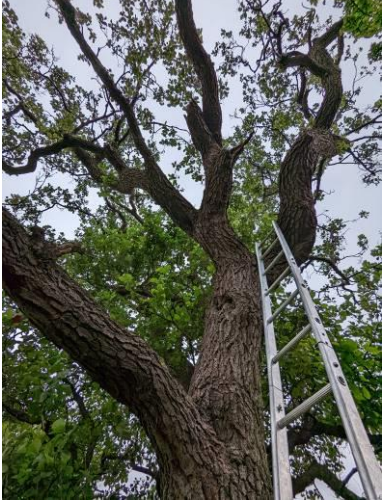
<p>NGR: SD 68951 50103</p> <p>Species: Alder</p> <p><u>2022 Inspection</u></p> <p>No potential bat roost features located during ground inspection. Categorisation downgraded to Negligible.</p>
TR3.BT117

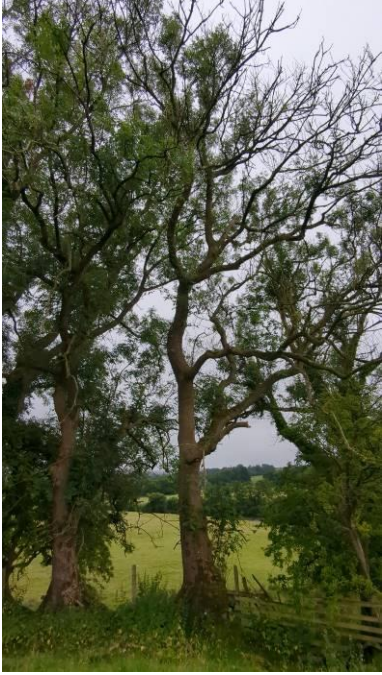
<p>NGR: SD 69200 49939</p> <p>Species: Ash</p> <p>Categorisation: Moderate downgraded to Low potential</p> <p><u>2022 Inspection</u></p> <p>Tear-out at 3.5m N found to offer low potential for roosting bats during climb inspection. Categorisation downgraded to Low.</p>

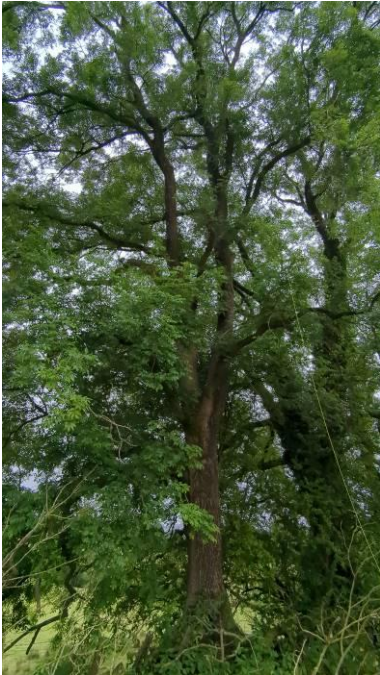
TR3.BT119

<p>NGR: SD 69213 49940</p> <p>Species: Ash</p> <p>Categorisation: Moderate downgraded to Low potential</p> <p><u>2022 Inspection</u></p> <p>Knot-holes at 5m SE, 7m W and 8m SE found to offer low or no potential for roosting bats during climb inspection. Categorisation downgraded to Low.</p>
TR3.BT121

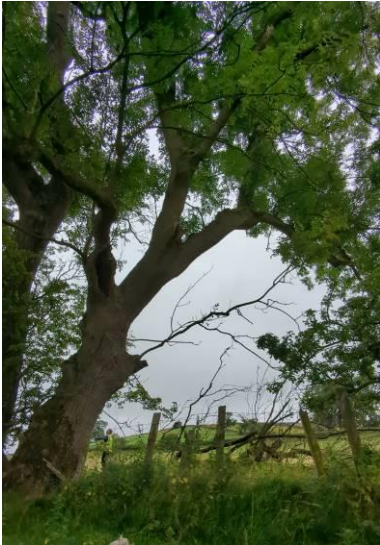
<p>NGR: SD 69225 49942</p> <p>Species: Ash</p> <p><u>2022 Inspection</u></p> <p>No potential bat roost features located during climb inspection. Tear-out feature found no suitable bat roosting habitat. Categorisation downgraded to Negligible.</p>
TR3.BT128

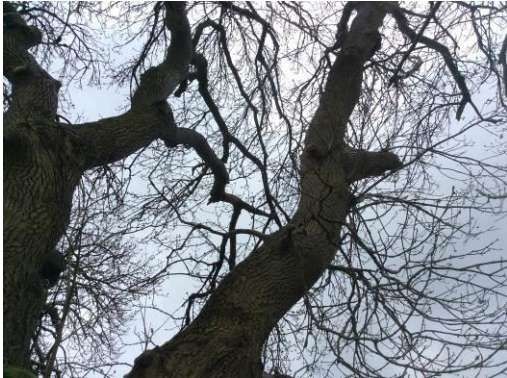
<p>NGR: SD 69334 49927</p> <p>Species: Ash</p> <p><u>2022 Inspection</u></p> <p>Following climbing inspection tree downgraded to Low potential.</p>
TR3.BT136

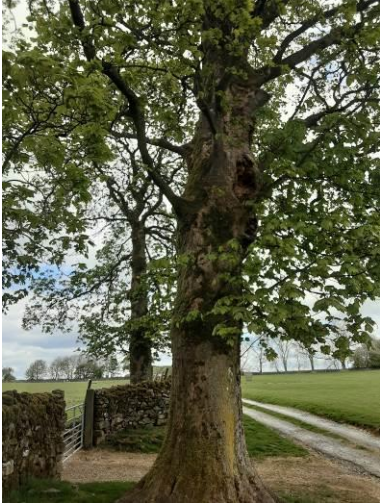
<p>NGR: SD 68741 51041</p> <p>Species: Sycamore</p> <p><u>2022 Inspection</u></p> <p>Knot-hole at 10m found to offer low potential for roosting bats during climb inspection. Categorisation downgraded to Low.</p>
<p>TR3.BT137</p>

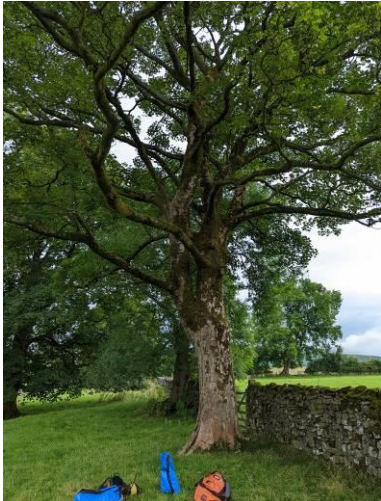
<p>NGR: SD 68699 51066</p> <p>Species: Sycamore</p> <p><u>2022 Inspection</u></p> <p>No potential bat roost features located during ground inspection. Pruning wounds at 4-6m are all well-sealed and offer no roosting potential. Categorisation downgraded to Negligible.</p>
<p>TR3.BG2</p>

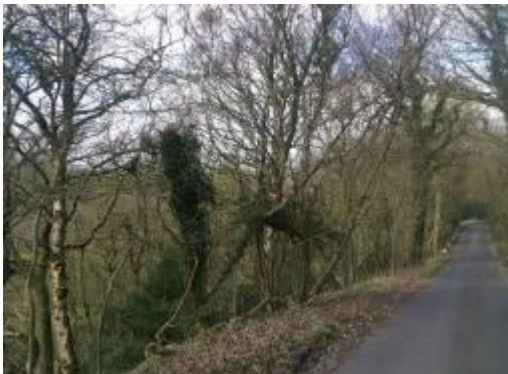
<p>NGR: SD 62160 66302</p> <p>Species: Oak, sycamore, beech, holly, silver birch</p> <p>Number of trees: 10</p> <p><u>2022 Inspection</u></p> <p>No trees with moderate or high potential bat roost features located during ground inspection within survey boundary except for those included in TR3.HBG15.T1-T3.</p>

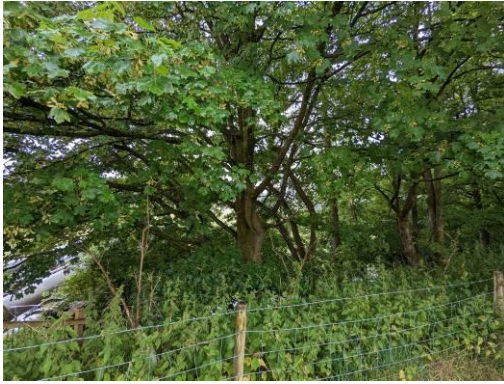
TR3.BG28

<p>NGR: SD 69009 49910</p> <p>Species: Oak, sycamore, alder, ash, cypress (<i>Cupressus</i> sp.), conifer species</p> <p>Number of trees: 10</p> <p><u>2022 Inspection</u></p> <p>No trees with moderate or high potential bat roost features located during ground inspection within survey boundary.</p>
TR3.BG33.T1 & T3

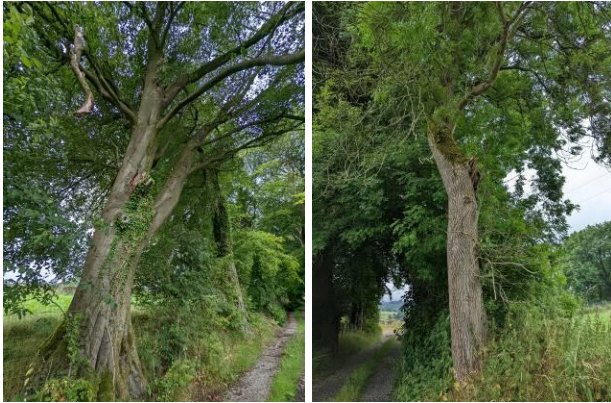
<p><u>2022 Inspection</u></p> <p>Inspection of moderate potential tree group on edge of redline boundary resulted in the downgrade of two trees.</p> <p>Tree 1 – Beech (NGR: SD 69763 50163), 120cm DBH, knot-hole at 4m SW, transverse snap at 8m N, climbing inspection found knot holes at 8m (N) and 12m (SE) to offer Low potential.</p> <p>Tree 3 – Ash (NGR: SD 69746 50122), 60cm DBH, tear-out at 5m facing NE. Inspected, shallow crevice and Ramshorn from 1-4m. Low potential.</p>
TR3.BG34.T2-T5

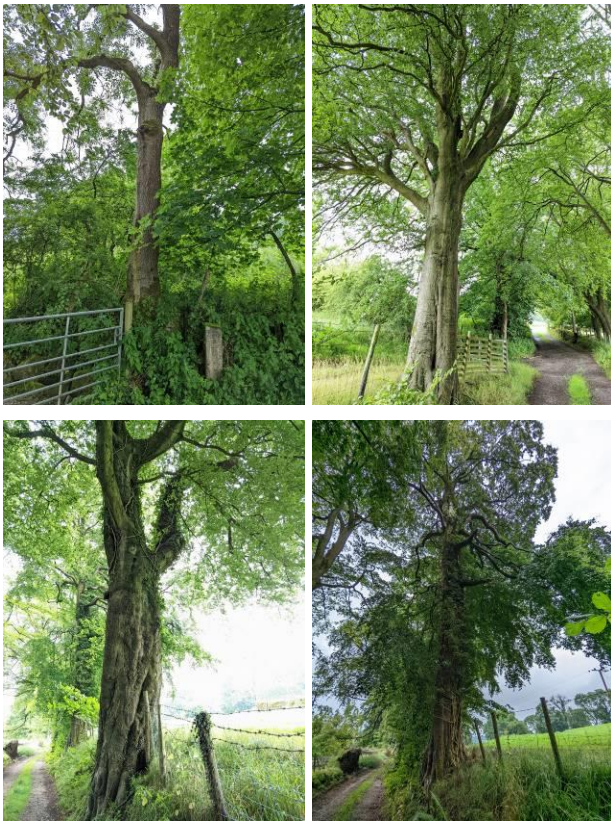
<p><u>2022 Inspection</u></p> <p>Inspection of moderate potential tree group on edge of redline boundary resulted in the downgrade of four trees.</p> <p>Tree 2 – Ash (NGR: SD 69796 50246), 50DBH, knot-hole at 6m SW, ladder inspection found no PRF features. Negligible Potential.</p> <p>Tree 3 – Beech (NGR: SD 69793 50238), 100cm DBH, flute on upward facing branch at 12m on NE side of tree. Climbing inspection found tree to offer Low potential.</p> <p>Tree 4 – SD 69775 50198 beech 130m, knot-hole on limb NE facing at 7m. Climbing inspection found knot hole to offer Low potential.</p> <p>Tree 5 – Beech (NGR: SD 69772 50188), 100cm DBH, knot-hole on NE side of main stem at 5m. Ladder inspection found no PRF features. Negligible Potential.</p>

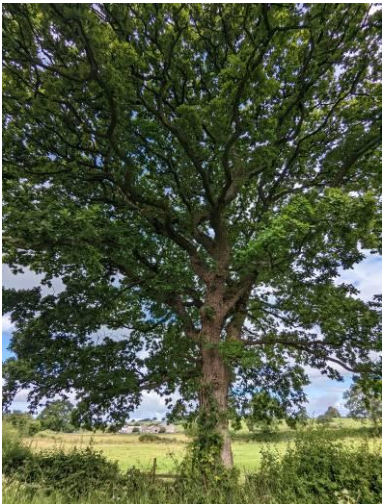
<p>NGR: SD 63902 68062</p> <p>Species: oak</p> <p><u>2022 Inspection</u></p> <p>No potential bat roost features located during ground inspection. Categorisation downgraded to Negligible.</p>

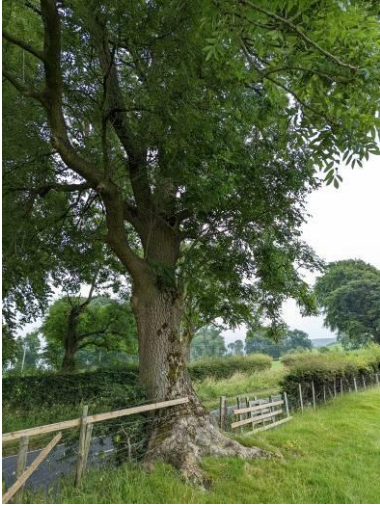
TR4.HBT10

<p>NGR: SD 70004 50143</p> <p>Species: Ash</p> <p><u>2022 Inspection</u></p> <p>No potential bat roost features located during ladder inspection. Categorisation downgraded to Negligible.</p>
TR4.HBG11

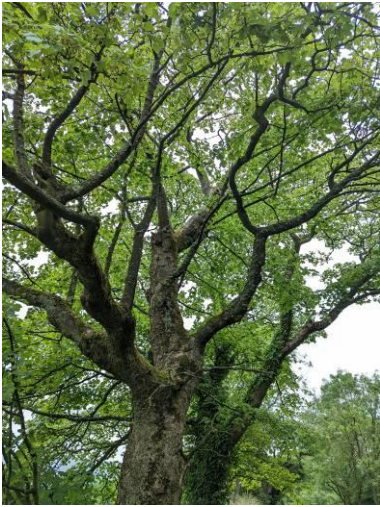
<p>NGR: SD 70490 48876</p> <p>Species: Sycamore</p> <p>Number of trees: 2</p> <p><u>2022 Inspection</u></p> <p>No potential bat roost features located during ground inspection. Categorisation downgraded to Negligible.</p>
TR4.HBG16

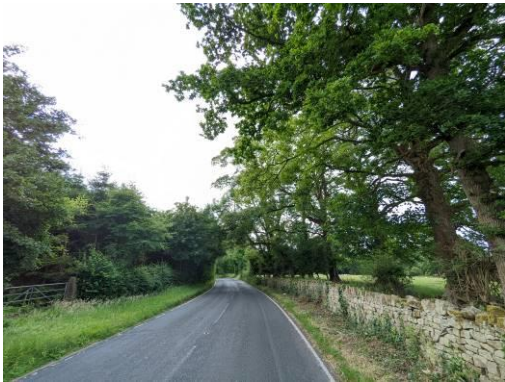
<p>NGR: SD 72414 44326</p> <p>Species: Ash, sycamore and alder</p> <p>Number of trees: 8</p> <p><u>2022 Inspection</u></p> <p>No trees with potential bat roost features located during ground inspection within survey boundary.</p>

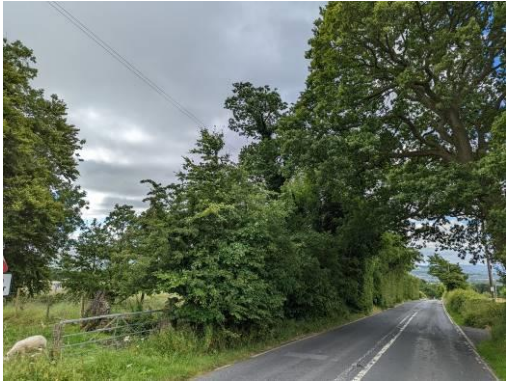
TR4.HBG44

<p>NGR: SD 72331 45172</p> <p>Species: Ash and alder</p> <p>Number of trees: 3</p> <p><u>2022 Inspection</u></p> <p>No trees with potential bat roost features located during ground inspection within survey boundary.</p>
