**Haweswater Aqueduct Resilience Programme - Proposed Marl Hill
Section**

Environmental Statement

Appendix 7.3: Geomorphology Proformas

June 2021

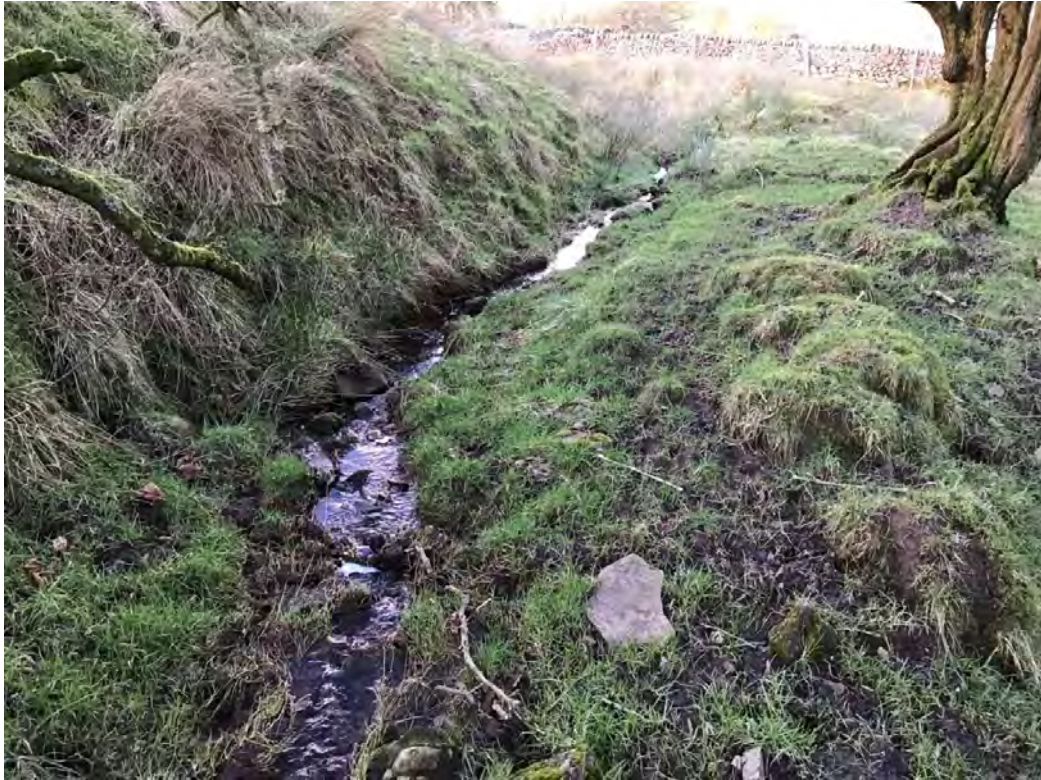
Illustration 1: Upstream view of riparian vegetation

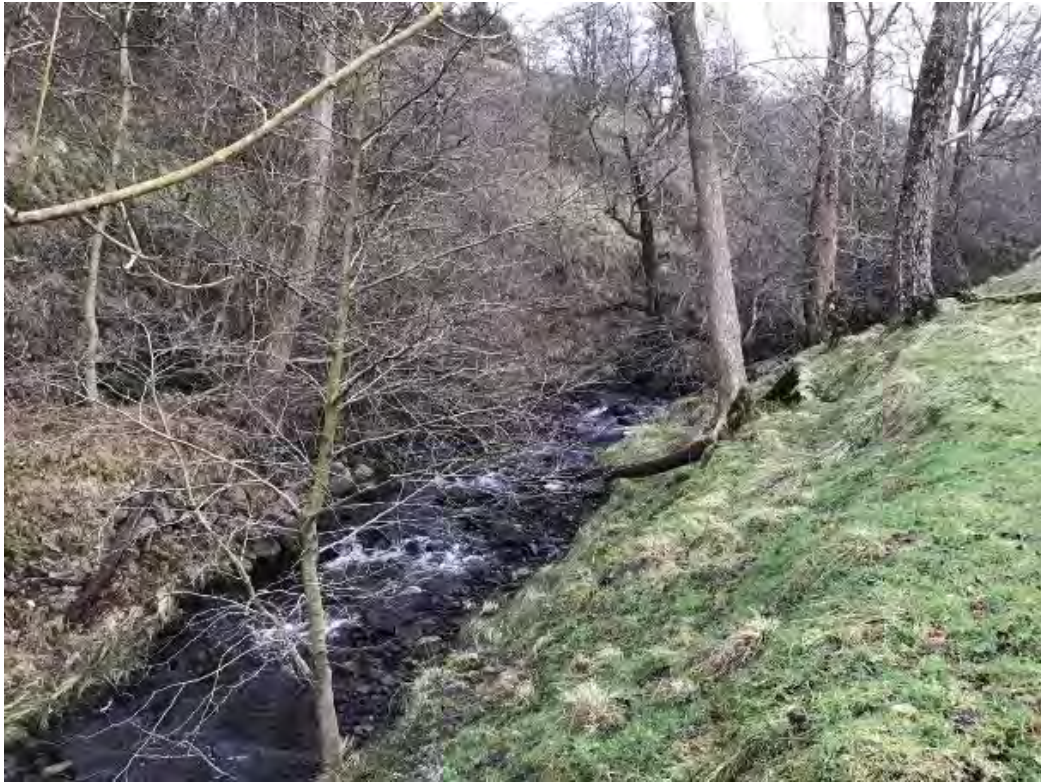
Illustration 2: Upstream view at upstream end of surveyed reach. Varied flow

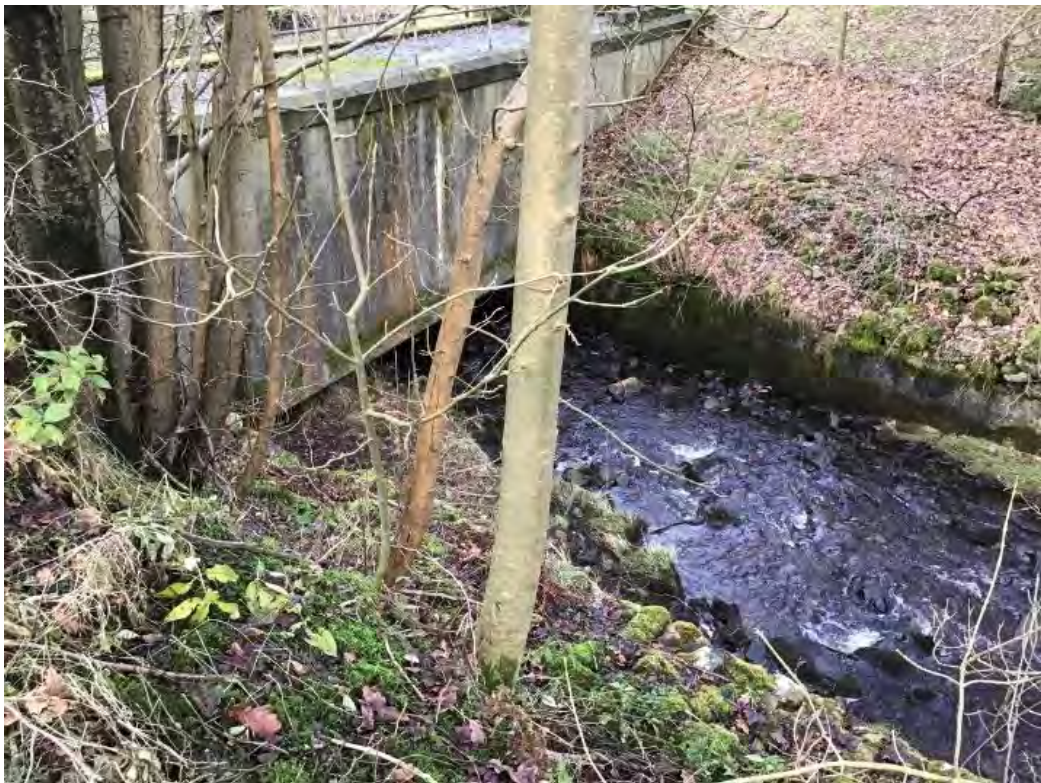
Illustration 3: Downstream view. Haweswater aqueduct pipe bridge

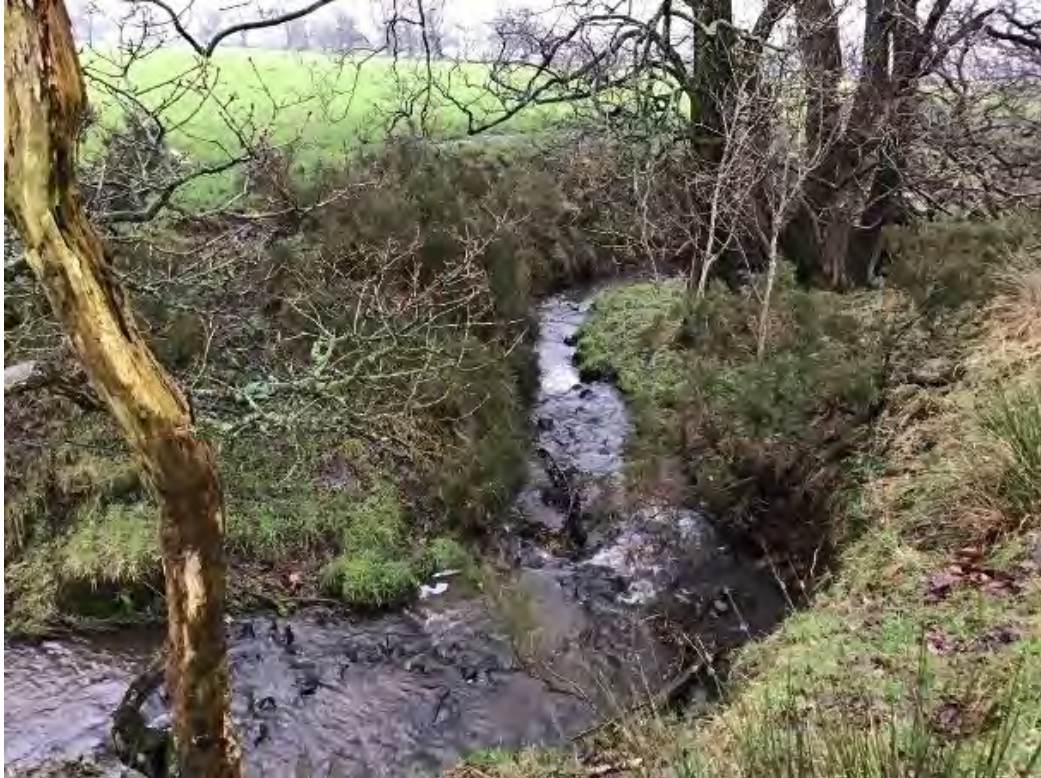
Illustration 4: Downstream view of varied flow types

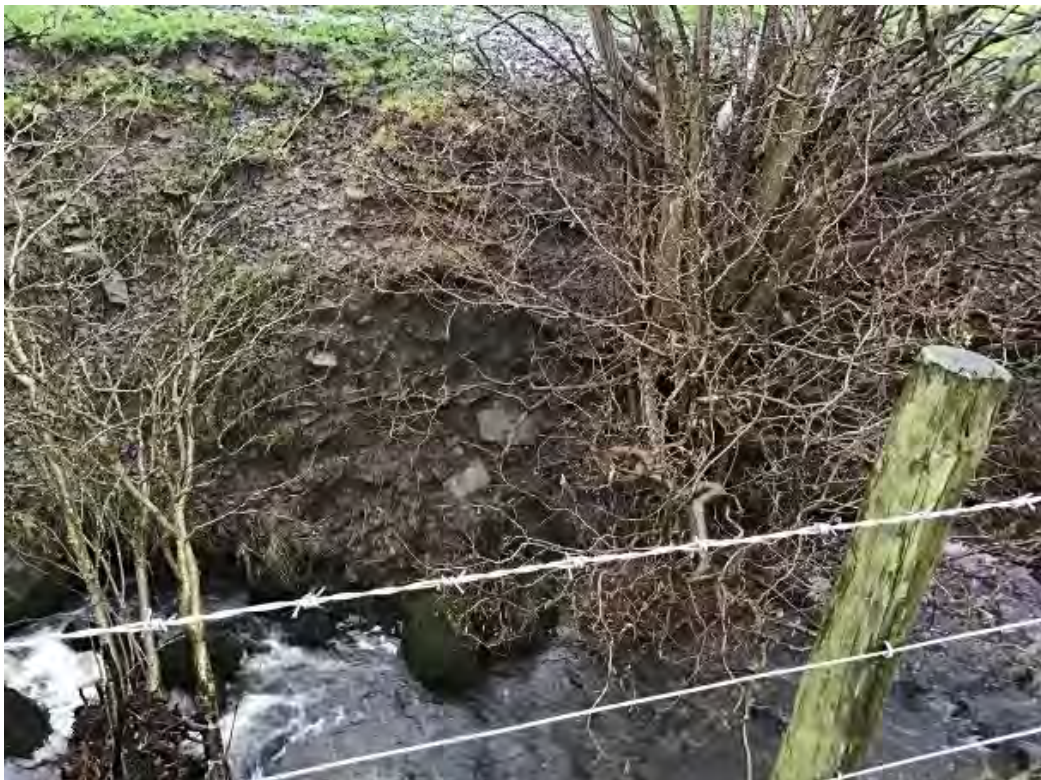
Illustration 5: View from right bank to left bank. Left bank erosion

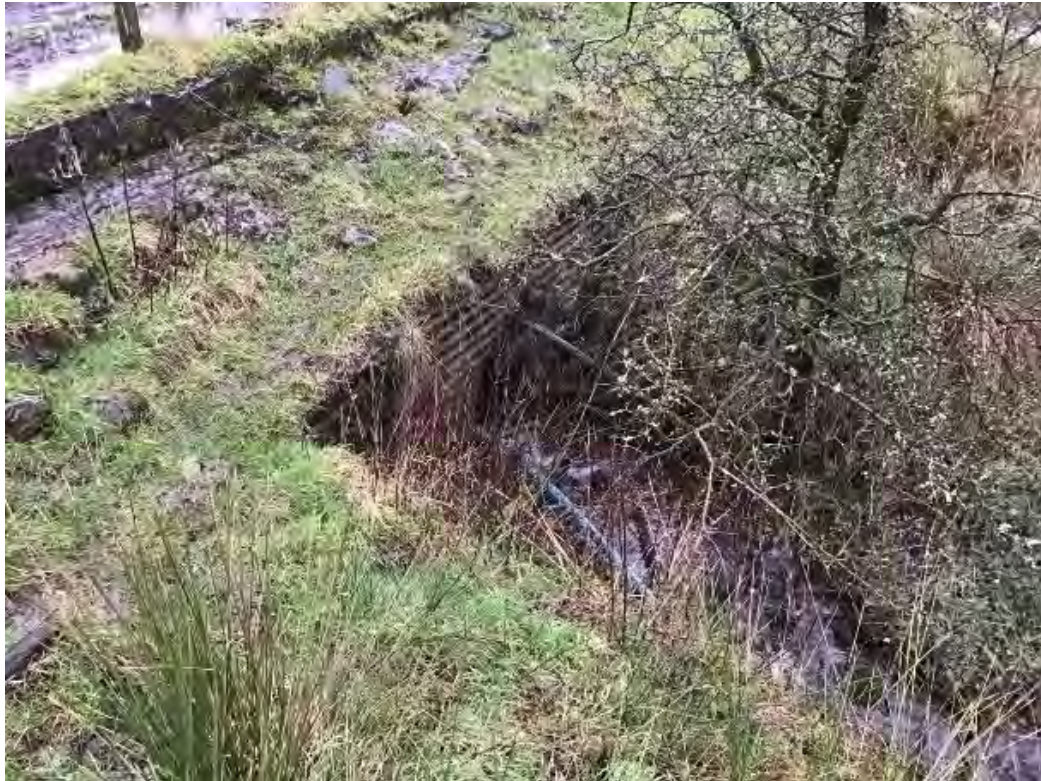
Illustration 6: Upstream view of culvert

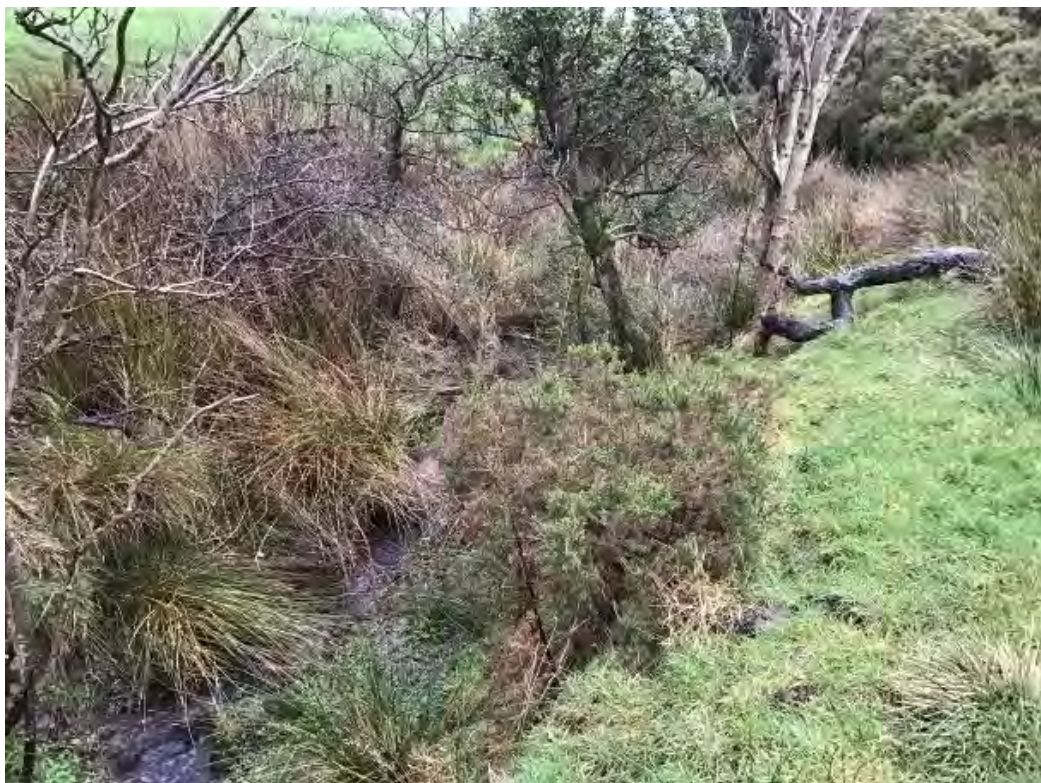
Illustration 7: Downstream view showing riparian vegetation

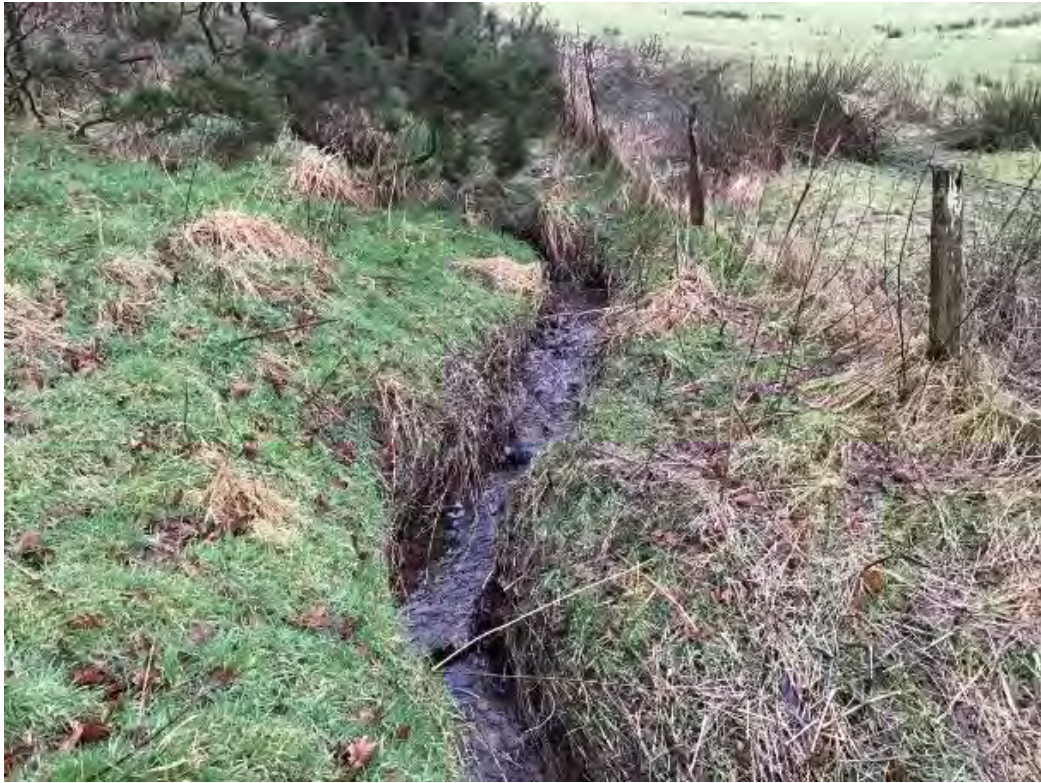
Illustration 8: Upstream view. Rippled flow

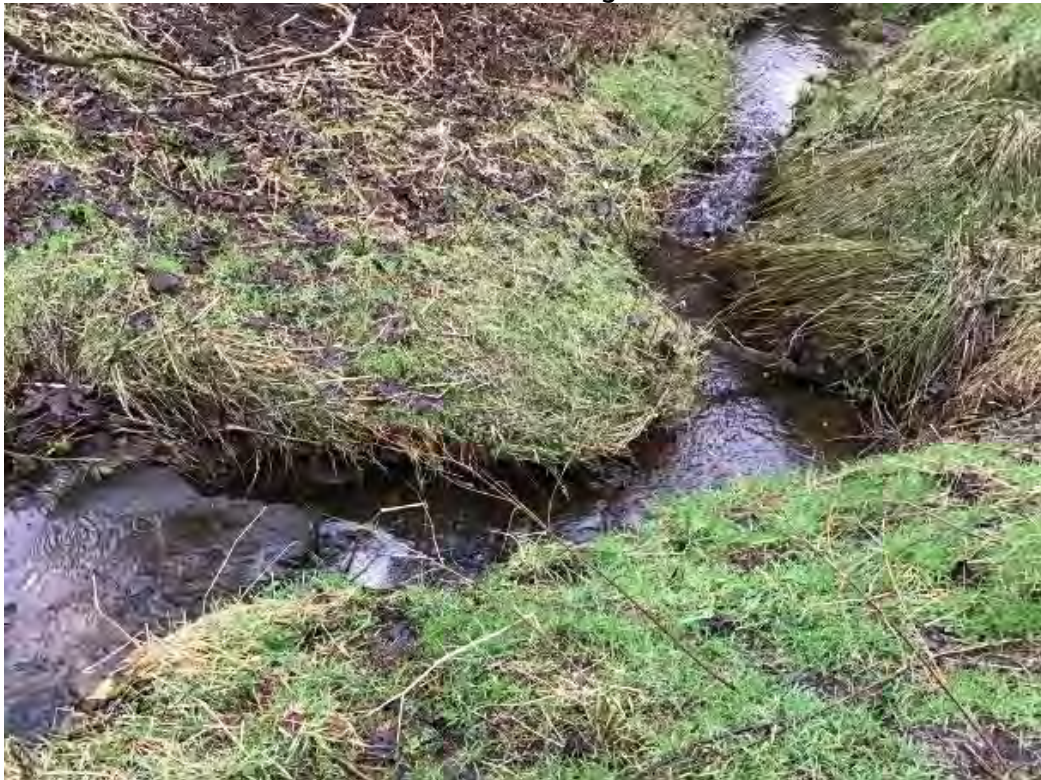
Illustration 9: Undercutting on left bank

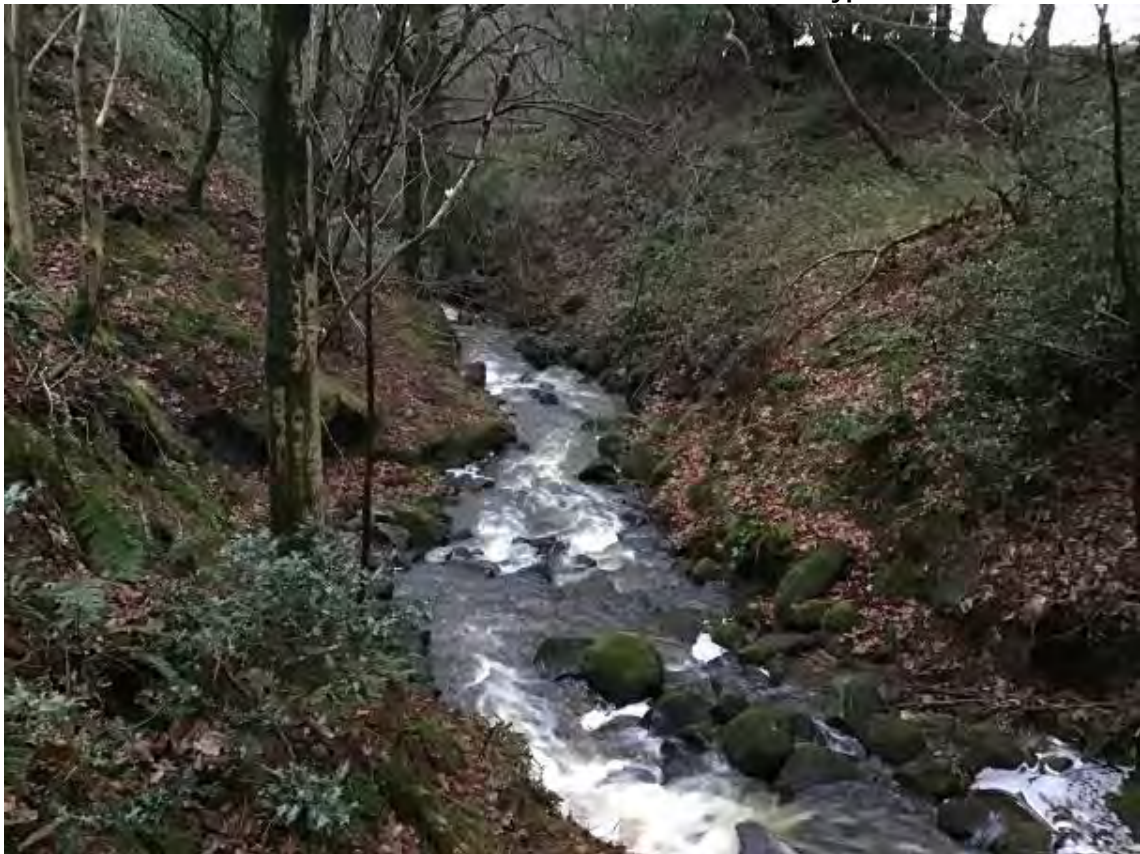
Illustration 10: Downstream view. Varied flow types

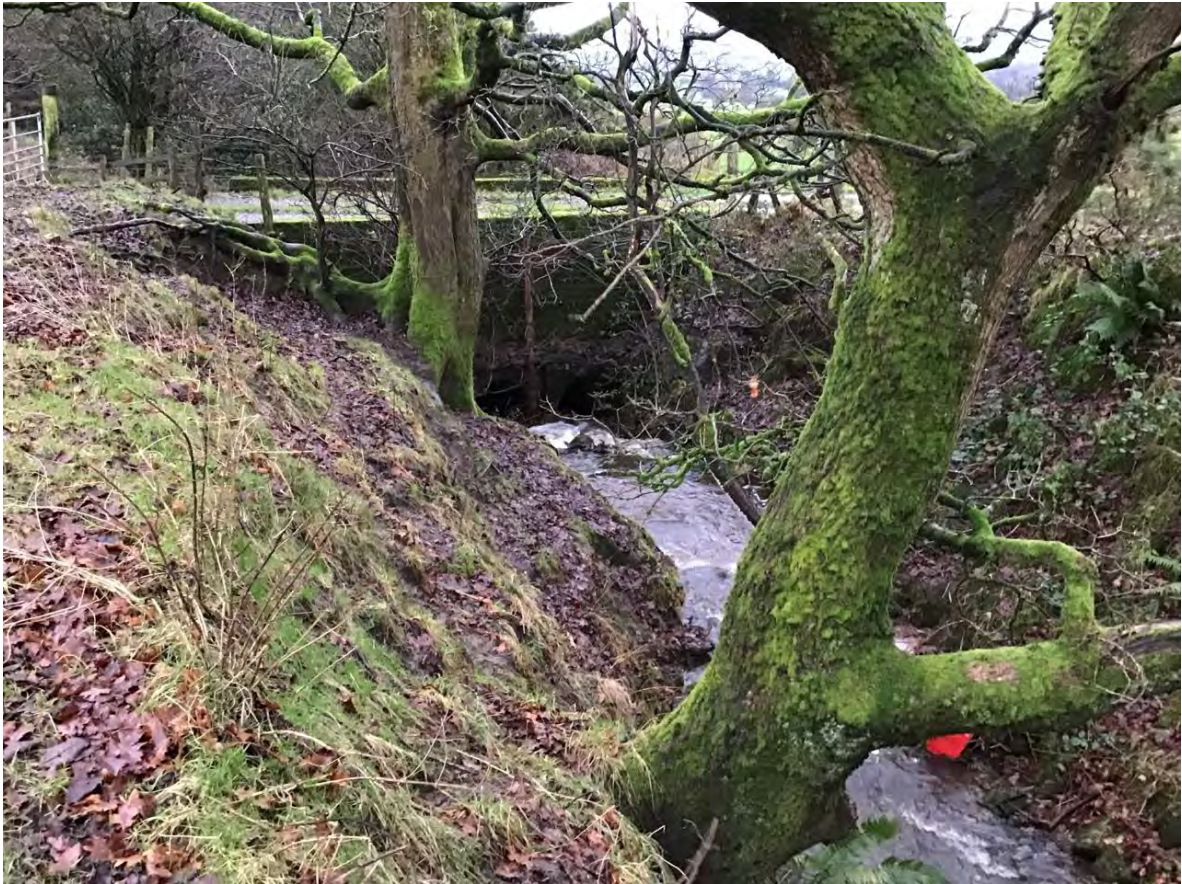
Illustration 11: Upstream view of culvert

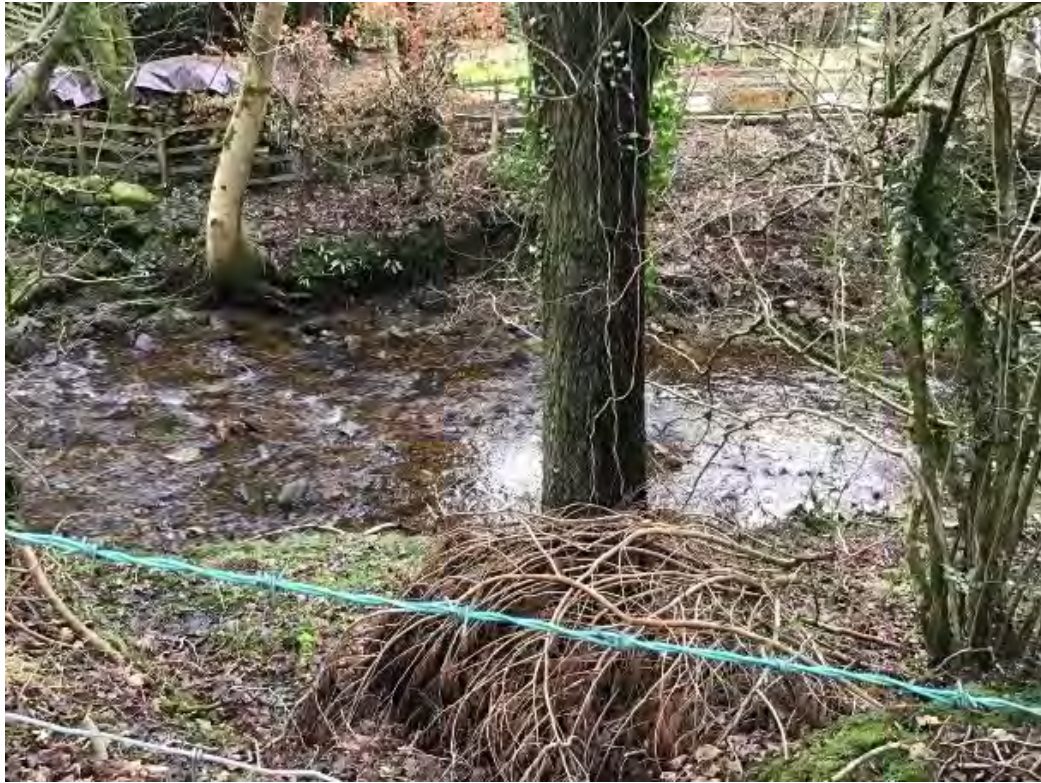
Illustration 12: Left bank to right bank view. Bank erosion on left bank

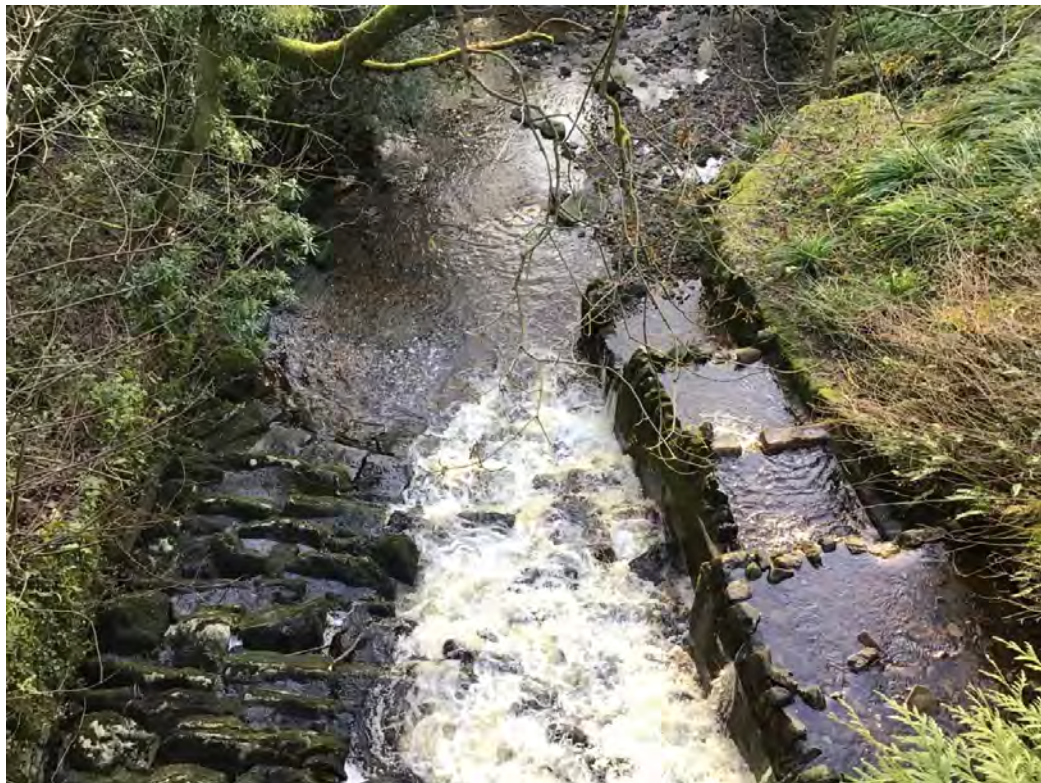
Illustration 13: Downstream view of weir

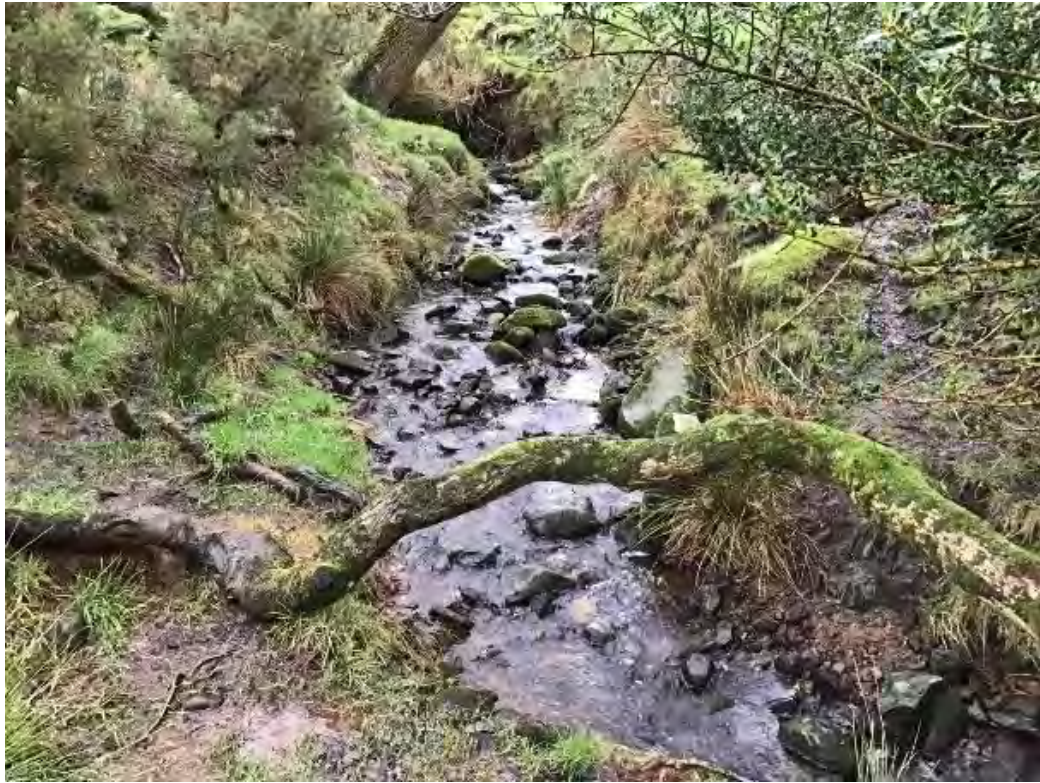
Illustration 14: Upstream view. Bank erosion

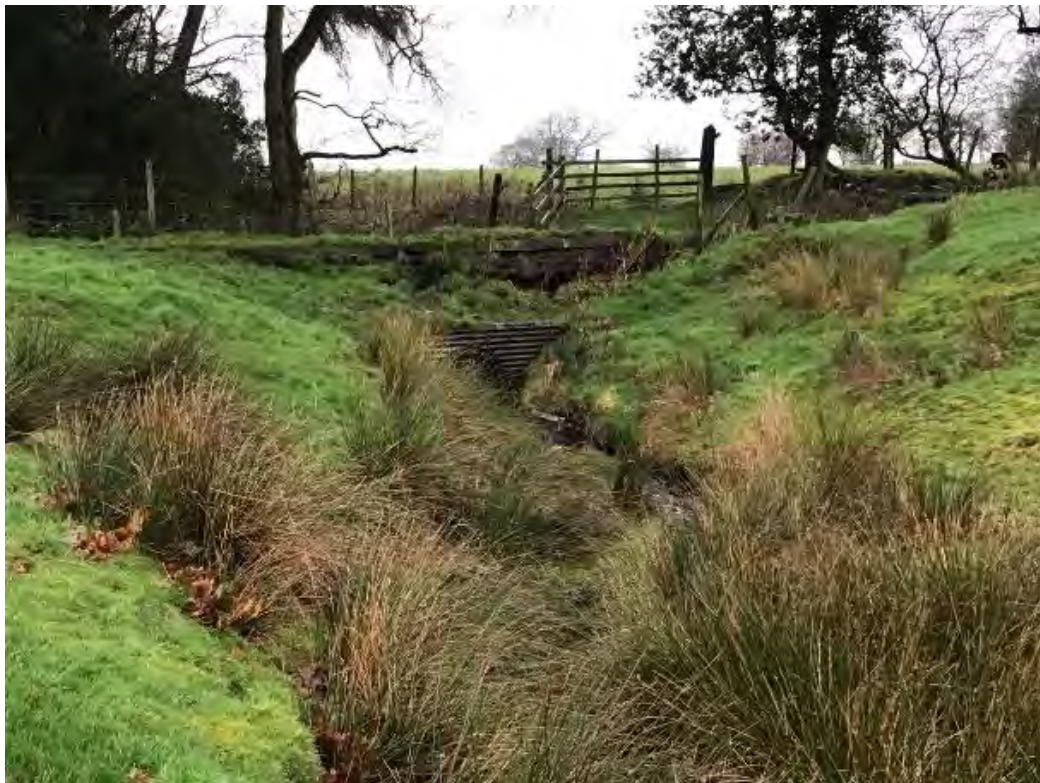
Illustration 15: Upstream view of culvert
