**Haweswater Aqueduct Resilience Programme - Proposed Marl Hill  
Section**

**Proposed Ribble Crossing**

**Appendix 6.5: Arboricultural Impact Assessment**

Project No: B27070CT  
Document Title: Volume 6 Proposed Ribble Crossing  
Appendix 6.5: Arboricultural Impact Assessment  
Document Ref.: RVBC-MH-RC-TA-006-005  
Revision: 0  
Date: June 2021  
Client Name: United Utilities Water Limited

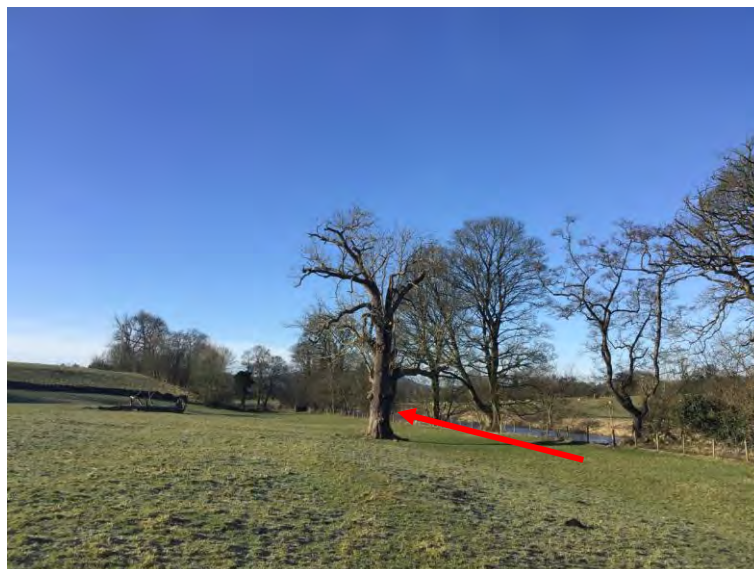
30) The assessment area is also intermittently covered with scattered individual broadleaf trees including two potential veteran ash trees.

**Illustration 1: Potential veteran ash (red arrowed) located in an agricultural field south of the River Ribble**

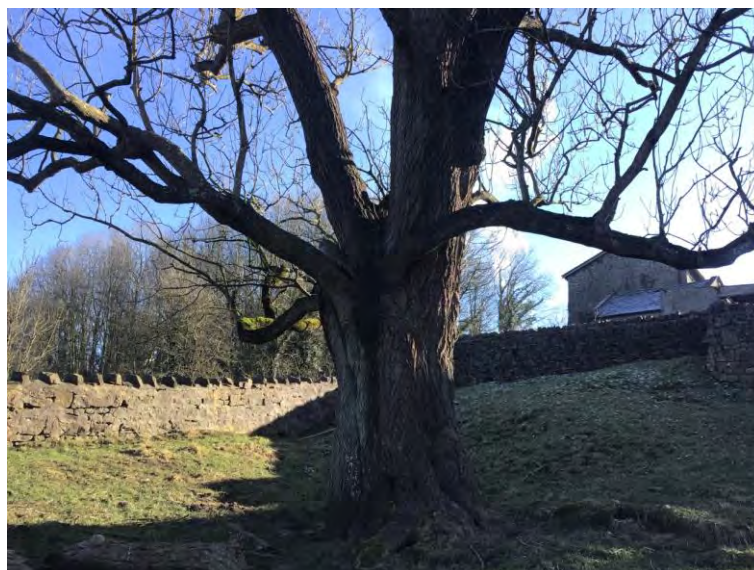
**Illustration 2: Potential veteran ash located in an agricultural field immediately south of the River Ribble/west of adjoining West Bradford Road**

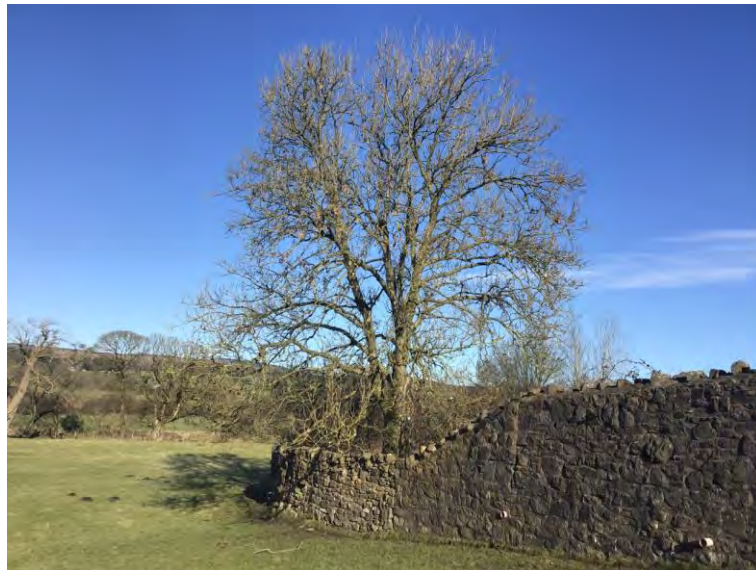
**Illustration 3: Low quality ash tree to be removed due to new road proposals south of the river. The tree has advanced symptoms of ash dieback.**

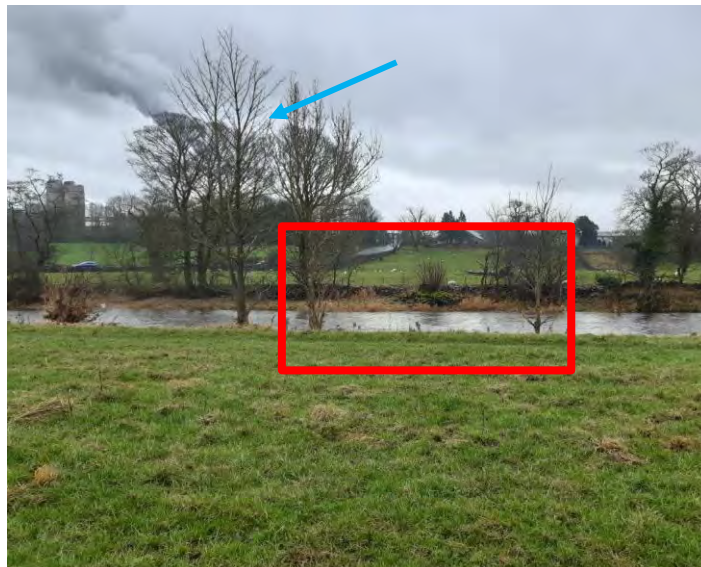
- 45) Three low quality riverside features would require removal in order to facilitate the proposed bridge crossing. The proposed bridge alignment, as indicated by Illustration 4, targets an existing gap between two prominent individual trees on the southern side of the riverbank. A moderate quality tree, blue arrowed in Illustration 4, is reported as at risk of removal due to its proximity to likely excavation required for the bridge footing on the southern side of the riverbank.

**Illustration 4: The proposed bridge crossing alignment targets a gap (red boxed) between established individual trees. Looking south, this gap is approximately 50 m wide and contains young low quality vegetation. The at risk moderate quality tree is approximately 3m from proposed works.**

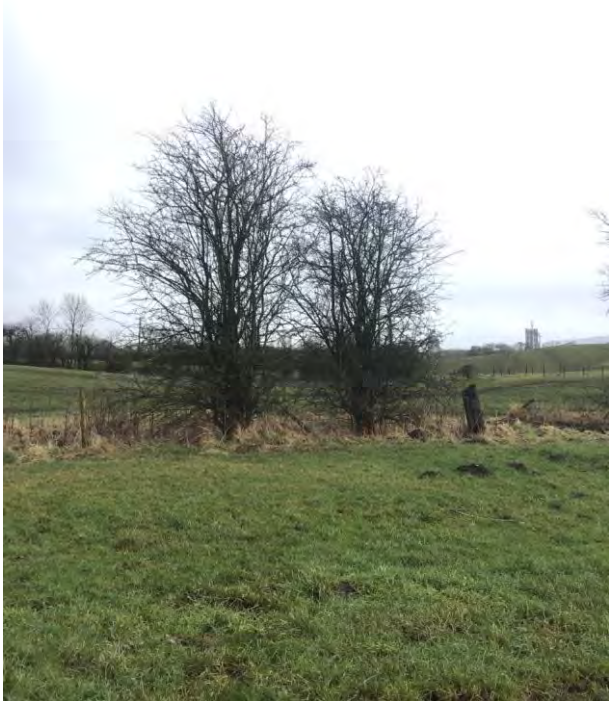
- 46) Three low quality boundary features are requiring varying extents of removal due to their encroachment within the proposed new road alignment and associated earthworks footprint. Features include boundary features located by minor watercourses (Illustration 5) or field boundary vegetation (Illustration 6).

**Illustration 5: Brookside feature to be removed**

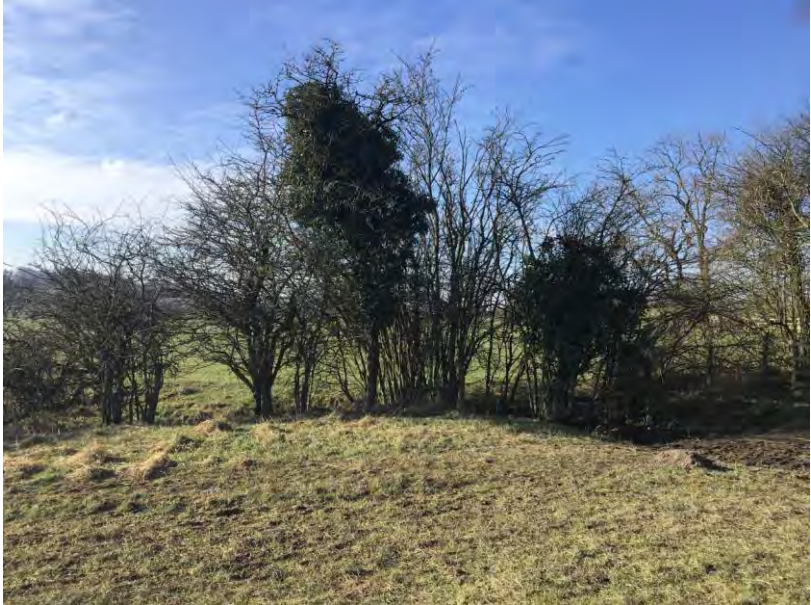
**Illustration 6: Field boundary feature to be removed**

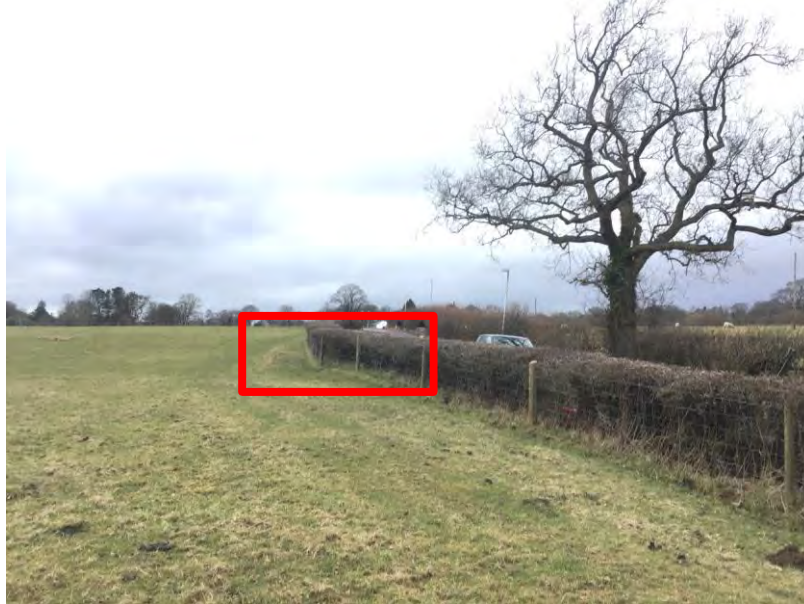
- 47) A section of moderate quality roadside hedge would require removal due to the proposed new road alignment and associated visibility splays for tie-in with the existing West Bradford Road (Illustration 7).

**Illustration 7: Roadside hedge section (red boxed) to be partially removed for proposed tie-in of new road alignment with the existing West Bradford Road.**

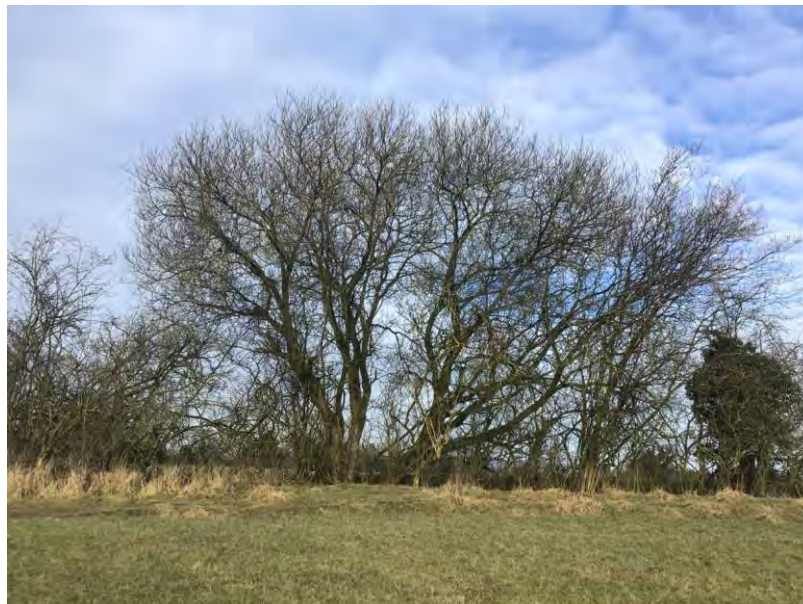
- 48) One moderate quality (Illustration 8) and one low quality boundary feature (Illustration 9) are at risk of removal due to their significant encroachment by the works area associated with the proposed new road alignment and earthworks.

**Illustration 8: Multi-stem goat willow at risk of removal located on field boundary**

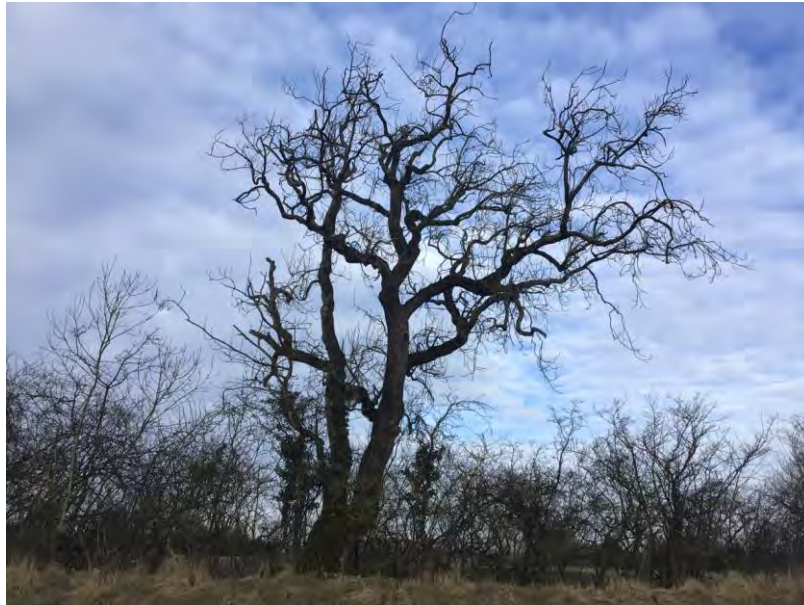
**Illustration 9: Low quality ash tree at risk of removal located on field boundary.**
