**Haweswater Aqueduct Resilience Programme - Proposed Marl Hill
Section**

Proposed Ribble Crossing

Appendix 7.2 Geomorphology Proforma

June 2021

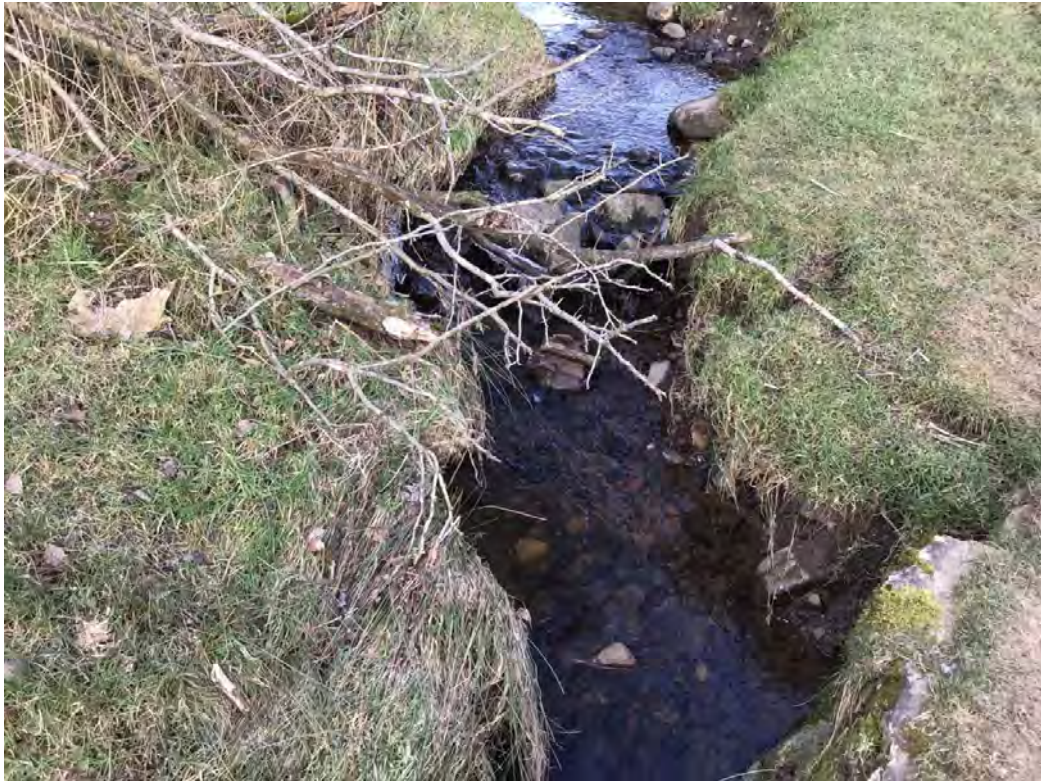
Illustration 4: Upstream view of step and woody debris

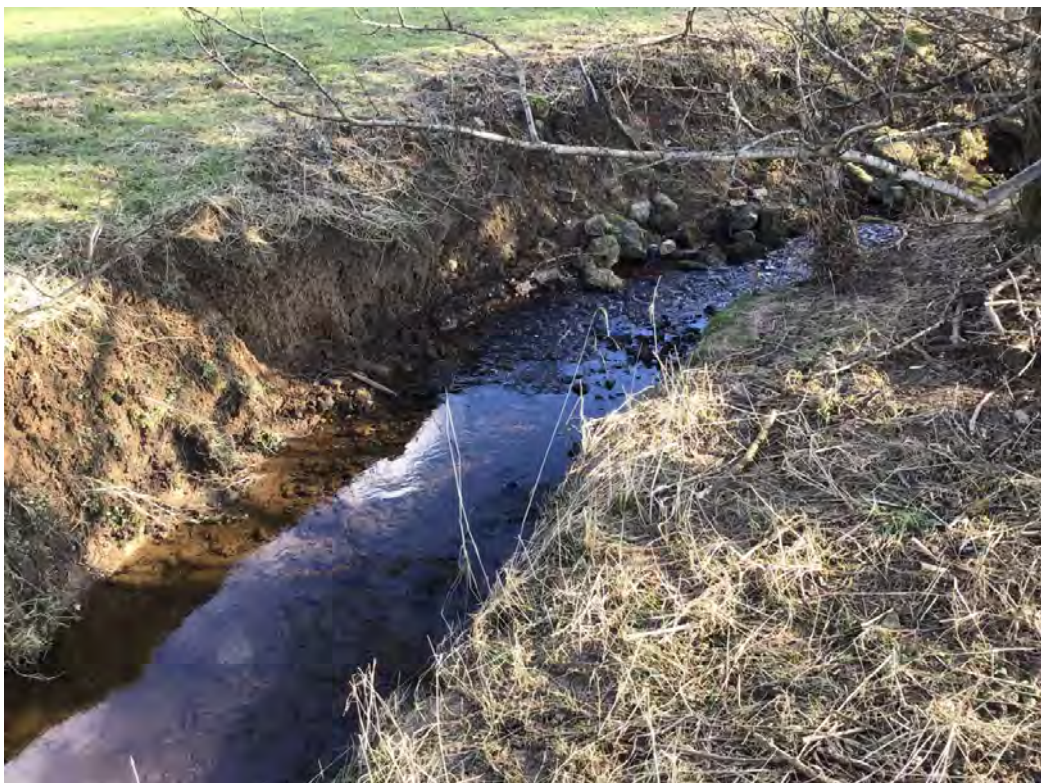
Illustration 5: Downstream view of riffle and erosion on left bank
