**Haweswater Aqueduct Resilience Programme - Proposed  
Marl Hill Section**

**Proposed Ribble Crossing**

**Technical Appendix 9A.3: Bats**

June 2021

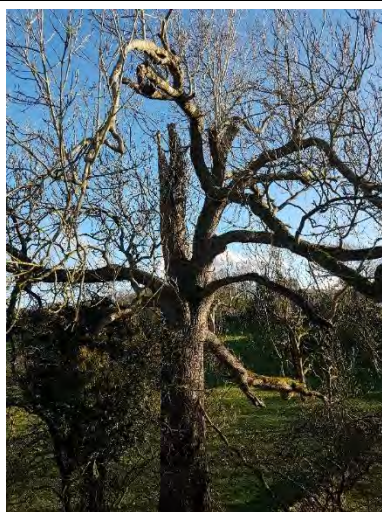
TEP ID	Unique Arb ID	Grid Ref	Description	
BT4	T130	SD 74440 43772	<p>Large ash around 12m high, growing towards the bottom of a steep embankment. Split limb leading to large cavities / decay at top. Aerial survey would be required to determine if possibly too wet to be a suitable potential roost features (PRF).</p> <p>Roost Suitability: High</p>

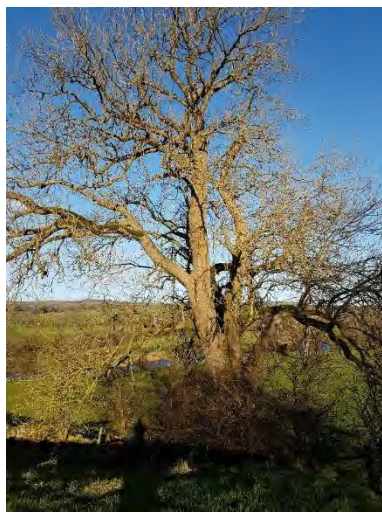
BT5	T120	SD 74433 43780	<p>Very large ash tree. Primary limb and secondary branch failures has resulted in a split in the main trunk providing high PRF. Number of knot holes also present.</p> <p>Roost Suitability: High</p>

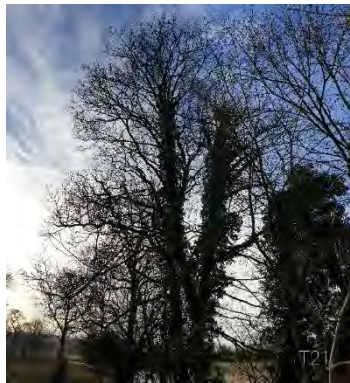
TEP ID	Unique Arb ID	Grid Ref	Description	
BT21	T89	SD 74378 43829	Dense ivy-clad sycamore, up to around 11m high. Ivy may be obscuring potential roost features and have therefore precautionary categorised as low potential.  Roost Suitability: Low

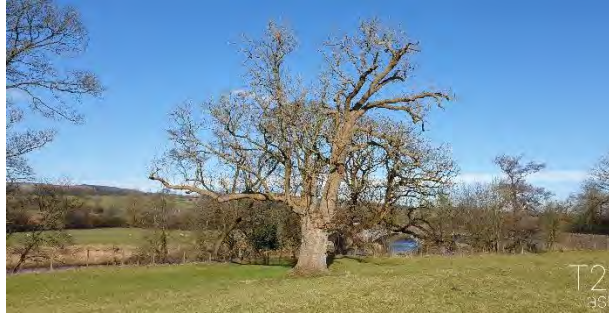
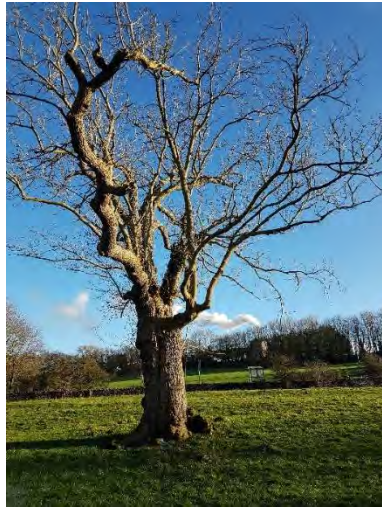
BT22	T67	SD 74464 43875	Large ash tree within field, south of river. Developing veteran features including large cavities and decay, providing high PRF. There are also transverse splits within the top branches and butt rot creating an internal cavity from then base.  Roost Suitability: High

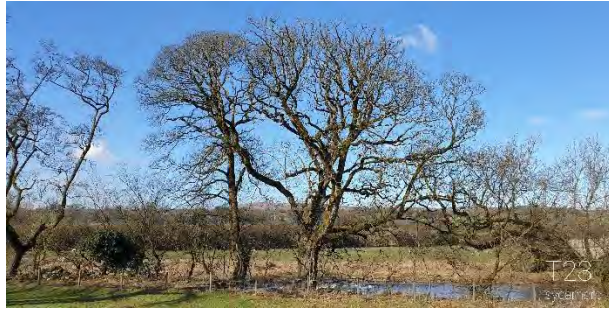
BT23	T54	SD 74478 43899	Mature sycamore, along riverside. Severe canopy dieback. Split in south facing branch around 3m from the ground. Limited access to view fully.  Roost Suitability: Moderate.

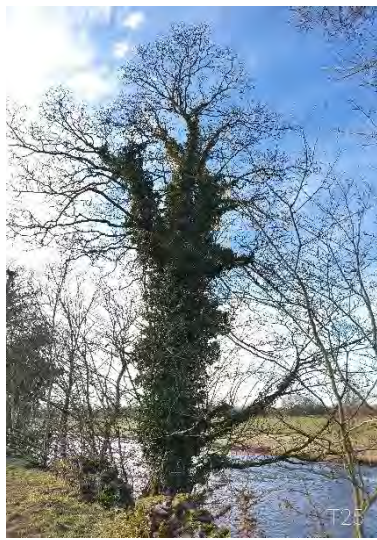
TEP ID	Unique Arb ID	Grid Ref	Description	
			Roost Suitability: Low	
BT25	T77	SD 74412 43850	Dense ivy covered sycamore along riverbank. Limited access for inspection. Ivy may be obscuring defects and potential roost features. Categorised as low on a precautionary basis.  Roost Suitability: Low.

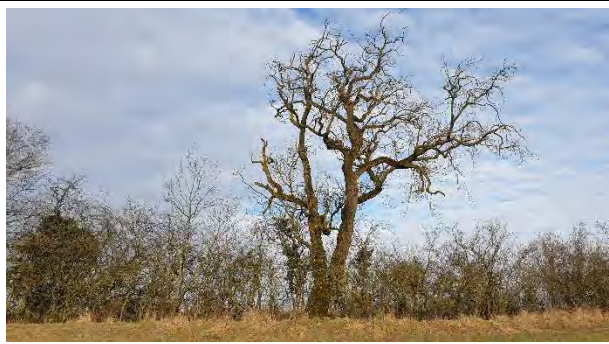
BT29	T39	SD 74186 43926	Ivy clad oak tree in dense understorey vegetation / hedge Inspection limited as the trees are fenced off. Ivy may be obscuring defects and potential roost features. Categorised as low on a precautionary basis.  Roost Suitability: Low.	No photo available.
BT30	T49	SD 74292 43908	Large ash tree in hedgerow / at field boundary. In severe decline with desiccations resulting in number of branches with holes.  Roost Suitability: Moderate.

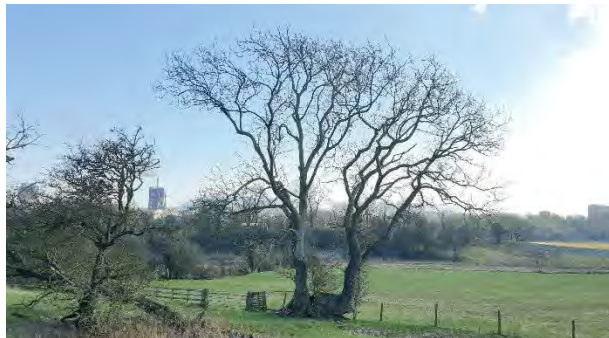
BT31	T95	SD 74151 43824	Twin stemmed ash tree around 10m high. Located along a field boundary / fence line that was likely from remnant historic hedgerow. Tree decayed and few knot holes in the western stem about 4m from the ground.  Roost Suitability: Moderate.

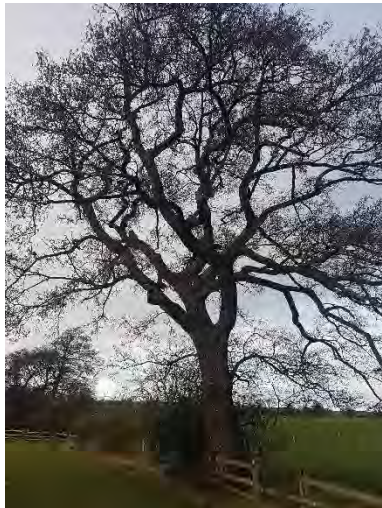
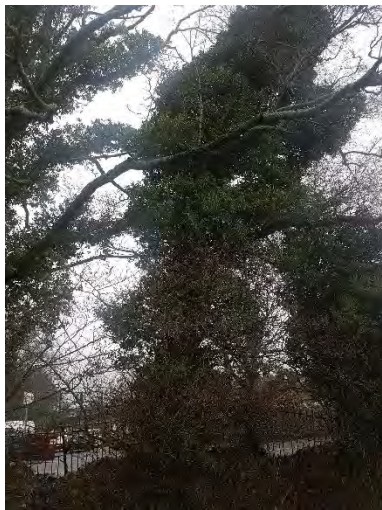
TEP ID	Unique Arb ID	Grid Ref	Description
BT34	T118	SD 74036 43786	<p>North of stream. Reasonably balanced canopy, slight bias east. No significant defects                      Young alder, on stream edge. Stem cavitation and decay resulting in butt rot and split in trunk from ground to around 2m. Broken branches.</p> <p>Roost Suitability: Moderate/ High.</p>
BT35	T134	SD 74060 43751	<p>Mature alder in fence line. Stem cavitation and decay. 2 PRFs; one south face and one north facing; cankers at branch junction</p> <p>Roost Suitability: Moderate</p>
BT45	T13	SD 73475 44012	<p>Icy clad alder along roadside, north of a stream. Due to icy cover potentially covering PRF, a precautionary approach has been taken with categorisation.</p> <p>Roost Suitability: Low</p>

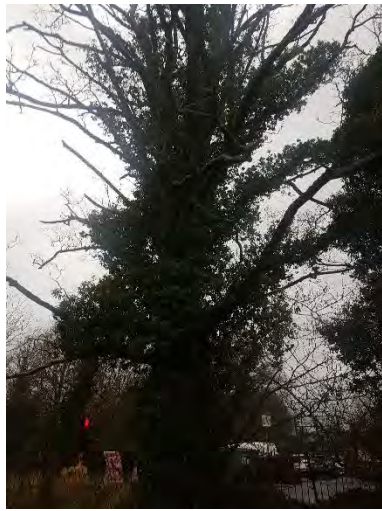
TEP ID	Unique Arb ID	Grid Ref	Description	
BT46	T12	SD 73471 44012	<p>Common ash along roadside.                      Knot hole in western branch and ivy possibly obscuring PRF.</p> <p>Roost Suitability: Low</p>

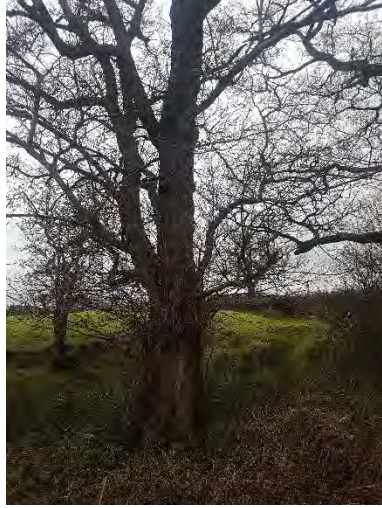
BT47	T15	SD 73464 44009	<p>Large roadside sycamore, along stream. Tree is in decline.</p> <p>Along stream, Butt rot, knot hole and split in main trunk</p> <p>Roost Suitability: Low</p>	<p>No photo available.</p>
BT48	G14	SD 73466 44002	<p>Common ash on west side of stream. Subject to ash dieback, resulting in few cavities.</p> <p>Roost Suitability: Moderate</p>

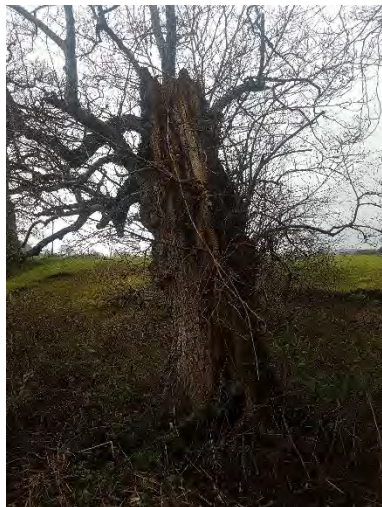
TEP ID	Unique Arb ID	Grid Ref	Description
BT49	G13	SD 73465 43999	<p>Alder that has been flailed. Large open wound in trunk resulting in northern cavity.</p> <p>Roost Suitability: High</p>

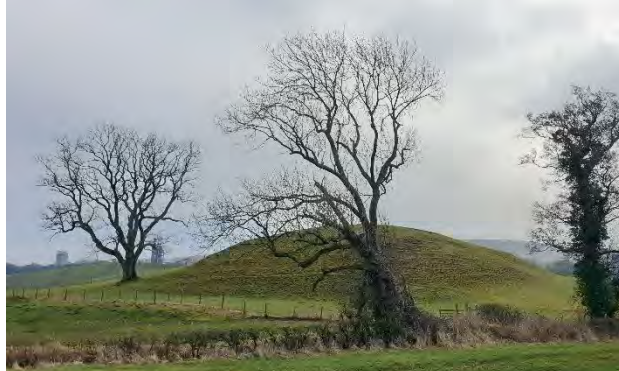
BT50	T128	SD 73550 43769	<p>An ash tree of around 14m high on western side of brook, overhanging. Transverse split on first east facing branch and desiccation fissures within south facing branch.</p> <p>Roost Suitability: Moderate</p>

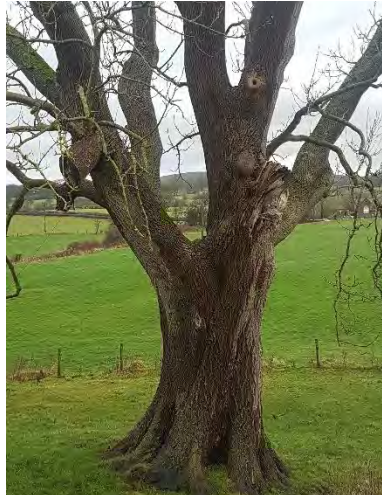
BT51	T126	SD 73605 43769	<p>Veteran ash tree at base of hilled field. Large tear out in south east trunk with hollowing providing suitable hibernation / maternity roosting opportunities, transverse splits in number of branches, pruning cuts at desiccated removed limbs, and lots of large knot holes.</p> <p>Roost Suitability: High</p>

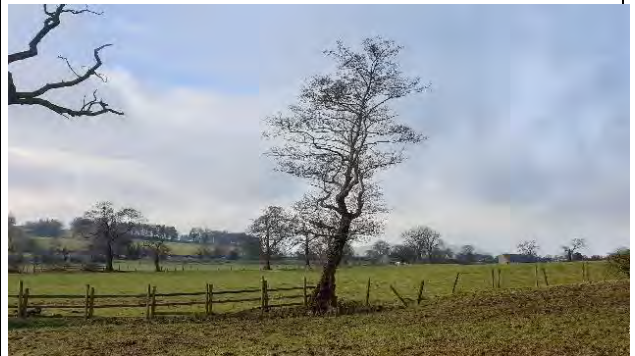
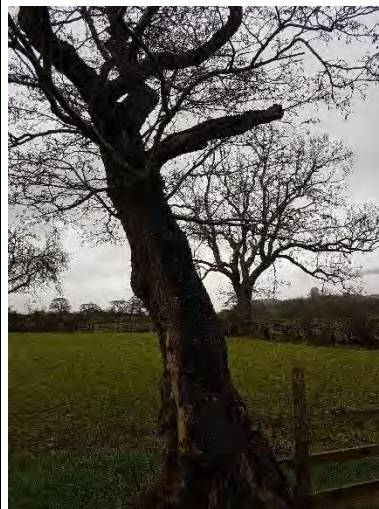
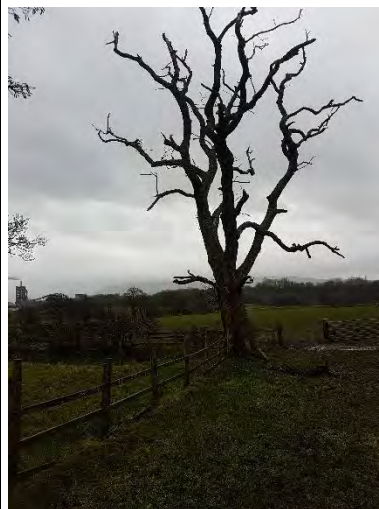
TEP ID	Unique Arb ID	Grid Ref	Description
BT55	T150	SD 73900 43702	<p>Ash tree along field boundary with transverse split in southern branch.</p> <p>Roost Suitability: Moderate</p>
BT56	T152	SD 73912 43692	<p>A mature decaying / predominantly dead alder on field boundary with a cavity split in first south west trunk.</p> <p>Roost Suitability: High</p>
BT57	T149	SD 79811 22191	<p>Large ash tree within corner of field boundaries. Tree is in decline with large crevice in main trunk, large limb failure / split and several knot holes.</p> <p>Roost Suitability: High</p>

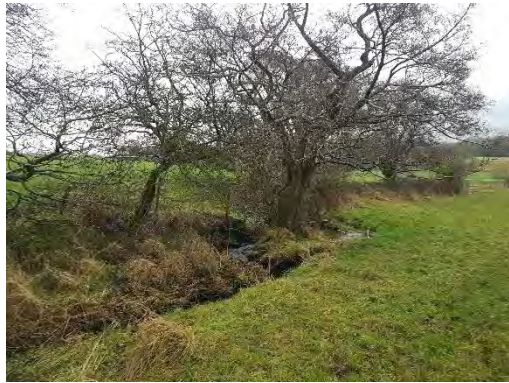
TEP ID	Unique Arb ID	Grid Ref	Description	
BT66	T109	SD 74016 43797	Alder on south of stream with split trunk and knot holes.  Roost Suitability: Moderate

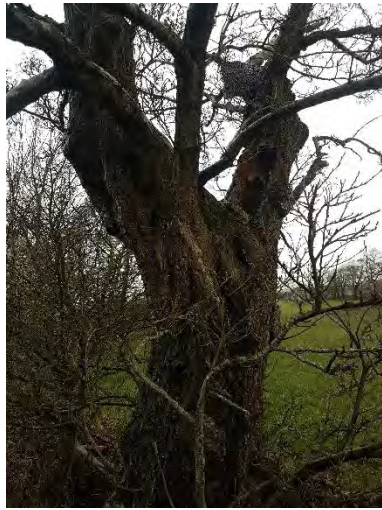
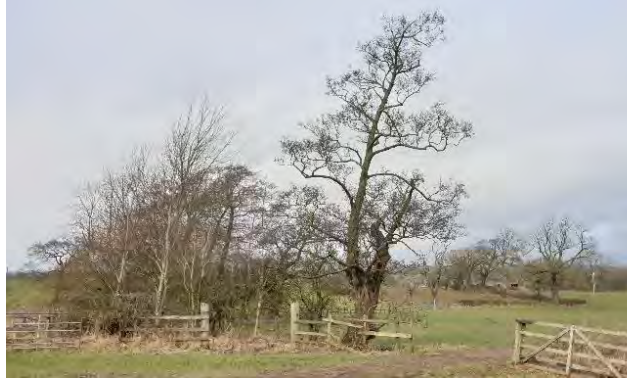
BT67	T121	SD 74035 43782	Alder on stream edge. Stem cavitation and decay.  Roost Suitability: High	No photo available
BT68, 68A & 68B	T116	SD 74035 43794	Cluster of 3 alder trees with knot holes present.  Roost Suitability: Low	No photo available
BT72	T196	SD 73946 43589	Alder on field boundary corner, adjacent to stream. Some branches subject on ash dieback resulting in large cavity in eastern limb, suitable for hibernation / maternity roosts.  Roost Suitability: High

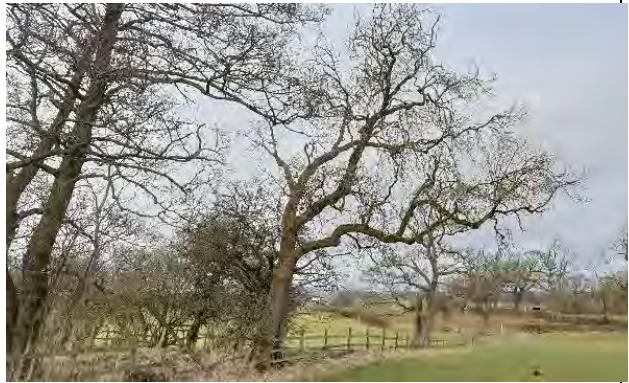
TEP ID	Unique Arb ID	Grid Ref	Description	
BT74	T183	SD 79815 22190	Ash tree with limb failure leading to large cavity in south facing top limb.  Roost Suitability: High

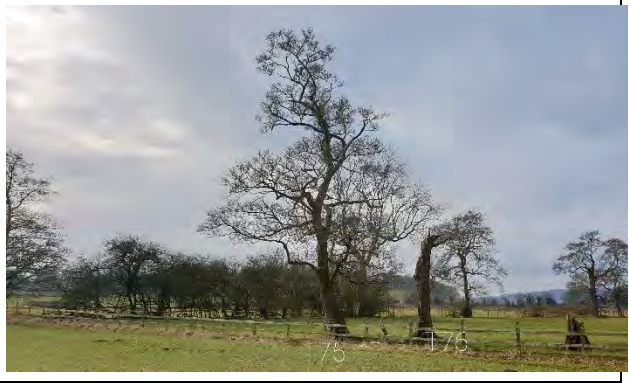
BT75	T166	SD 73919 43646	Alder tree on field boundary with occasional branches dying back. Butt rot / basal cavity resulting in large cavity in main stem extending up trunk <0.5m.  Roost Suitability: High

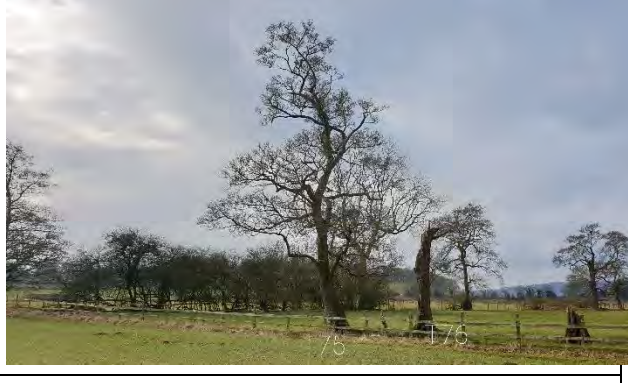
BT76	T165	SD 73914 43643	Alder with stem failed up to around 5m but two small diameter branches growing to north. Deadwood / wood decay up length of the trunk providing PRFs.  Roost Suitability: High

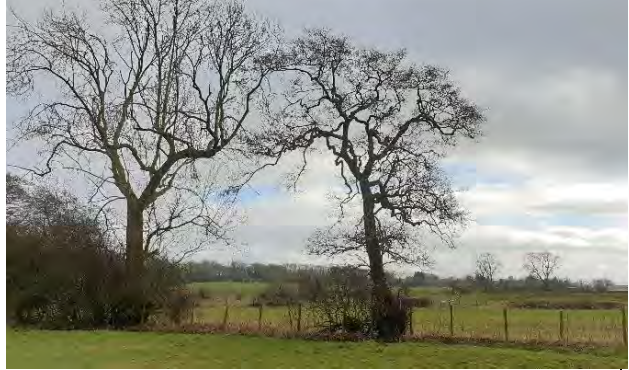
BT77	T177	SD 73882 43629	Alder on east side of stream. Canker forming internal crevice. While large, due to position on trunk categorised as Moderate.  Roost Suitability: Moderate

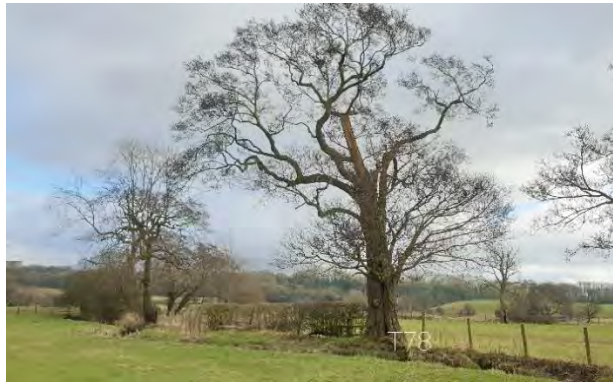
TEP ID	Unique Arb ID	Grid Ref	Description	
BT78	T176	SD 73841 43632	Larger alder within line of trees on field boundary edge. Subject to storm damage with large split all the way up main trunk to main bifurcations. Potentially hollow trunk with cankers, knot holes, branch splits.  Roost Suitability: High

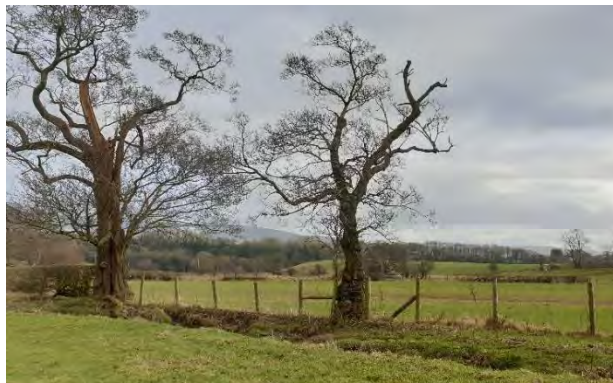
BT79	T174	SD 73841 43632	Alder with branch split near top southern limb.  Roost Suitability: Moderate

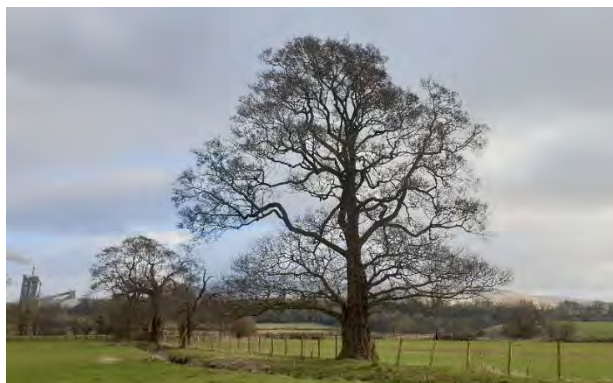
BT80	T175	SD 73813 43634	Large, mature alder with number of small crevices in main stem.  Roost Suitability: Moderate

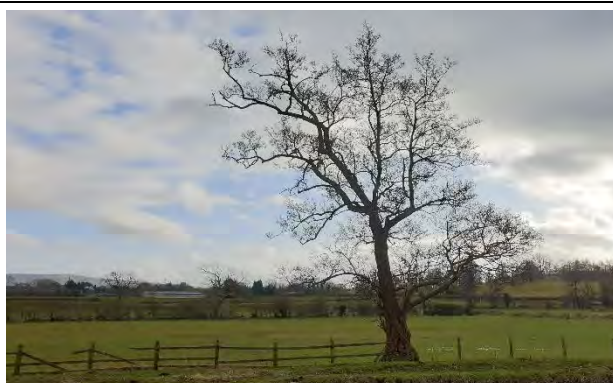
BT81	T179	SD 73786 43624	Mature alder with open wound in north facing branch and small open fissure on main stem. Some deadwood present.  Roost Suitability: Moderate

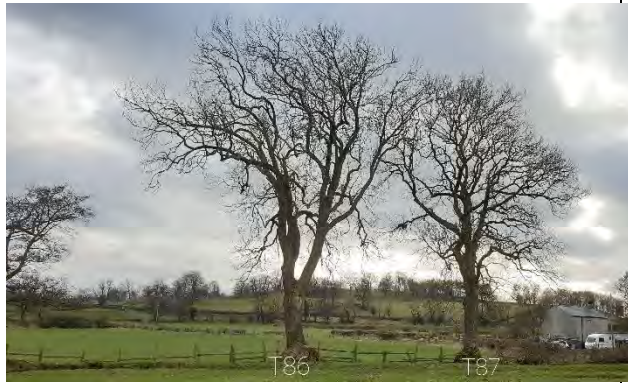
TEP ID	Unique Arb ID	Grid Ref	Description	
BT86	T190	SD 82135 12638	Mature ash with open canker hole at base of branch junction and occasional limbs with longitudinal cracks towards base.  Roost Suitability: Moderate.

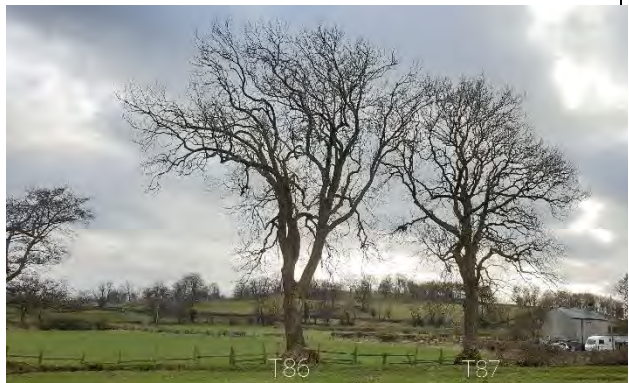
BT87	T188	SD 82161 12638	Ash with small branch splits and knot holes.  Roost Suitability: Moderate

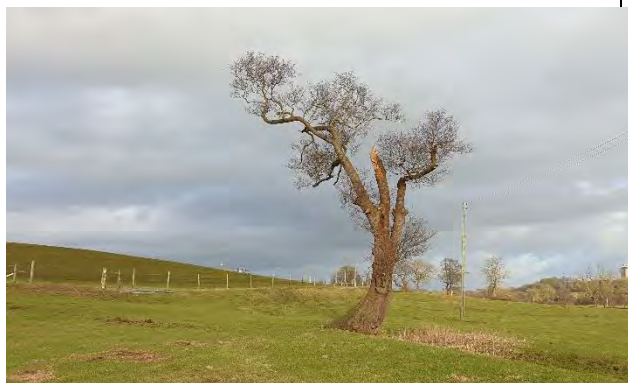
BT88	T157	SD 73685 43674	Alder subject to storm damage and decay, resulting in large split / failures in main stem.  Roost Suitability: High

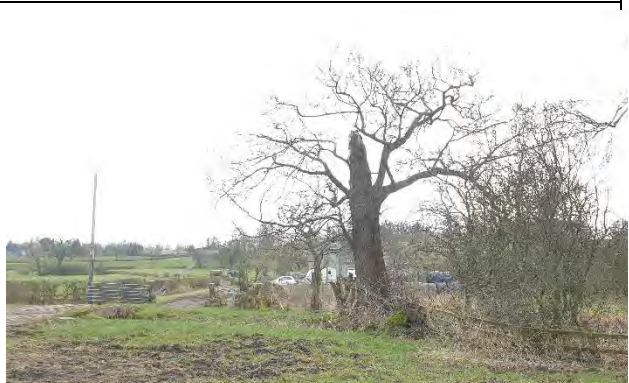
BT95	T170	SD 73622 43636	Alder on eastern side of stream bank with open trunk forming internal crevice. Small branch and stem cavities, in addition to lifting bark; all providing PRFs.  Roost Suitability: High

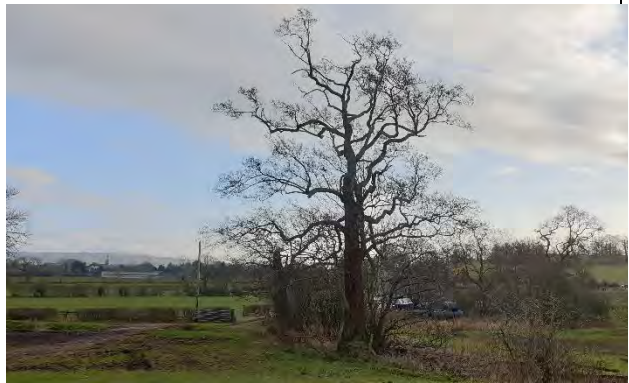
TEP ID	Unique Arb ID	Grid Ref	Description	
BT96	T167	SD 73617 43646	Alder on eastern side of stream with failed stem; decay within large open wound, cavitation north and number of holes throughout the tree.  Roost Suitability: High

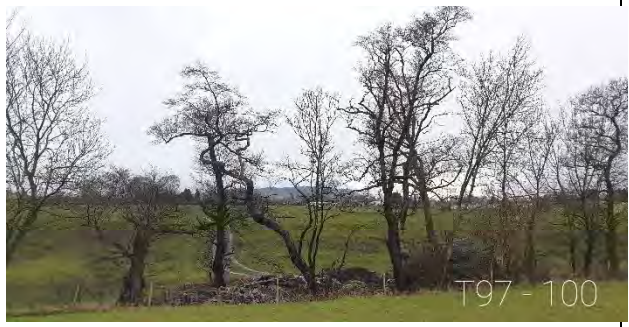
BT97	G76	SD 73575 43692	Alder overhanging west side of stream. Due to storm damage, cavity at point of stem failure at around 4m high, and large transverse break in west limb.  Roost Suitability: High

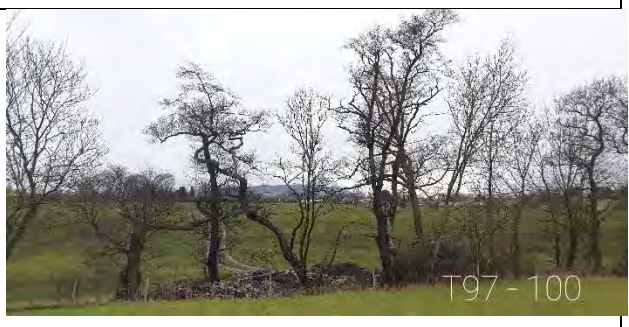
BT98	G76	SD 73573 43695	Fairly young alder tree overhanging west side of stream with decaying trunk resulting in a number of open holes throughout structure.  Roost Suitability: Moderate

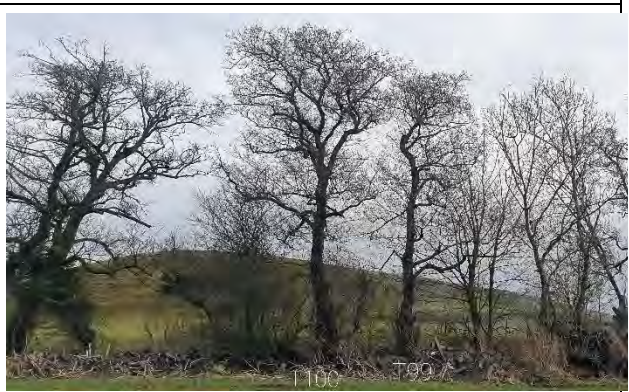
BT99	G76	SD 73568 43701	Fairly young alder tree overhanging west side of stream with small split in main trunk.  Roost Suitability: Low

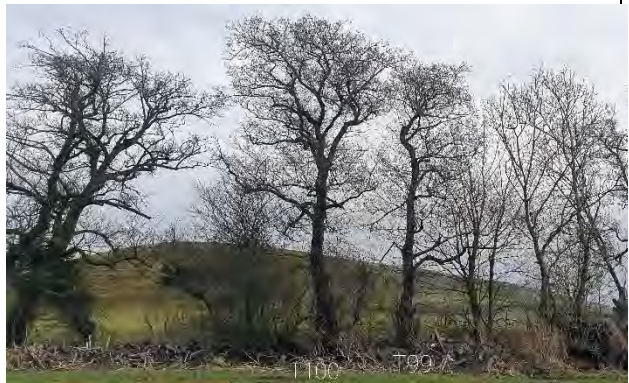
TEP ID	Unique Arb ID	Grid Ref	Description	
BT 100	G73	SD 73568 43701	Fairly young alder growing on / around manmade rubble pile on western side of stream, with transverse split in branch.  Roost Suitability: Moderate.

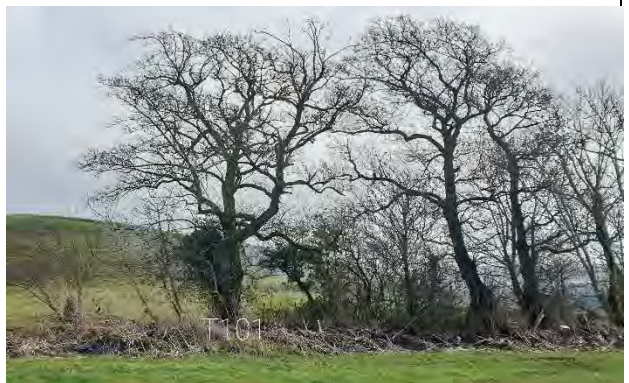
BT 101	G69	SD 73565 43705	Alder on west side of stream with few knot holes.  Roost Suitability: Low

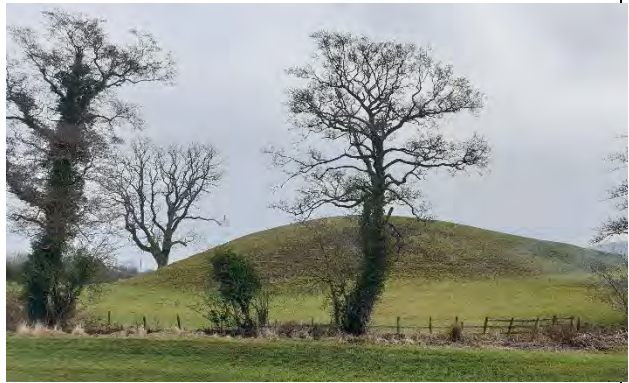
BT 102	T141	SD 73545 43737	Ivy clad alder on eastern side of stream. Ivy possibly obscuring potential roost features.  Roost Suitability: Low	No photo available
BT 103	T135	SD 73549 43754	Ivy clad alder on eastern side of stream, possibly obscuring potential roost feature.  Roost Suitability: Low

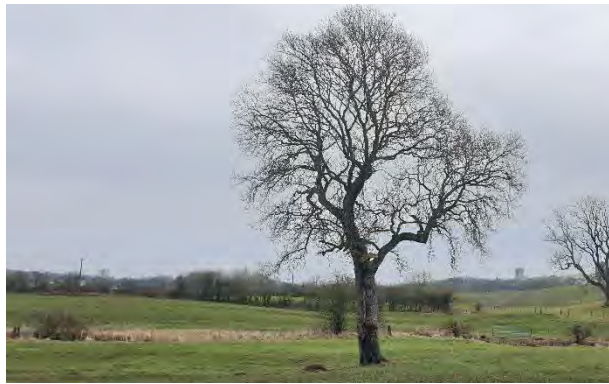
TEP ID	Unique Arb ID	Grid Ref	Description	
BT 104	T115	SD 73506 43795	Mature pedunculate oak within open field. Large wound on trunk leading to large central cavity in main stem, west facing. Split limbs and crevices.  Roost Suitability: High
