**HERITAGE STATEMENT**

**13 YORK STREET**

**CLITHEROE**

**Job Reference Number: BS 1141**

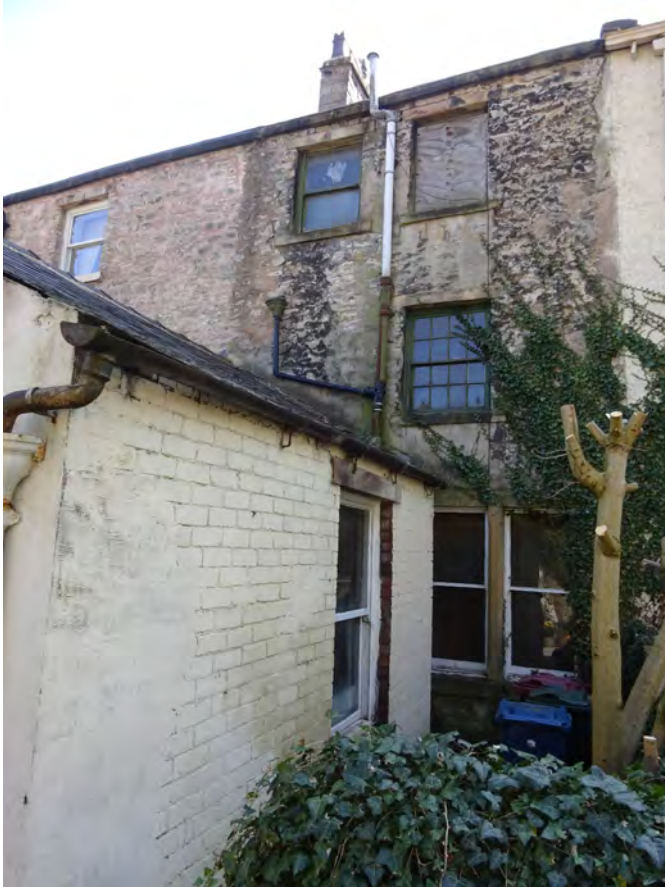
13 York Street – Rear Elevation

- 6.35 The existing unsuitable cement render / pointing is heavily smeared over the surface of the stone and is intended on being carefully removed followed by re-pointing using lime mortar as necessary. The ivy growth is also proposed to be carefully removed.

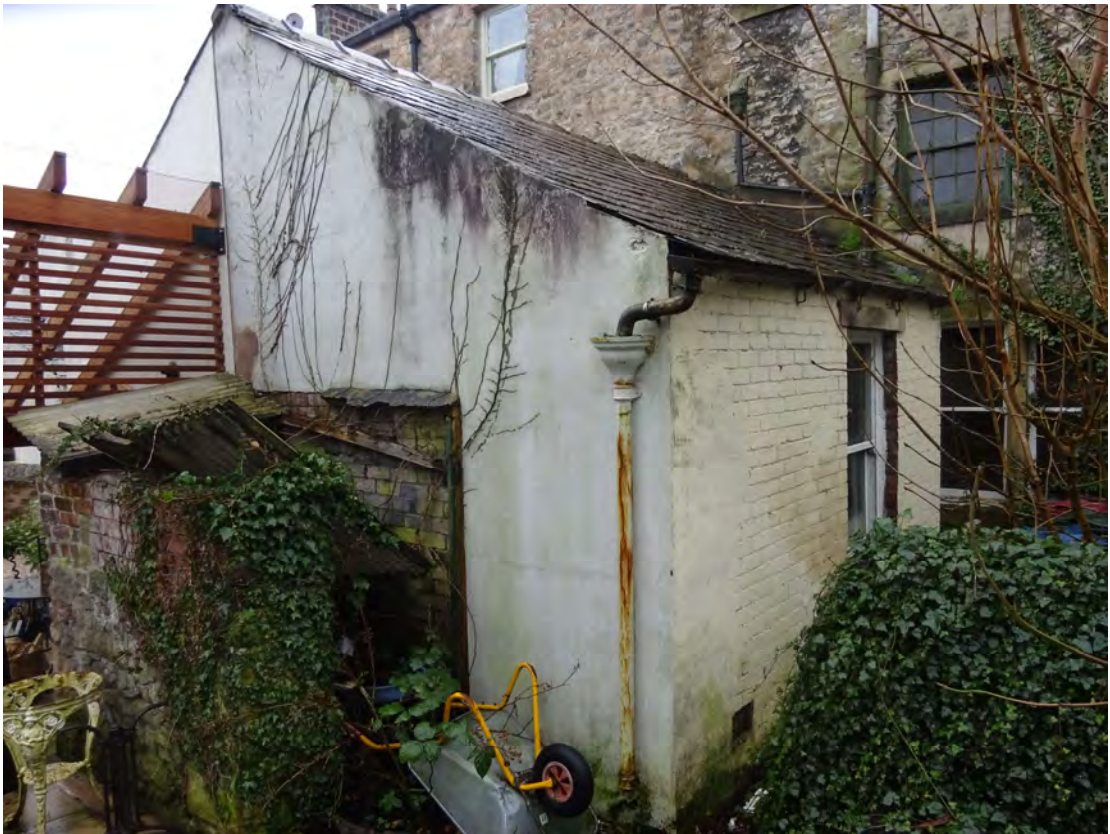
13 York Street – Rear outrigger

- 6.10 The existing outrigger is of cavity brickwork with a cut timber rafter and purlin roof with the ridge beam being shared with the neighbouring property, the floor is constructed with mastic asphalt, presumably over a concrete slab.

- 6.38 The existing rainwater fittings are a mixture of uPVC and painted cast iron and it is proposed to replace these with new painted cast iron fittings.

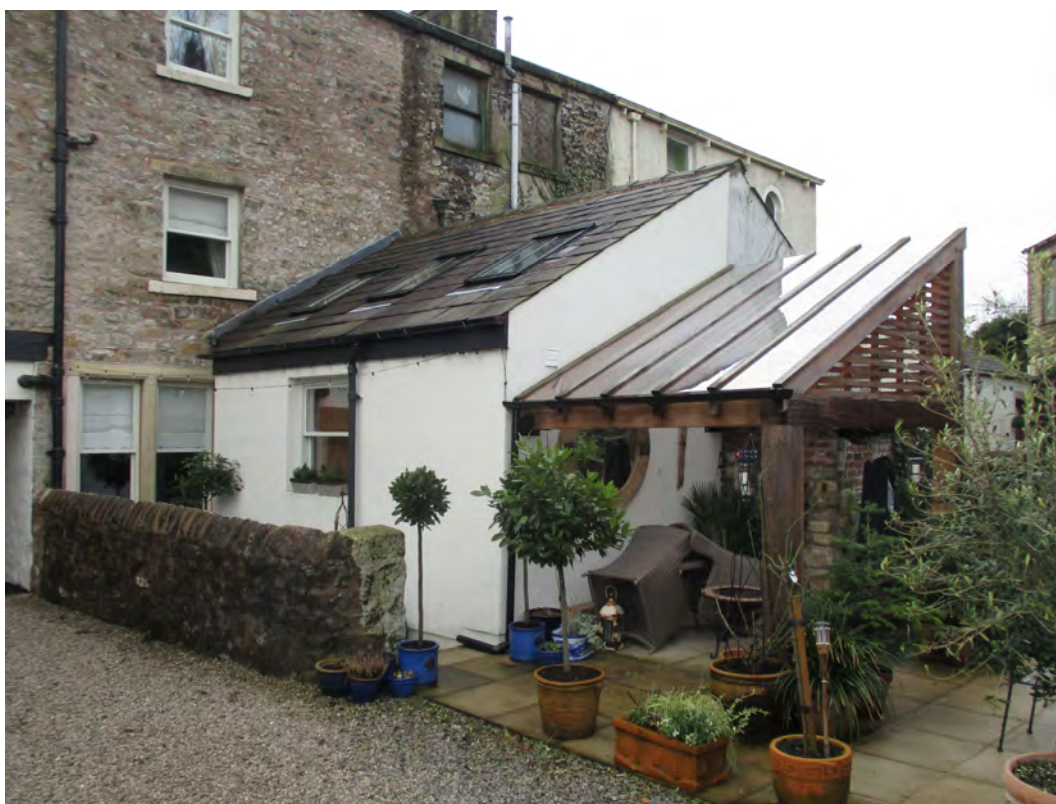
Proposed conservation roof windows to same size and spacing as exists to adjoining half of outrigger

- 6.12 A new warm roof will be created maintain the ridge height, pitch and eaves as existing. Breathable roofing underlay will be fitted over new timber rafters and roofing battens with the existing slates being re-fixed. The roof will be insulated with PIR rigid insulation boards between the rafters and insulated plasterboard and skim coat finish to the underside of the rafters. Three Velux Conservation roof windows will be trimmed out and incorporated within the new roof as per the neighbouring property to the shared roof.

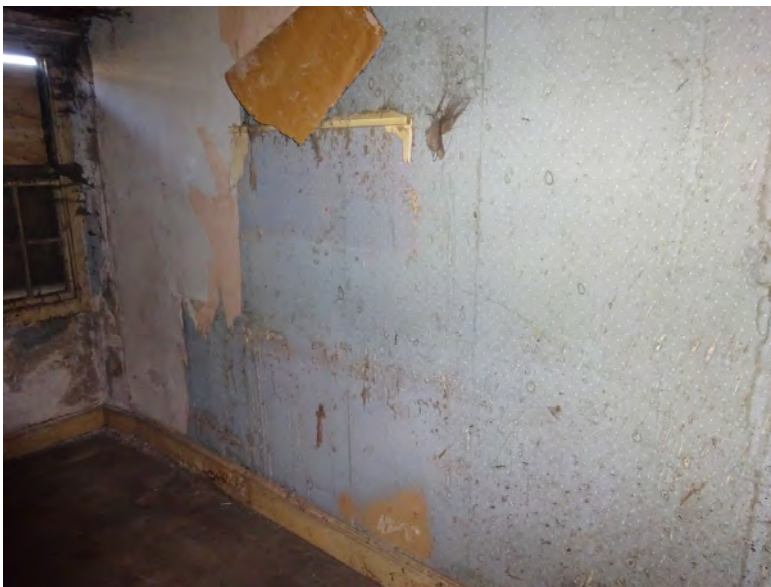
The partition walls to be removed have no decorative or ornate plasterwork or timber and are in poor condition and have no special historic or architectural value.

Partiton wall proposed to be removed between bedroom and bathroom

- 6.21 To facilitate the change in layout the partition wall added early in the 20<sup>th</sup> century will be taken down as will the timber cladding and framework. The existing doors for the bedroom and bathroom are to be retained with the bedroom door being moved to the top of the stairs and the bathroom door to become the en-suite.

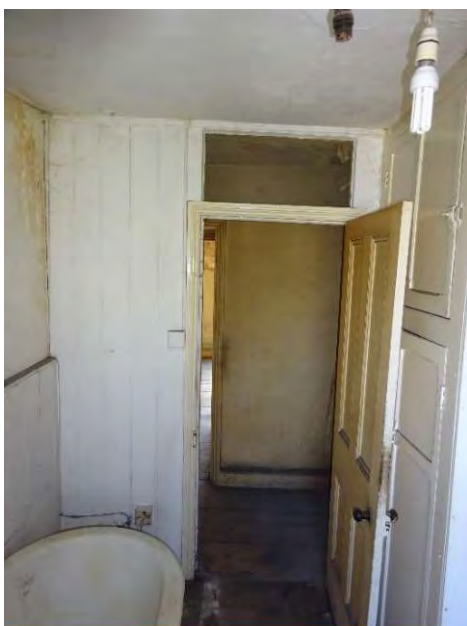
Timber clad partition wall proposed to be removed between bathroom and corridor

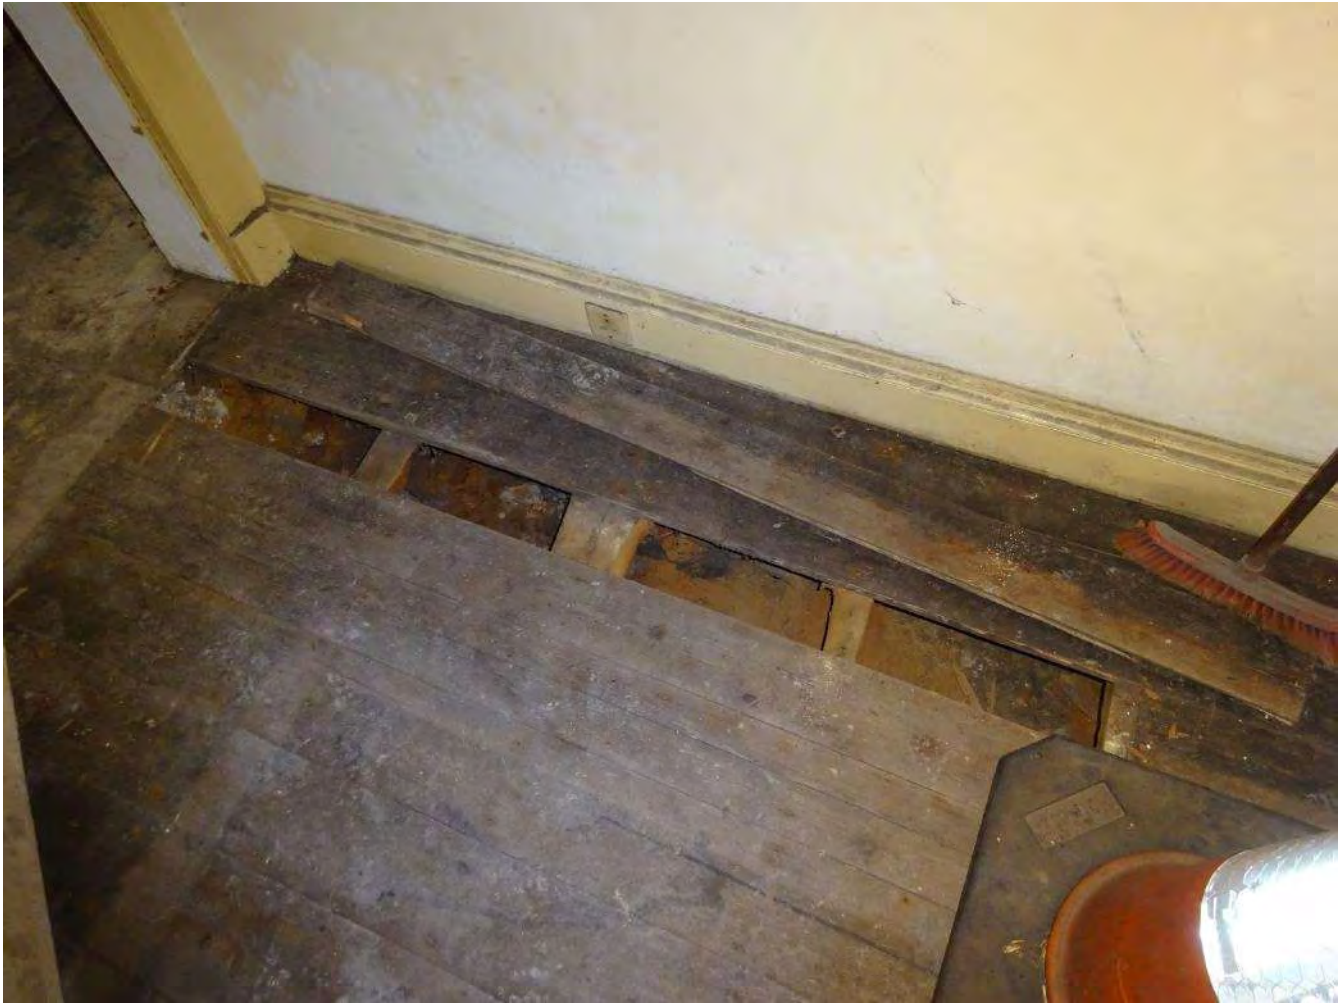
- 6.8 Several of the existing timber floor joists are rotten at the bearing end to the internal loadbearing wall. Elsewhere in the room the original floorboards have been replaced with narrower modern softwood floorboards which suggests that some repairs are likely to have been carried out at some point in the past relatively recently. It is considered likely that the joists have become rotten as there is no apparent means of ventilation to the floor void. It is proposed to maintain the existing joists which will be doubled up with new timber supported on steel hangers. No changes will be made to the existing floor levels.

Front Room – Rotten floor joists
