# **HERITAGE STATEMENT FOR REFURBISHMENT WORKS TO 11 RAILWAY VIEW ROAD, CLITHEROE**

Revision A 06.10.21

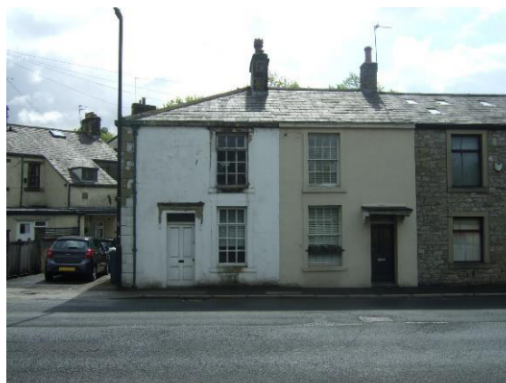
*Picture 4 – West elevation along Railway View Road*

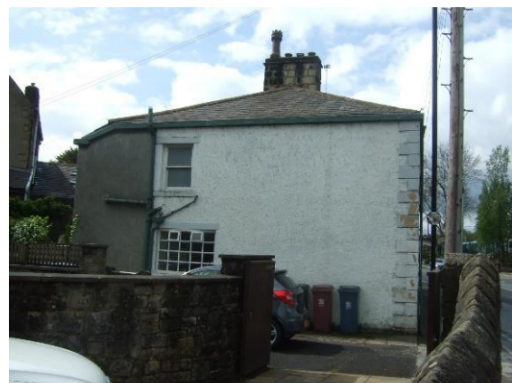
- 2.7 The northern elevation is more utilitarian in appearance with two windows; the ground floor bowed window being a C20 intervention whilst the first floor sliding sash window appears to be original. The render finish is also less ornate on this elevation being standard roughcast render with a paint finish and no applied coursing.

- 2.8 The render to both elevations appears to be a hard cement-based product with evidence of cracking to the surface finish.
- 2.9 Unusually, the demise of 11 Railway View Road only extends to  $\frac{3}{4}$  width of the northern gable end with the final  $\frac{1}{4}$  occupied by 13 Railway View Road.

*Picture 5 - North elevation*

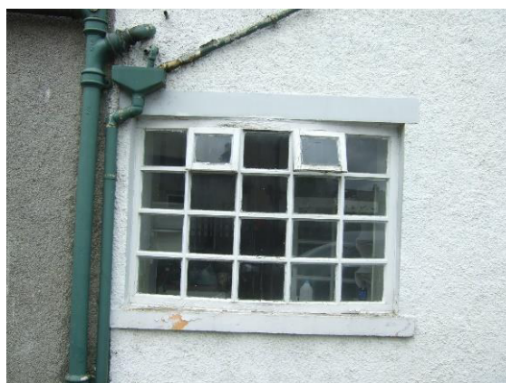
*Picture 6 - Bow window to kitchen*

- 4.6 The existing building is in need of renovation and repair. The windows in particular require replacement. The current arrangement, with the exception of the bathroom window to the northern elevation, are C20 interventions with top hung casements. The bow window to the kitchen in particular appears incongruous and causes visual HARM.

- 3.8 The original sliding sash window and bow fronted window to the kitchen will also be removed and replaced with new single glazed sliding sash windows incorporating weatherseals for improved thermal and acoustic comfort.

- 4.8 The bow window on the north will be replaced with a pair of vertical sliding sash windows with central mullion. We cannot be entirely sure of the original window configuration to this opening but rather than major structural intervention, the use of a double sliding sash restores the verticality and proportions associated with this age of property.

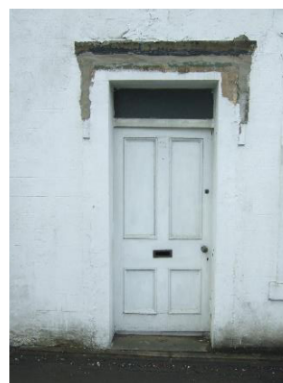
- 2.2 The timber hood referenced in the Listing has fallen off the building due to rot but has been retained. Unfortunately, the timber hood is in very poor condition and beyond repair therefore an exact replica has been manufactured copying details, size etc.

- 2.4 A 4 panelled timber door, assumed to be original, with glazed fan light over provides the only access into the property.
- 2.5 As noted in the Listing, the property has rusticated quoins and stone surrounds to the windows and doors. These appear to have been painted with a modern plastic based paint which is flaking and in poor condition generally.

*Picture 7 - Original front door with hood missing*

- 3.5 The replica timber hood will be reinstated over the door to match the retained feature at #13.
- 3.6 The existing door will be retained, repaired as necessary and re-decorated.

- 4.10 In addition to the window replacements, the front door will be retained, repaired and re-decorated with the broken wooden hood canopy reinstated with an authentic replica of the original. This will restore the appearance of the dwelling to match #13 adjacent, matching the description in the Listing and thus making a POSITIVE contribution to the asset.

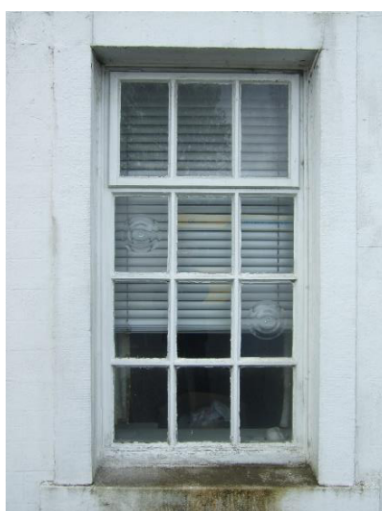
- 2.3 The simple façade is punctuated with a pair of narrow timber window openings providing light to the living room and bedroom above. These windows are not original and we would estimate their age to be around 1960. Although replicating the traditional glazing bar patterns one would expect for this period of property, they are in fact top hung hinged casements.

*Picture 8 - Mock sash window with top hung casement*

- 3.7 Existing top hung casement windows to the west (front) elevation will be removed and replaced with Accoya factory finished single glazed sliding sash windows. Refer to application drawings 5561 (PL) 02B & 03A for details.

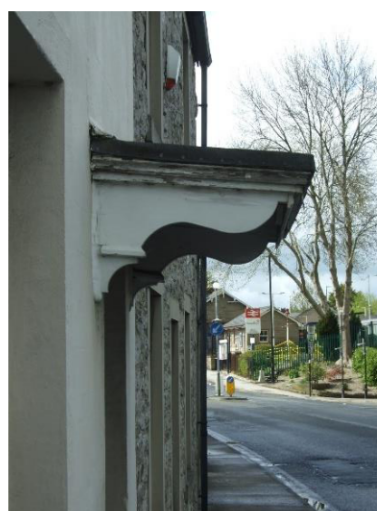
*Picture 9 - Timber hood to #13*
