Arboricultural Impact Assessment

Talbot Hotel
Talbot Street
Chipping
PR3 2QE

March 2022

Job no.	LTC115
Site	Talbot Hotel, Talbot Street, Chipping, PR3 2QE
Client	Sunderland Peacock & Associates Ltd.
Arboriculturist	Jennie Keighley PhD MSc MArborA
Local authority	Ribble Valley Borough Council
Date	7 March 2022
Issue	Final issue for planning

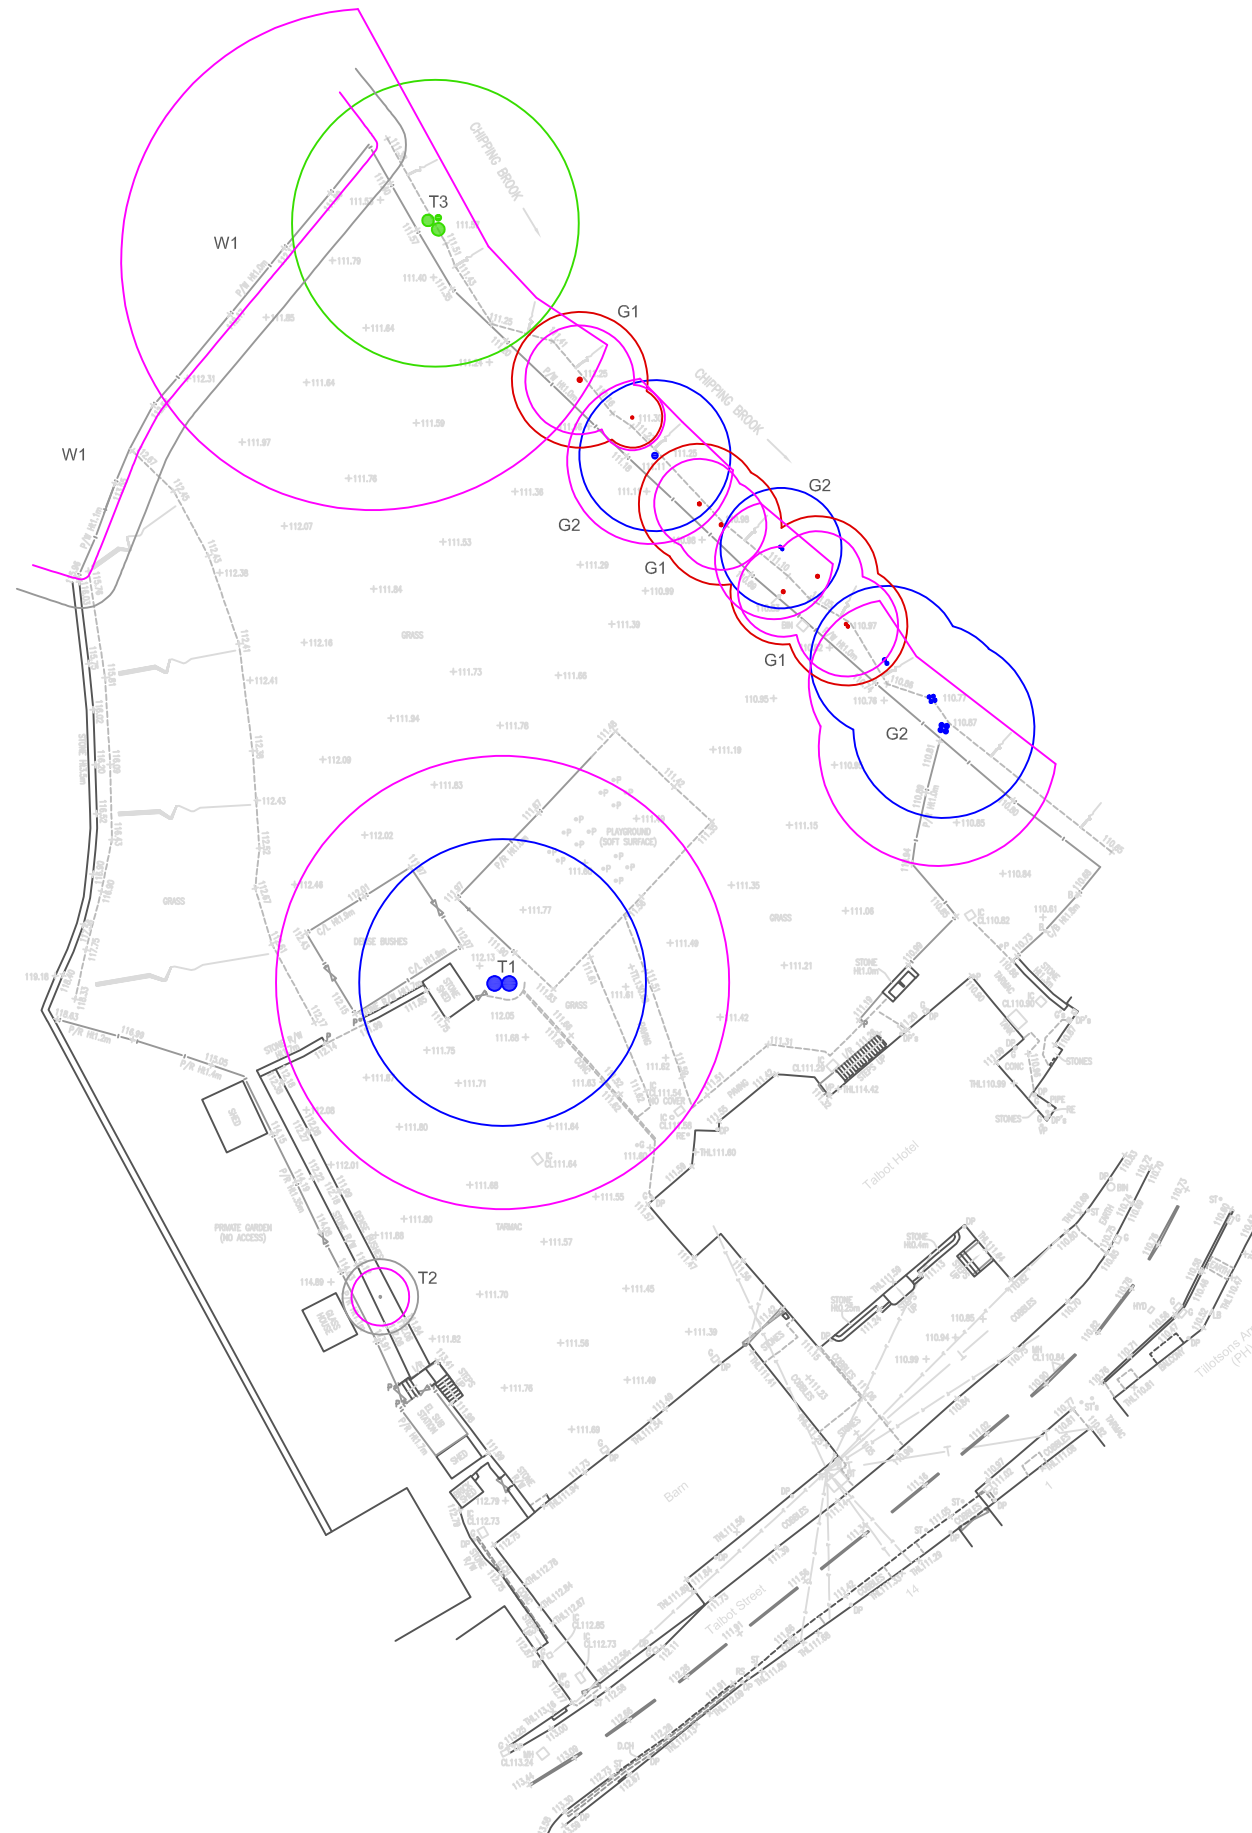
Drawing: LTC115-TSP

3.2 The survey identified three individual trees, two groups of trees and a woodland potentially within influencing distance of the proposed works. The positions of the surveyed trees in relation to the existing site are shown on the appended tree survey plan.

Tree Survey Schedule Summary		
ID No.	Species	Cat.
T1	Sycamore	B
T2	Cherry	C
T3	Sycamore	A
G1	≈ 7no. ash	U
G2	≈ 5no. sycamore	B
W1	Various	C

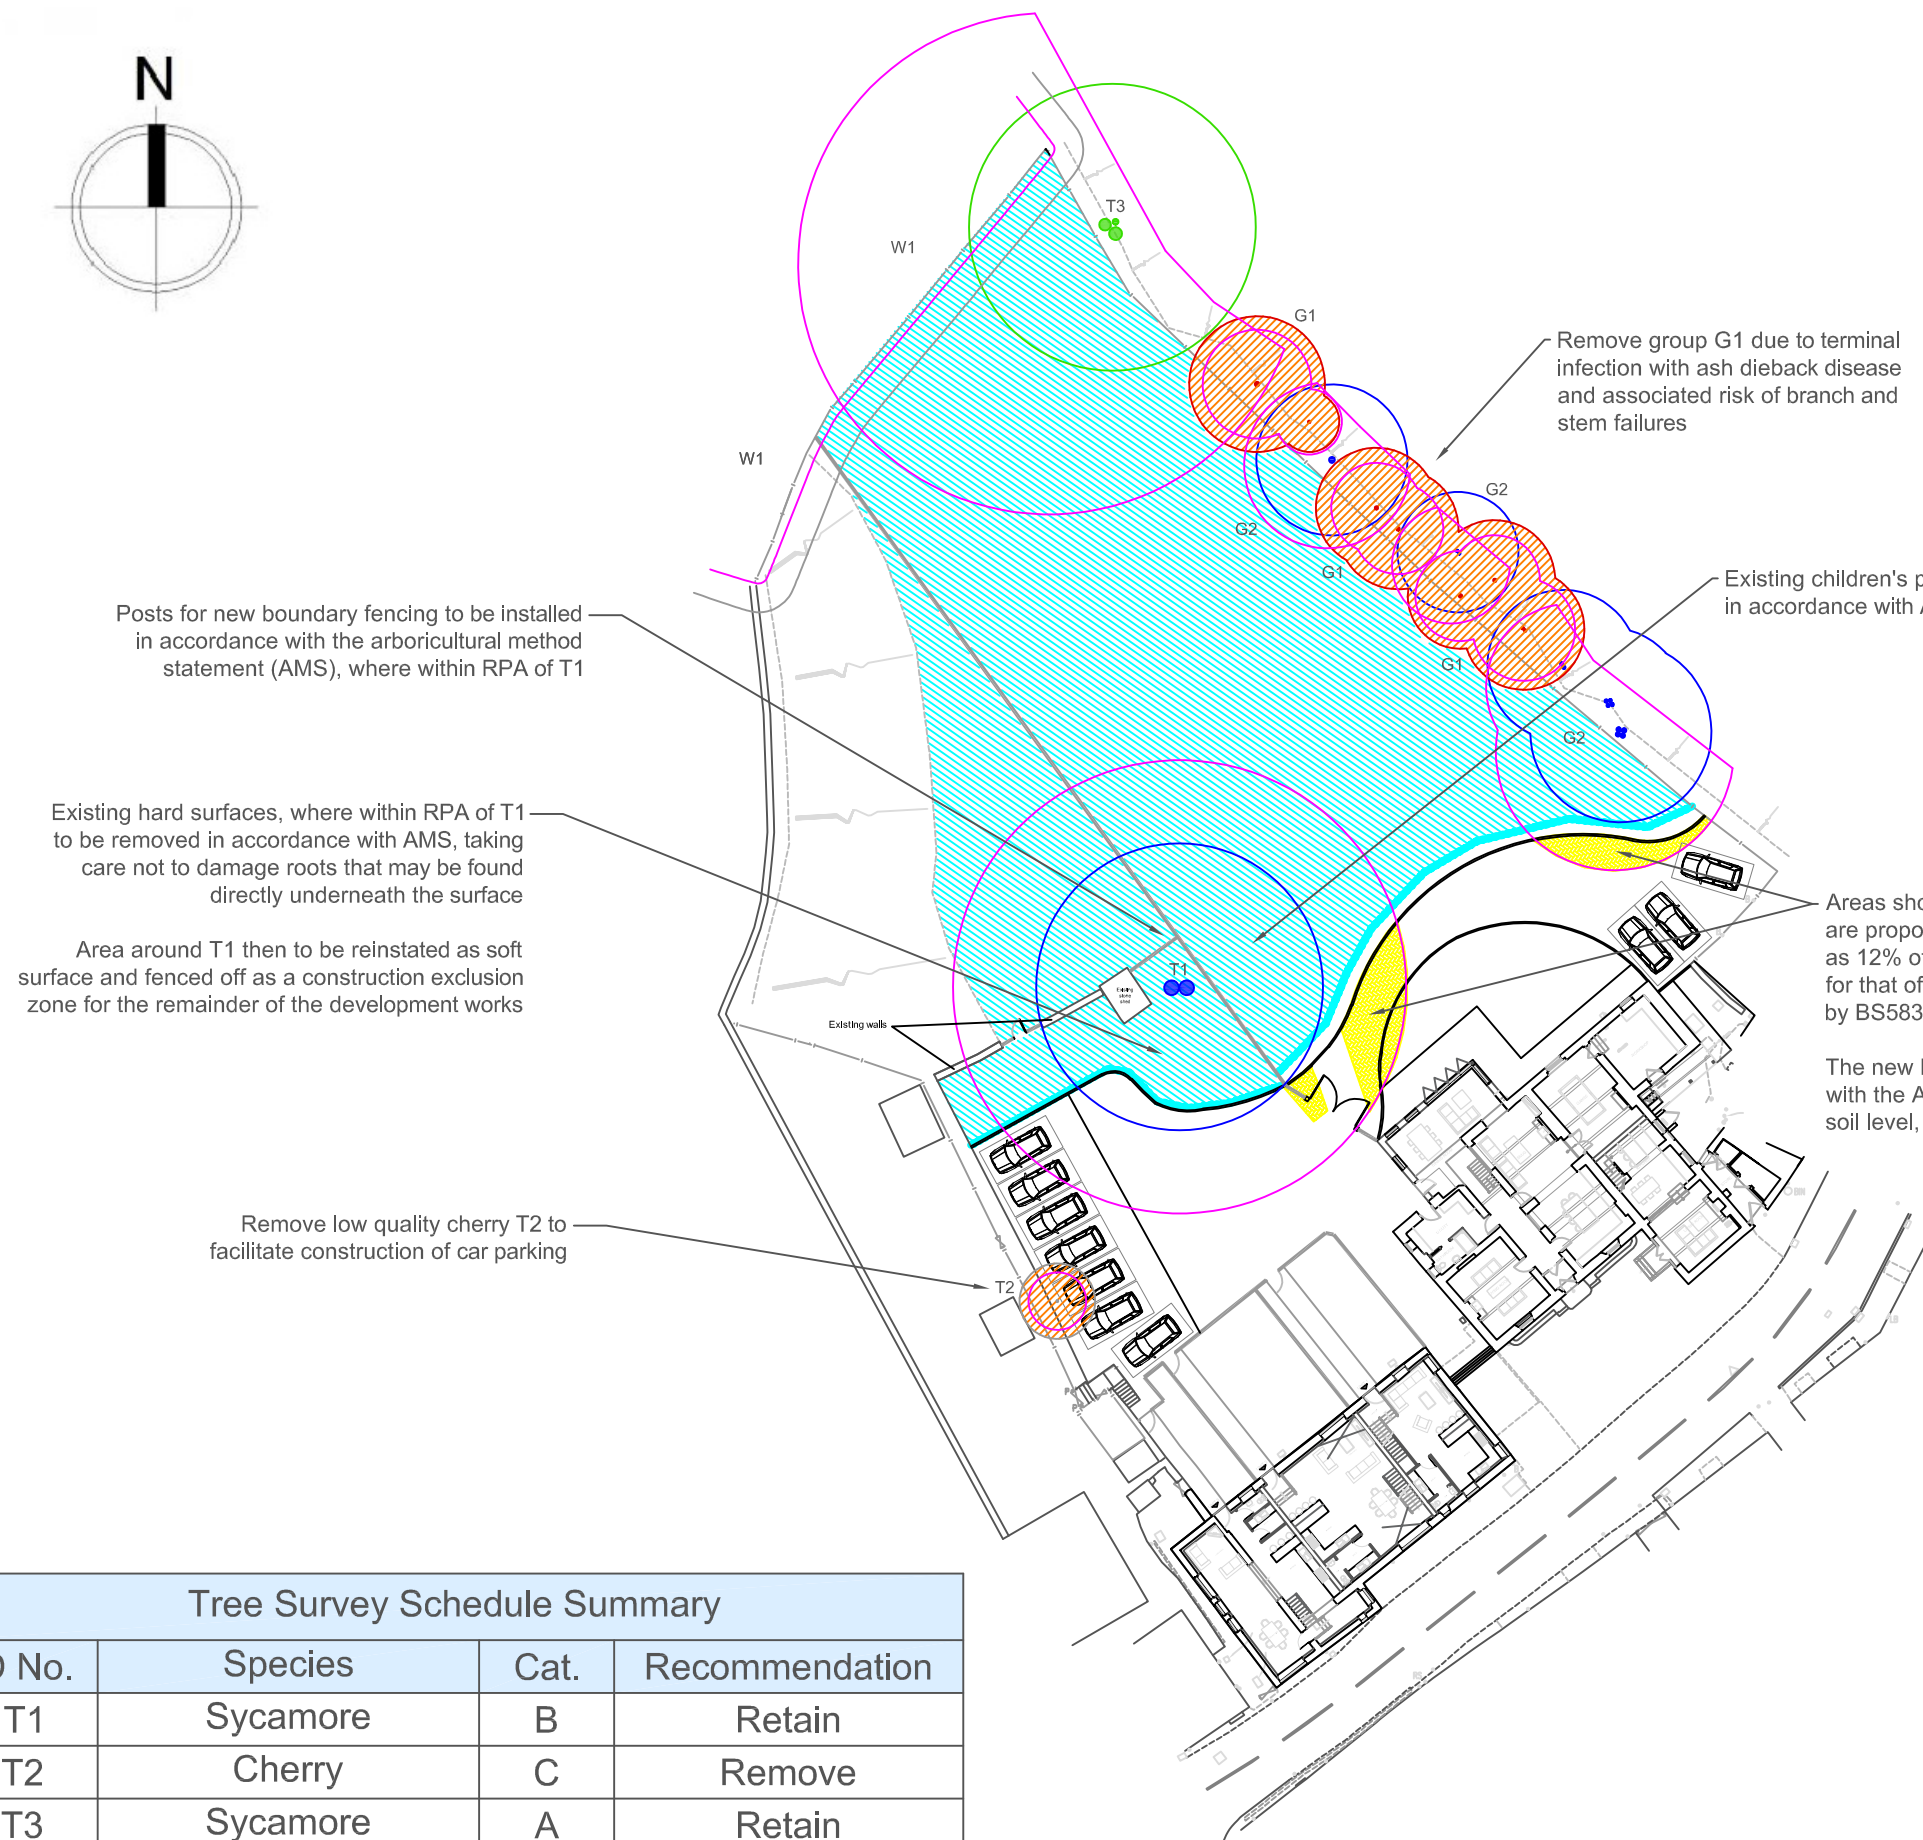
Drawing: LTC115-TPP

4.3 As shown on the appended tree protection plan and in Table 1, below, construction of the development as proposed will require the removal of one small, low quality cherry tree. Additionally, one U-category group is suffering from terminal infection with ash dieback disease and is recommended for removal for reasons unrelated to the development.

ID no.	BS5837 Category	Recommendation
T2	C	Remove in order to facilitate construction of car parking area
G1	U	Remove in full due to terminal infection with ash dieback disease and associated risk of branch and stem failures
Total arboricultural impacts		Removals: 1no. C-category tree 1no. U-category group (not development related)

- 1.4 The retained trees can be adequately protected by means of BS5837-specification tree protection fencing, which is to be laid-out as shown on the appended tree protection plan, and by following the tree protection recommendations made herein.

- 5.2 For the development in question, the default BS5837 (2012) tree protection fencing specification, as shown on the appended illustration, is expected to be suitable. The fencing is to be laid-out as indicated on the appended tree protection plan prior to any works on site, including deliveries, and shall remain in place until the development is complete. Once erected, the tree protection fencing should be labelled at regular intervals with all-weather notices stating 'TREE PROTECTION AREA - KEEP OUT!'.

Tree Survey Schedule Summary			
ID No.	Species	Cat.	Recommendation
T1	Sycamore	B	Retain
T2	Cherry	C	Remove
T3	Sycamore	A	Retain
G1	≈ 7no. ash	U	Remove
G2	≈ 5no. sycamore	B	Retain
W1	Various	C	Retain
