Appendix 2 - Preliminary Roost Assessment

Project: **Standen Phase 5 & 6**

Title: **Bat Roost Suitability Map**

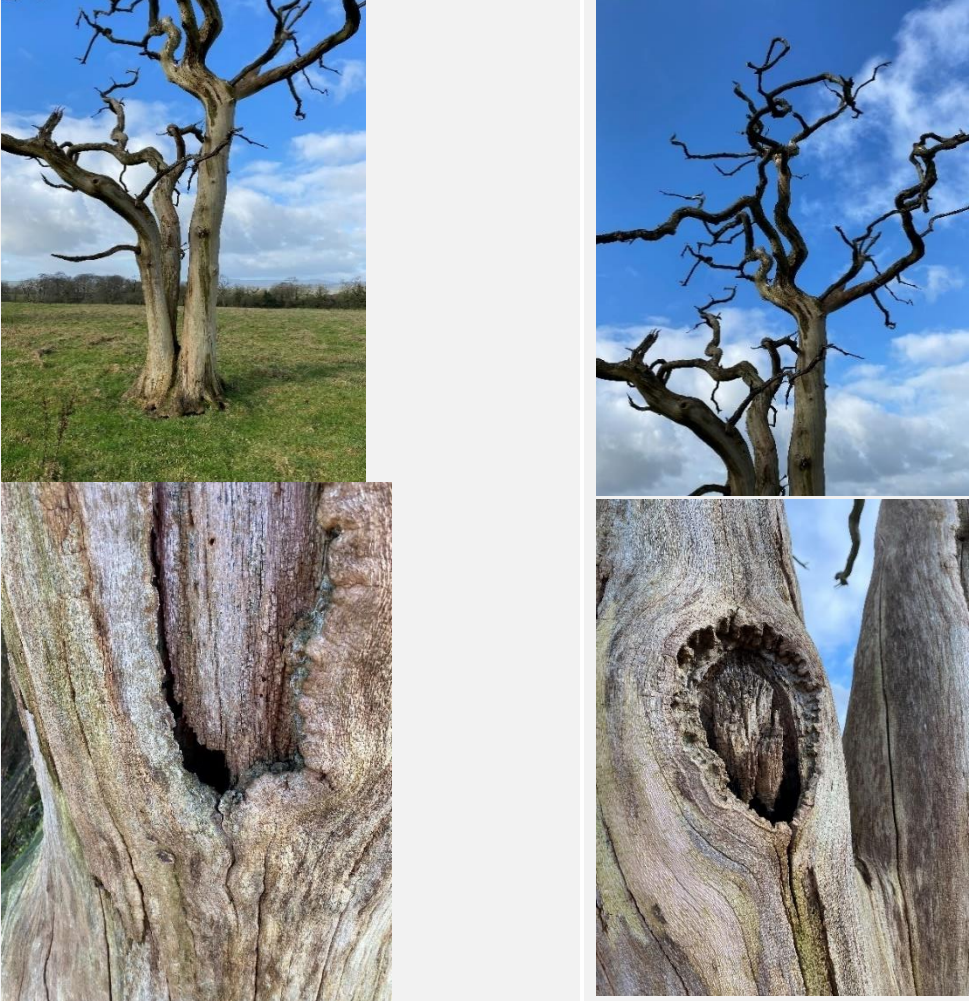
Building Reference	Description	Evidence	Category of Suitability
T5	T5 was a dead mature oak tree that had multiple crack and crevices that led into cavity within the stem of the tree.

High

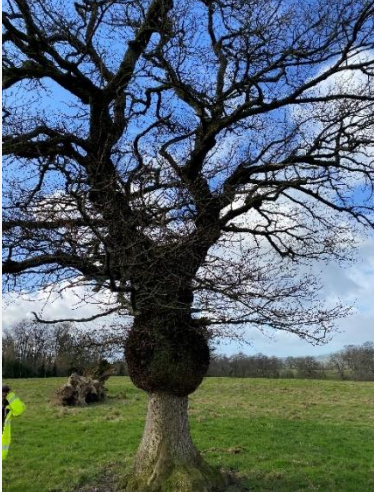
Building Reference	Description	Evidence	Category of Suitability
T6	T6 was a mature pedunculate oak that had cracks in the bark present but was unable to determine whether they led anywhere.

Low

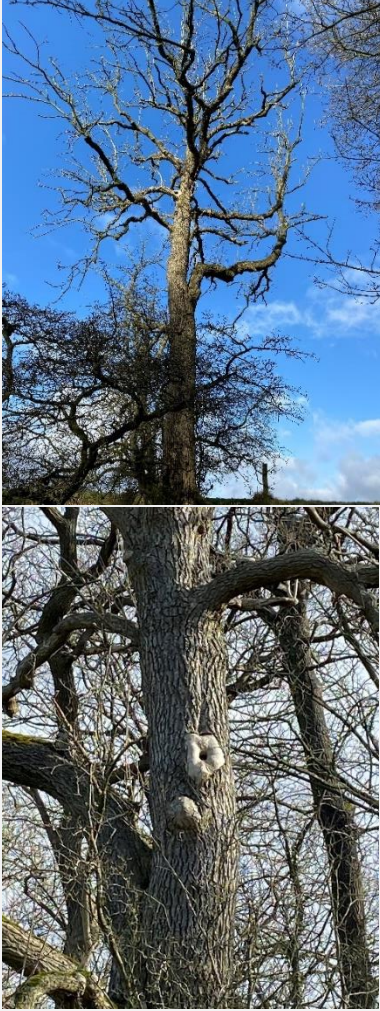
Building Reference	Description	Evidence	Category of Suitability
T7	<p>T7 was mature ash tree that had two knot wounds present on the southern and western aspect high in the canopy.</p>

<p>Moderate</p>

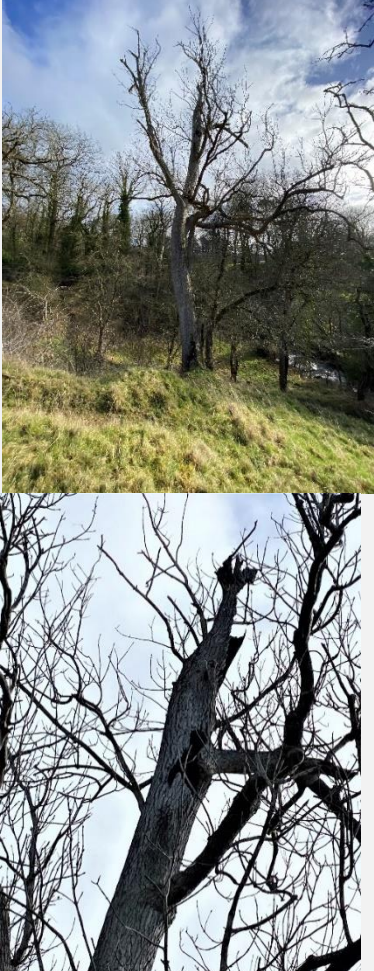
Building Reference	Description	Evidence	Category of Suitability
T8	T8 was a mature ash tree that had a knot wound present on the western aspect and a large crack at the apex of the tree stem.

Moderate

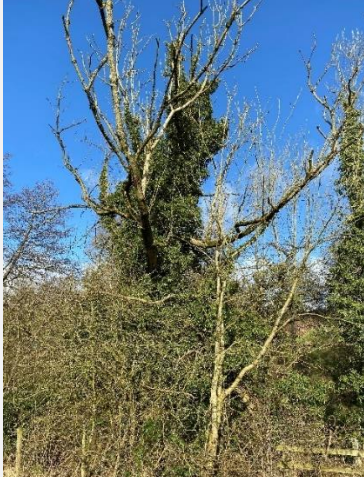
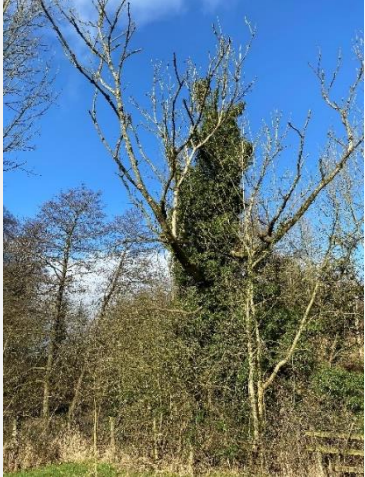
Building Reference	Description	Evidence		Category of Suitability		
T9	T9 was a mature ash tree that was covered in a dense growth of ivy preventing a more detailed inspection of the tree for other PRFs

Low

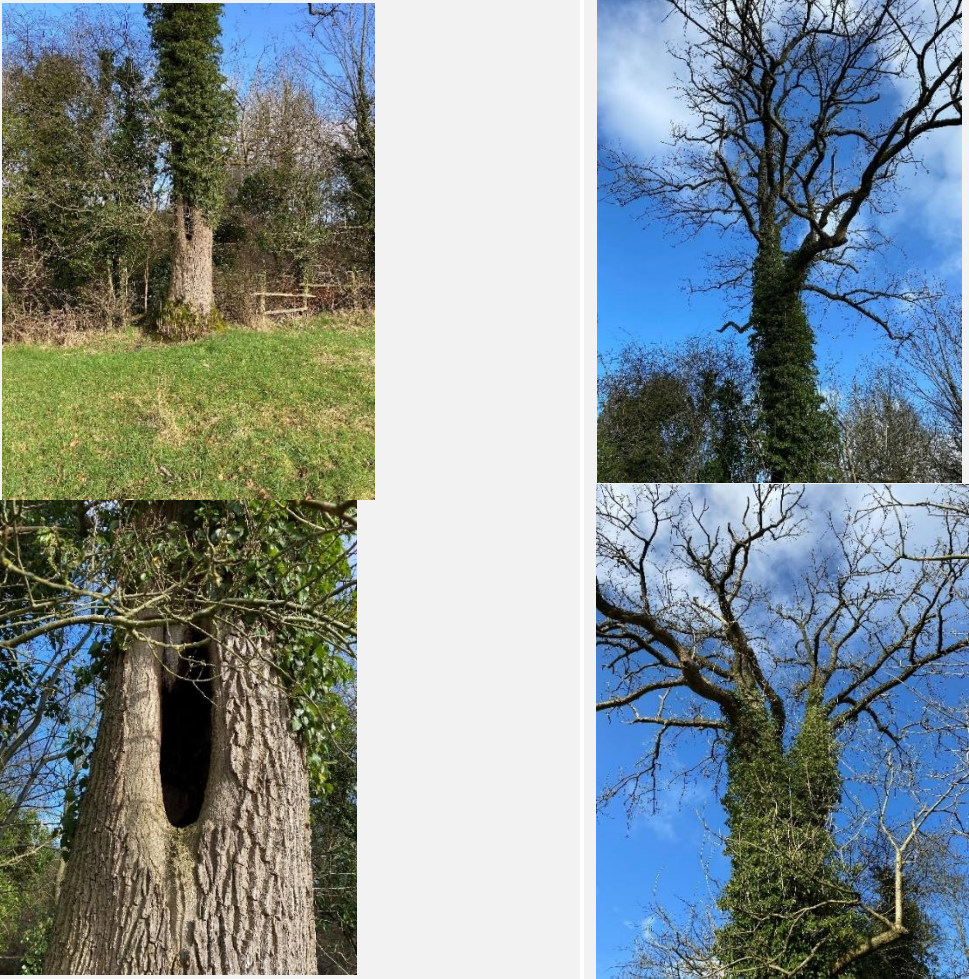
Building Reference	Description	Evidence	Category of Suitability
T10	<p>T10 was a mature ash tree with a dense growth of ivy covering the majority of the stem. A large wound from previous branch failure was present on the southern aspect at approximately 1.5m high.</p> <p>The large wound also offered potential barn owl nesting habitat.</p>

Low

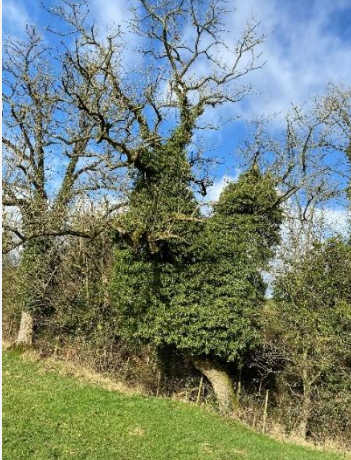
Building Reference	Description	Evidence		Category of Suitability	
T11	T11 was an early mature ash with a dense growth of ivy around the majority of the stem.

Low

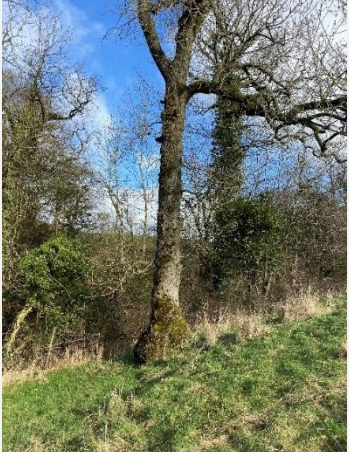
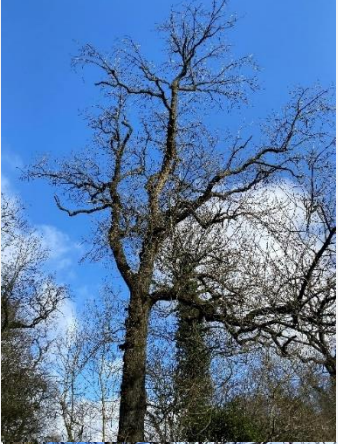
Building Reference	Description	Evidence		Category of Suitability
T12	T12 was an early mature elder tree with multiple cracks and crevices present on the branches towards the top of the tree.

Moderate

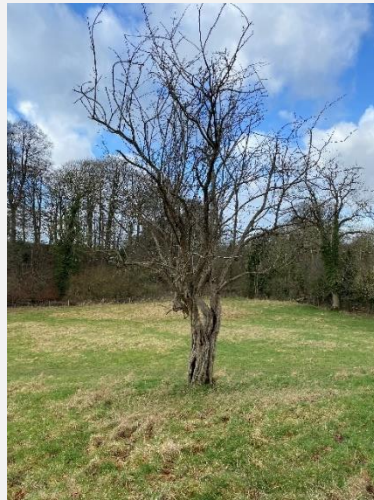
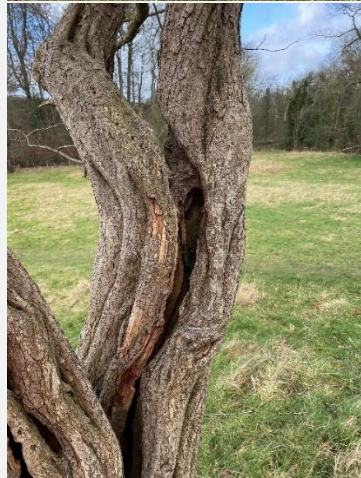
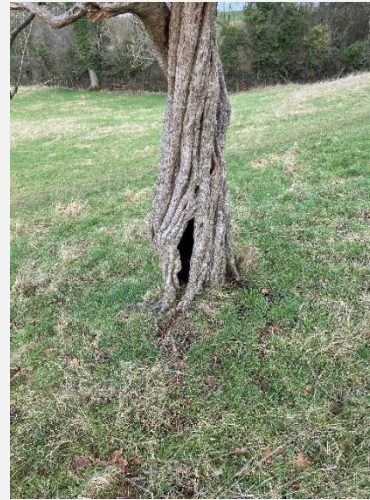
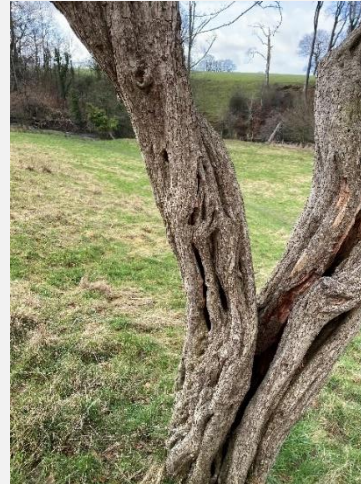
T13 was a small mature hawthorn tree with a with various cracks and crevices within the bark. The fork in the stem opens into a cavity which would allow rainwater to enter the cavity limiting the potential of the feature.

Low

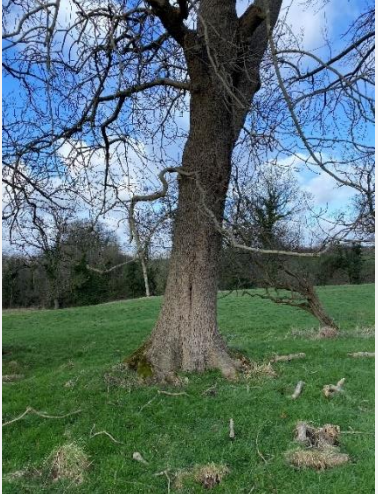
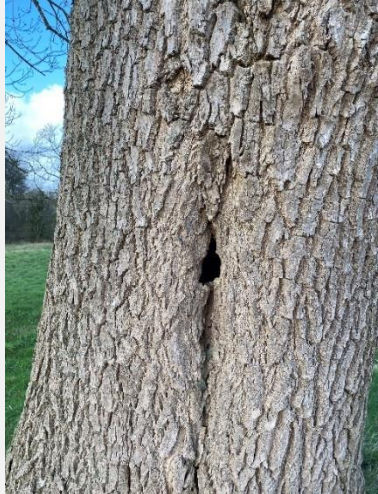
T14	<p>T14 was a mature ash tree with a single hole into the stem of the tree at approximately 1m on the eastern aspect of the tree. This hole led into a cavity within the tree.</p>

Low

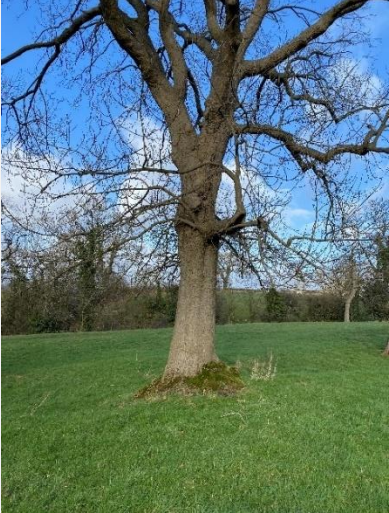
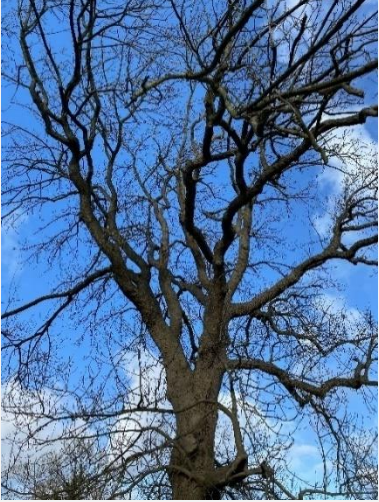
Building Reference	Description	Evidence		Category of Suitability	
T15	T15 was a mature pedunculate oak that had various cracks in the bark and a large wound at the end of a lower limb branch.

Moderate

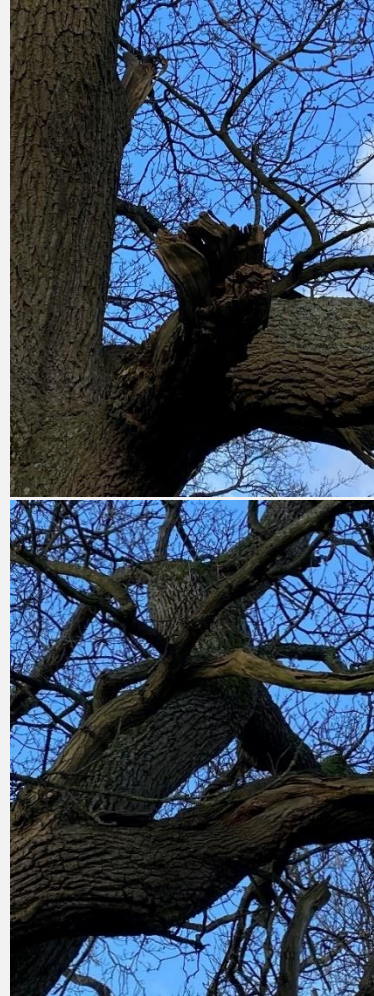
T16 was a mature pedunculate oak with multiple defects and wounds in bark and branches where previous branches had failed.

Moderate

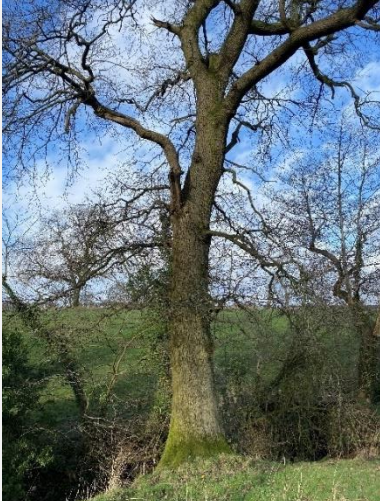
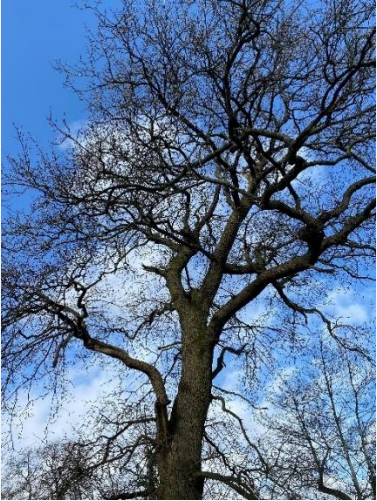
T17	<p>T17 is a mature elder tree that showed some failure with upper limbs offering potential cracks and knot wounds.</p>

Low

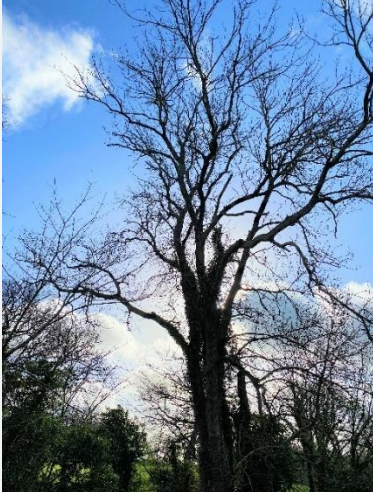
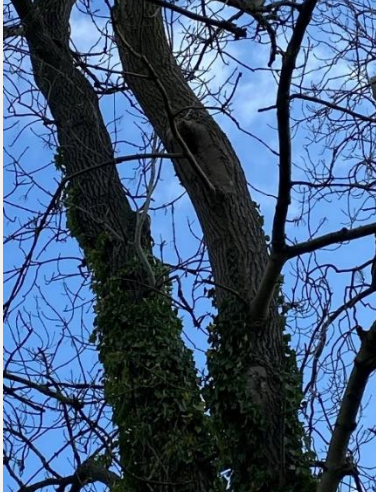
Building Reference	Description	Evidence		Category of Suitability	
T19	T19 is a double stemmed early mature alder tree with a knot wound in the upper southern stem. Sparse ivy also surrounds part of the northern stem.

Low

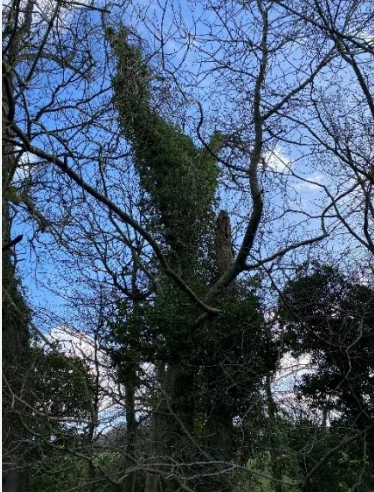
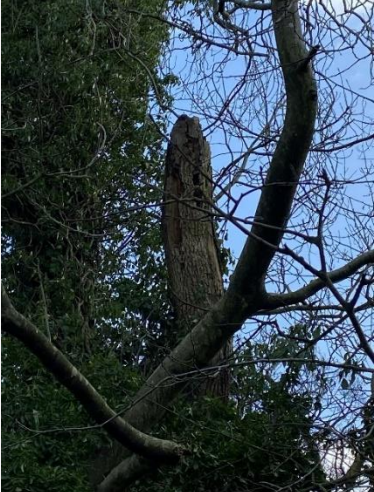
Building Reference	Description	Evidence		Category of Suitability	
T20	<p>T20 was an early mature alder tree with a forked stem. The southern stem was broken at approximately 5m with cracks and a cavity in the bark towards the break in the stem. The northern stem was covered in a dense growth of ivy.</p>

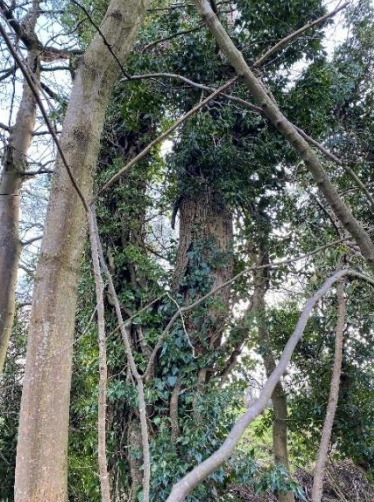
Low
T21	<p>T21 is a fork stemmed oak tree with cracks present in the bark underneath sparsely grown ivy.</p>

Low

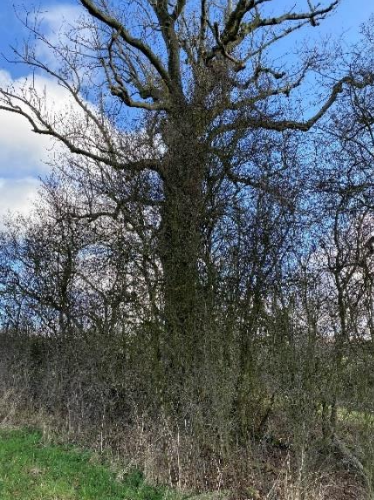
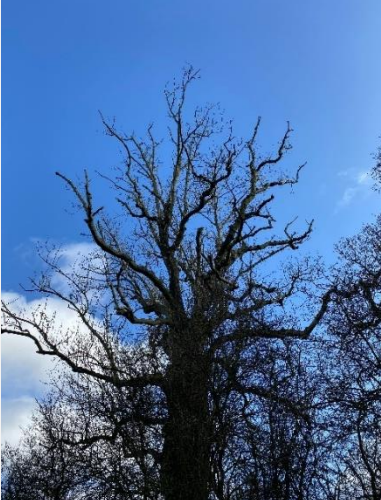
Building Reference	Description	Evidence		Category of Suitability	
T22	T22 is an early mature ash tree with a number of cracks in the bark around a broken branch in the canopy.

Low

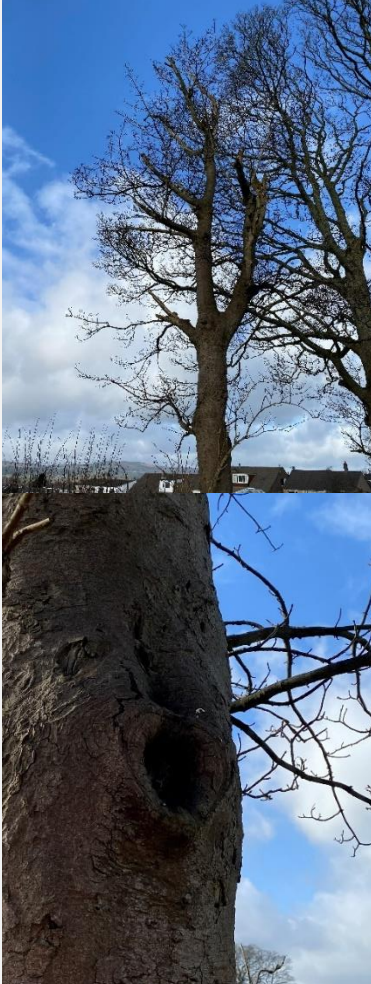
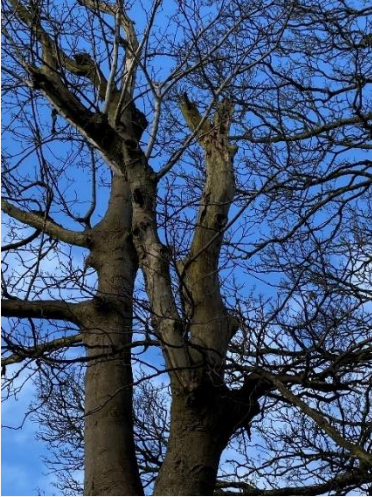
Building Reference	Description	Evidence		Category of Suitability
T23	T23 is an early mature sycamore tree with cracks present in a forked stem and a knot wound on the northern aspect.

Low

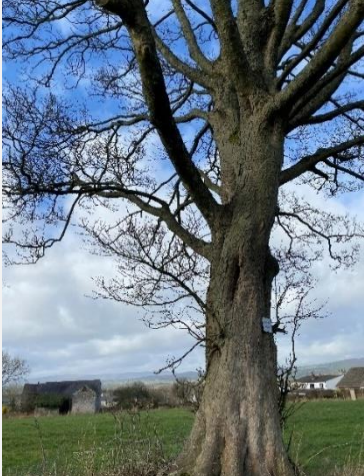
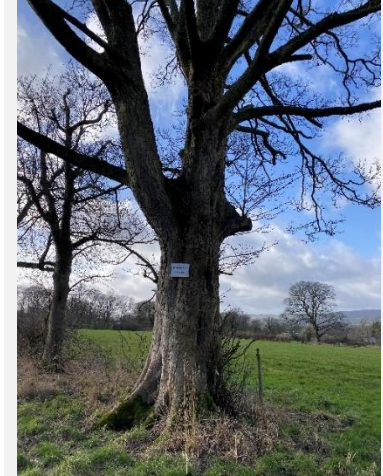
Building Reference	Description	Evidence		Category of Suitability
T24	T24 is a mature sycamore tree with a knot wound present on the northern aspect.

Low
