## ARBORICULTURAL REPORT (BS 5837:2012)

FOR  
PROPOSED DEVELOPMENT

LAND AT  
NORTHCOTE ROAD  
LANGHO  
BLACKBURN  
BB6 8BG

Job Number 4986

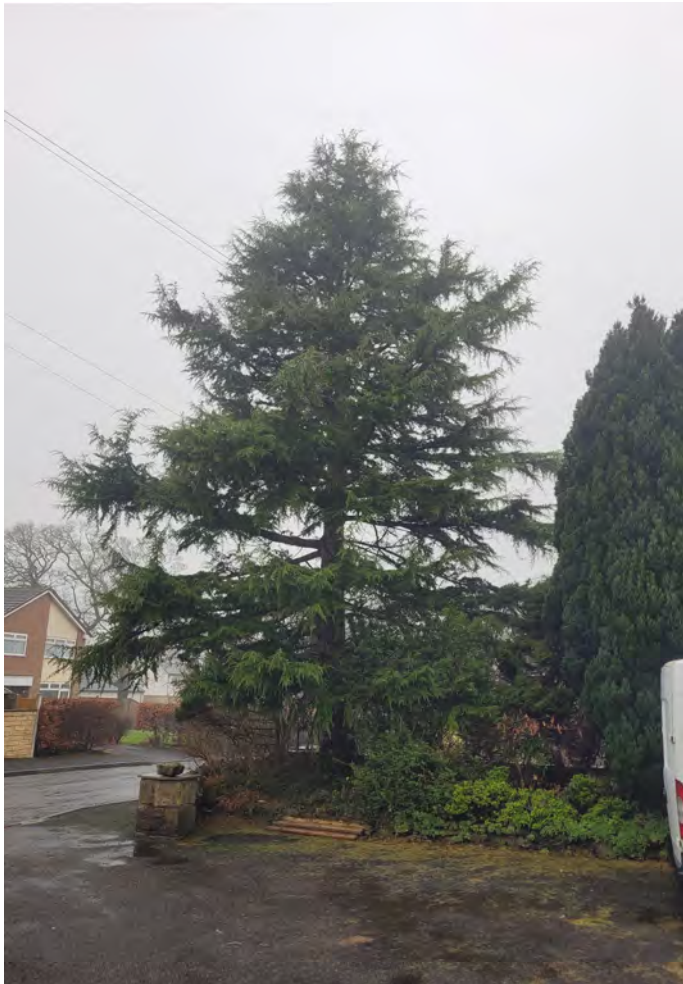
T19	Deodar Cedar	590	10	M	4	5	5	6	1.5	B	A well-shaped specimen located within the front garden of the adjacent property. Good vigour. Evidence of previous height reduction works.	n/a	20+	B2	157.48	7.08

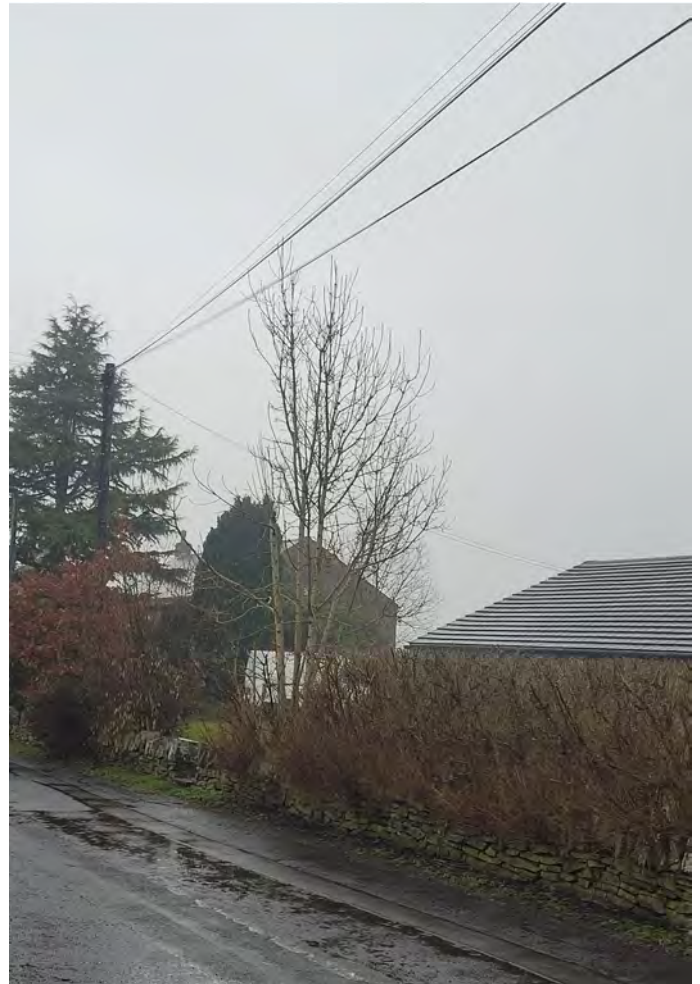
Arboricultural Data Sheet: Land at Northcote Road, Langho, Blackburn, BB6 8BG											Date of Survey: 03/03/22		Weather: Inclement		Surveyor: PM		
Crown C = Crown Clearance; Cond R = Condition Rating; ERC (Yrs) = Estimated Remaining Contribution; TQRA = Tree Quality Category Rating; RPA (m²) = Root Protection Area (m²) Recommended works should be carried out to the <i>British Standard Recommendations for Tree Work, BS 3998:2010</i>																	
Tree No.	Species	Dbh (mm)	Height (m)	Age	Crown Spread				Crown C	Cond R	Observations and Comments	Preliminary Recommendations	ERC (Yrs)	TQC R	RPA (m²)	RPA Circle Radius (m)	
					N	E	S	W									
T1	Ash	300	6	SM	2	3	2	2	1.8	B/C	A minor multi-stemmed specimen within hedge. Showing some signs of stress in crown, most likely due to Ash Dieback. Previously pruned from BT lines.	n/a	5-10	U	40.72	3.60	
T2	Ash	300	6	SM	2	3	3	2	2	B/C	A minor multi-stemmed specimen within hedge. Showing some signs of stress in crown, most likely due to Ash Dieback.	n/a	5-10	U	40.72	3.60

Tree No.	Proposed Works
T1, T2, H1, T3, T11 & T12	Fell to ground level and remove stumps.
T13, T14, T15 & T16	Remove significant deadwood and broken branches.

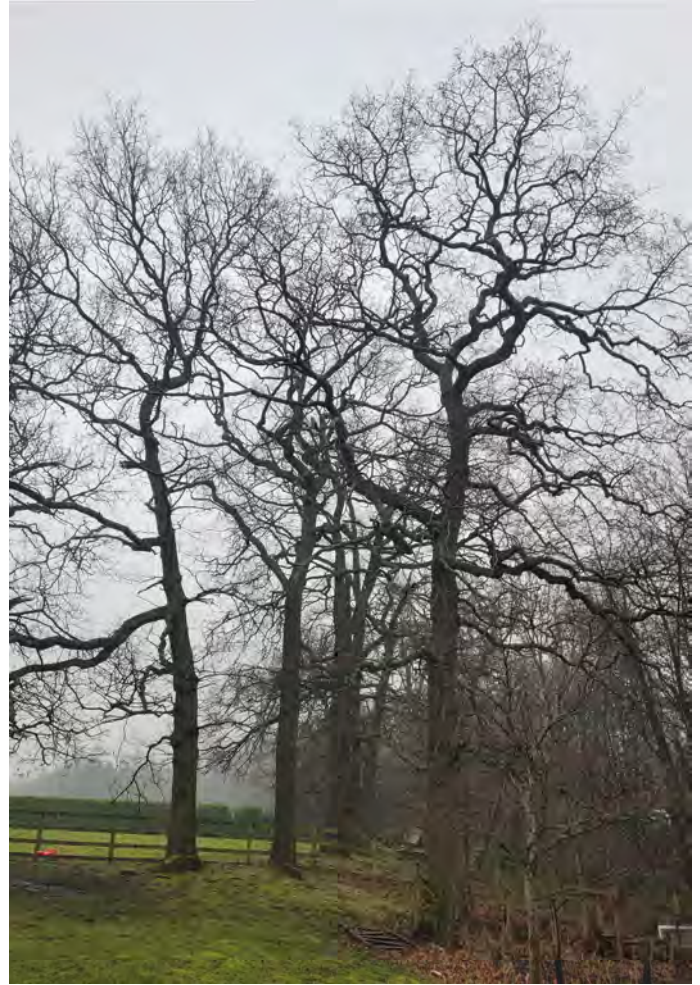
T13 - T16

- 5.2.3 The Oak trees T13, T15 & T16 have typical deadwood and broken branches present but are in good condition for their age and species. Some remedial works will be required in order to remove the most significant deadwood, which does not require consent under the TPO. None of the canopies are over the development so no pruning will be required in order to facilitate development.

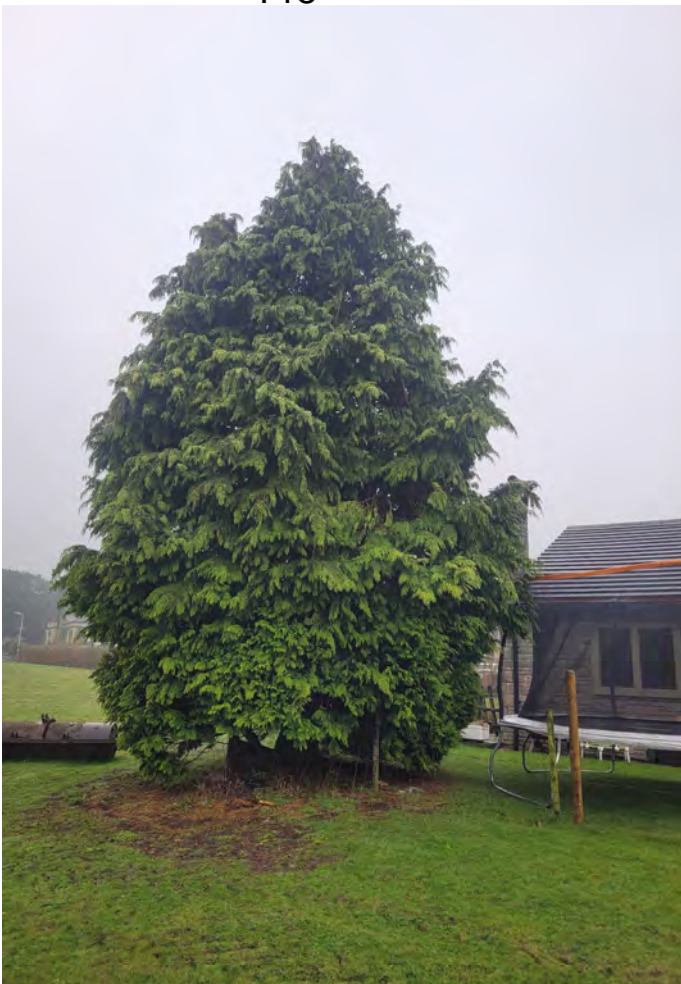
- 5.2.1 The above data table identifies that T18 is shown to have development within its shown Root Protection Area (RPA) due to new surfacing.
- 5.2.2 However, this intrusion is less than 20% of the overall RPA and far enough away from the buttress area not to cause too much root damage. This species is tolerant of some root intrusion and should not affect it long term. Some minor trimming back of foliage may be required for the new car parking space.
