WOODFOLD PARK STUD, WOODFOLD PARK

Preliminary Roost Assessment Report

May 2022

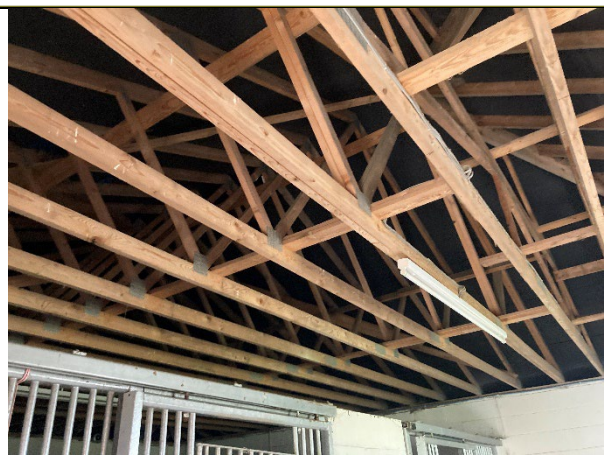
Table 3.1 Building Photographs

Feature	Photograph
Both buildings were of similar construction and condition, comprising stables.	 
The overhanging eaves were well-sealed with no potential access points or PRFs observed.	 
Eastern stable block.	 
Potential access point relating to gaps in the wall

Exposed roof structure with thin timber beams
