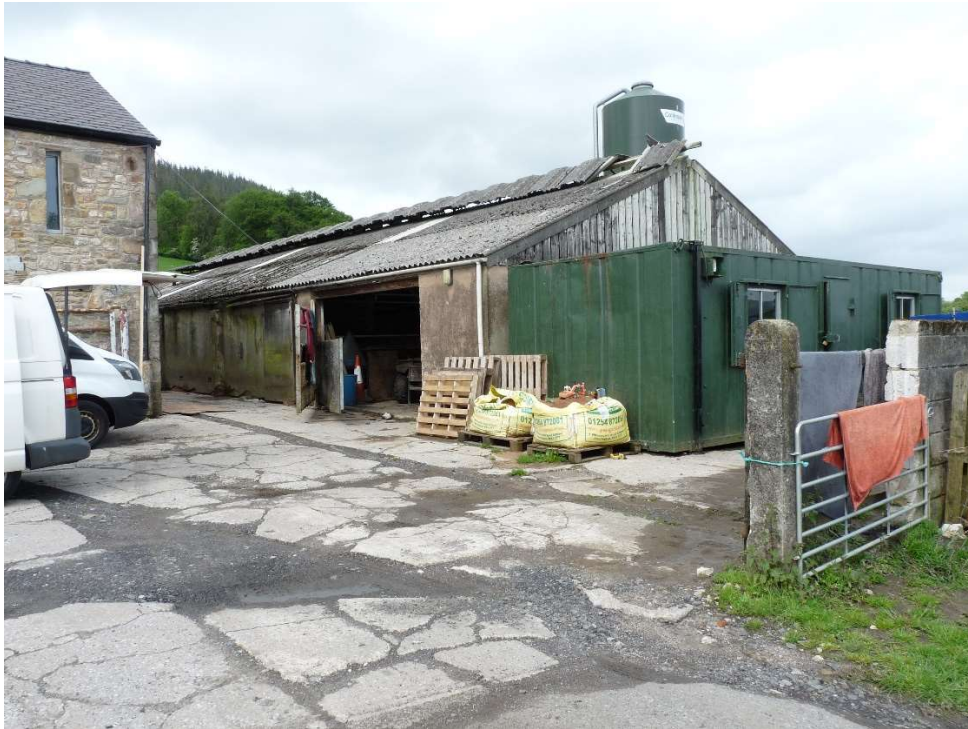
Entering site office and wall to be removed, note storm damage to roof

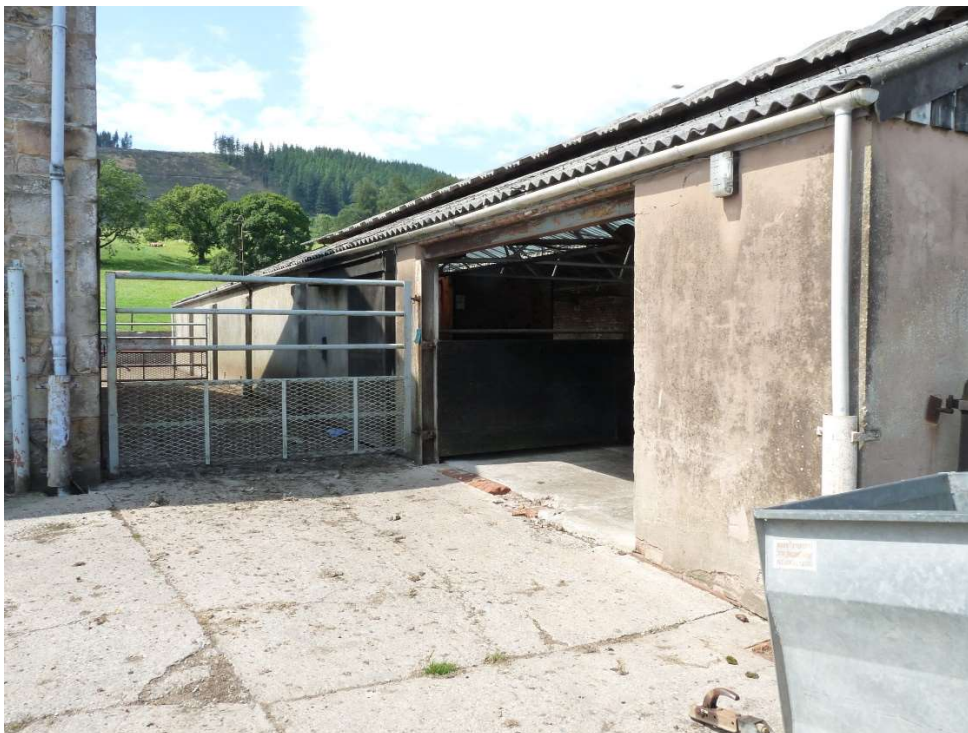
Side elevation building demolished, proposed reduced 3.2 m. Not secure

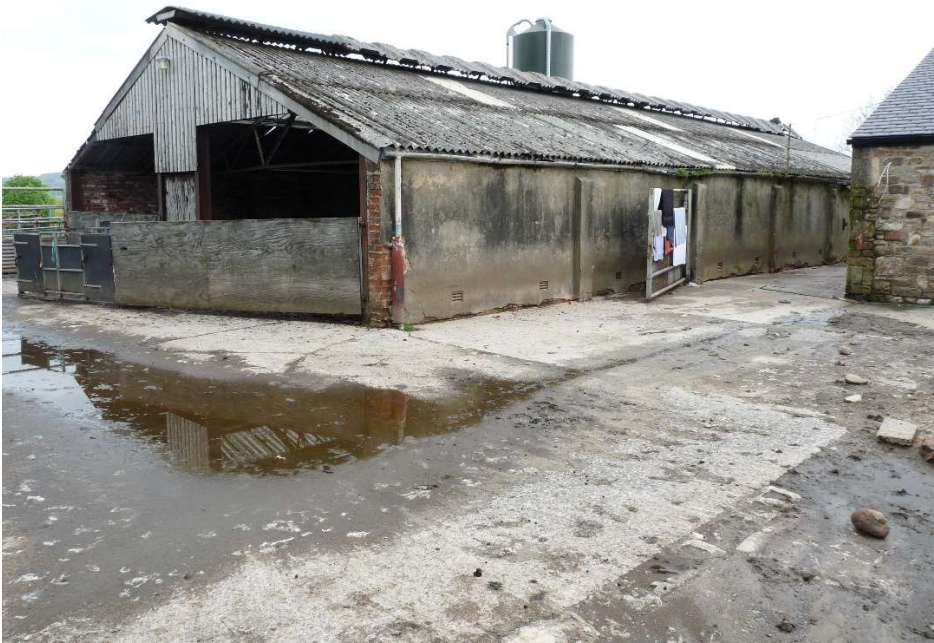
Rear elevation building width reduced 3.2 m

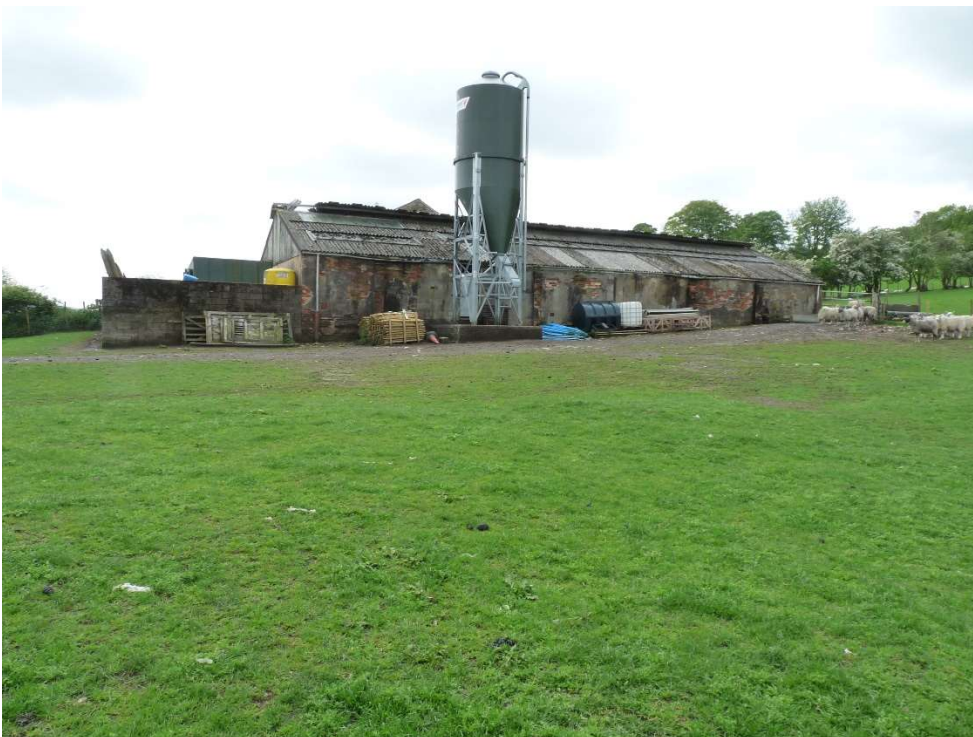
Elevation to field silo, portacabin, lorry and wall removed

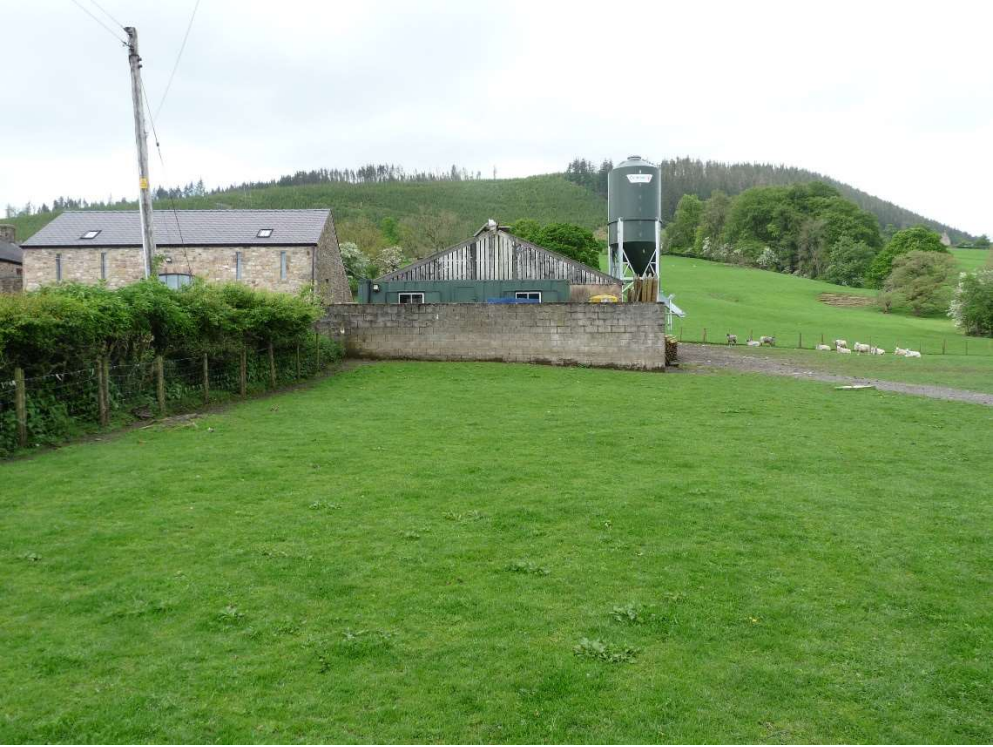
Front from field silo,office,loo removed wall changed to stone

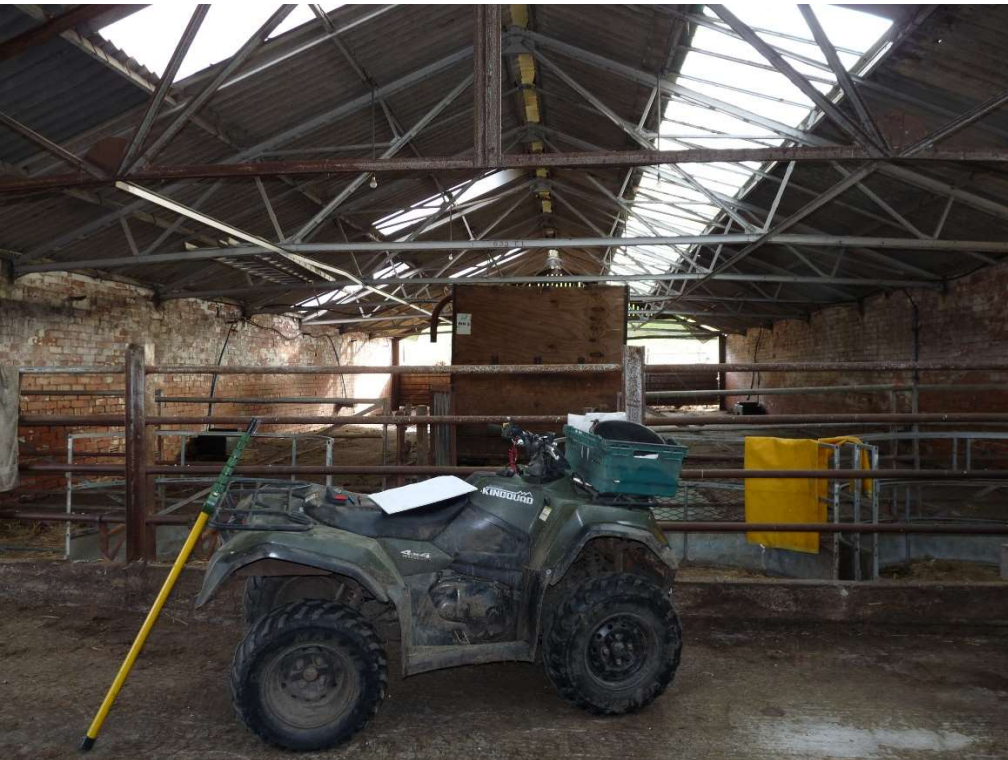
Internal structure quad storage not secure

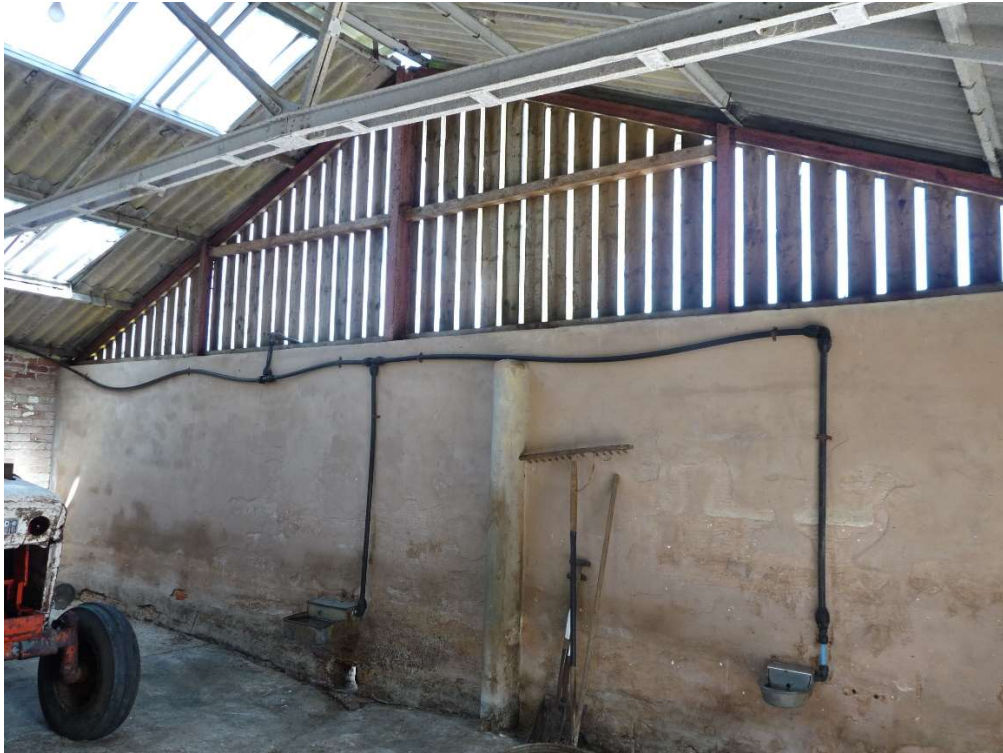
Internal wall finish machine storage not secure

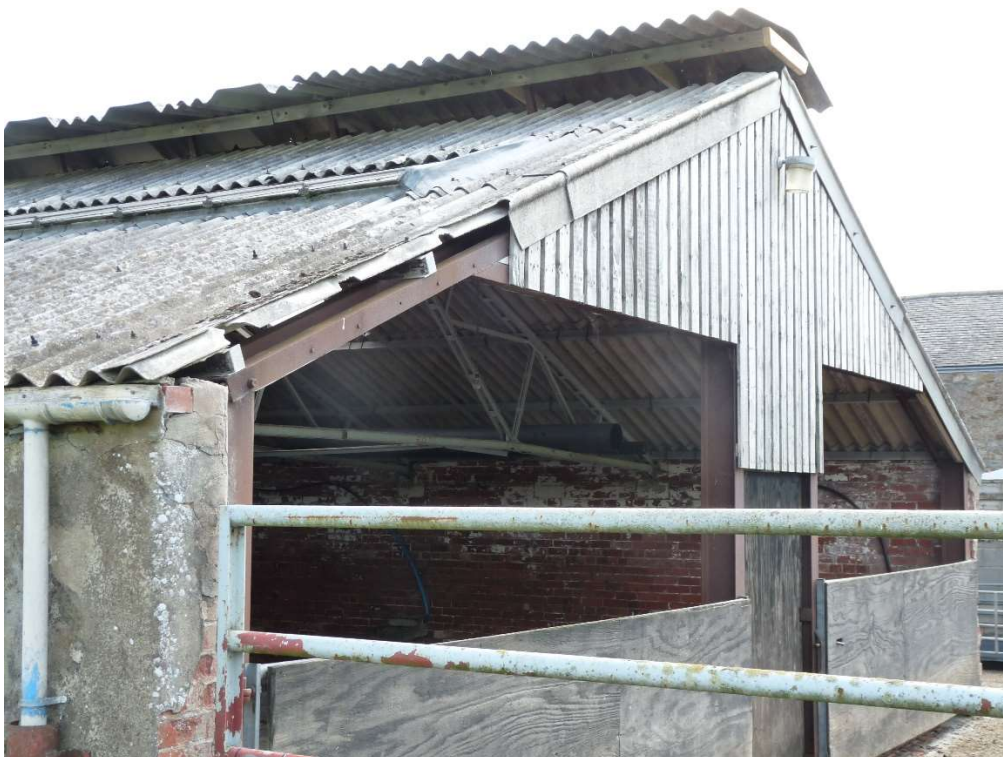
Storm damage
