Bat Survey Report

2 Beacon View, Longridge, Preston, PR3 2NB

11th October 2022

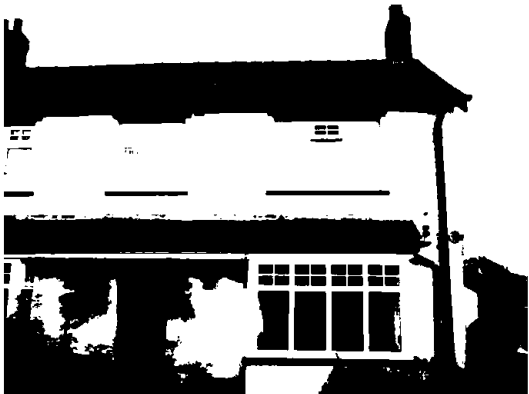
The only identified PRF related to two tiles to the rear of the property, one above the conservatory with a gap beneath and a second relating to newly replaced tiles, one that has dislodged. The gaps associated with the tiles are large enough to accommodate crevice dwelling bats such as common pipistrelle *Pipistrellus pipistrellus*.

Plate 2: Rear view of property with PRF associated with two tiles. No bat droppings stuck to walls or windows.	Plate 4: Fascia boarding at rear of house has no gaps beneath, it is fully sealed to the wall. No bat droppings stuck to walls or windows.
